Re: RCRA Corrective Action Administrative Order on Consent (AOC)
Progress Report 71, Fourth Quarter 2018
GM GPS – Bedford Facility, ID 006036099, Docket No. RCRA 05 2017 0011
Bedford, Indiana

Appendix A

Cover System Inspection Fourth Quarter 2018

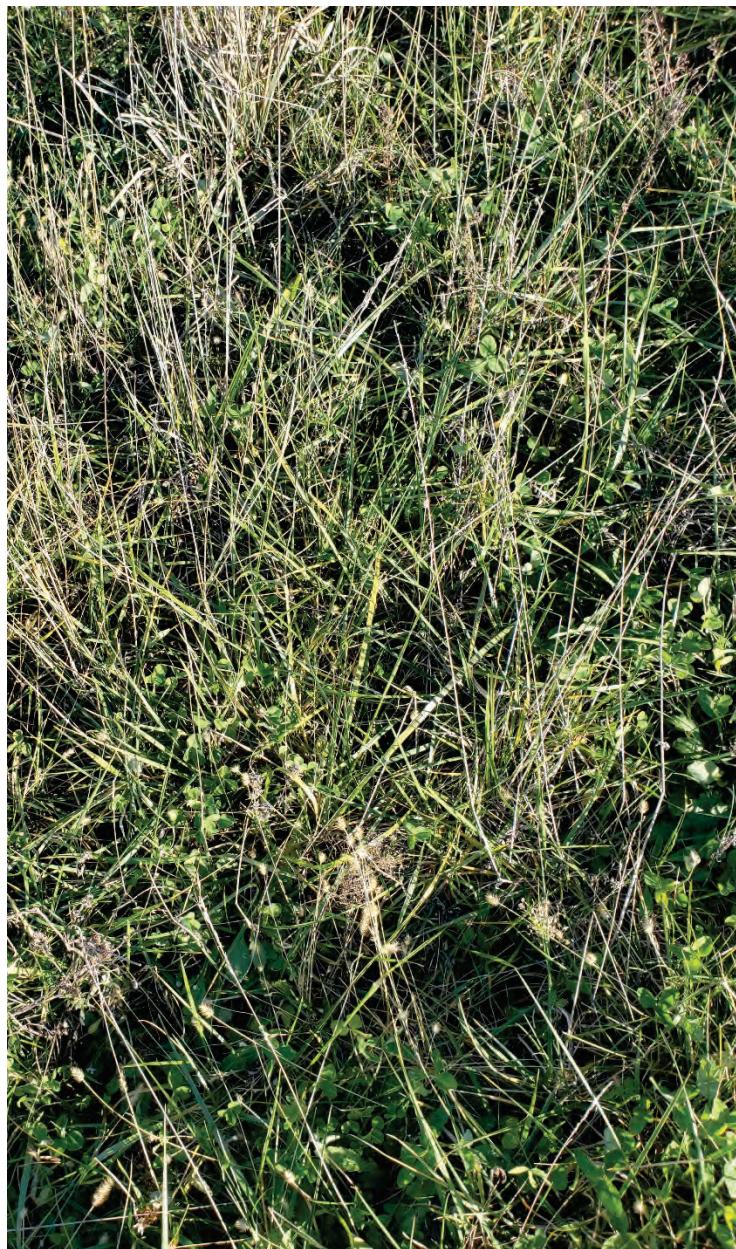
Photo 1: Vegetation along EV2 facing southeast

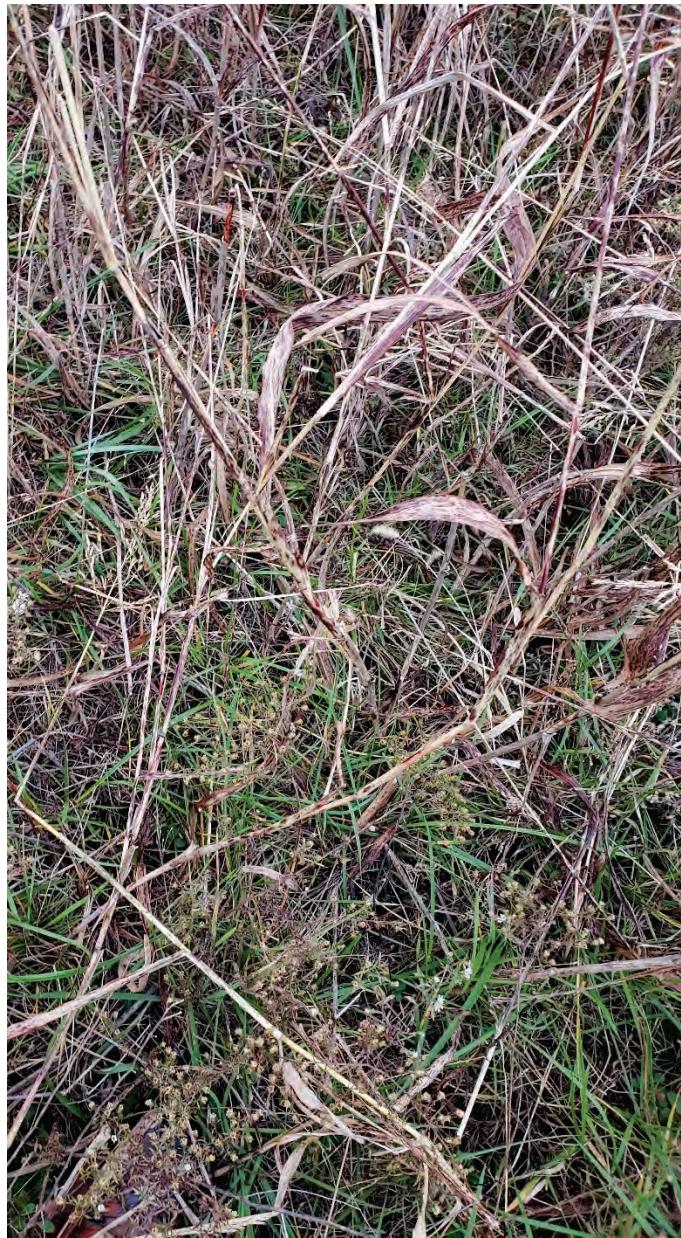
Photo 2: EV3 East Plant Cover facing southeast

ITEM	TYPES OF PROBLEMS	CHECKED		DETAILED ACTIONS REQUIRED	DATE AND NATURE OF ACTIONS COMPLETED
		NO PROBLEMS	CORRECTIVE ACTION REQUIRED		
VEGETATED SOIL COVER SYSTEM (CONTINUED)					
	Transect EV3	- QUALITY OF VEGETATIVE COVER - LENGTH OF GRASS - DEAD/DYING GRASS - GRASS COVERAGE - NOXIOUS WEEDS	X		heavy weed growth and some bare spots

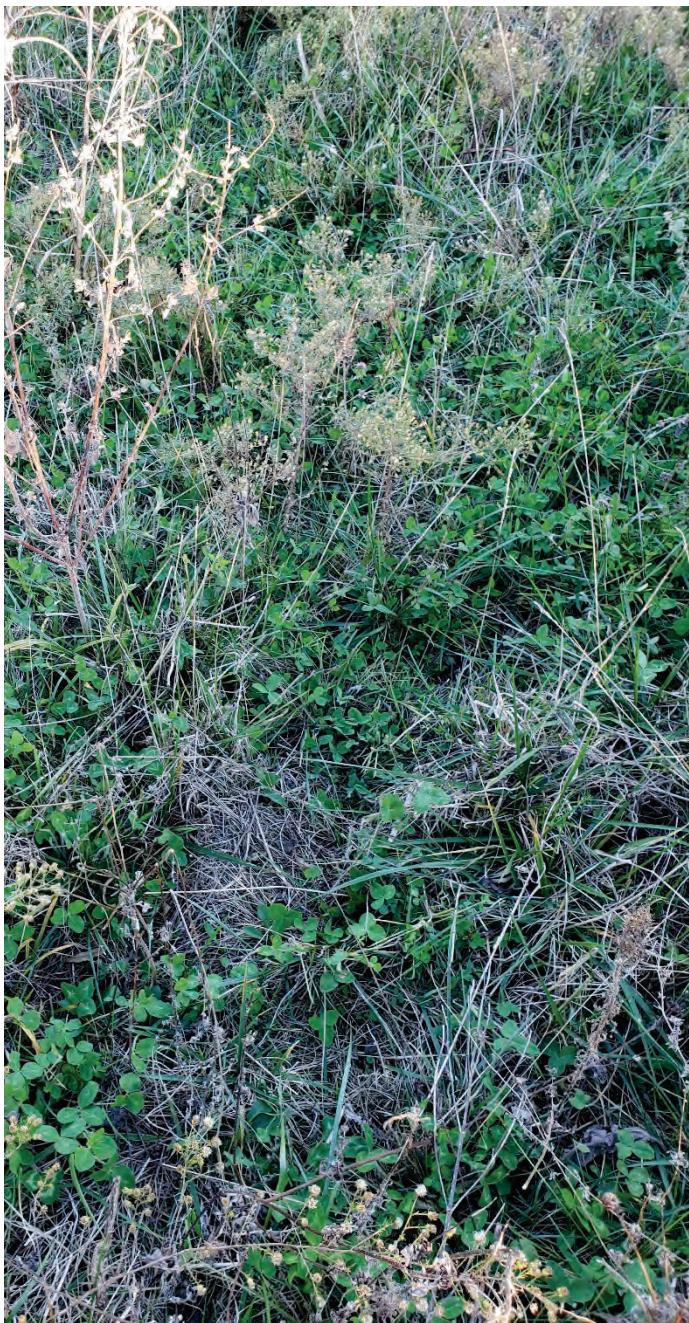
Photo 3: Vegetation at ES1 along EV1 facing southeast

ITEM	TYPES OF PROBLEMS	CHECKED		DETAILED ACTIONS REQUIRED	DATE AND NATURE OF ACTIONS COMPLETED
		NO PROBLEMS	CORRECTIVE ACTION REQUIRED		
SWALE/DRAINAGE DITCHES					
	<u>Transect ES1</u>	- QUALITY OF VEGETATIVE COVER - LENGTH OF GRASS - DEAD/DYING GRASS - GRASS COVERAGE - NOXIOUS WEEDS	X		heavy weed growth and some bare spots

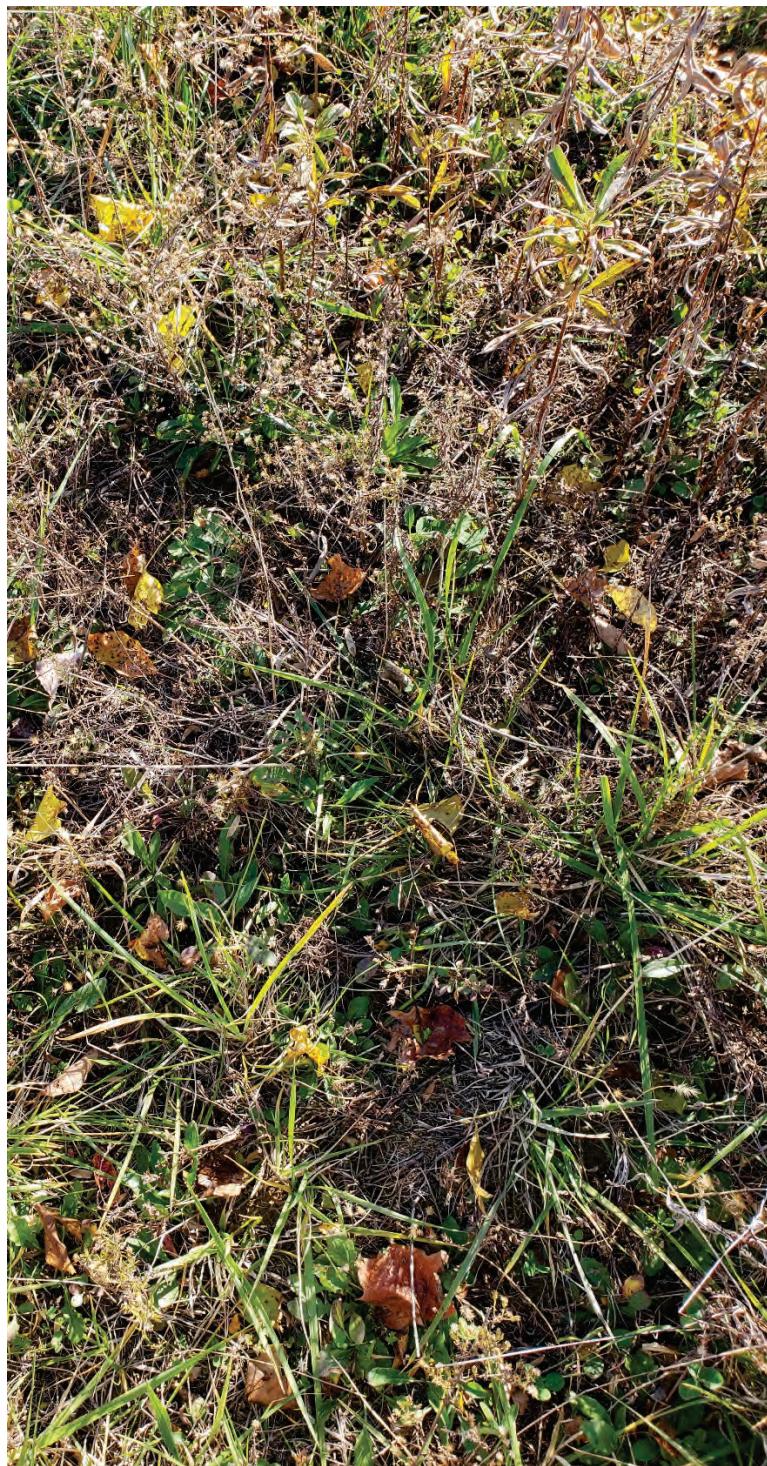
Photo 4: EV3 at ES9 East Plant Cover area facing southeast

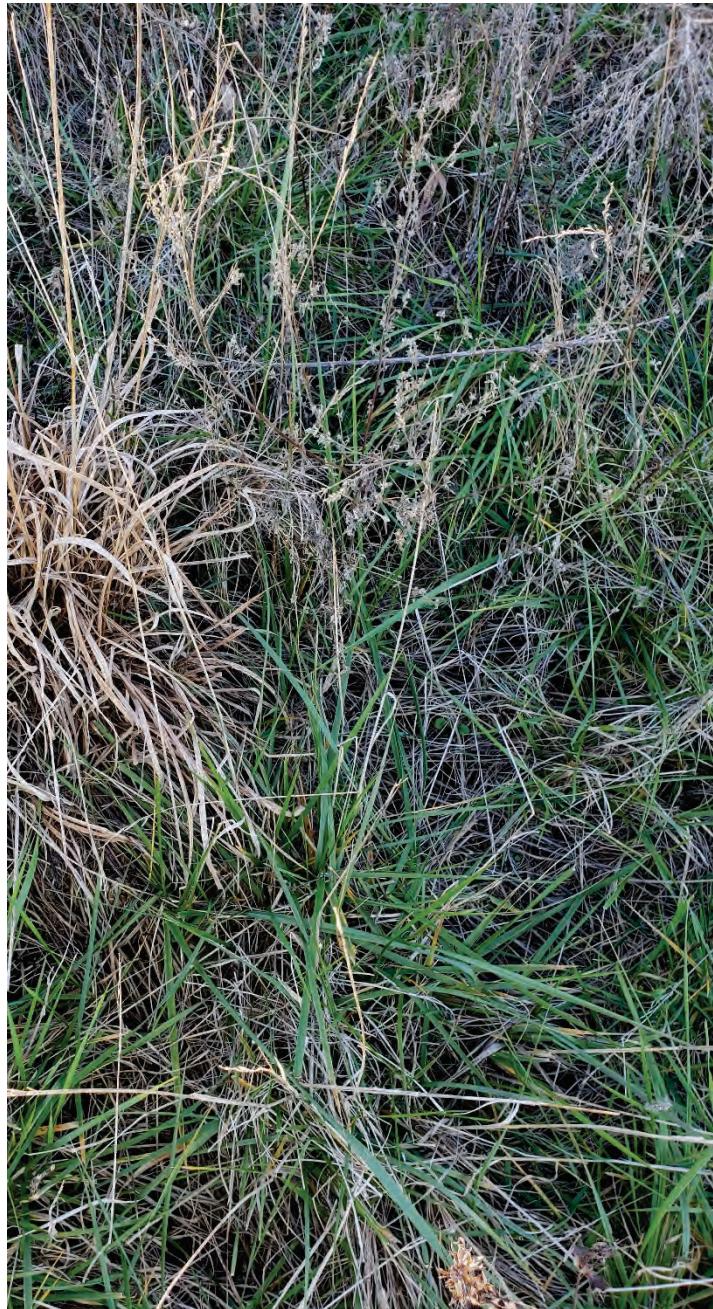
Photo 5: ES2 East Plant Area Cover facing southwest

- EROSION	X		
		- OBSTRUCTIONS	X		
		- CULVERT/CATCH BASIN - OBSTRUCTIONS - SEDIMENT ACCUMULATION	X		
		- SIGNS OF BURROWING BY ANIMALS	X		
		- ROOTING OF TREES	X		
	<u>Transect ES2</u>	- QUALITY OF VEGETATIVE COVER - LENGTH OF GRASS - DEAD/DYING GRASS - GRASS COVERAGE - NOXIOUS WEEDS	X		heavy weed growth and some bare spots

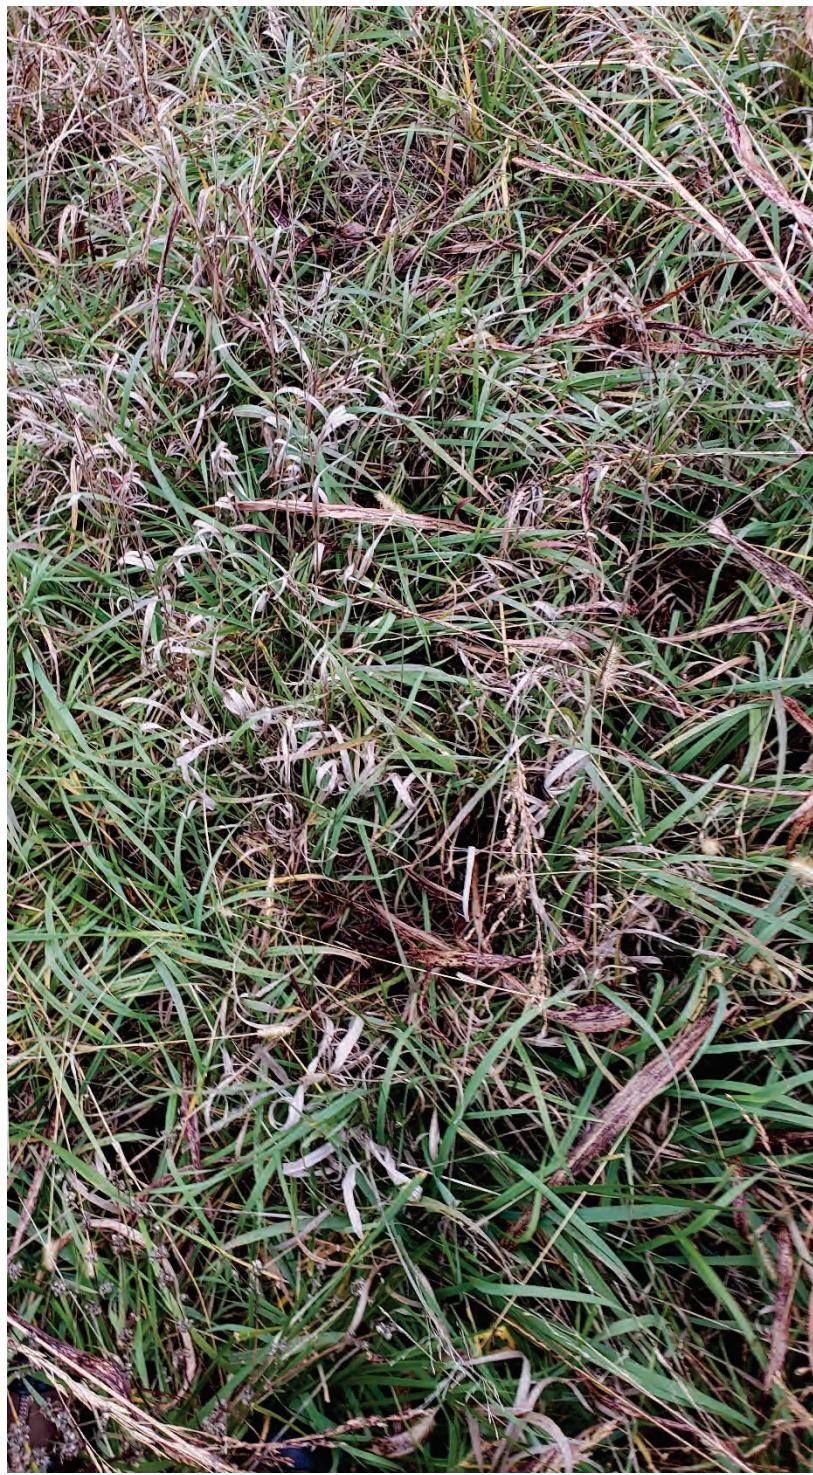
Photo 6: EV2 East Plant Cover area facing southeast

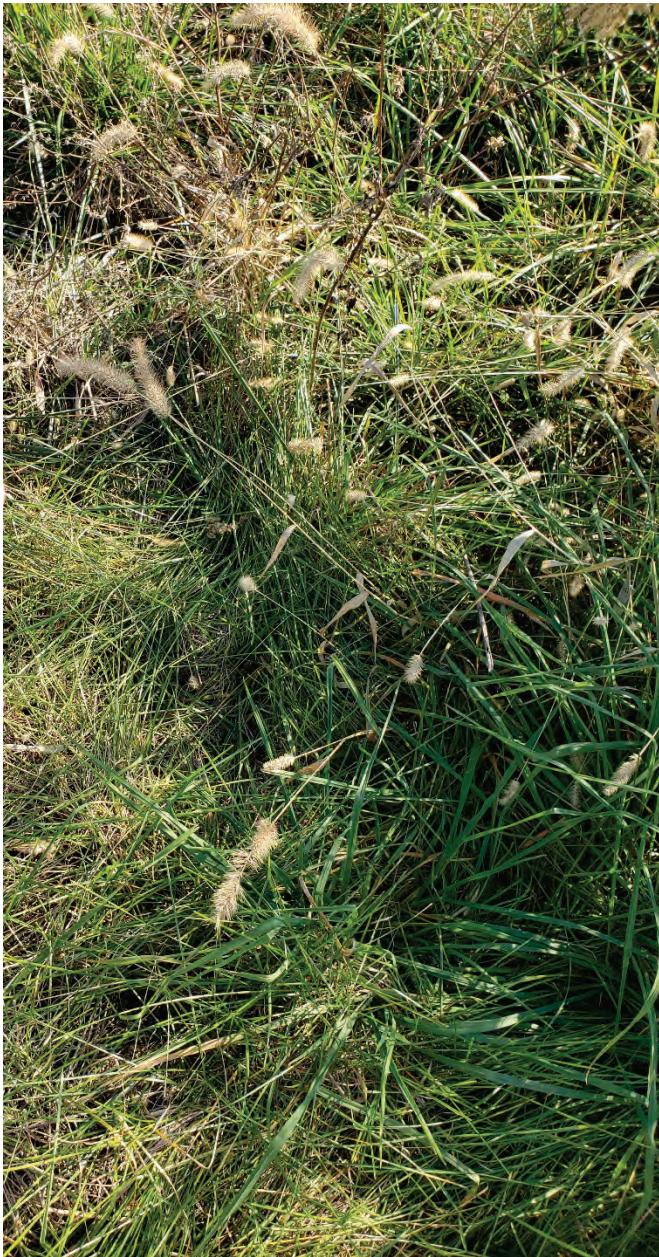
Photo 7: Vegetation at ES6 facing south at EV5

- EROSION	X		
		- OBSTRUCTIONS	X		
		- CULVERT/CATCH BASIN - OBSTRUCTIONS - SEDIMENT ACCUMULATION	X		
		- SIGNS OF BURROWING BY ANIMALS	X		
		- ROOTING OF TREES	X		
	<u>Transect ES6</u>	- QUALITY OF VEGETATIVE COVER - LENGTH OF GRASS - DEAD/DYING GRASS - GRASS COVERAGE - NOXIOUS WEEDS	X		heavy weed growth and some bare spots

- EROSION	X		slight erosion
		- OBSTRUCTIONS	X		
		- CULVERT/CATCH BASIN - OBSTRUCTIONS - SEDIMENT ACCUMULATION	X		
		- SIGNS OF BURROWING BY ANIMALS	X

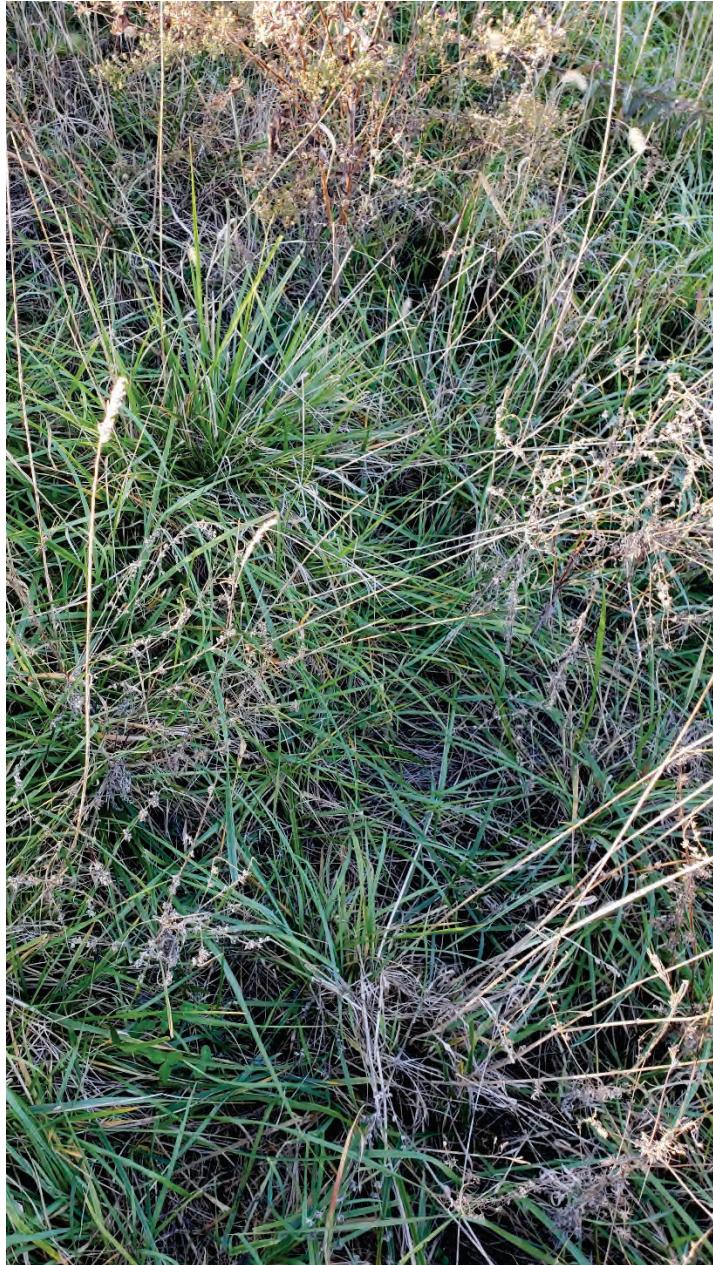
Photo 8: Vegetation along EV5 East Plant Area Cover facing south

- ROOTING OF TREES	X		
	Transect EV5	- QUALITY OF VEGETATIVE COVER - LENGTH OF GRASS - DEAD/DYING GRASS - GRASS COVERAGE - NOXIOUS WEEDS	X		heavy weed growth and some bare spots

- EXPOSURE OF LINER	X		
		- EROSION	X		slight erosion
		- LOCALIZED SETTLEMENT/SLUMPING	X		
		- PONDING OF WATER/DRAINAGE	X		
		- SIGNS OF BURROWING BY ANIMALS	X

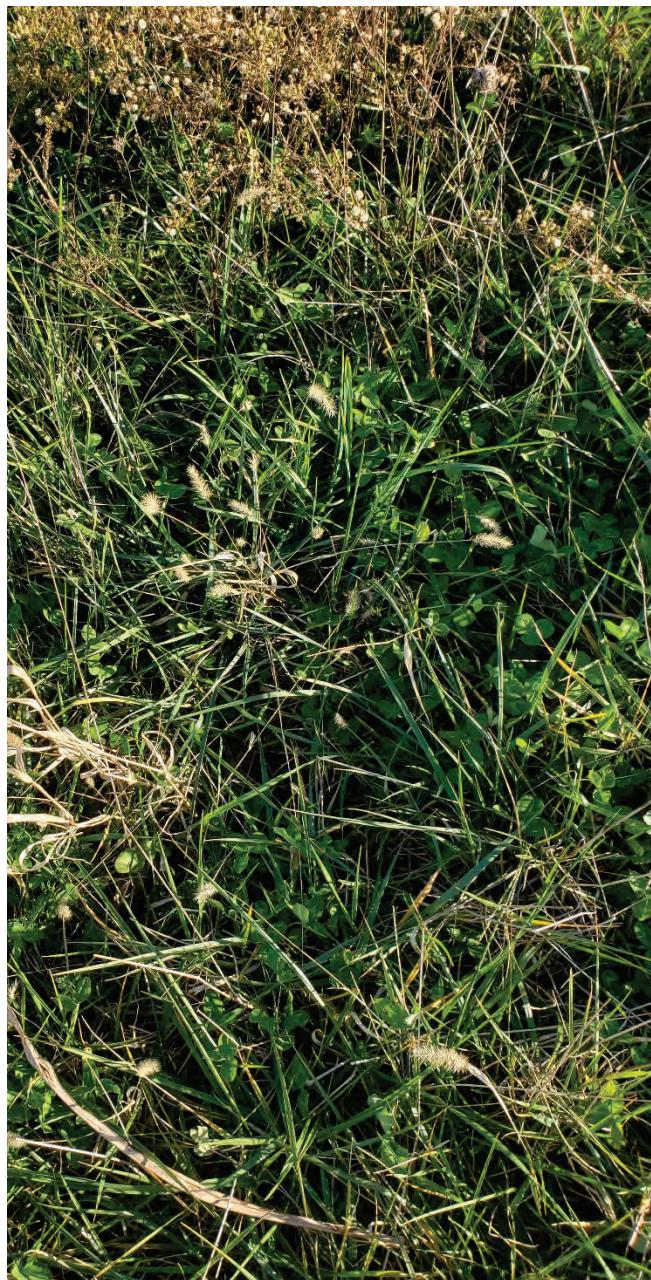
Photo 9: Vegetation north of ES6 East Plant Area Cover facing southeast

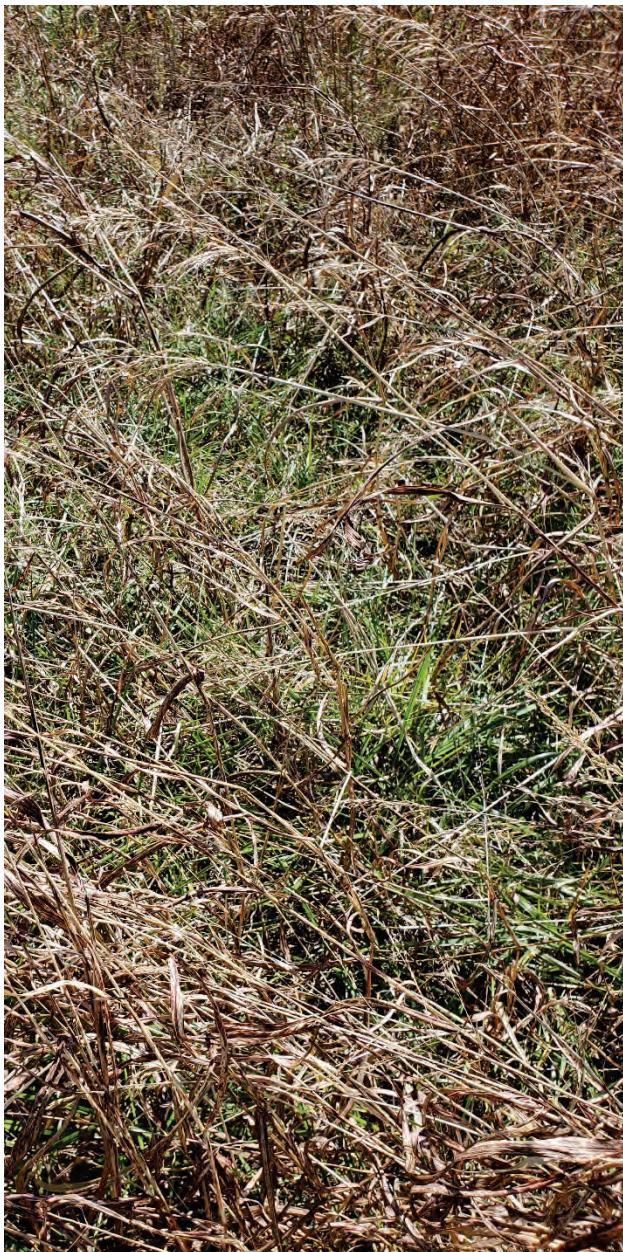
Photo 10: EV6 near EA1 East Plant Area Cover facing south

ITEM	TYPES OF PROBLEMS	CHECKED		DETAILED ACTIONS REQUIRED	DATE AND NATURE OF ACTIONS COMPLETED
		NO PROBLEMS	CORRECTIVE ACTION REQUIRED		
VEGETATED SOIL COVER SYSTEM (CONTINUED)					
	Transect EV6	- QUALITY OF VEGETATIVE COVER - LENGTH OF GRASS - DEAD/DYING GRASS - GRASS COVERAGE - NOXIOUS WEEDS	X		heavy weed growth and some bare spots

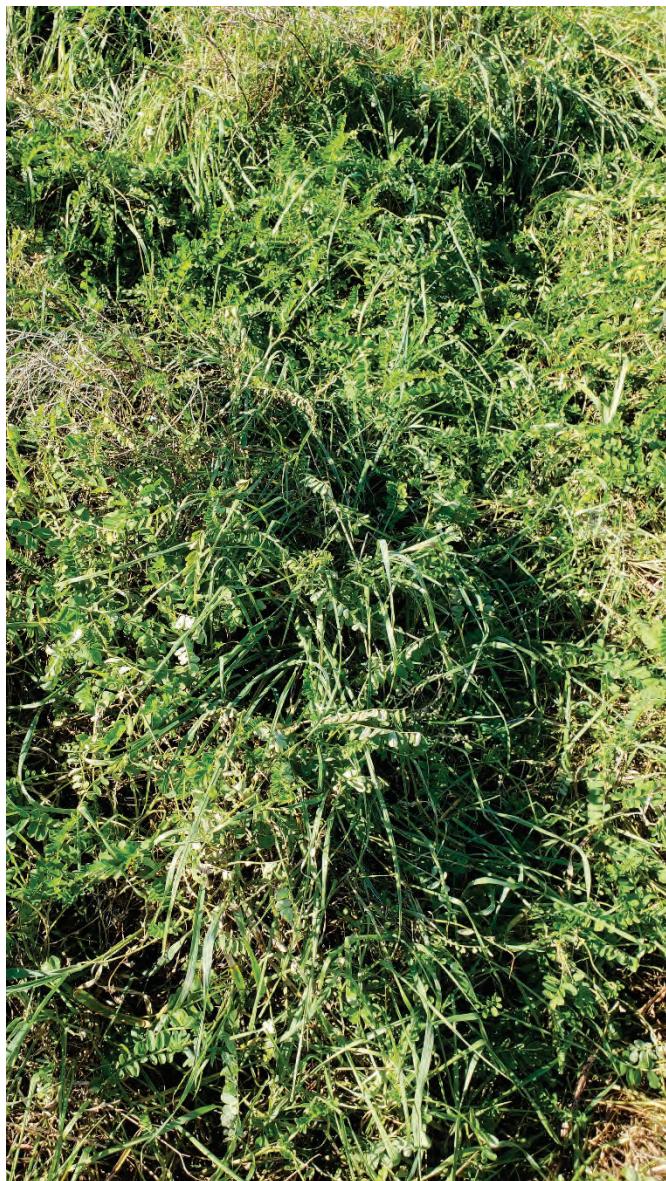
Photo 11: Vegetation at EV8 East Plant Cover area facing southwest

- EXPOSURE OF LINER	X		
		- EROSION	X		
		- LOCALIZED SETTLEMENT/SLUMPING	X		
		- PONDING OF WATER/DRAINAGE	X		
		- SIGNS OF BURROWING BY ANIMALS	X		
		- ROOTING OF TREES	X		
	Transect EV8	- QUALITY OF VEGETATIVE COVER - LENGTH OF GRASS - DEAD/DYING GRASS - GRASS COVERAGE - NOXIOUS WEEDS	X		heavy weed growth and some bare spots

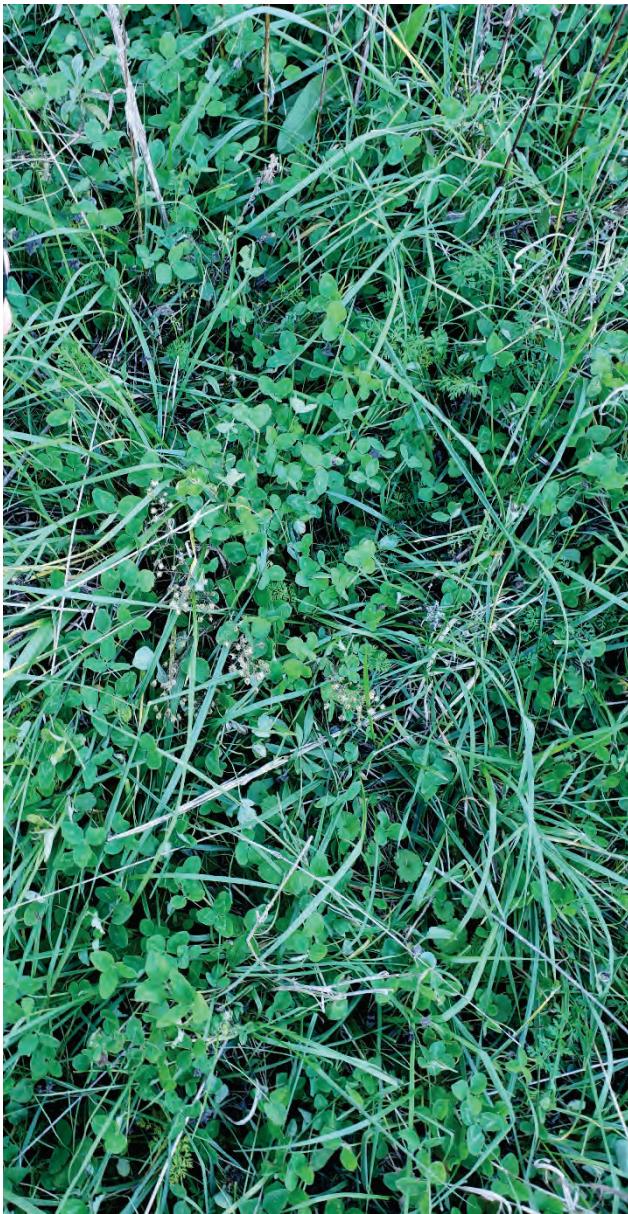
Photo 12: Vegetative growth along EV5 East Plant Area facing southwest

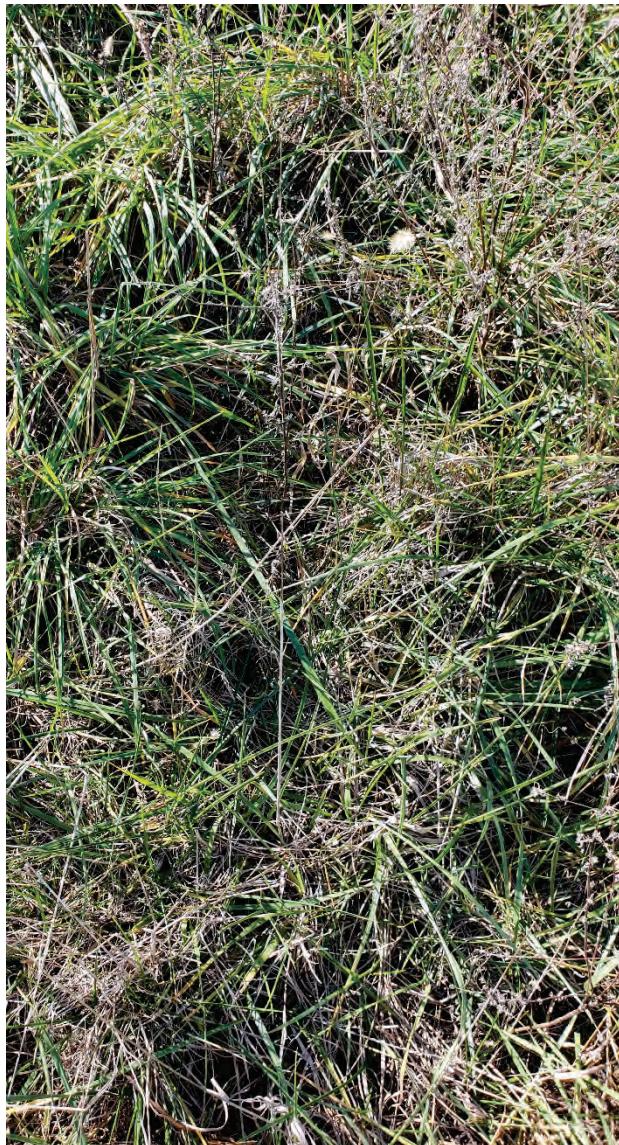
Photo 13: Vegetation growth at ES12 East Plant Area Cover facing west

- EROSION	X		
		- OBSTRUCTIONS	X		
		- CULVERT/CATCH BASIN - OBSTRUCTIONS - SEDIMENT ACCUMULATION	X		
		- SIGNS OF BURROWING BY ANIMALS	X		
		- ROOTING OF TREES	X		
	<u>Transect ES12</u>	- QUALITY OF VEGETATIVE COVER - LENGTH OF GRASS - DEAD/DYING GRASS - GRASS COVERAGE - NOXIOUS WEEDS	X		heavy weed growth and some bare spots

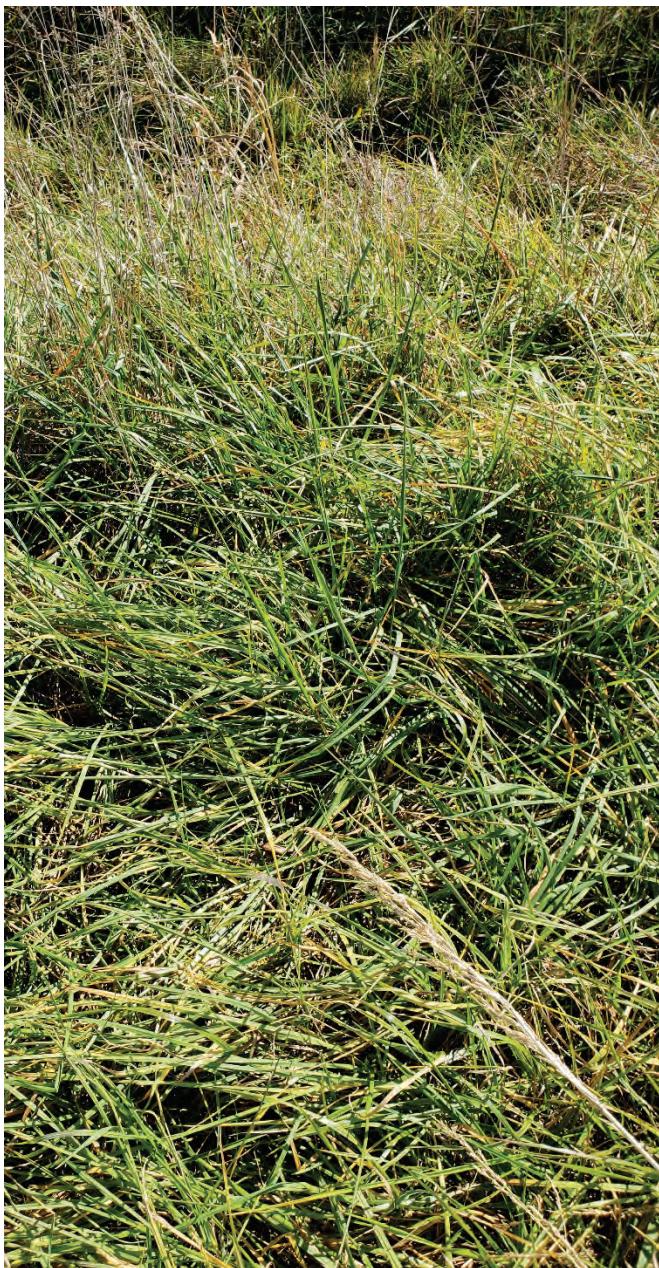
Photo 14: EV7 East Plant Cover facing south

- EXPOSURE OF LINER	X		
		- EROSION	X		
		- LOCALIZED SETTLEMENT/SLUMPING	X		
		- PONDING OF WATER/DRAINAGE	X		
		- SIGNS OF BURROWING BY ANIMALS	X		
		- ROOTING OF TREES	X		
	Transect EV7	- QUALITY OF VEGETATIVE COVER - LENGTH OF GRASS - DEAD/DYING GRASS - GRASS COVERAGE - NOXIOUS WEEDS	X		heavy weed growth and some bare spots

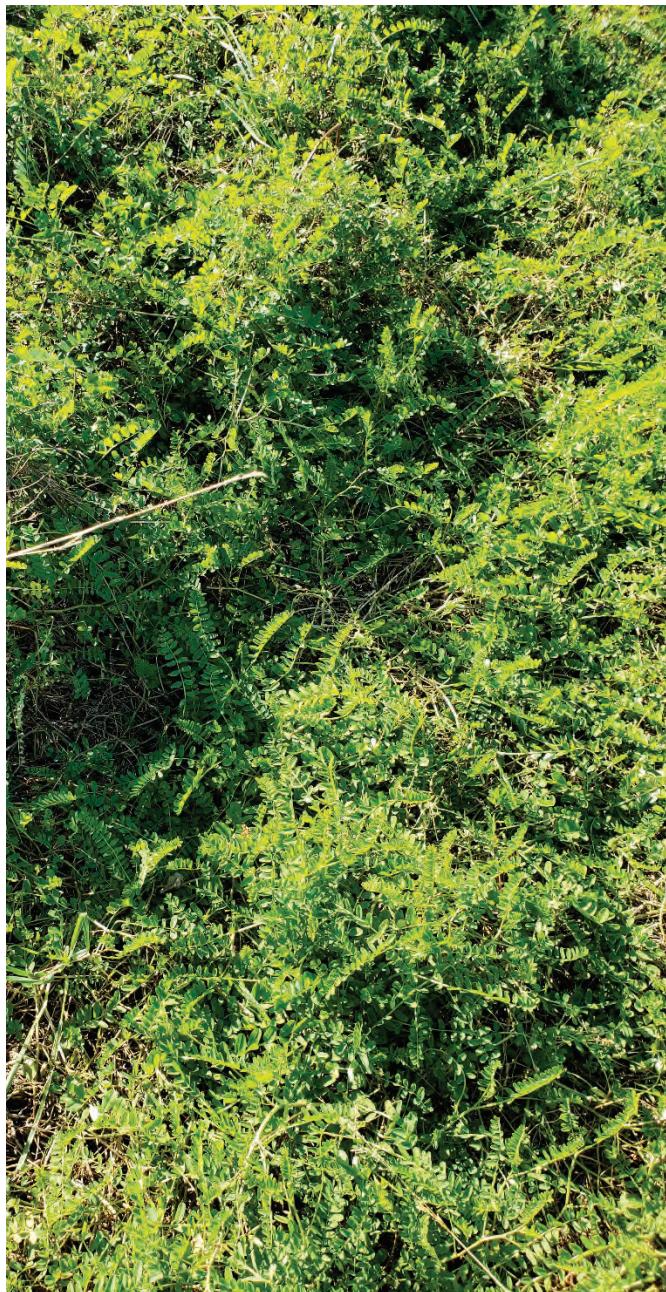
Photo 15: EV6 East Plant Area Cover area facing southwest

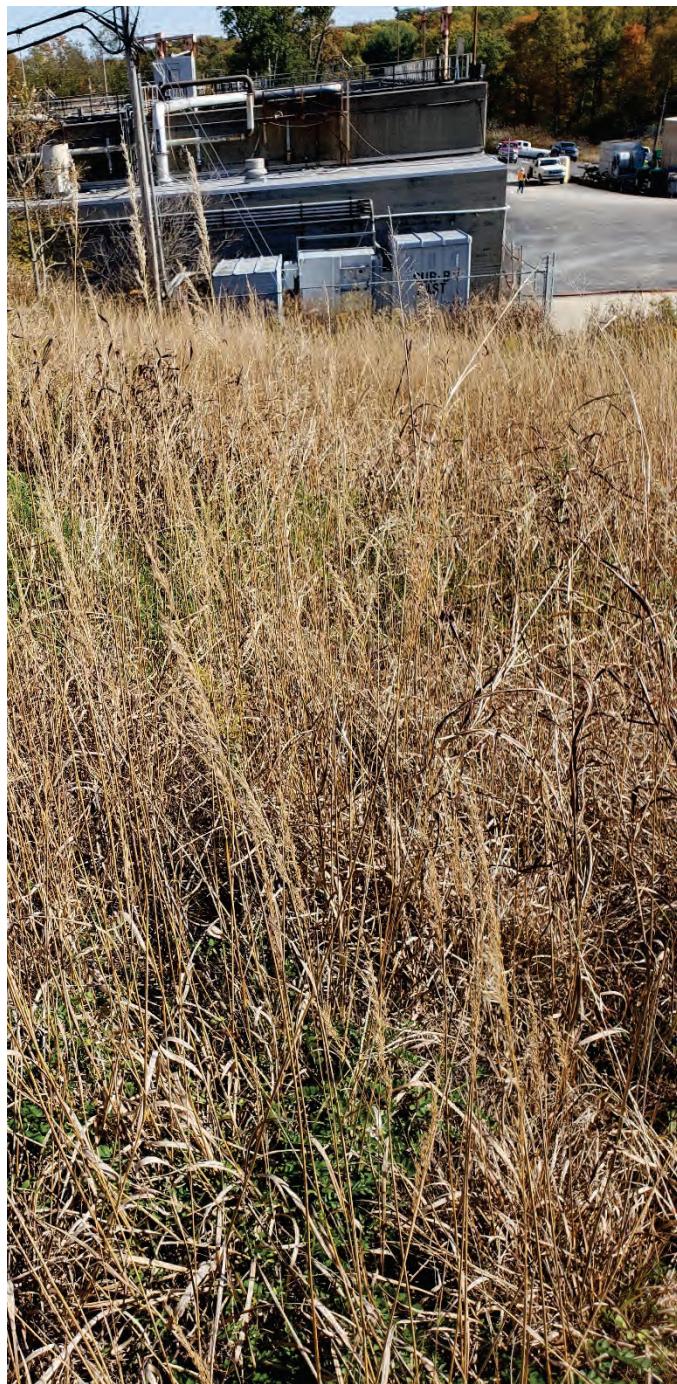
Photo 16: East Plant Area Cover north of EV7 facing south

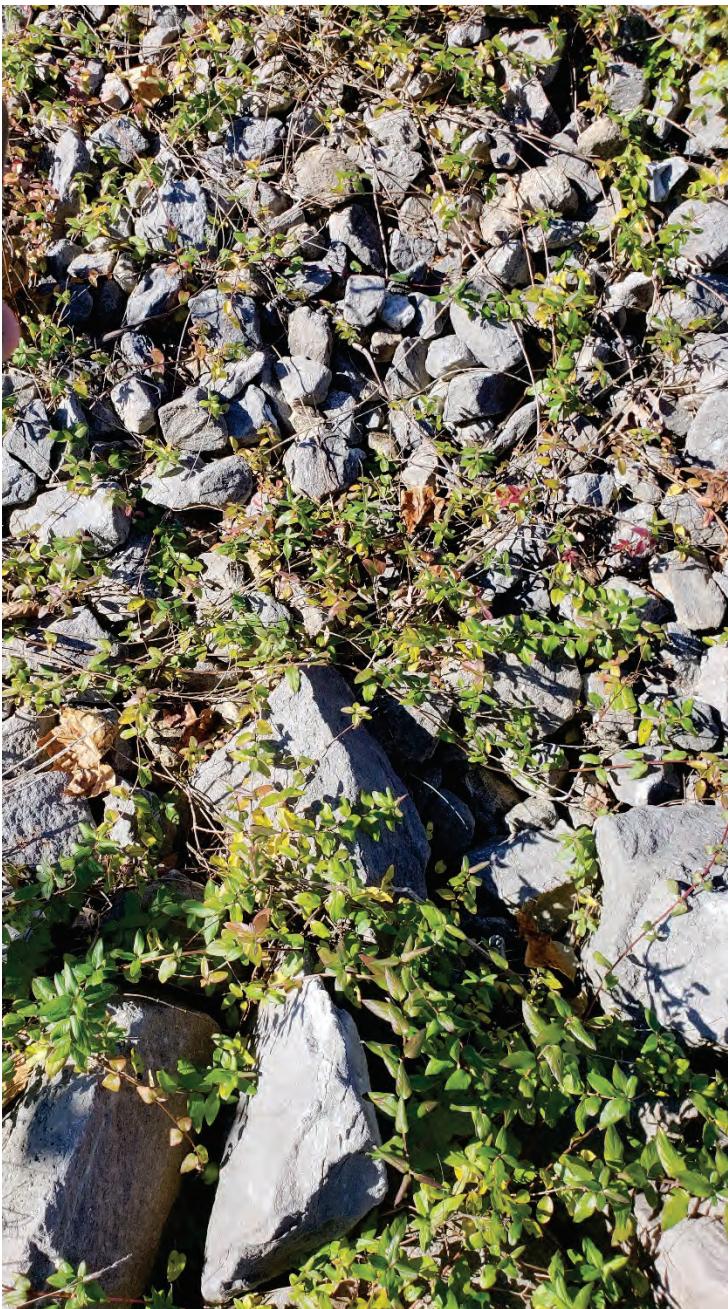
Photo 17: Drainage along EV9 East Plant Area Cover facing southwest

ITEM	TYPES OF PROBLEMS	CHECKED		DETAILED ACTIONS REQUIRED	DATE AND NATURE OF ACTIONS COMPLETED
		NO PROBLEMS	CORRECTIVE ACTION REQUIRED		
VEGETATED SOIL COVER SYSTEM (CONTINUED)					
Transect EV9	- QUALITY OF VEGETATIVE COVER - LENGTH OF GRASS - DEAD/DYING GRASS - GRASS COVERAGE - NOVOIS WEEDS	X		heavy weed growth and some bare spots	
	- EXPOSURE OF LINER	X			
	- EROSION	X			
	- LOCALIZED SETTLEMENT/SLUMPING	X			
	- PONDING OF WATER/DRAINAGE	X			
	- SIGNS OF BURROWING BY ANIMALS	X			
	- ROOTING OF TREES	X			
Transect WV1	- QUALITY OF VEGETATIVE COVER - LENGTH OF GRASS - DEAD/DYING GRASS - GRASS COVERAGE - NOVOIS WEEDS	X		heavy weed growth and some bare spots	
	- EXPOSURE OF LINER	X			
	- EROSION	X			
	- LOCALIZED SETTLEMENT/SLUMPING	X			
	- PONDING OF WATER/DRAINAGE	X			
	- SIGNS OF BURROWING BY ANIMALS	X			
	- ROOTING OF TREES	X

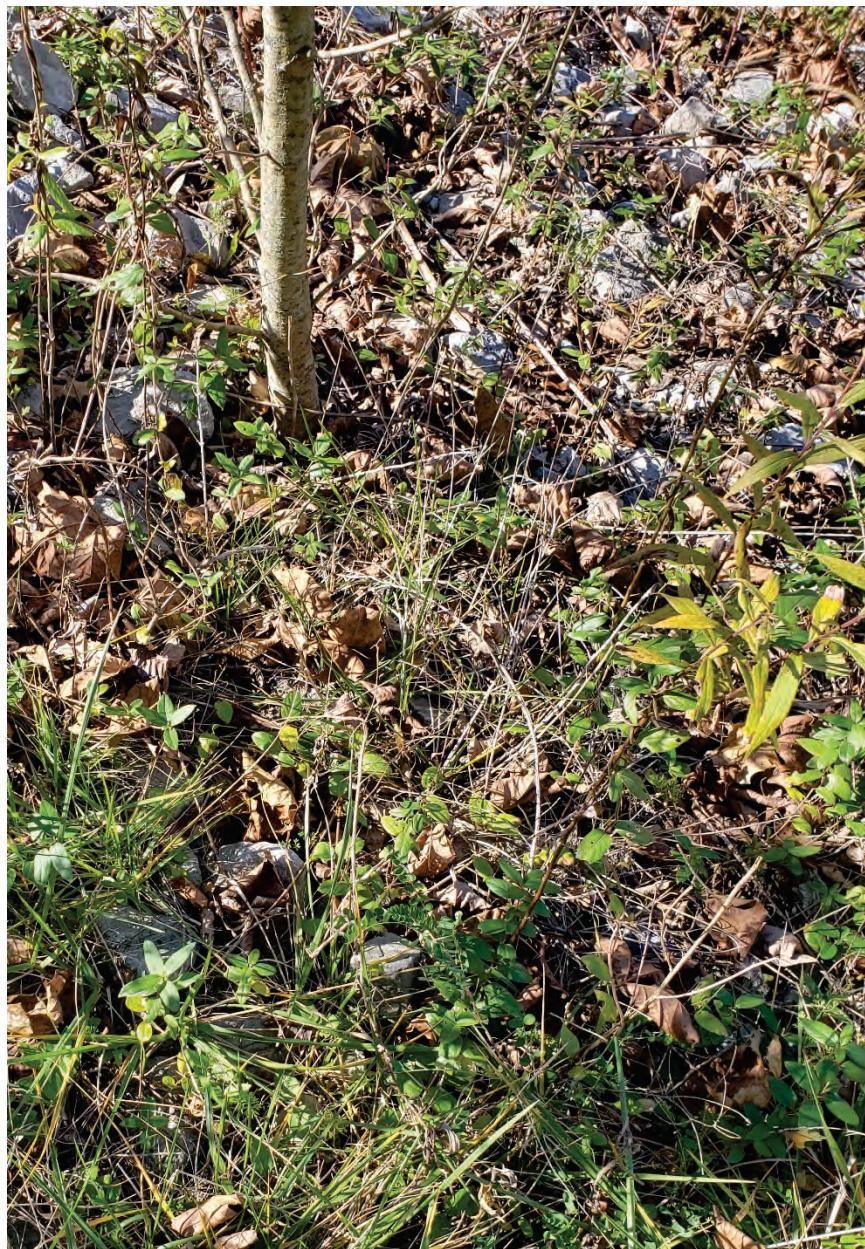
Photo 18: Vegetation at ES14 East Plant Area Cover facing southwest
