Re: RCRA Corrective Action Administrative Order on Consent (AOC)  
Progress Report 73, Second Quarter 2019  
GM GPS – Bedford Facility, ID 006036099, Docket No. RCRA 05 2017 0011  
Bedford, Indiana

## Cover System Inspection Second Quarter 2019

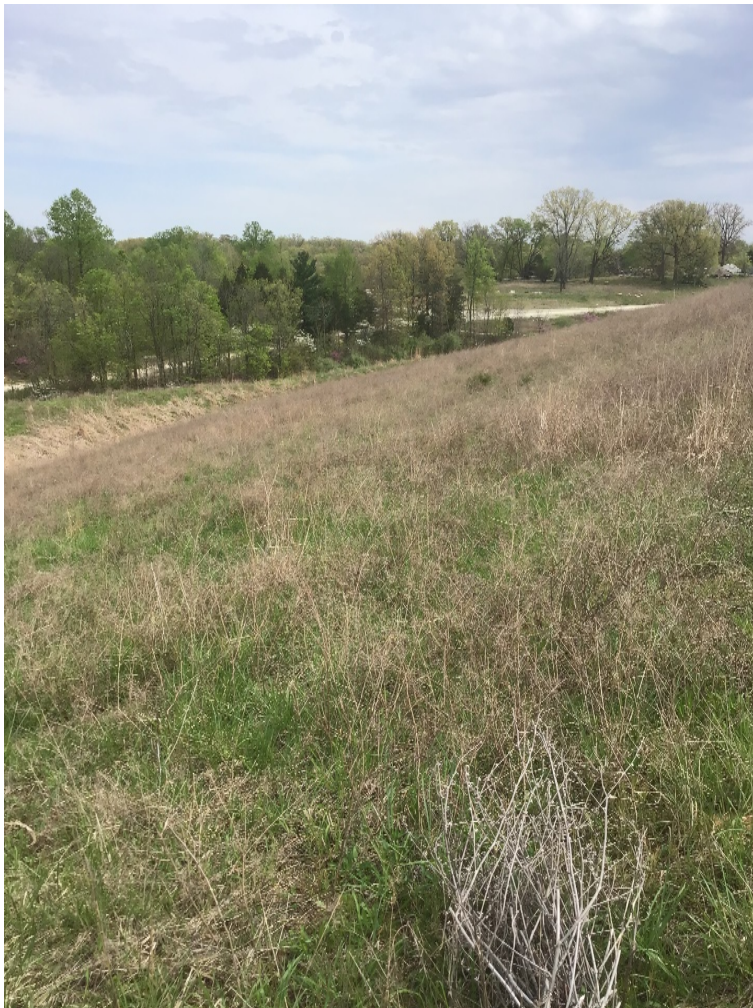
Photo 1: Vegetation at ES6 facing southeast at EV5

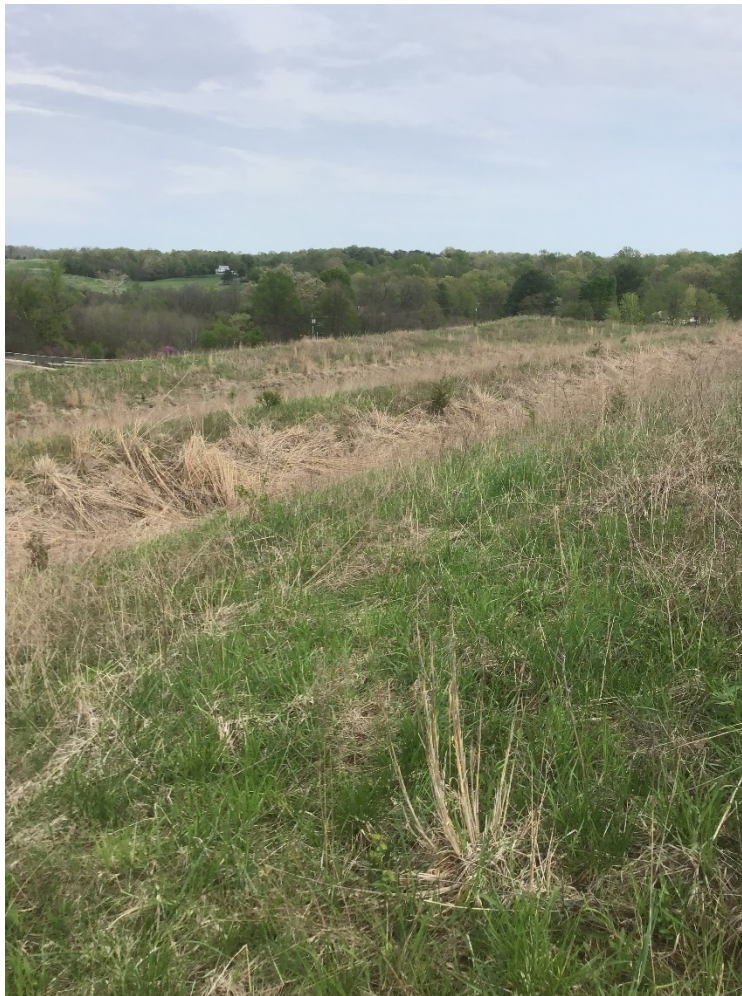
Photo 2: Vegetation at ES6 along EV4 facing southeast

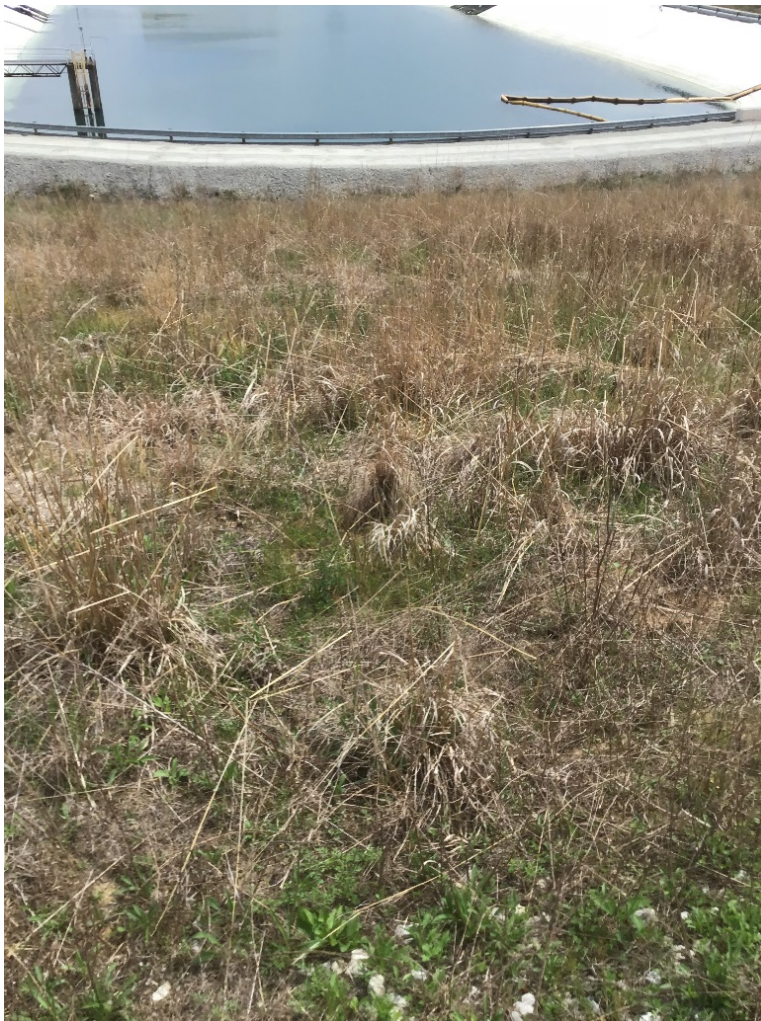
Photo 3: EV3 East Plant Cover facing south towards stormwater pond

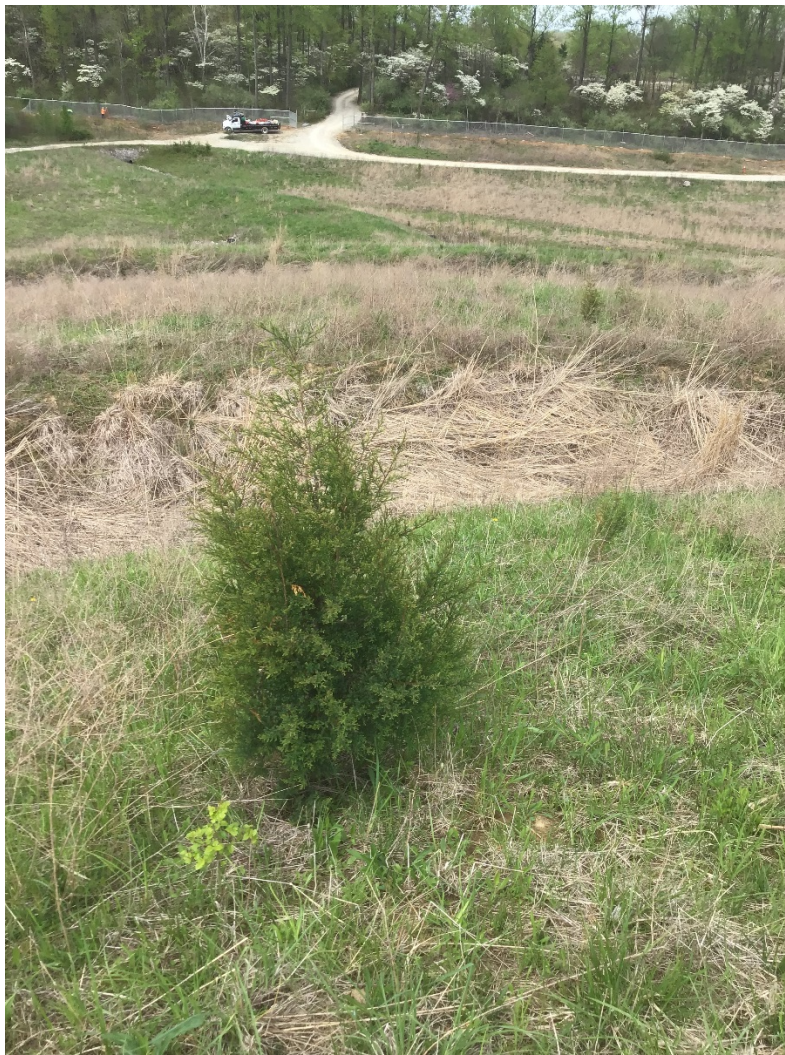
Photo 4: Sapling growth along EV3 at ES6 facing north

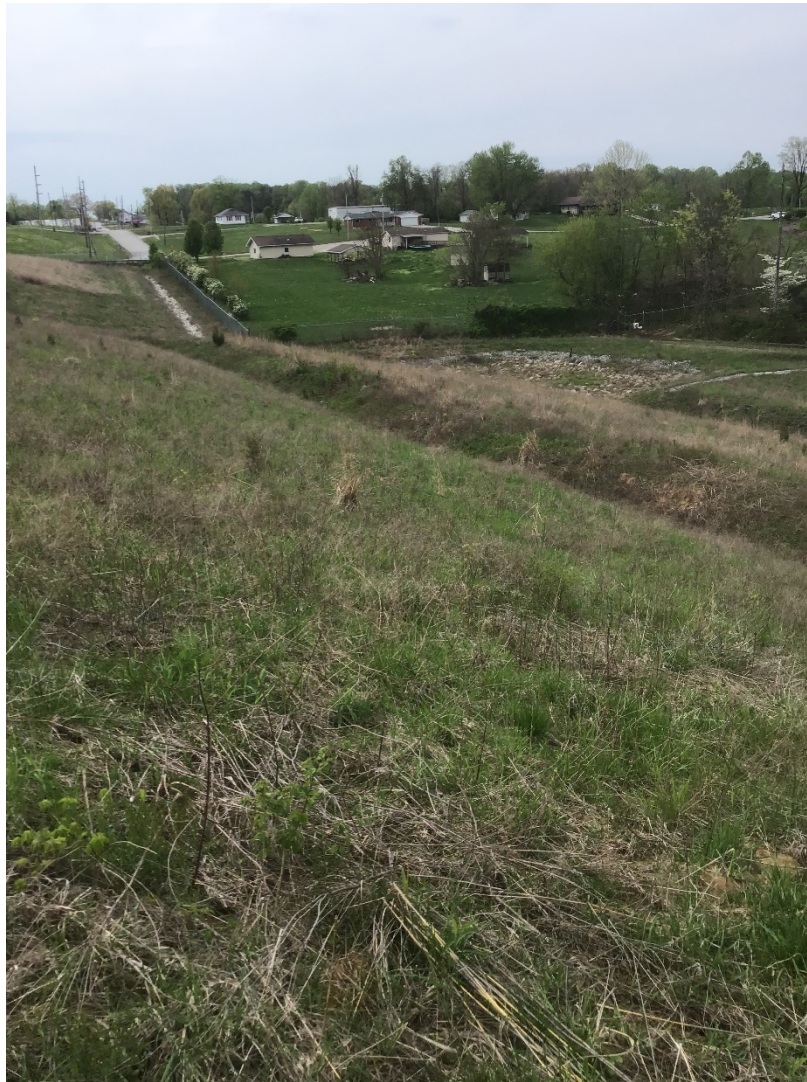
Photo 5: Vegetation along ES2 East Plant Cover area facing west

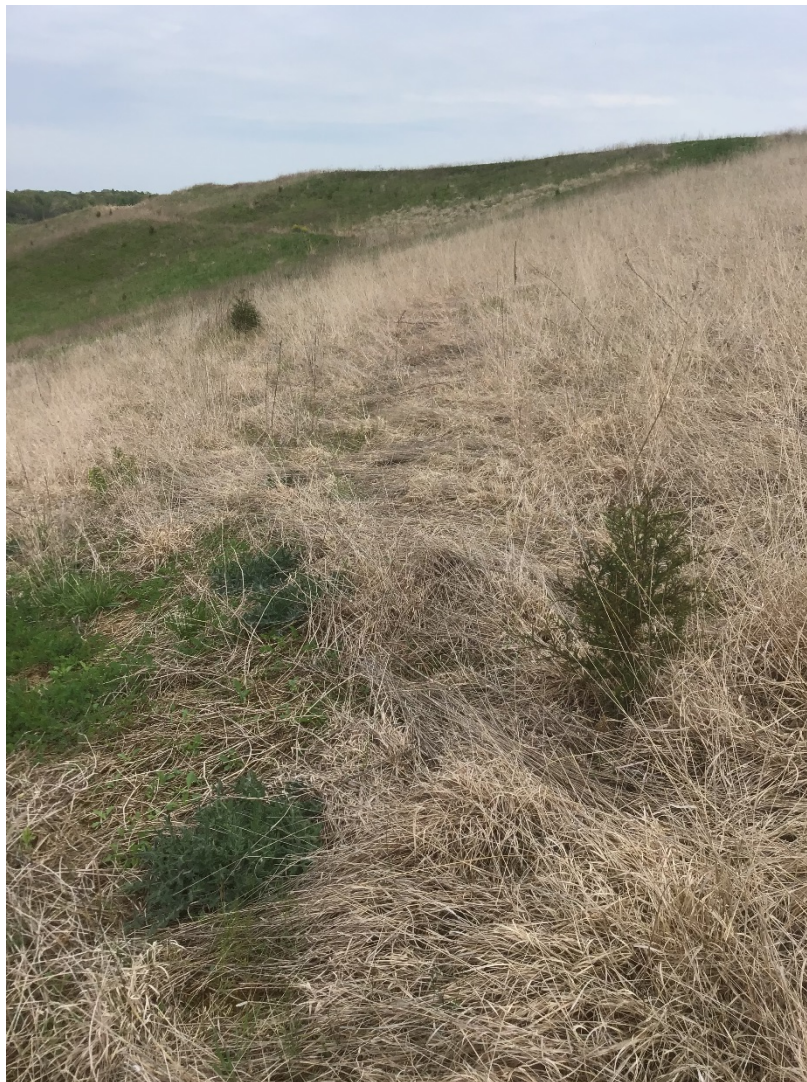
Photo 6: EV2 East Plant Cover area facing southeast

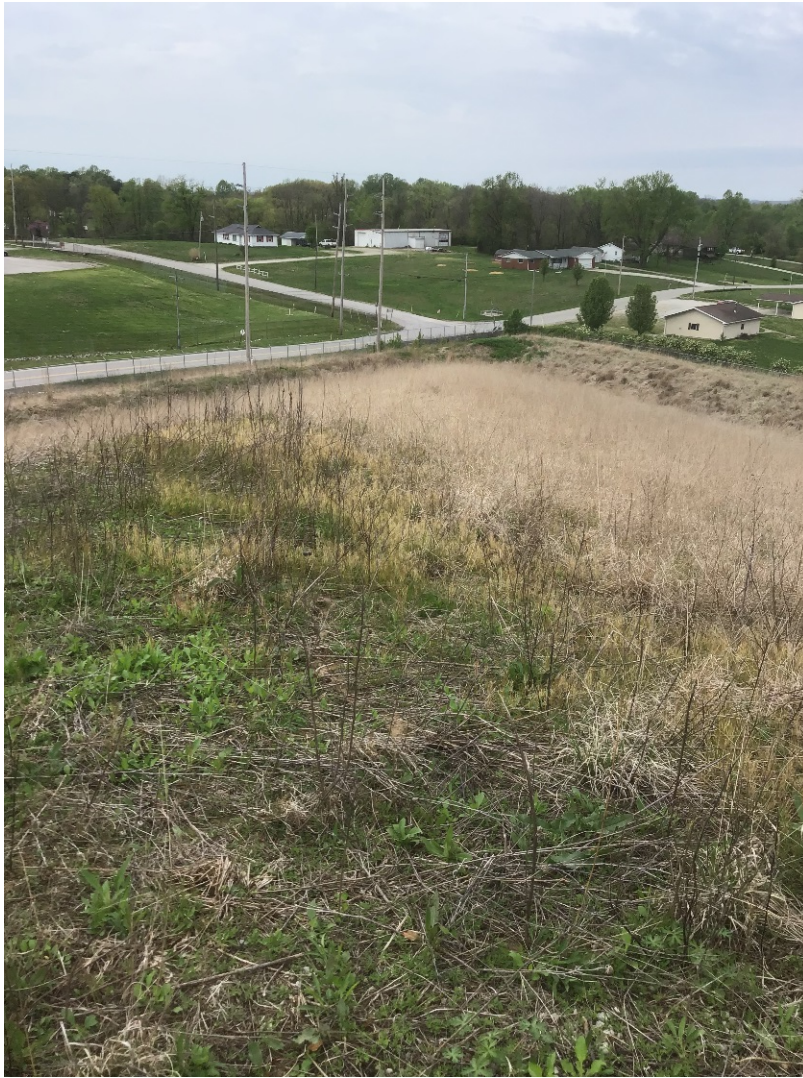
Photo 7: Vegetation along EV2 facing northwest

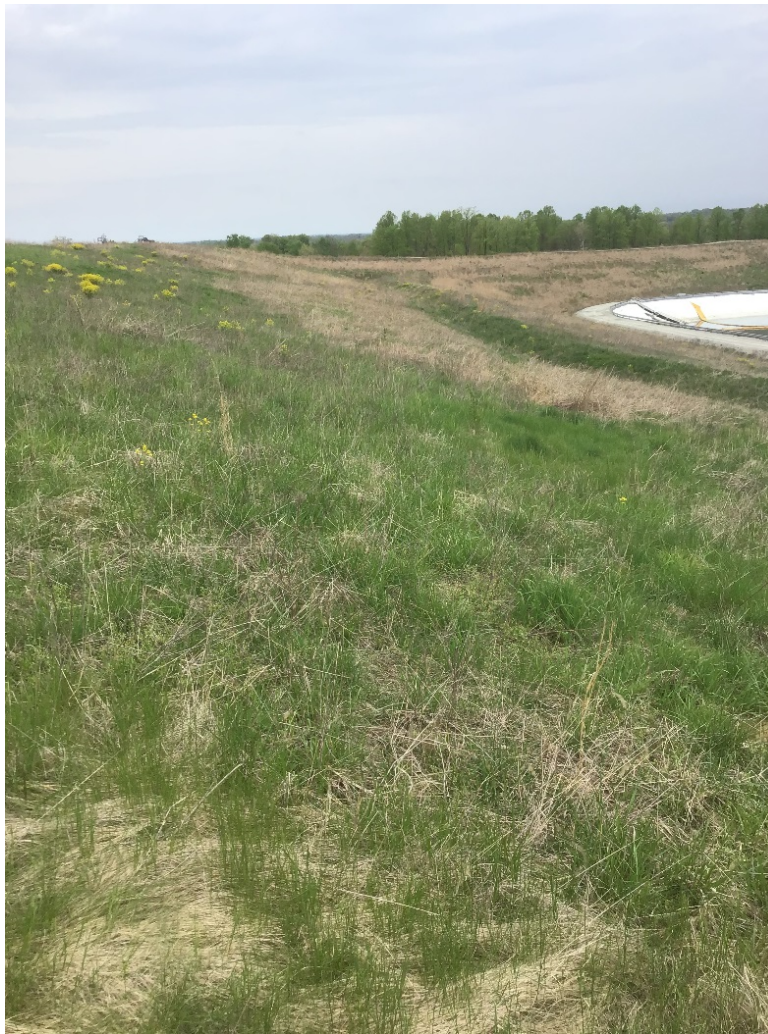
Photo 8: Vegetation at ES1 along EV1 facing north

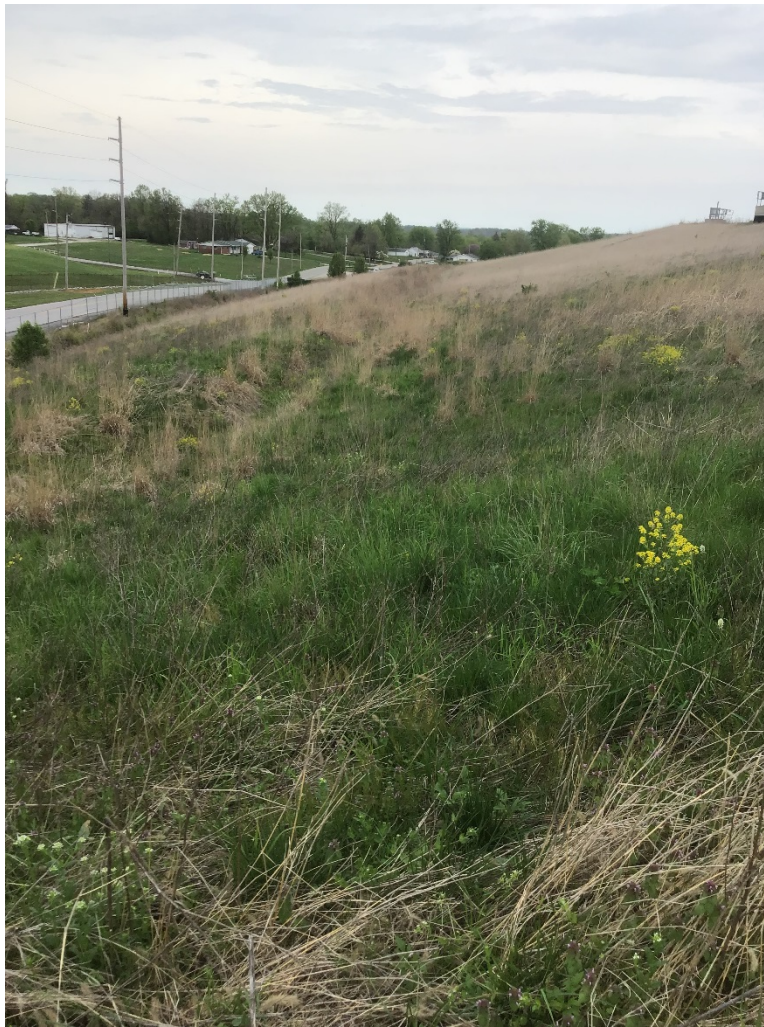
Photo 9: Vegetation at EV1 East Plant Cover area facing north

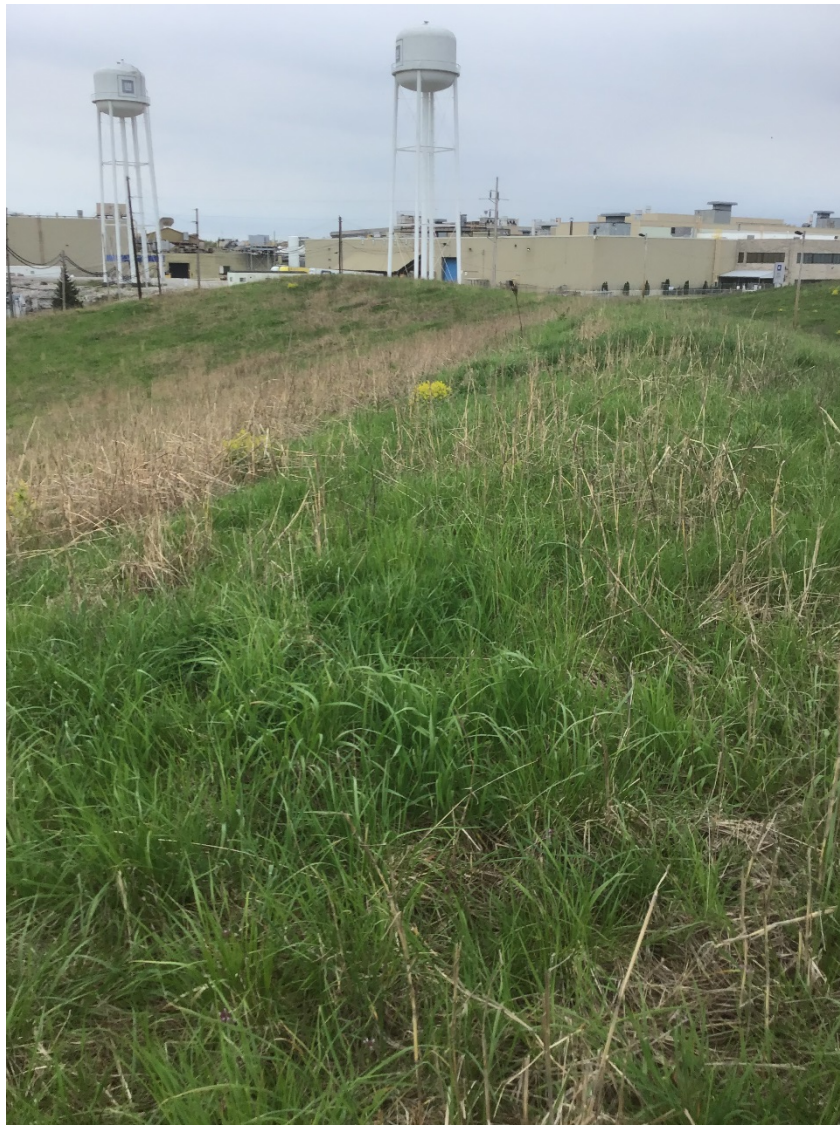
Photo 10: Vegetation at ES2 near EA1 facing southwest

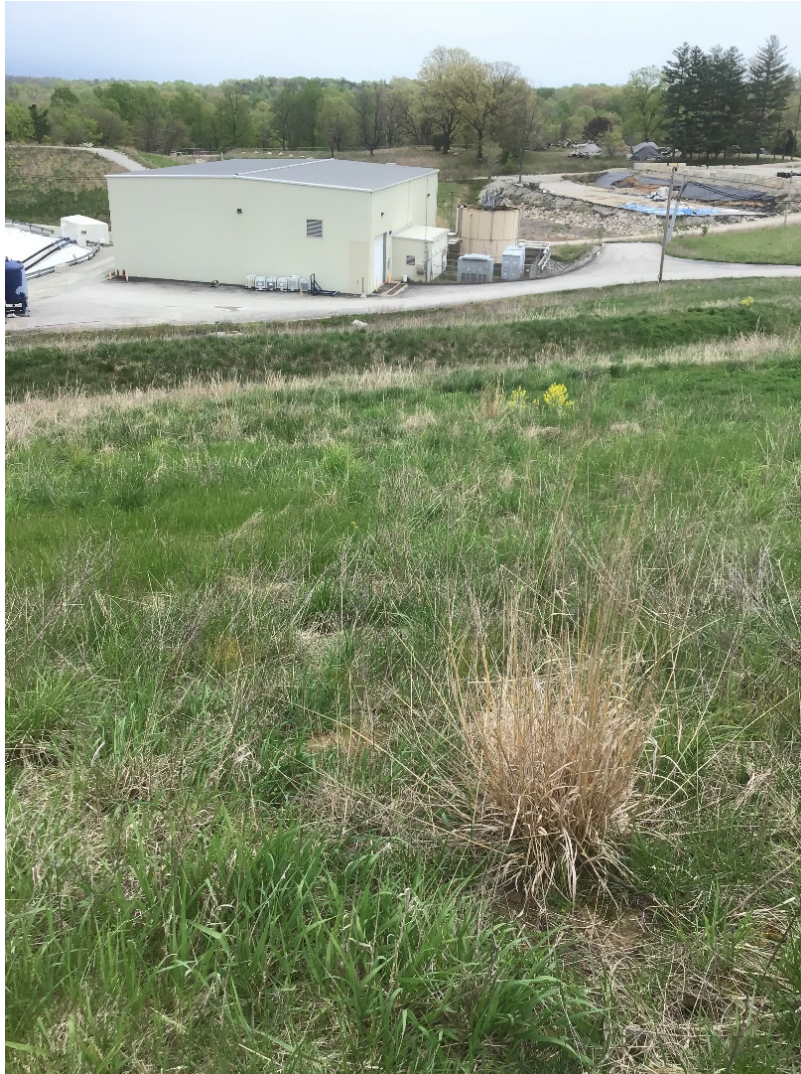
Photo 11: South end of ES2 cover area facing east towards stormwater treatment plant

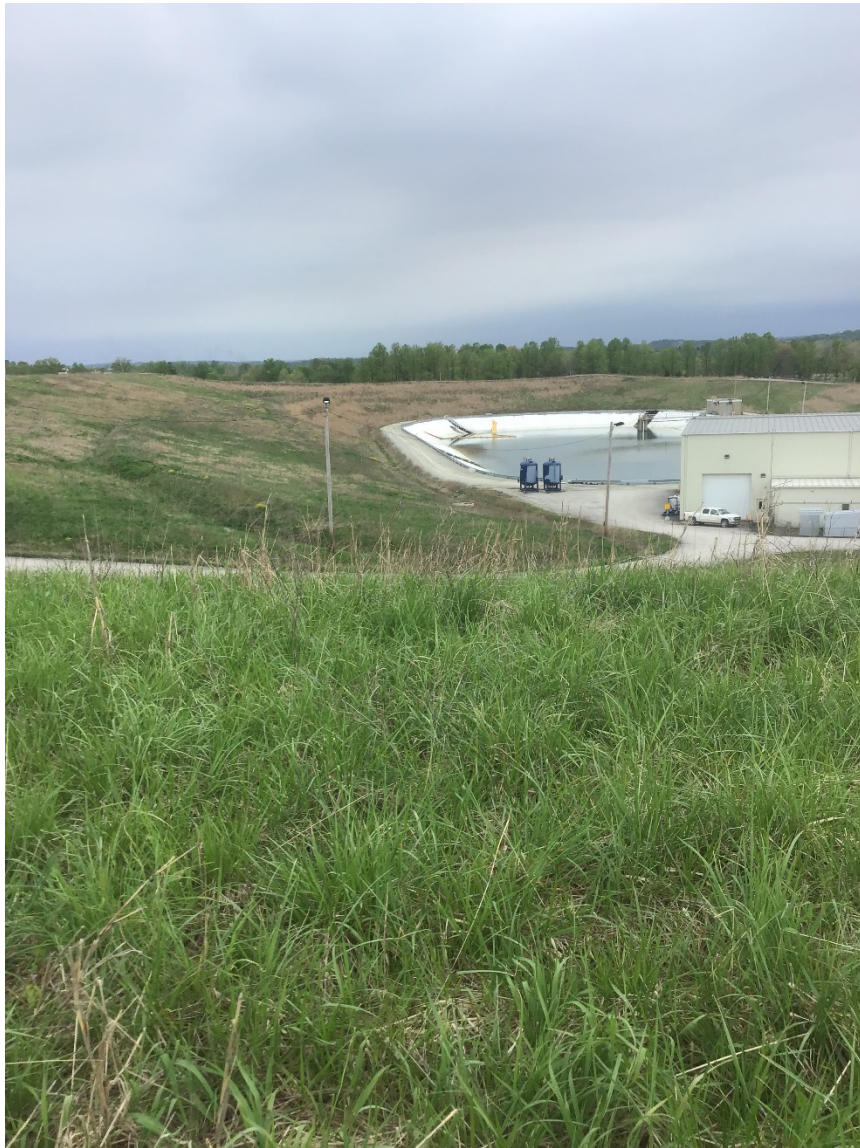
Photo 12: Vegetation at EV6 facing north

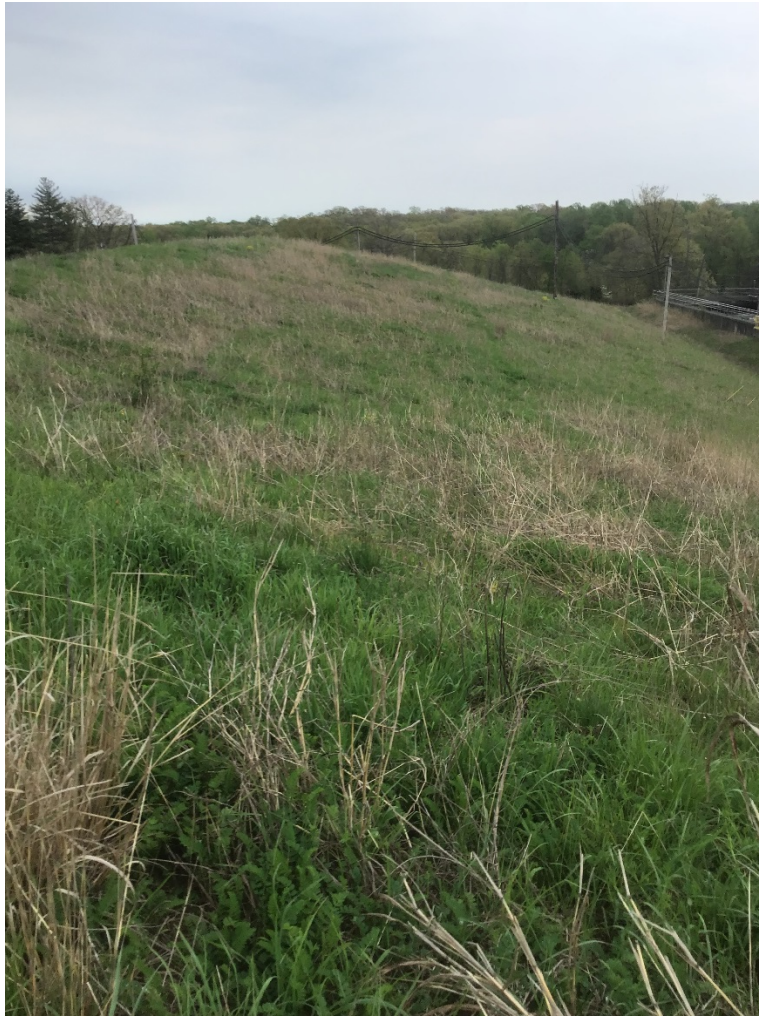
Photo 13: EV6 near EA1 East Plant Area Cover facing east

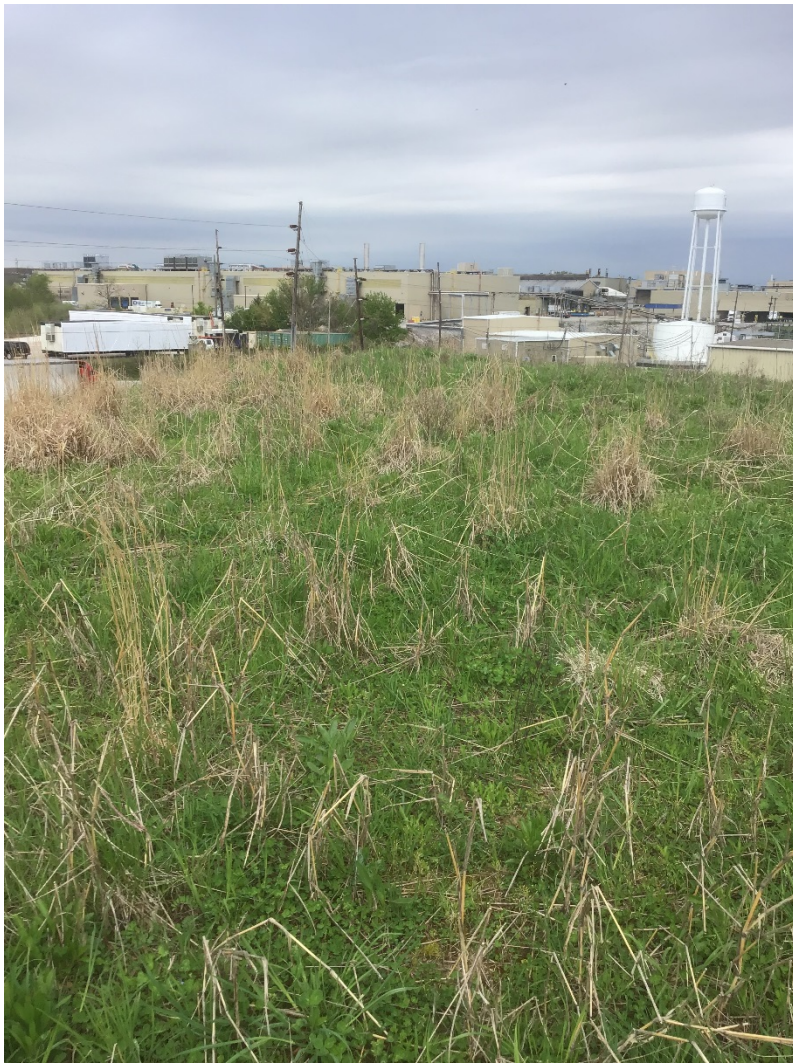
Photo 14: Vegetation along EV6 facing west

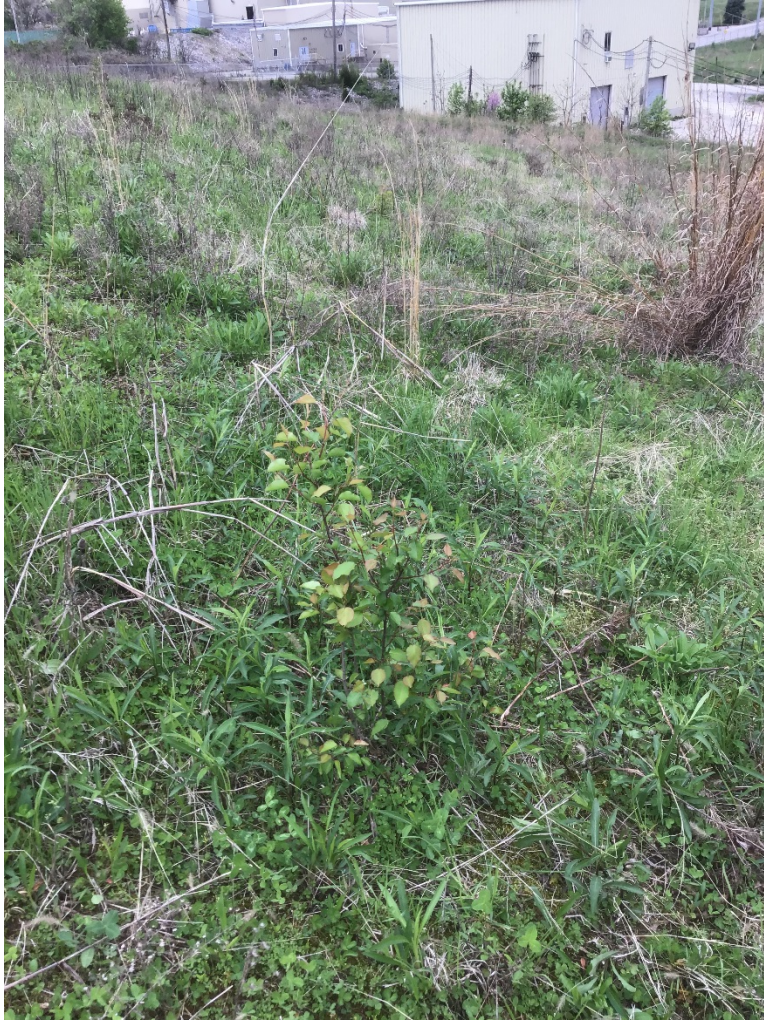
Photo 15: Vegetative growth at ES14 East Plant Area facing northwest

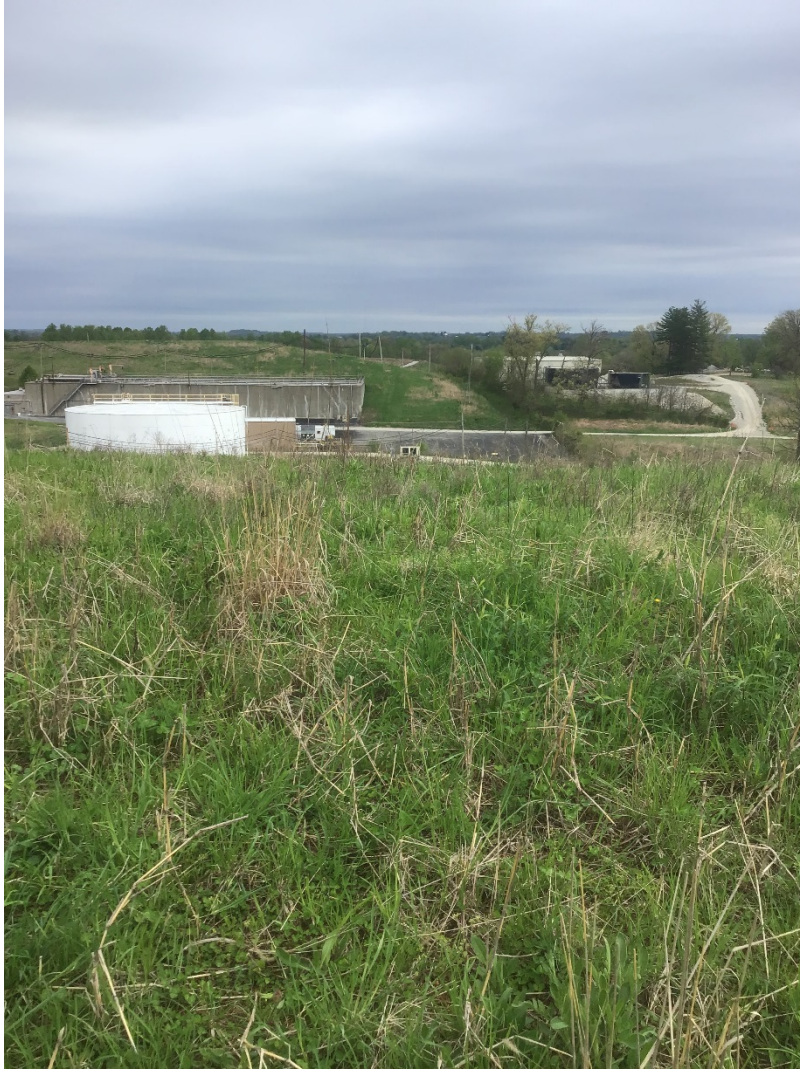
Photo 16: Vegetation growth along EV9 near ES14 facing north

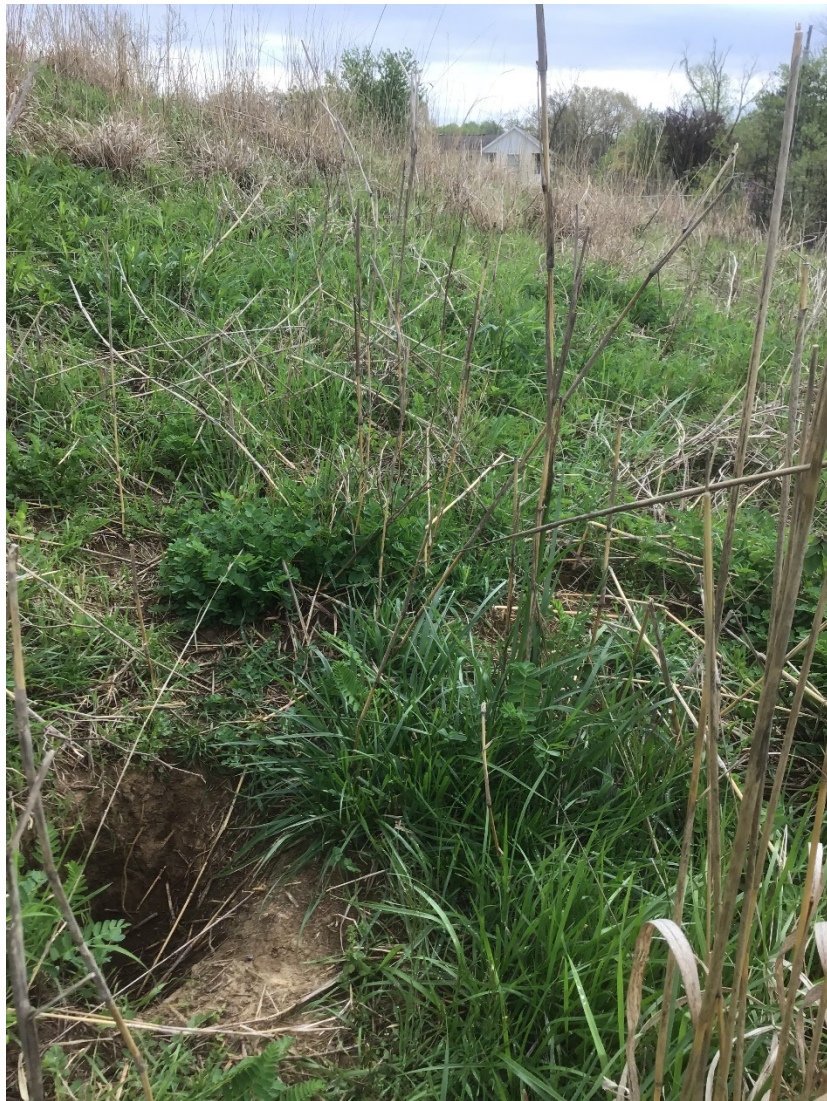
Photo 17: Burrowing and vegetation found near EV9 facing east

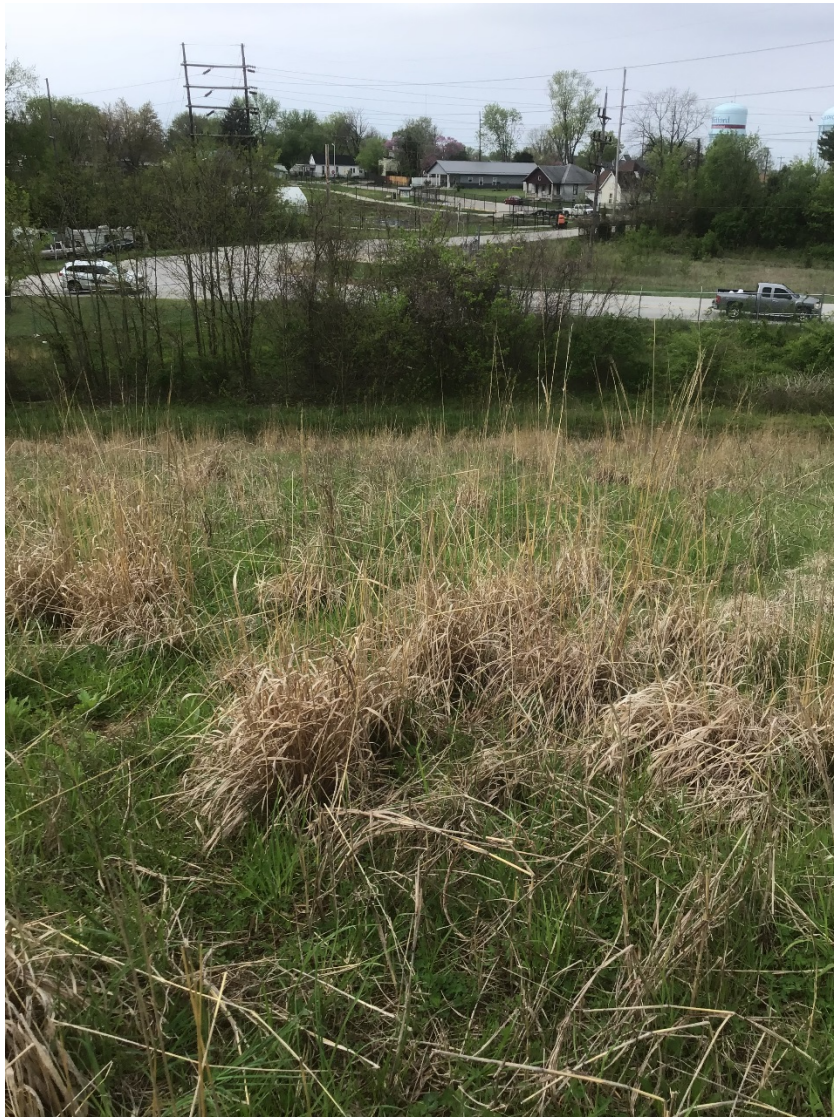
Photo 18: Vegetation growth near south end of EV9 facing southwest
