Re: RCRA Corrective Action Administrative Order on Consent (AOC)
Progress Report 56, First Quarter 2015
GM CET – Bedford Facility, IND 006036099, Docket No. RCRA-05-2014-0011
Bedford, Indiana

RCRA Facility Investigation and CERCLA Removal Action

Progress Report 56 First Quarter 2015

GM CET – Bedford Facility
105 GM Drive
Bedford, Indiana

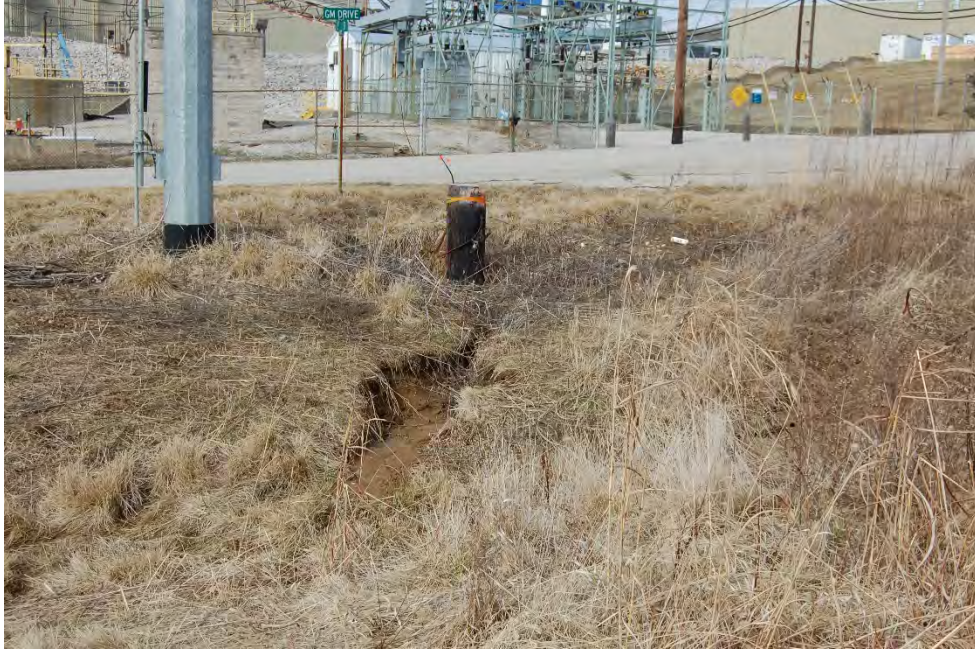
4. There are some erosion ruts along the east side of GM Drive, outside the cover system area. This does not appear to be due to any on-Site RCRA activities, but could have an impact on the liner system in the ditch and so will be addressed.

Photo 9: EV6 erosion rut outside cap limit

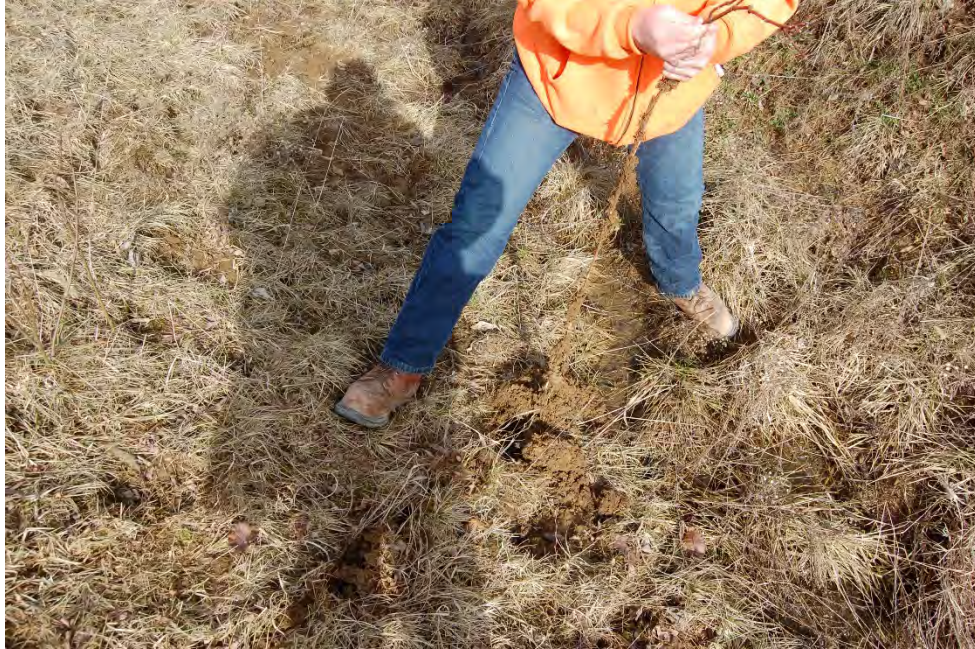
1. In the exterior ditch, adjacent to wooded areas (south side of Parcel 201 and the east side of the cover system along Parcels 208, 412 and 413), we noted some saplings starting to grow. The saplings will be pulled to the extent possible after the ground has softened. Saplings that cannot be pulled will be cut.
2. One other sapling was encountered during the walking of the rest of the cover system (already pulled).
3. Numerous mole holes were identified on the west and north side of the east plant cover system. Moles typically burrow 8-12 inches, however, they tend to damage root growth in their quest for grubs. CRA will confirm with the liner companies to see if there is any

* ~~these~~ saplings present in the outside berm at the top of the ~~landfill~~^{cover} where the cover is adjacent to wooded areas

Photo 13: EV9 Parcel 201 sapling removal

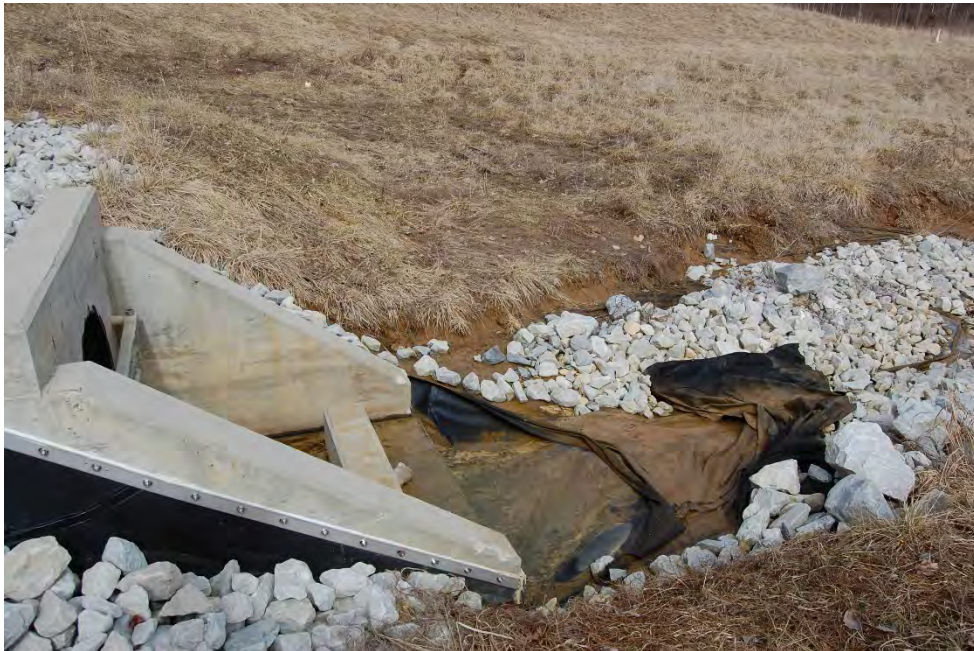
7. During the inspection it was noted that the velocity of the water coming from Detention Basin 1 (DB1) into DB2 has at times been strong enough to displace the riprap at the point the water enters the basin, exposing about a 5 foot length of the channel, including the underlying liner. The riprap will be replaced with larger diameter stone as used in DB1.

Photo 22: EV9 rip rap erosion at storm drain into detention basin #2 facing north

- EROSION	OK			
	- OBSTRUCTIONS	OK			
	- CULVERT/CATCH BASIN - OBSTRUCTIONS - SEDIMENT ACCUMULATION			rip rap washed out have SES get \$ to repair w/ bigger rip rap	need to wait until spring rain ceases so it is dry when doing the repair

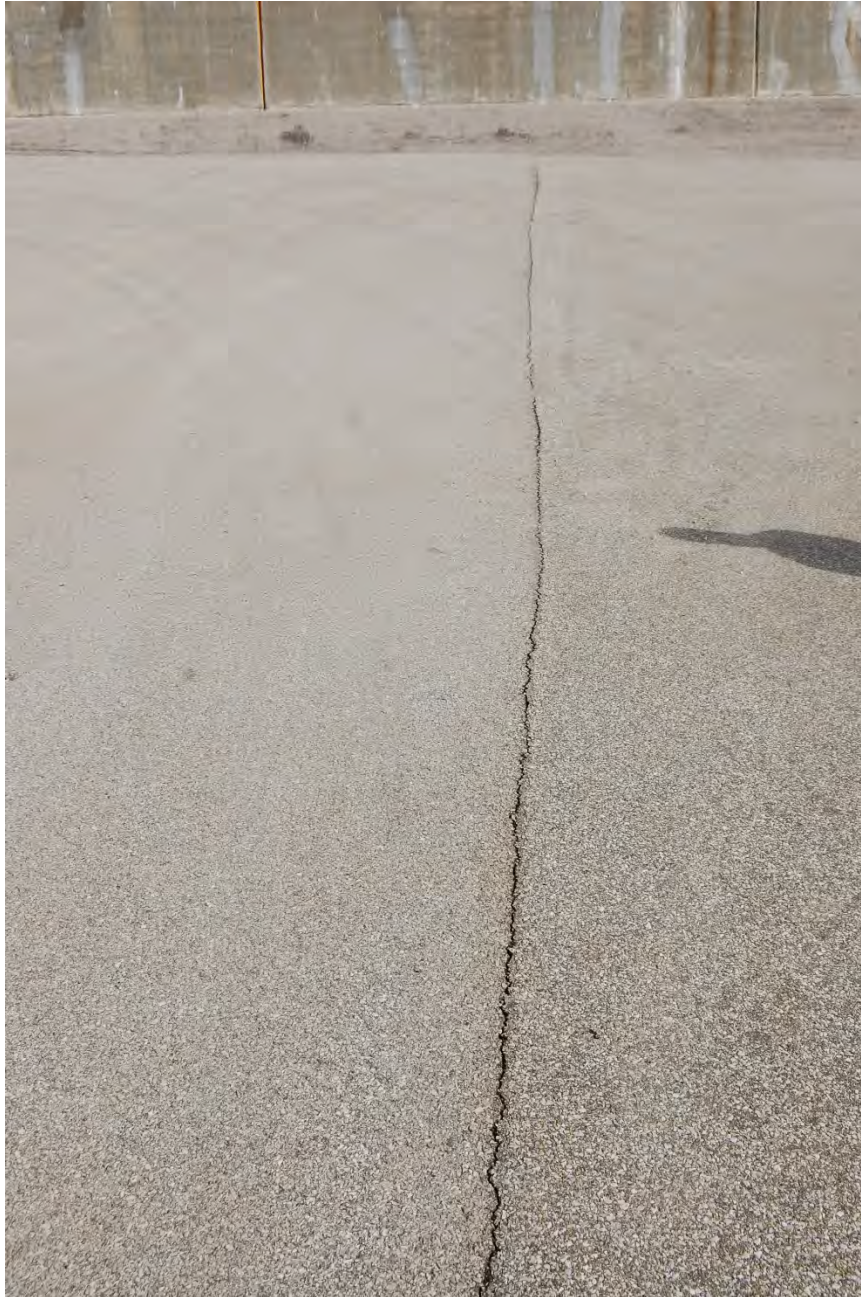
5. Cracks are present along the seams in the asphalt cover system. The cracks do not extend the full depth of the asphalt thickness. O'Mara Paving has been contacted to discuss options to fill the cracks.

Photo 25: EA2 crack near WWTP aeration basin facing north

- PRESENCE OF CRACKING OR DISCOLORATION		cracking noted	contact paving co. & get cost to fill crack	
<u>Transect WA1</u>	- QUALITY OF ASPHALT COVER	ok

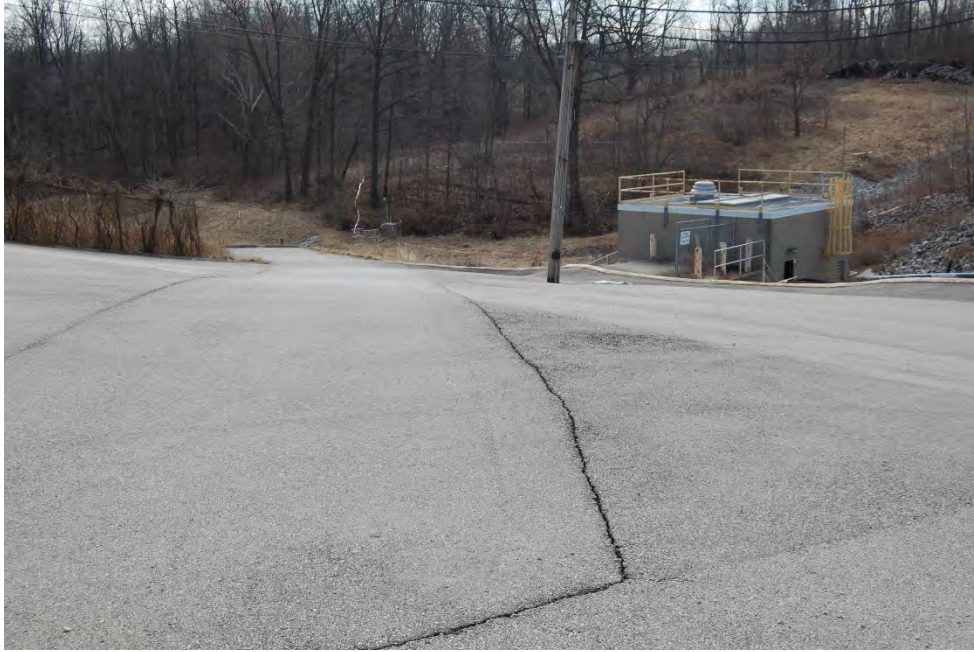
Photo 26: EA2 facing east, cracks in asphalt west of Parcel 205

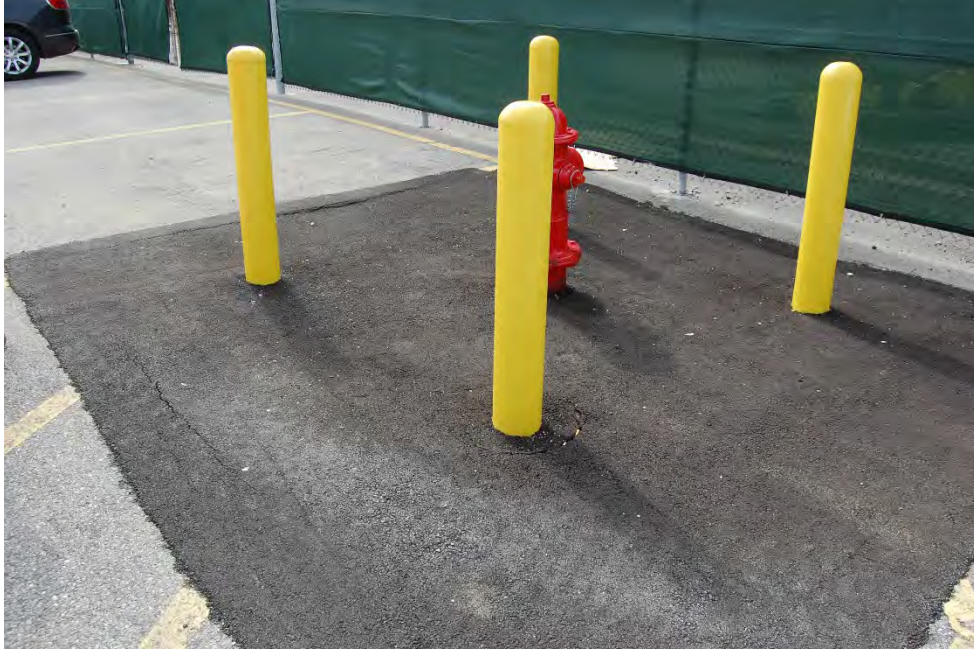
9. The Facility repaired two fire hydrants along the far west side of the paved West Plant cover system. The Facility's contractor excavated the soils surrounding the hydrant, repaired the hydrant, backfilled, and SES/O'Mara Paving made the necessary repairs to the asphalt. There are signs of settlement under the repaved area as the new asphalt has sunk. O'Mara Paving will look at this area for recommended repairs.

Photo 28: WA West Plant fire hydrant repair asphalt patch 1

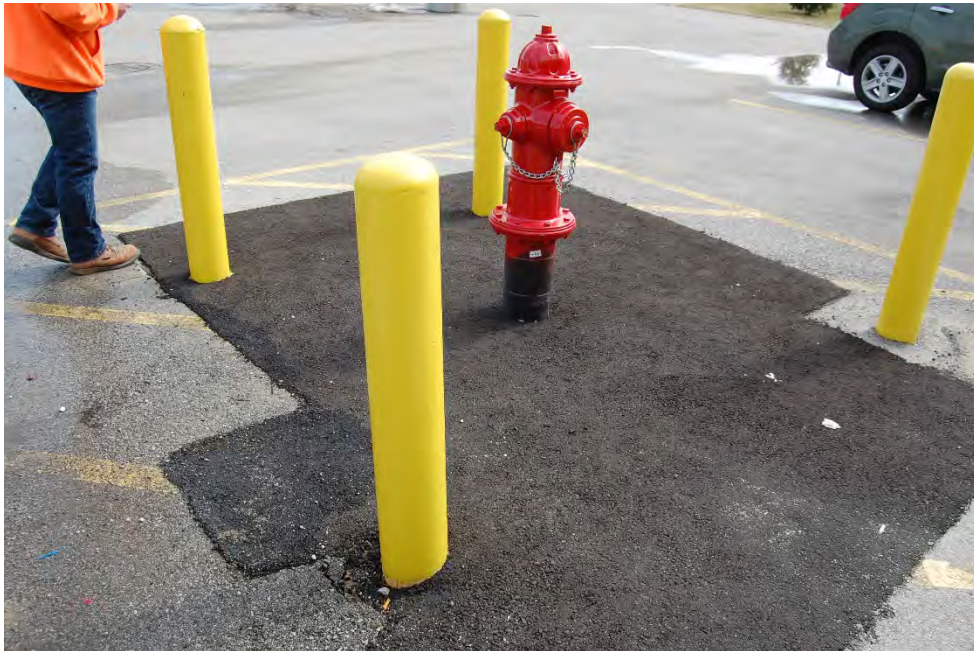
Photo 29: WA West Plant fire hydrant repair asphalt patch 2

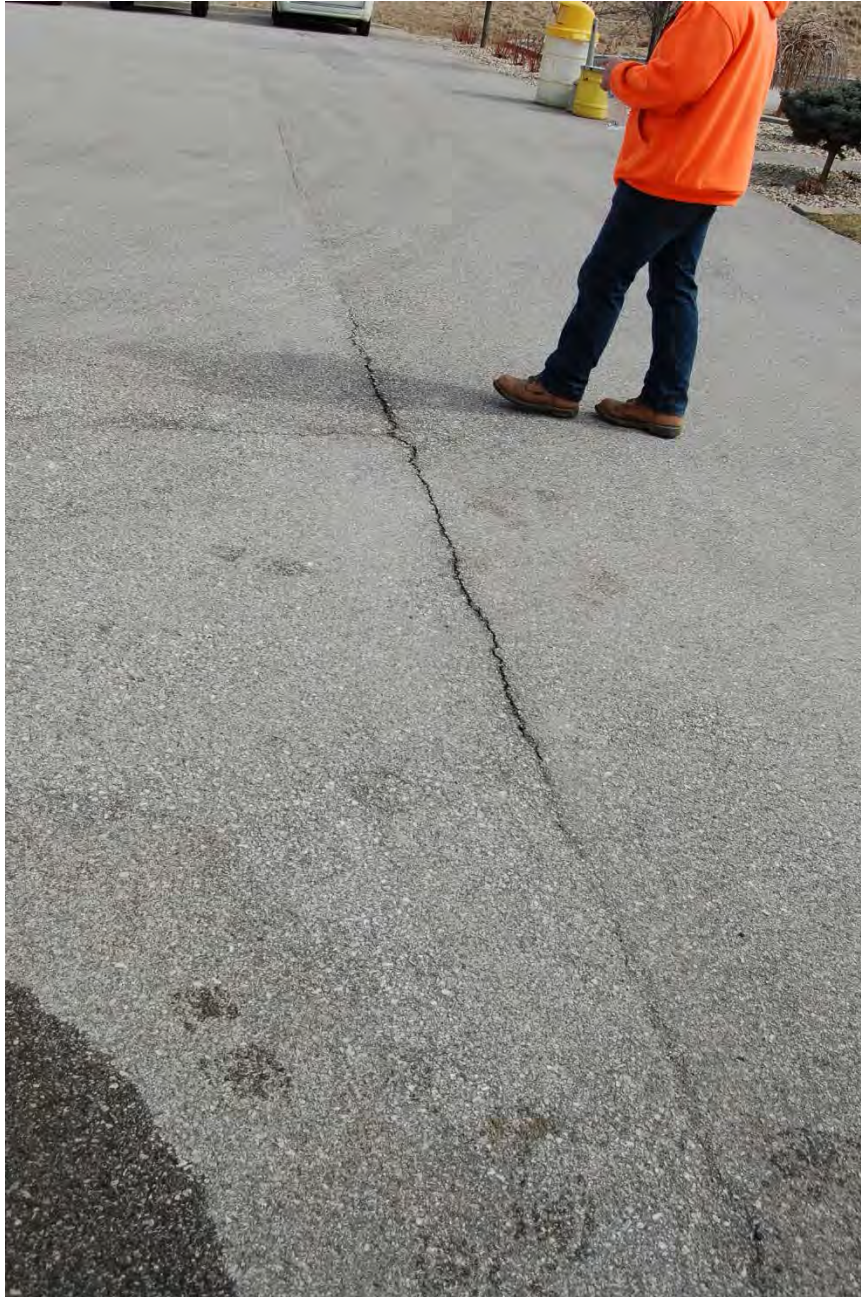
Photo 30: WA surficial asphalt crack facing east

- PRESENCE OF CRACKING OR DISCOLORATION		cracking	contact paving co. & get cost to fill cracks	
ACCESS ROAD					
<u>ACCESS ROAD</u>	- EROSION	ok			
	- OBSTRUCTIONS/DEBRIS	ok

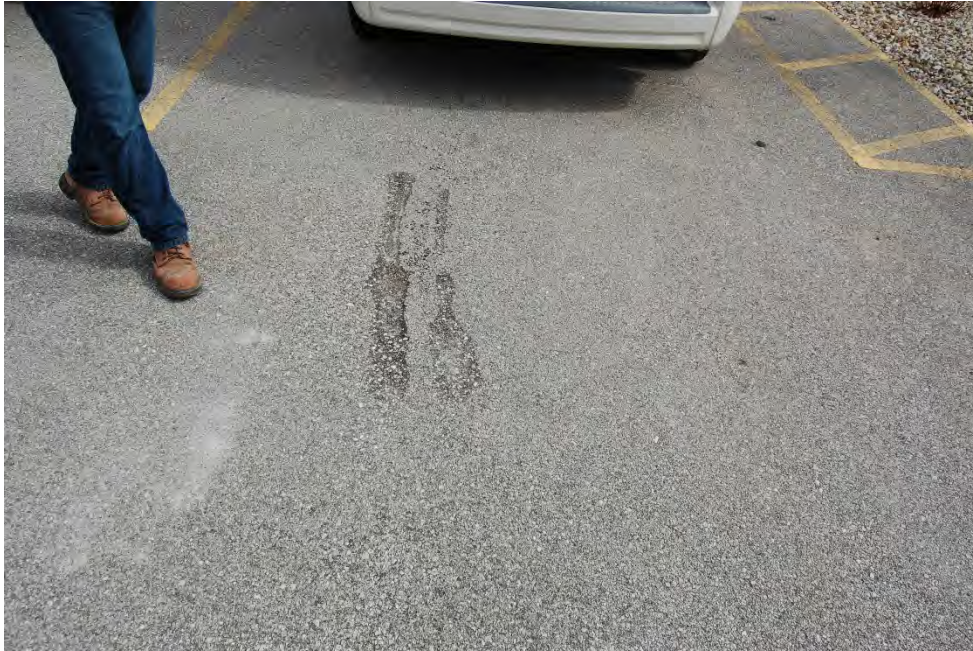
Photo 31: WA asphalt gouge in parking spot

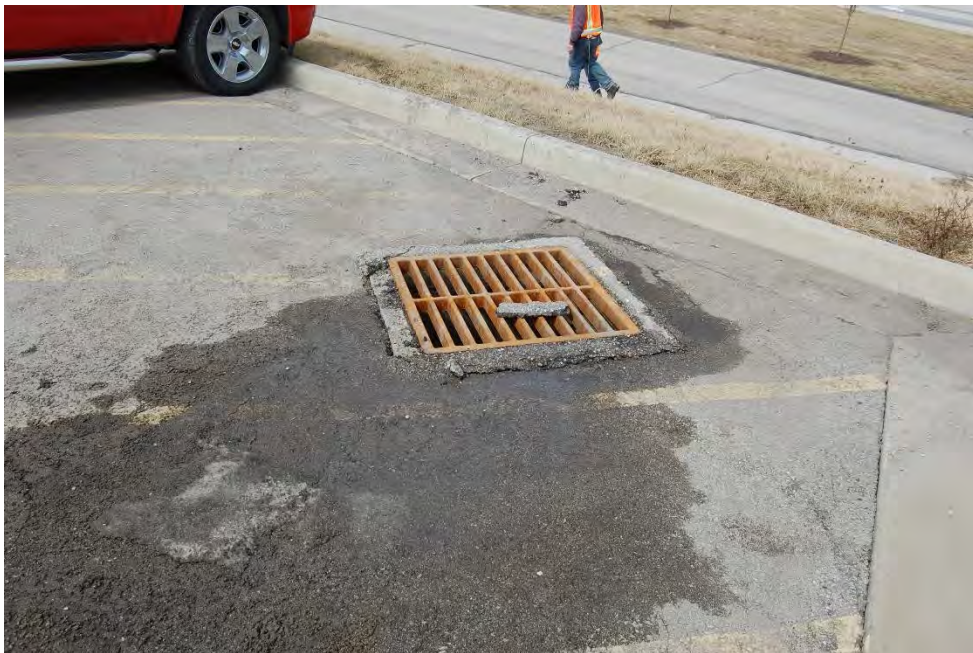
Photo 32: WA damaged asphalt surface near catch basin
