Re: RCRA Corrective Action Administrative Order on Consent (AOC)
Progress Report 67, Fourth Quarter 2017
GM GPS – Bedford Facility, IND 006036099, Docket No. RCRA 05-2014-0011
Bedford, Indiana

Fourth Quarter 2017 Progress Report 67

GM GPS – Bedford Facility
105 GM Drive
Bedford, Indiana
EPA ID# IND006036099
AOC Docket No. RCRA 05 2014 0011

Fourth Quarter 2017 Cover System Inspection: Photograph Log, Transect Figures, and Field Logs

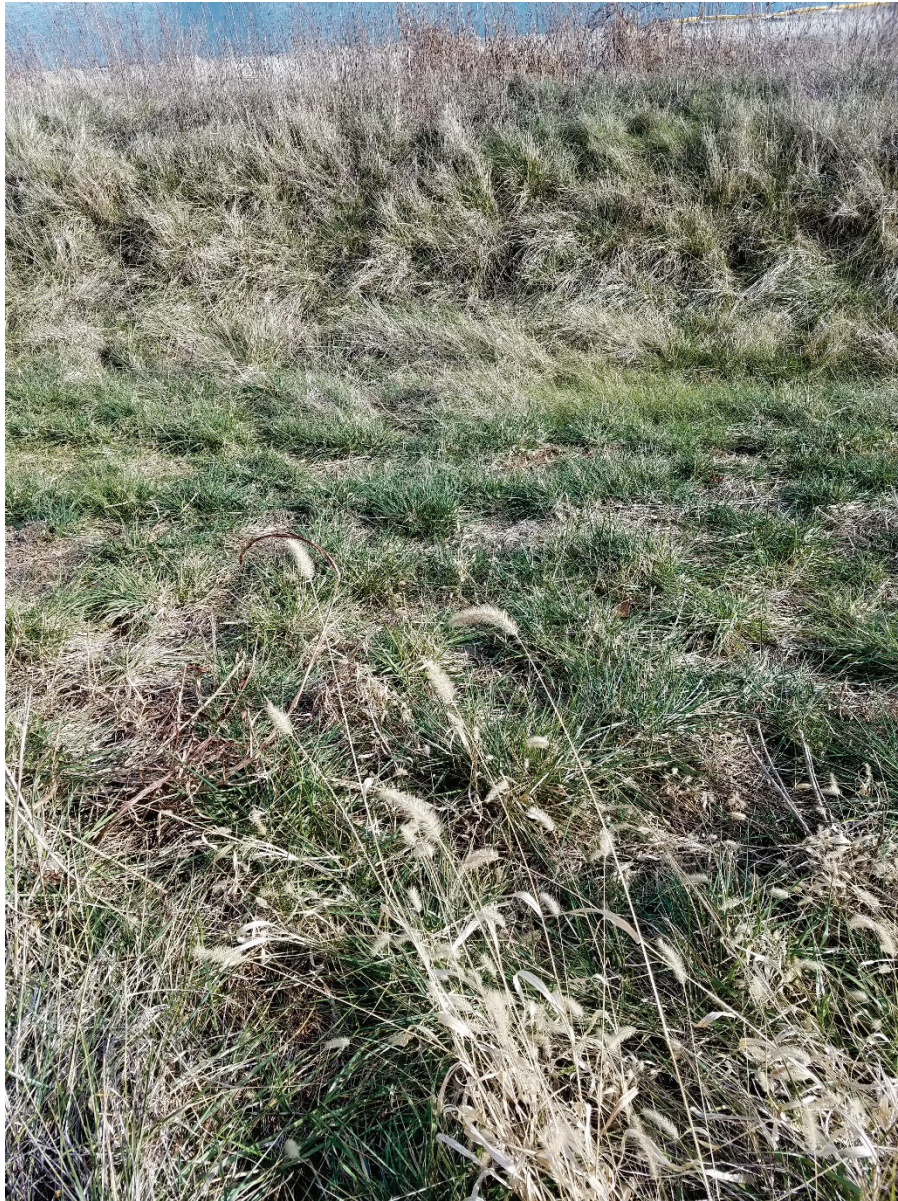
Photo 1: EV1 Vault Cover System vegetation growth

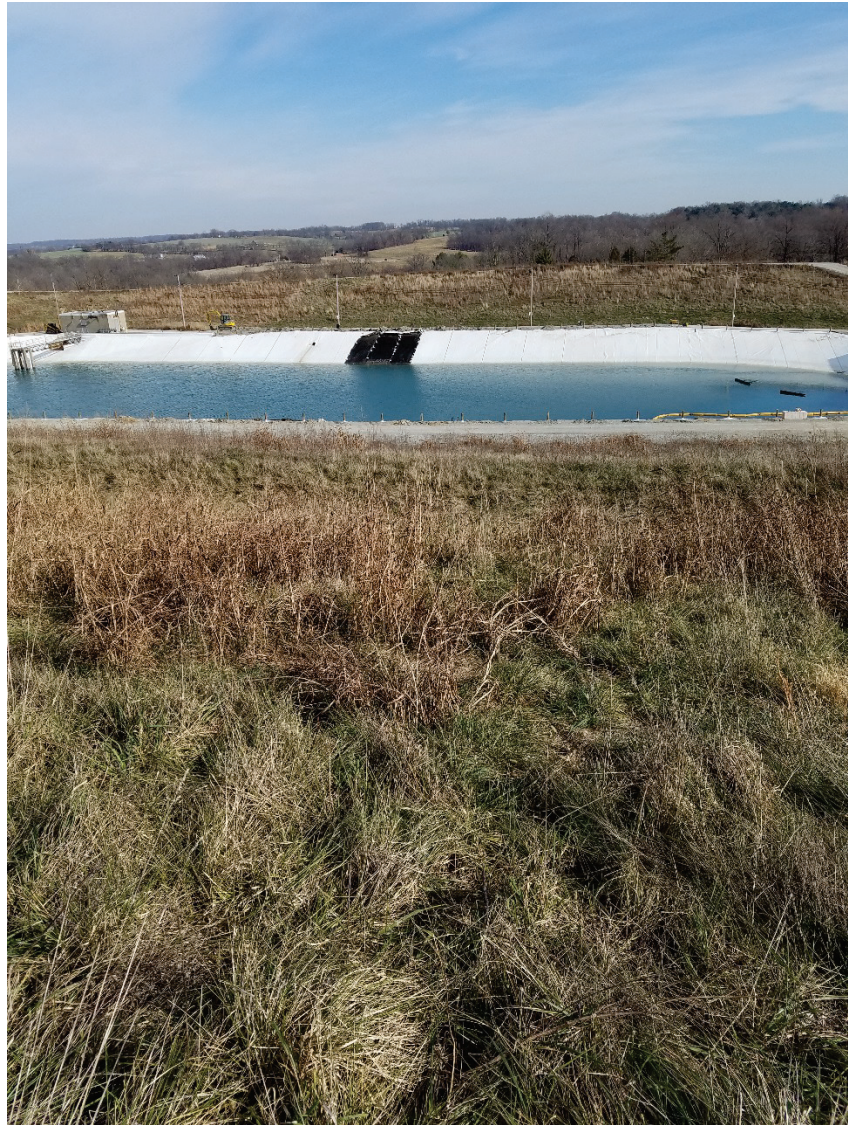
Photo 2: EV1 Vault Cover facing east toward pond

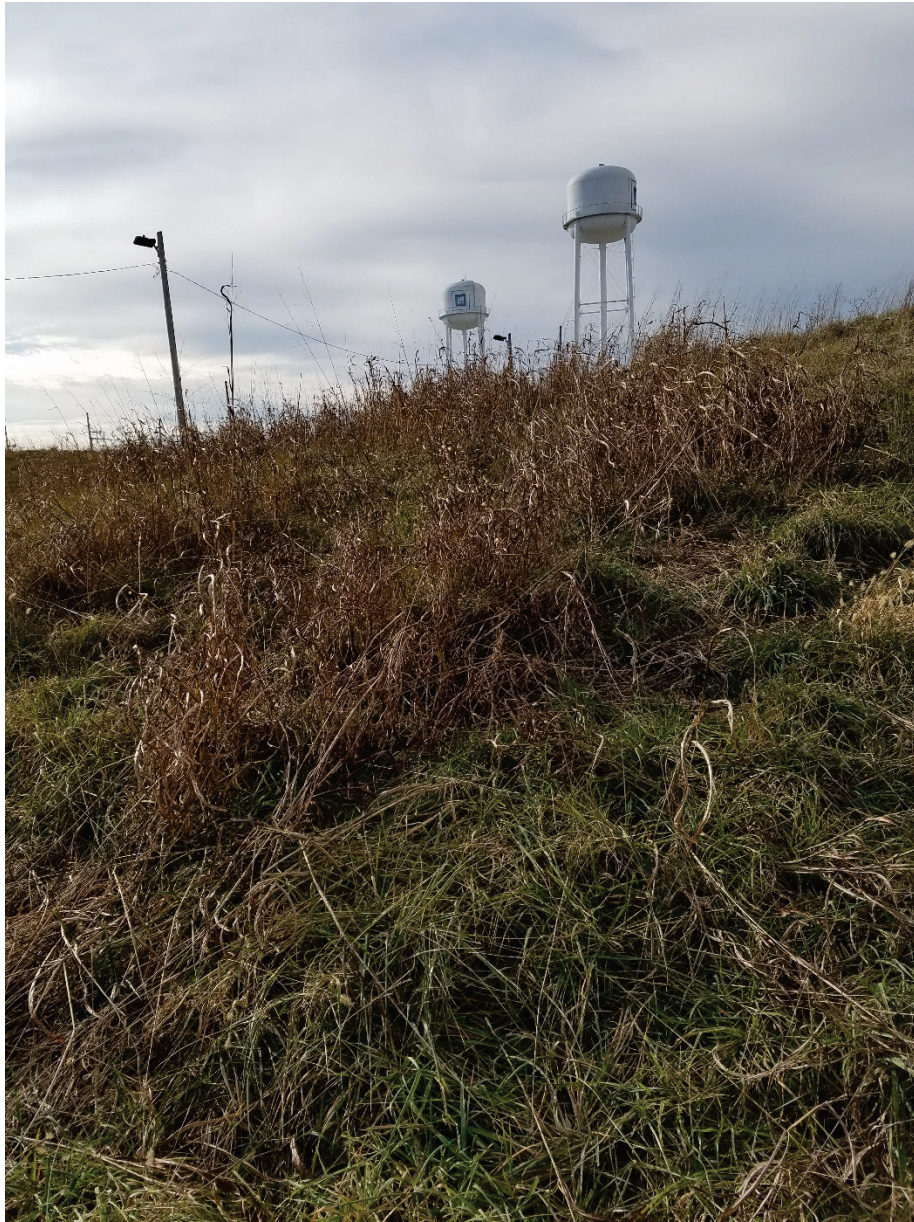
Photo 3: Vegetation at ES1 facing southwest.

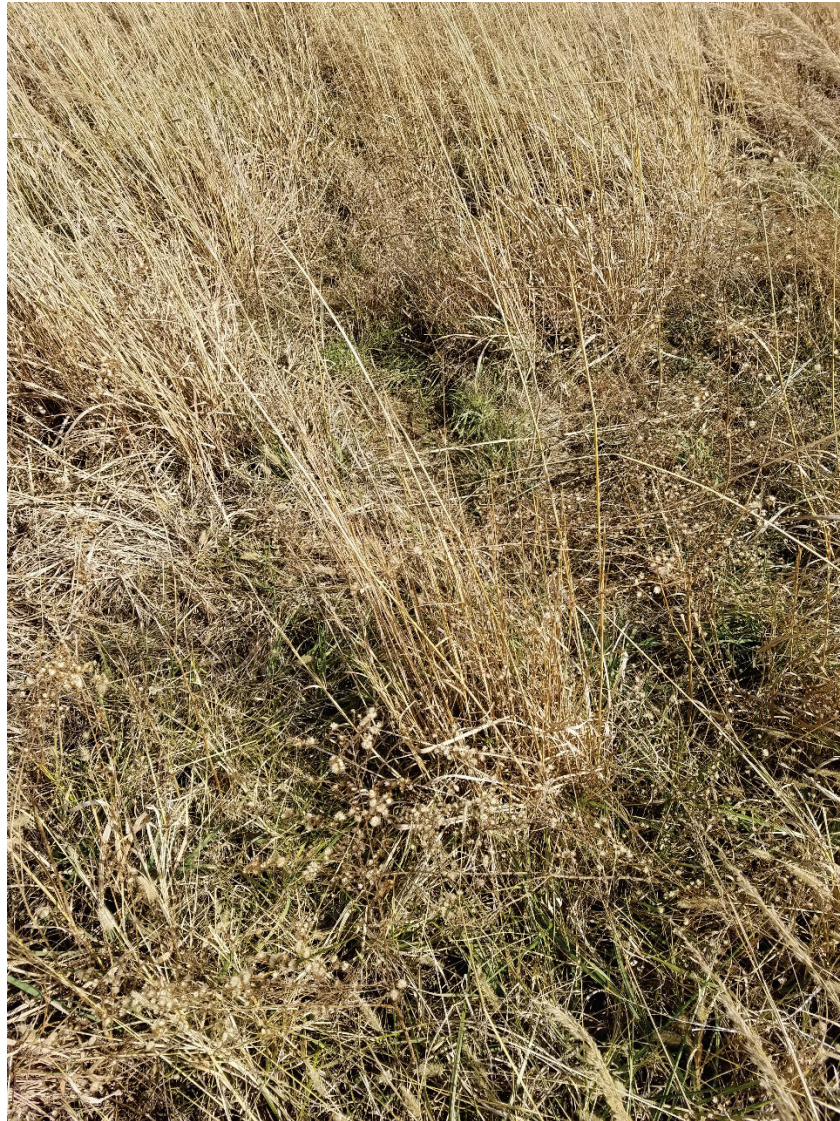
Photo 4: Vegetation growth at EV2

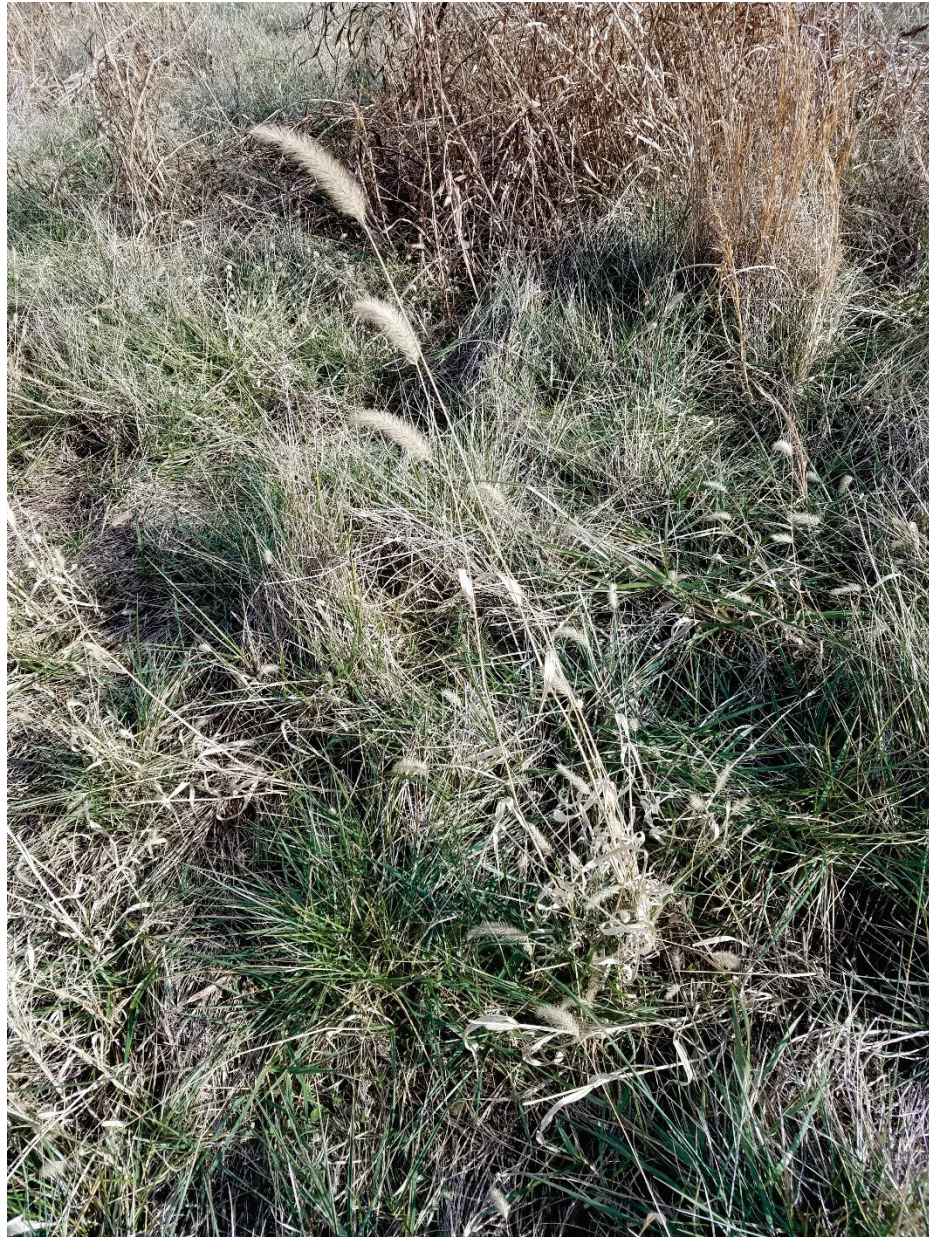
Photo 5: Vegetation growth at ES3.

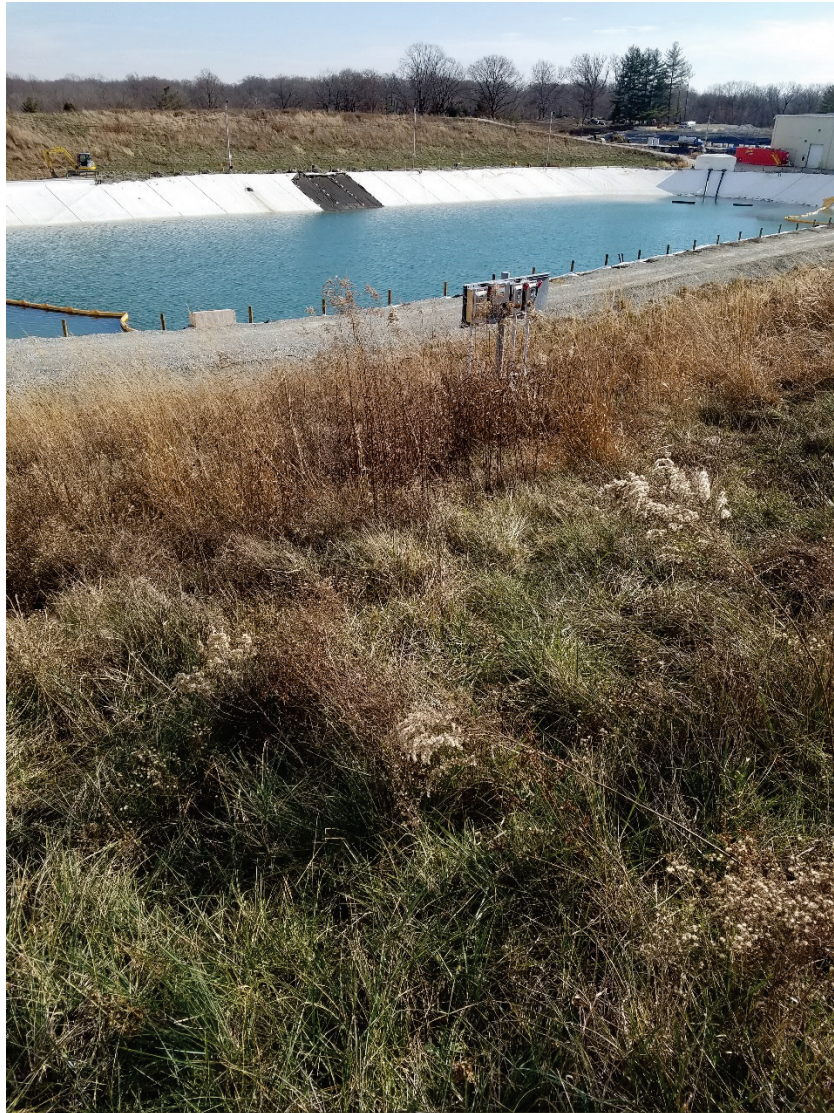
Photo 6: EV2 East Plant Area Cover facing southeast towards pond

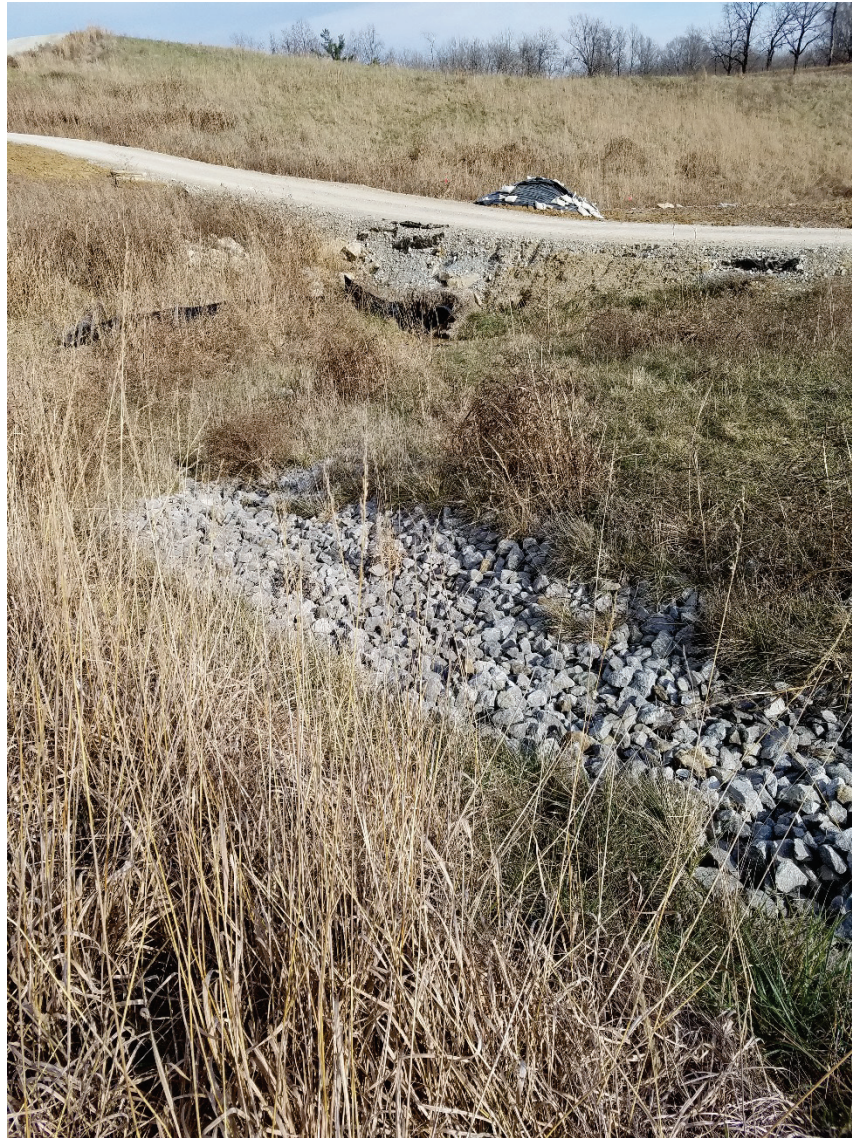
Photo 7: Drainage at ES12 facing northeast.

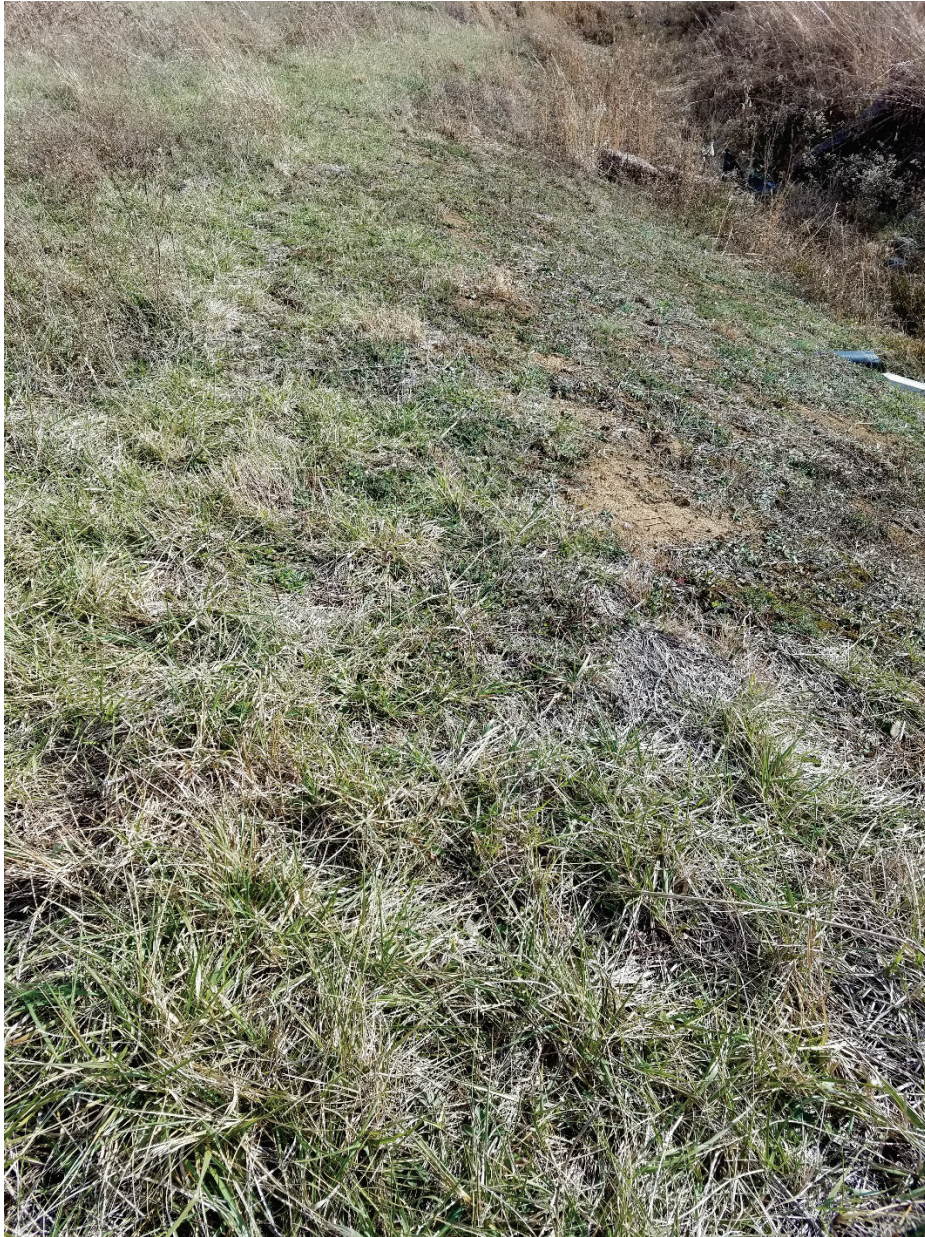
Photo 8: Drainage pipe along EV3 East Plant Area Cover.

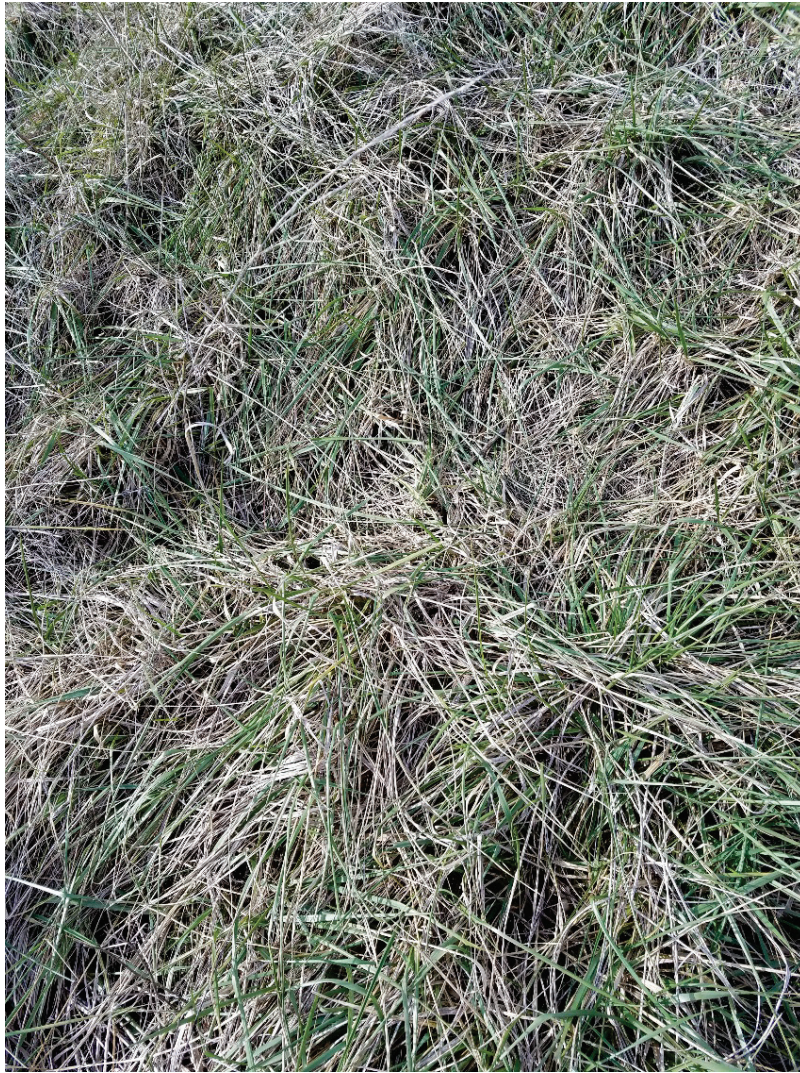
Photo 9: Vegetation on ES1 East Plant Area Cover at south end of Pond.

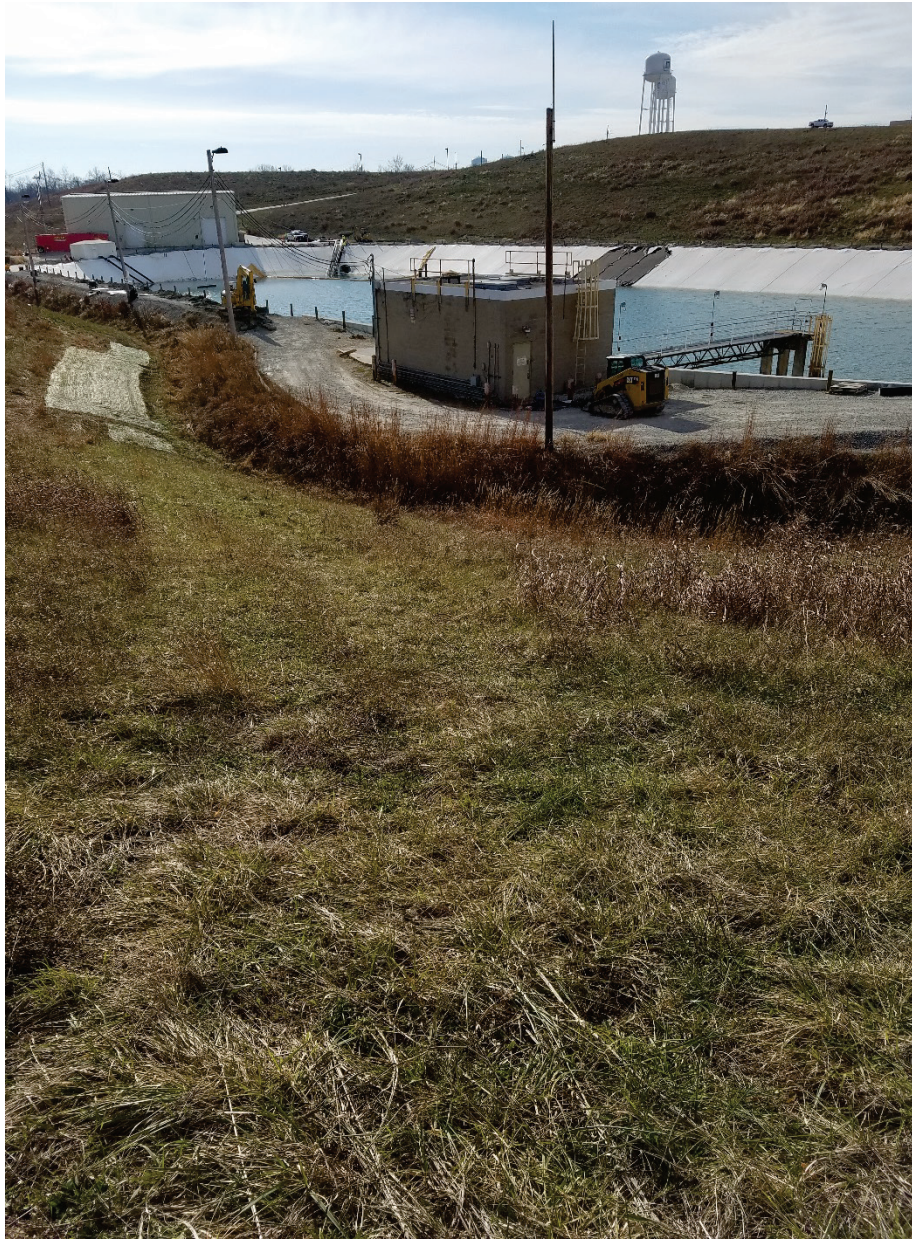
Photo 10: Vegetation along EV4 East Plant Area Cover facing southwest

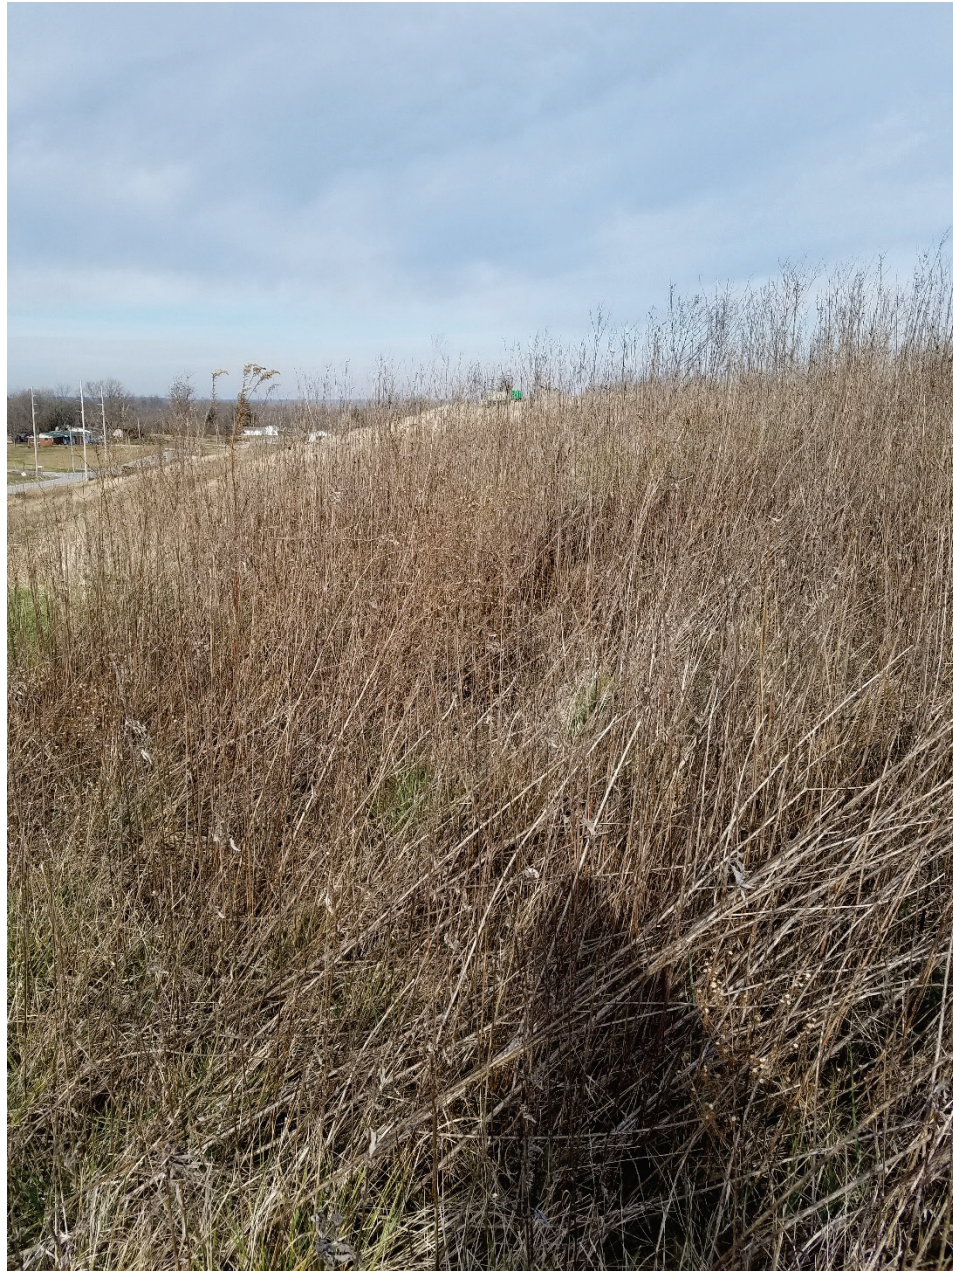
Photo 11: ES3 East Plant Cover System facing north

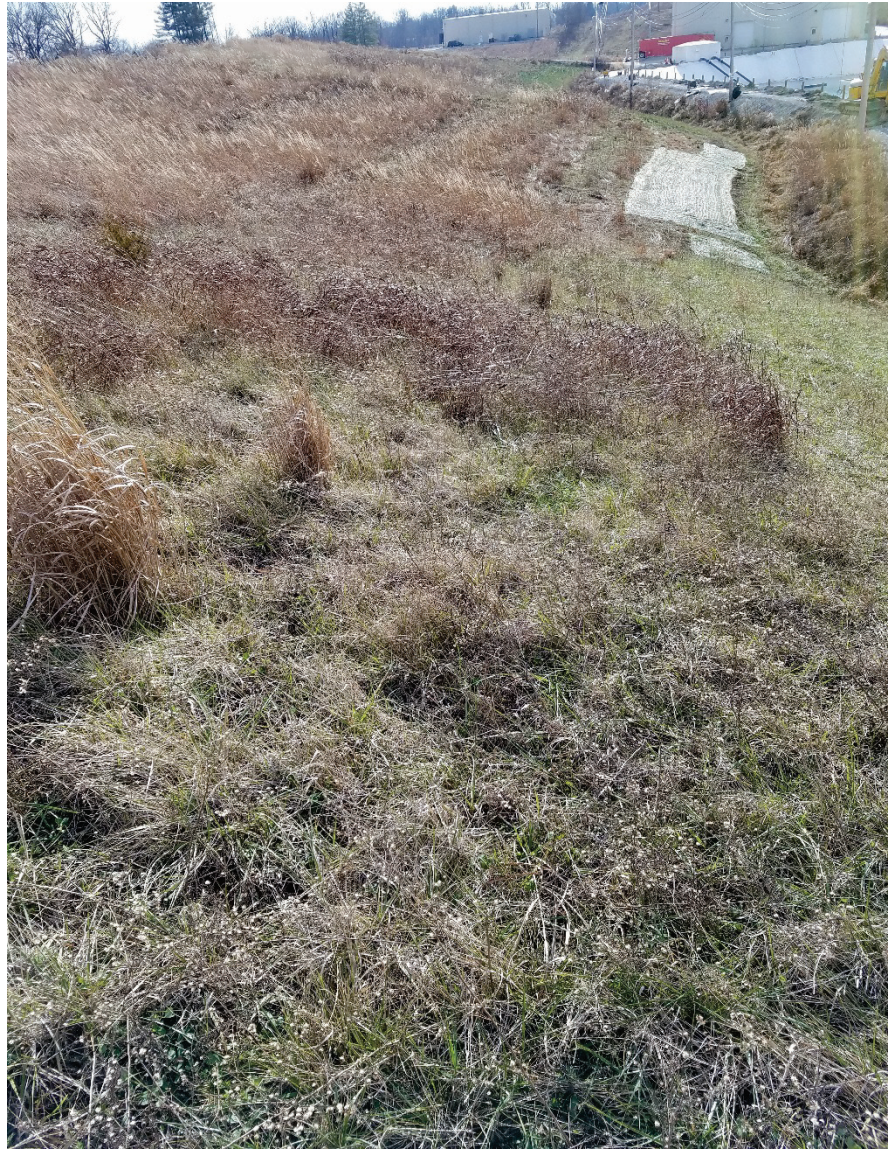
Photo 12: EV4 East Plant Area Cover erosion repairs.

- Erosion within drainage ditches for the East Plant Cover System ditches was repaired during the week of December 11, 2017.
- Conference calls were held with U.S. EPA and IDEM on October 5, November 7, and December 6, 2017, to discuss items related to the project.

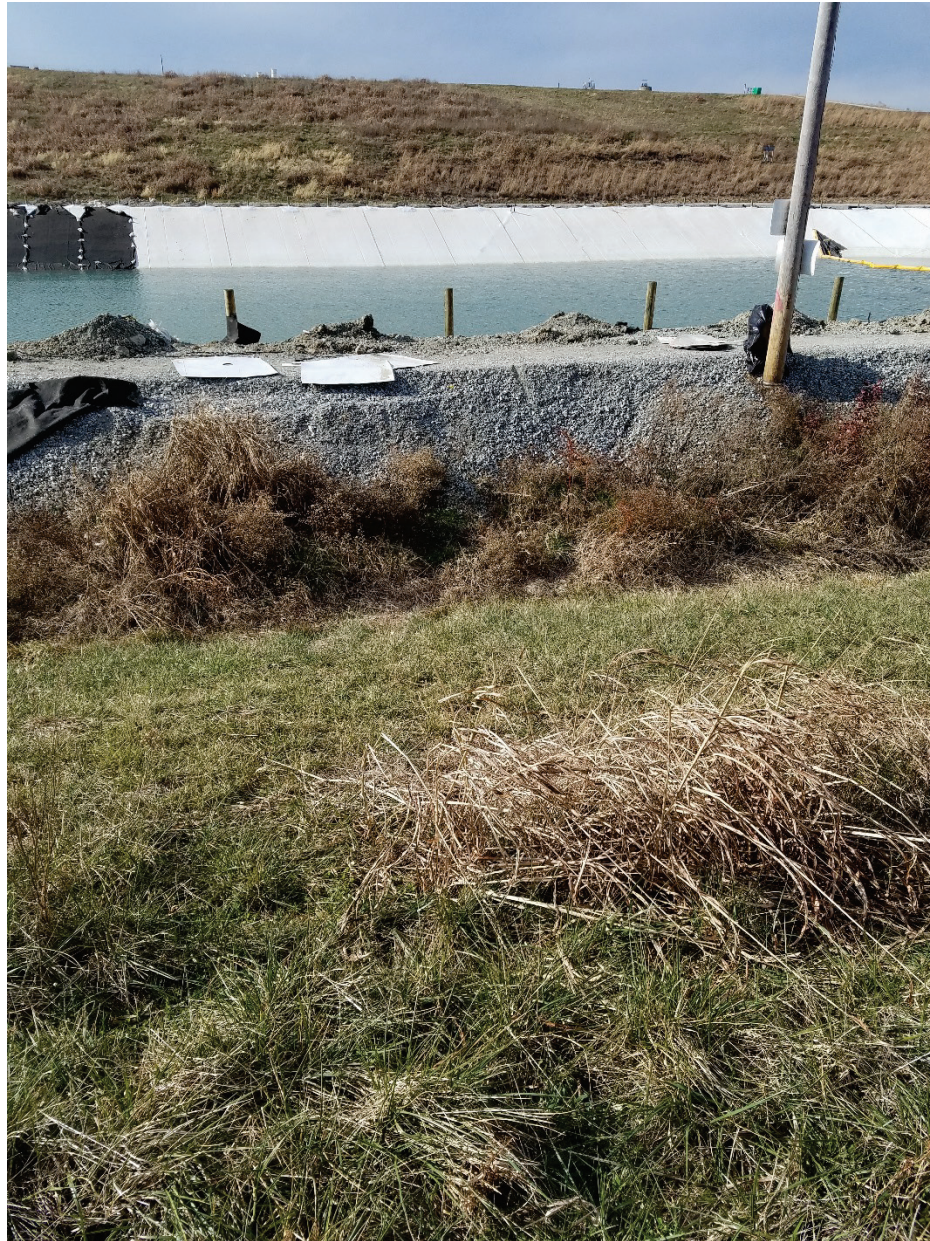
Photo 13: Vegetation south of EV5, facing pond

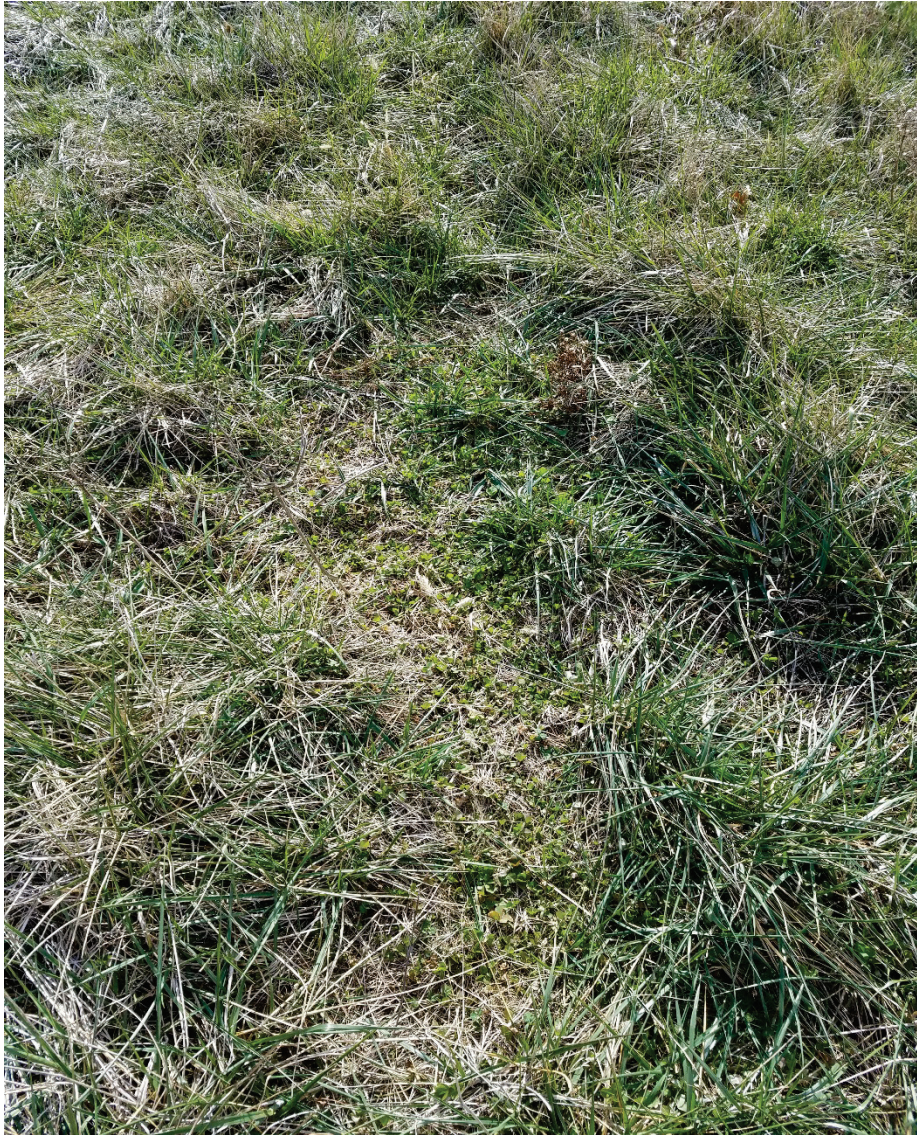
Photo 14: Vegetative growth along EV5 East Plant Area.

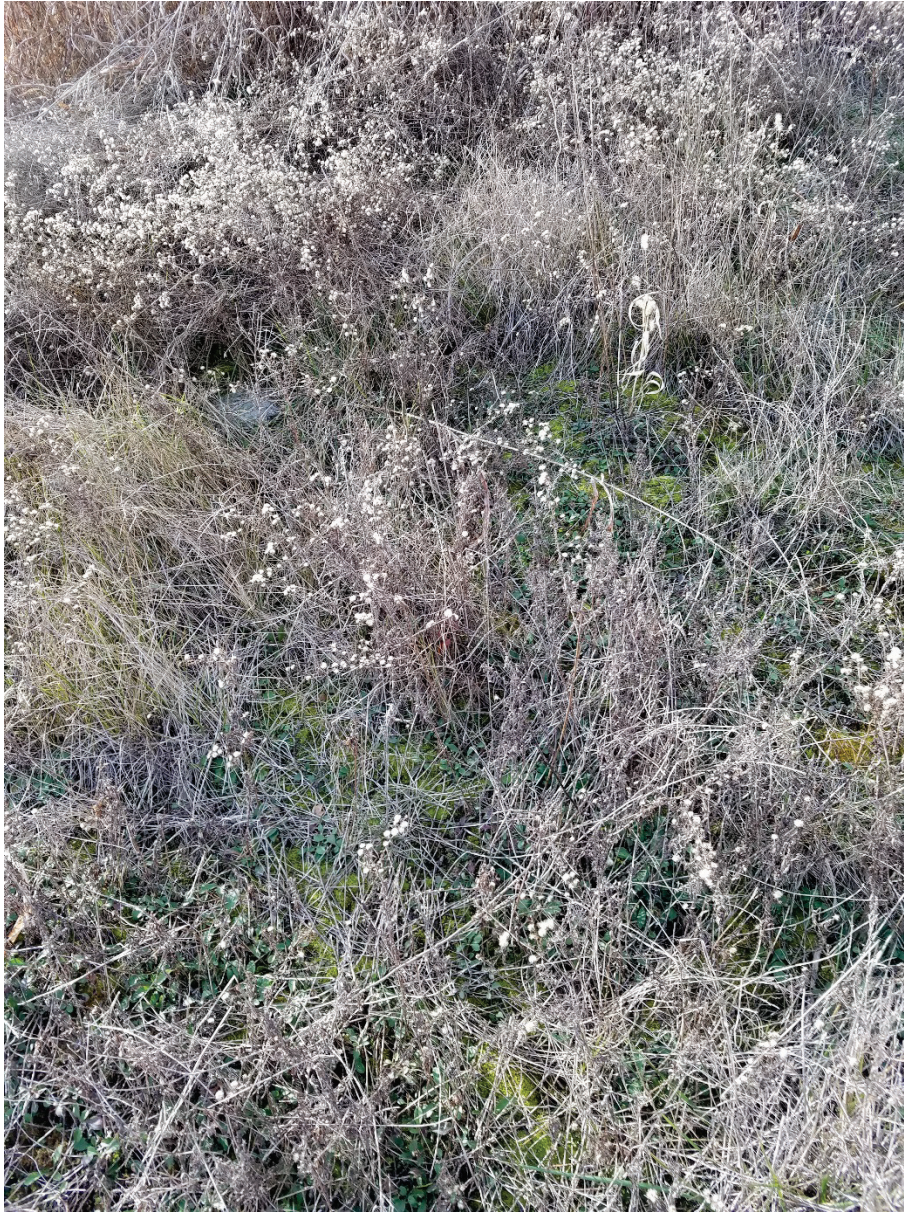
Photo 15: Vegetation growth at ES12 East Plant Area Cover.

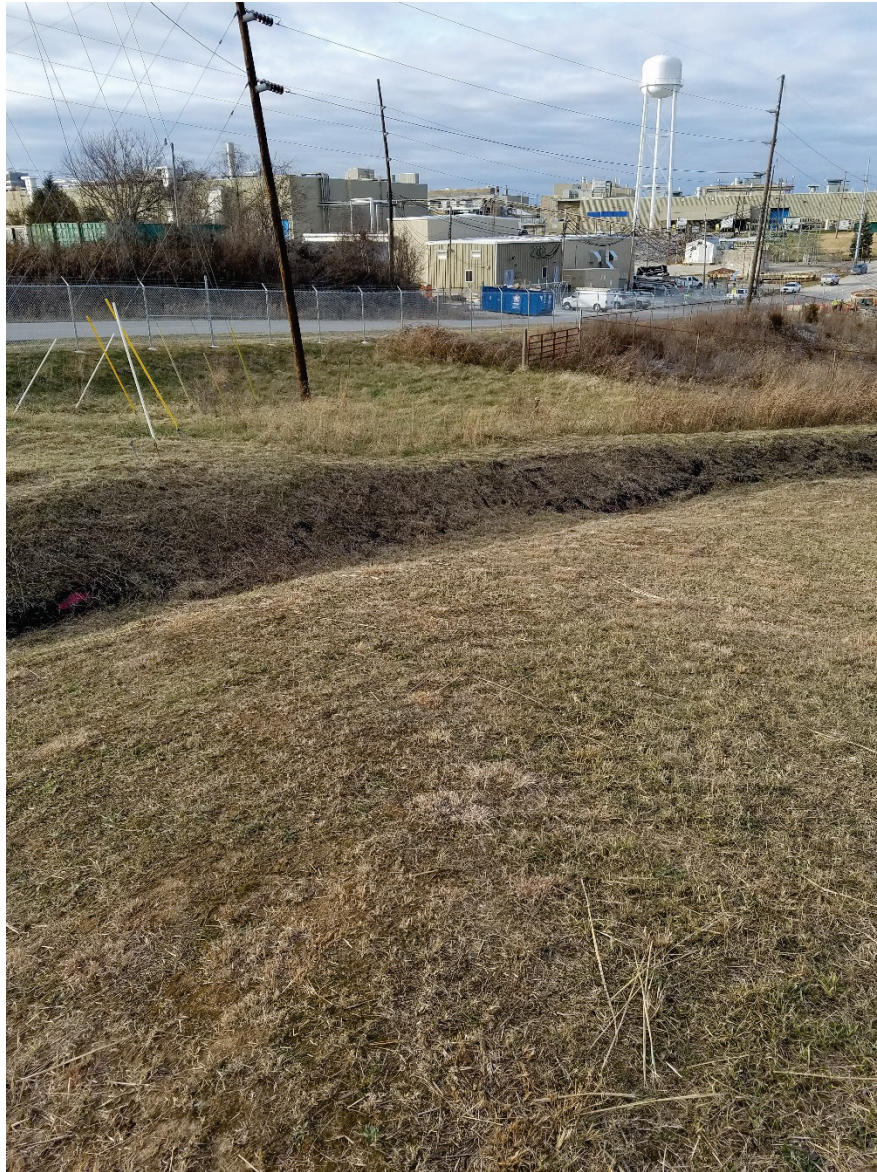
Photo 16: EV7 East Plant Cover facing northwest, mowed to promote wildflower growth.

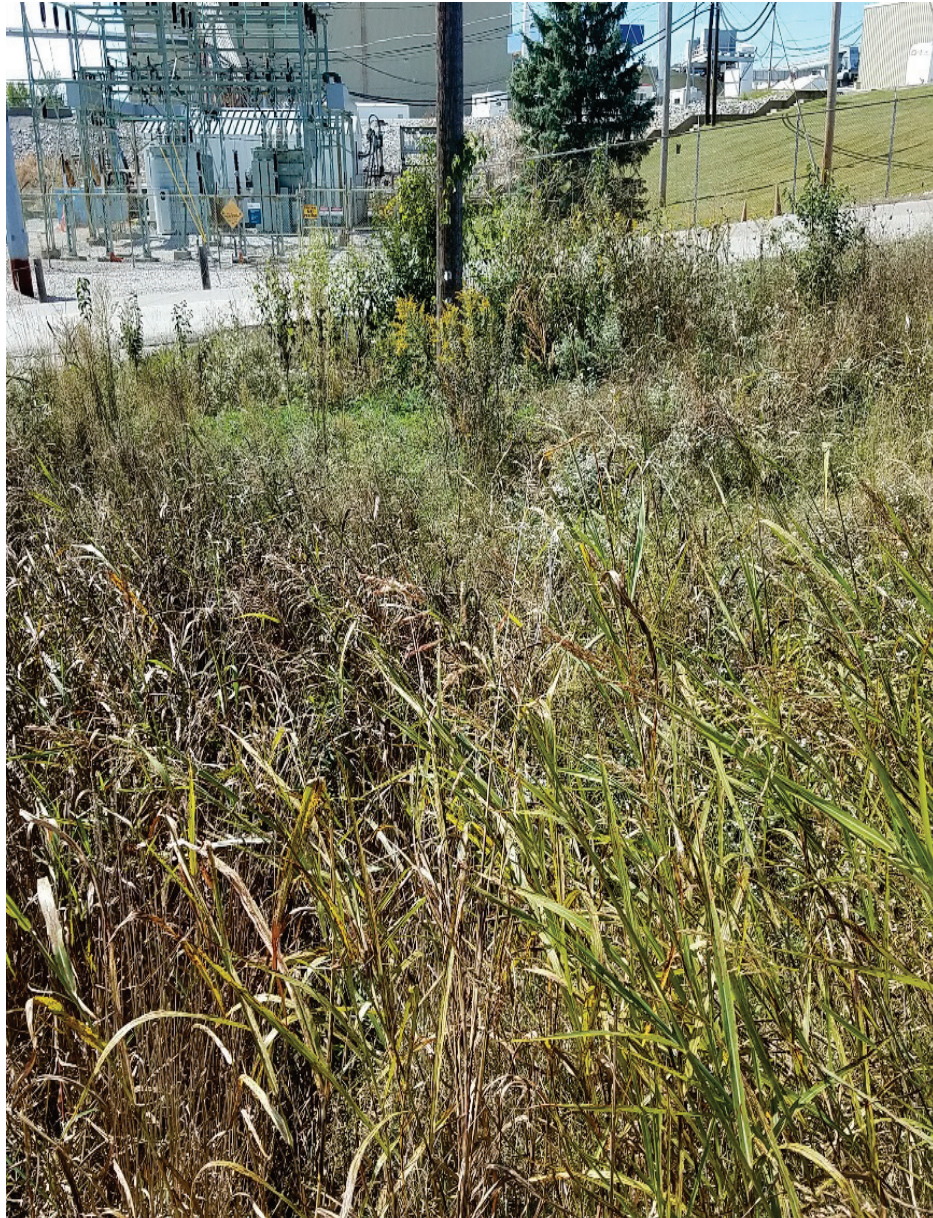
Photo 17: East Plant Area Cover System along EV6, facing northwest.

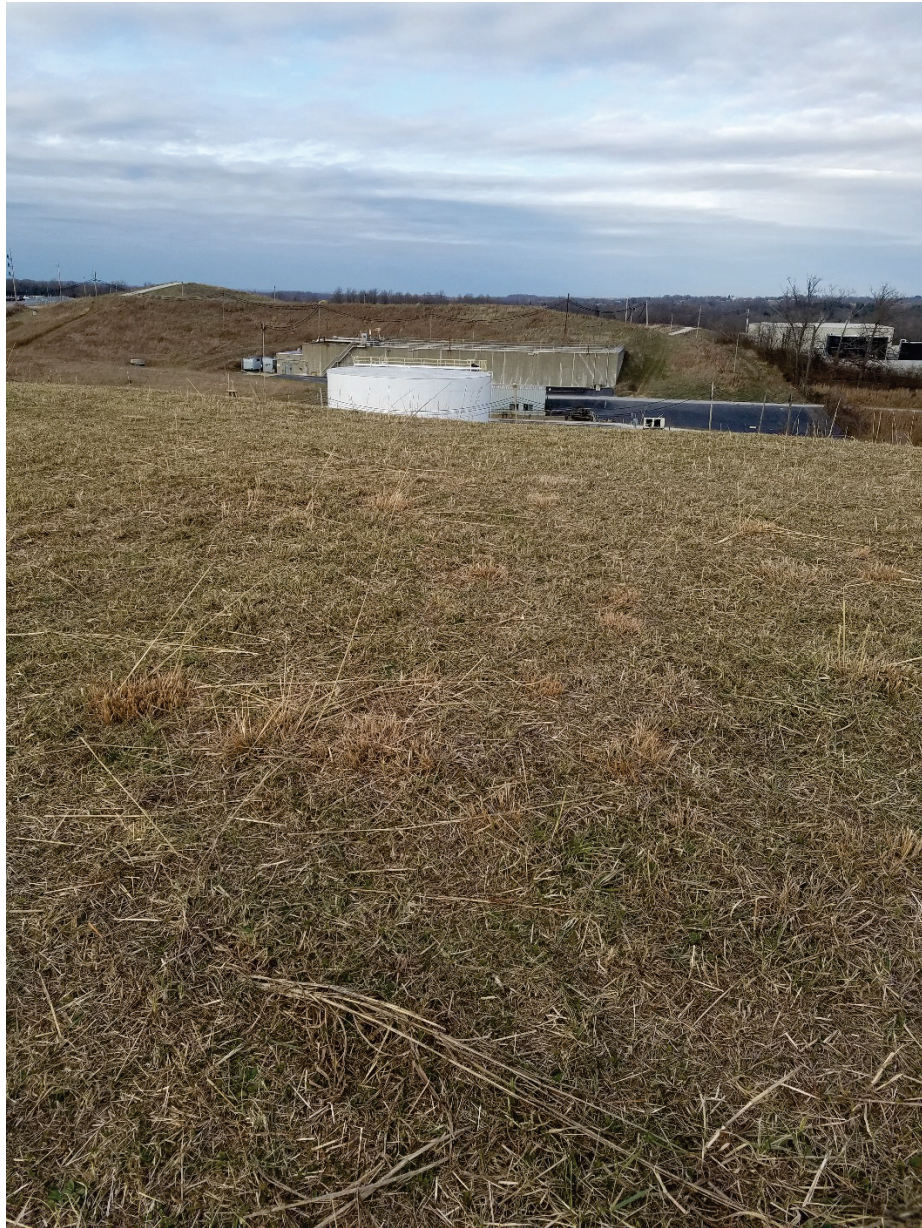
Photo 18: East Plant Area Cover overview facing north.

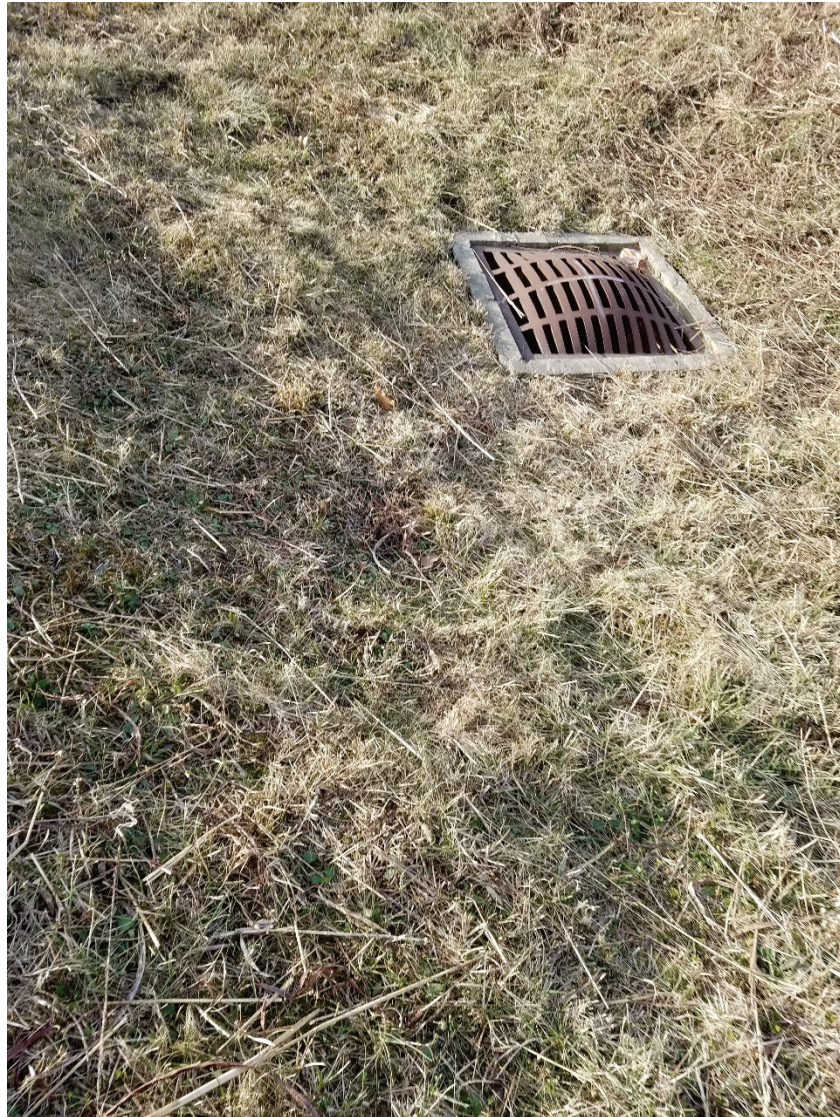
Photo 19: EV9 East Plant Area Cover surface water drainage.

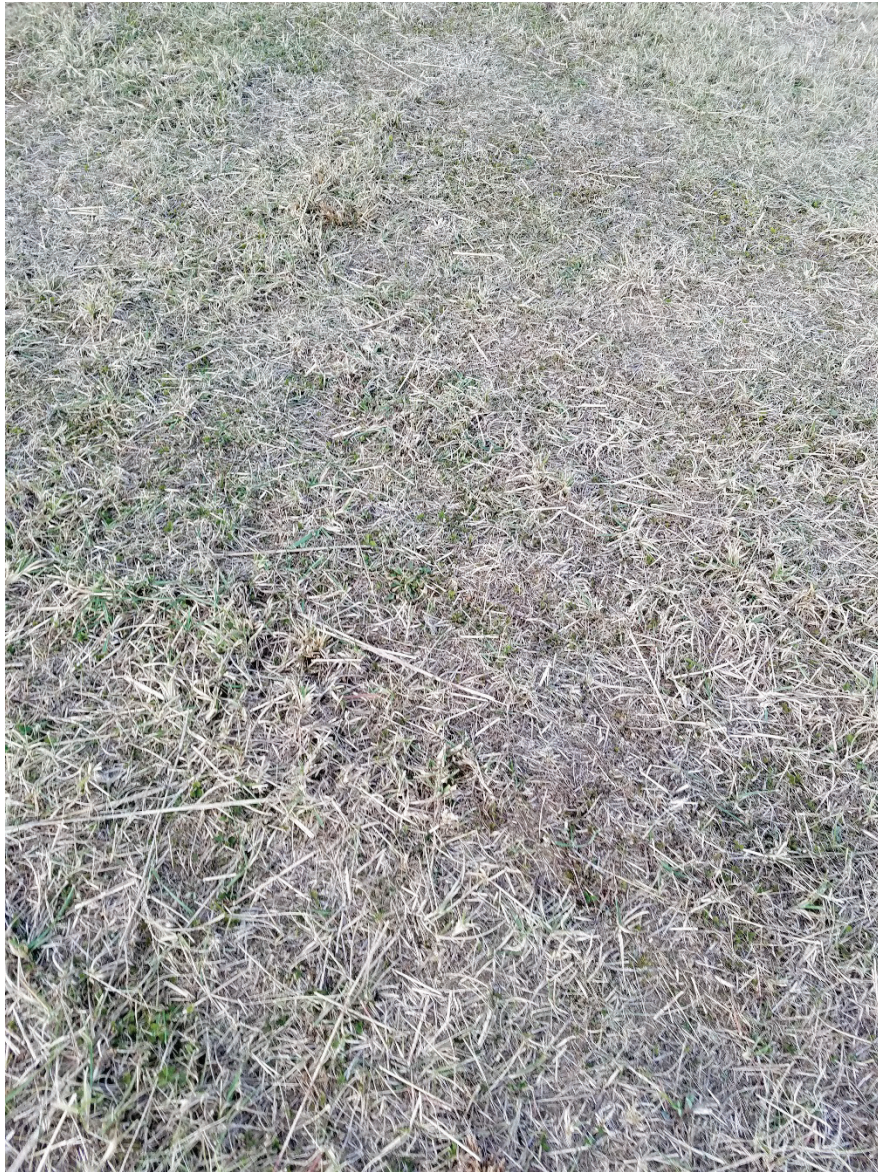
Photo 20: ES14 East Plant Area Cover
