## **Fourth Quarter 2015 Progress Report 59**

GM CET – Bedford Facility

Bedford, Indiana

AOC Docket No. RCRA-05-2014-0011

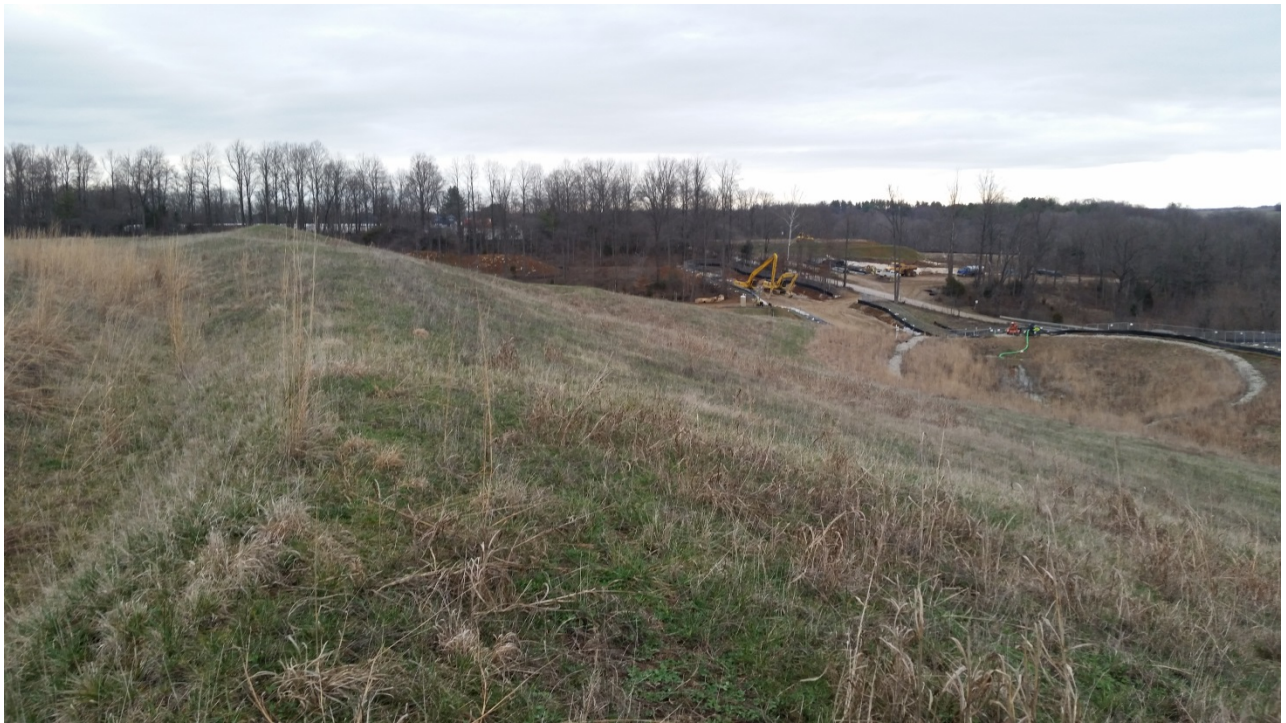
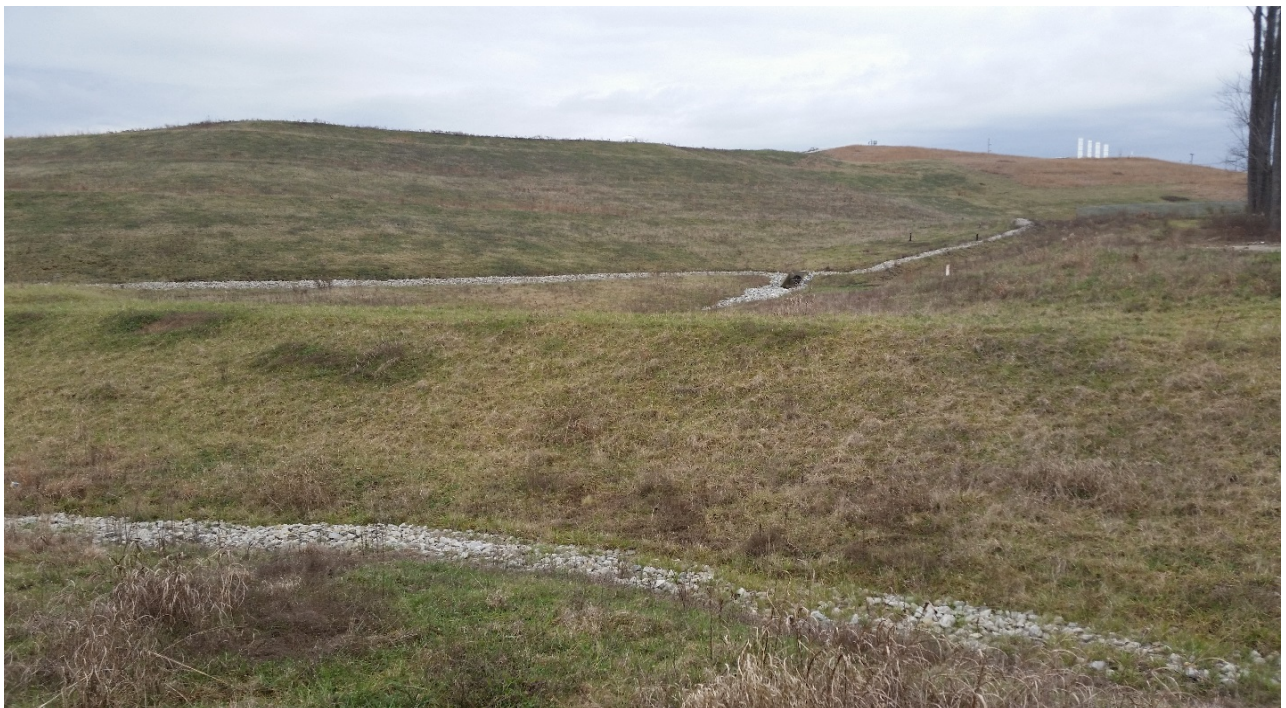
4. Light erosion was identified along EV4, and in ES6. This area will be re-seeded in the spring.
5. SES completed repairs to rip-rap the channel on EV7. Some additional erosion of the rip-rap has occurred that will be repaired in the next quarter.

Photo 6: EV4 East Plant Area cover facing northeast.

Photo 7: EV4 East Plant Area cover facing southwest.

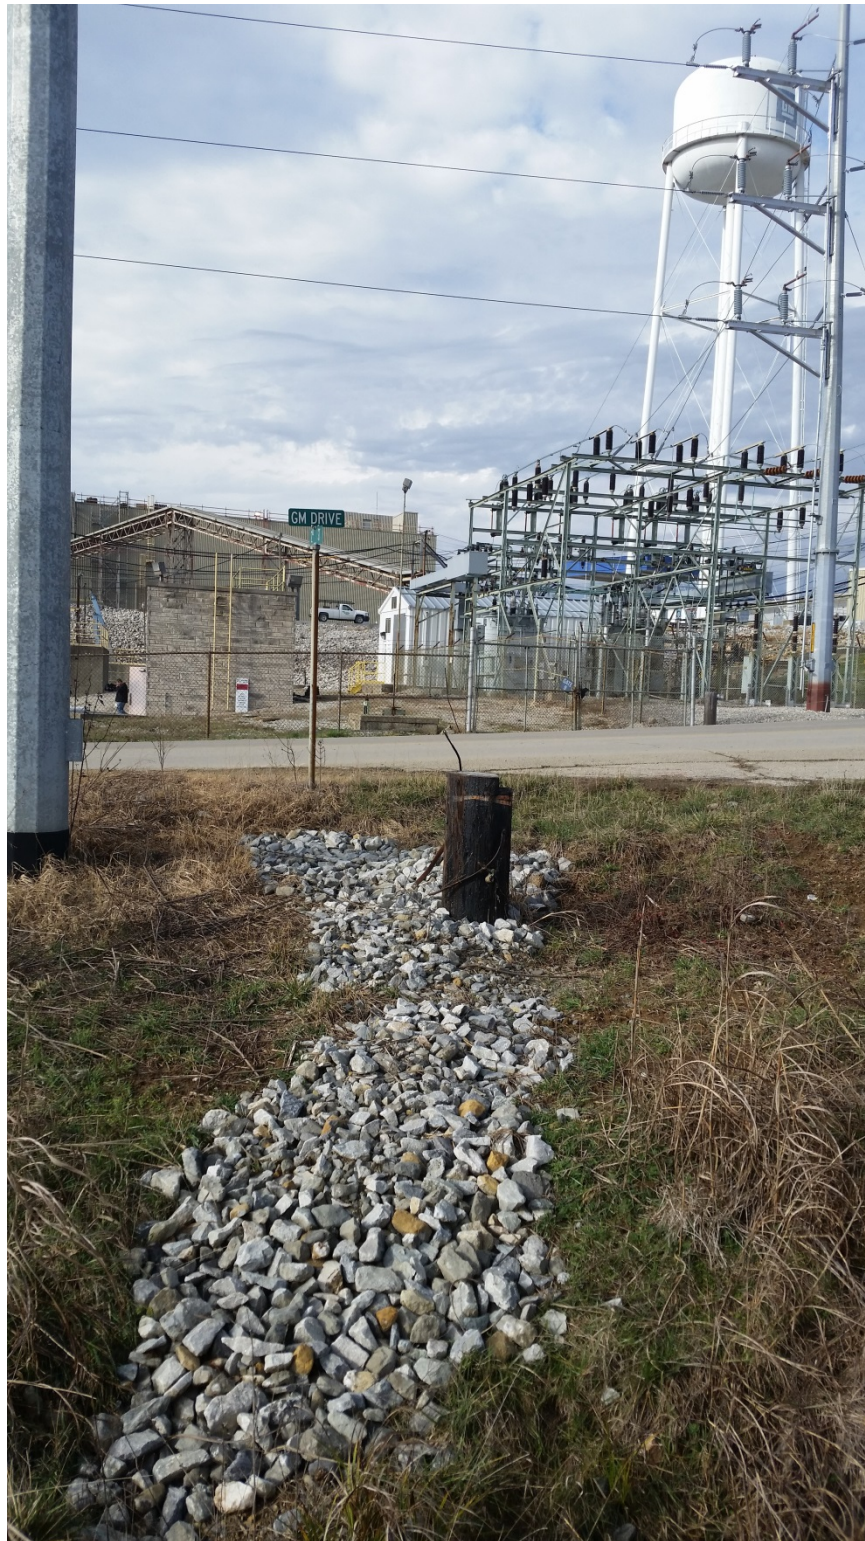
6. There are some erosion ruts along the east side of GM Drive, outside the cover system area adjacent to power poles. This does not appear to be due to any on-Site RCRA activities, but could have an impact on the liner system in the ditch. Work is still to be conducted on power poles in this area by the utility company. Repairs will not be addressed until after this work is completed.

Photo 10: EV6 erosion rut repairs outside cap limit.

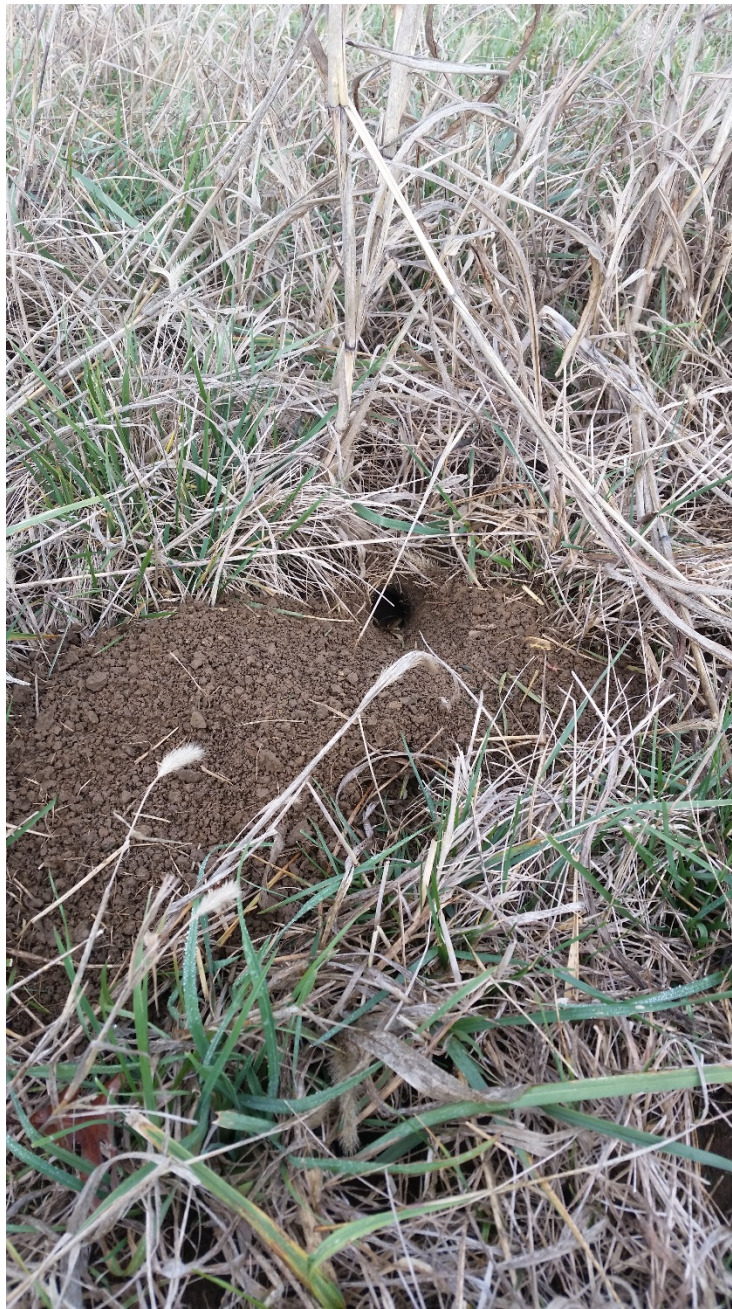
1. Weeds or clover growth was noted at most Transects in the East Plant Area but not on the West Plant Area. This is also typically accompanied by some bare patches as well.
2. Mole holes were identified over much of the East Plant cover system. GHD has contacted the liner companies and the moles do not burrow deep enough to damage the liner and so the vegetation will continue to be monitored, however, there is no immediate risk to the Cover.
3. Possible evidence of a burrowing animal was identified near EV6. A pest control company and/or Indiana Department of Natural Resources (IDNR) will be consulted on identifying, and

Photo 12: EV6 evidence of possible animal burrowing.

subsequently relocating the animal(s), if necessary. Soil and vegetation repairs will be made as necessary.

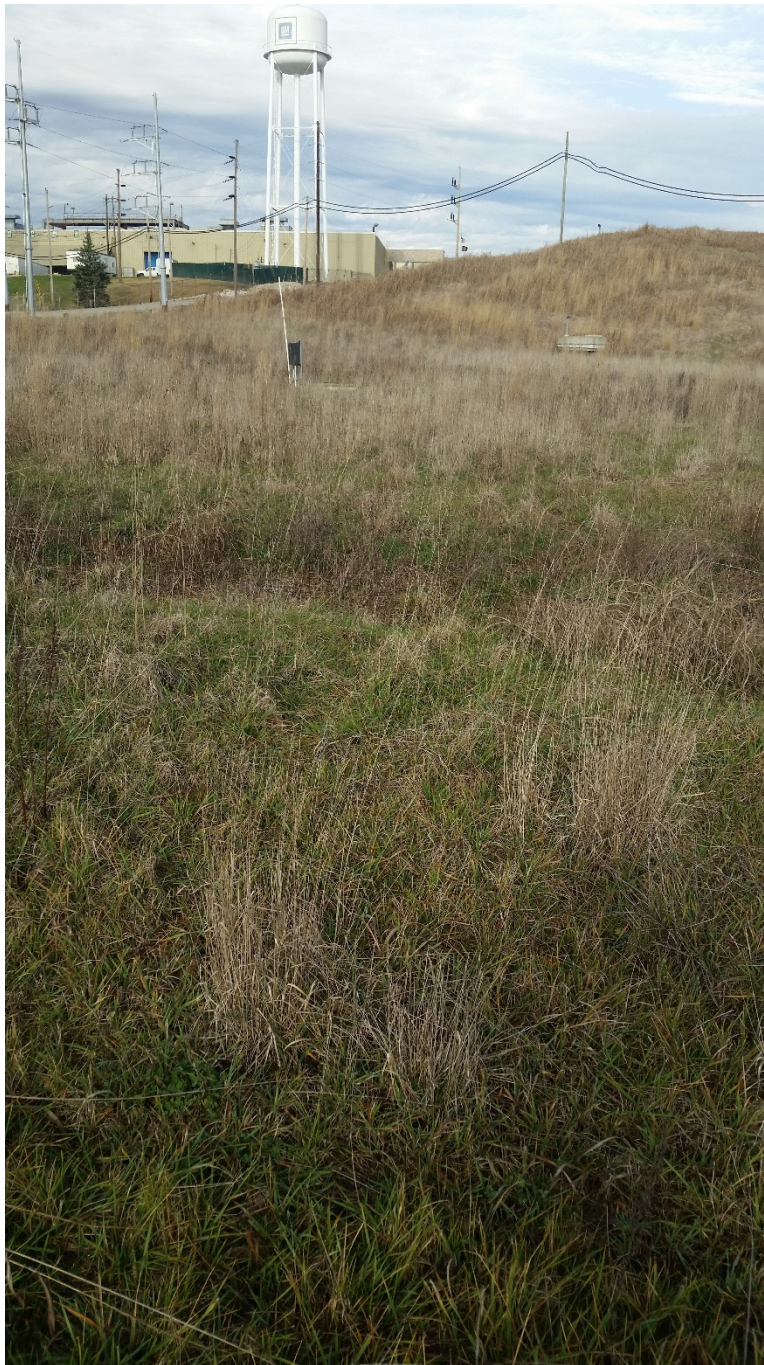
Photo 13: EV7 East Plant Area cover facing north.

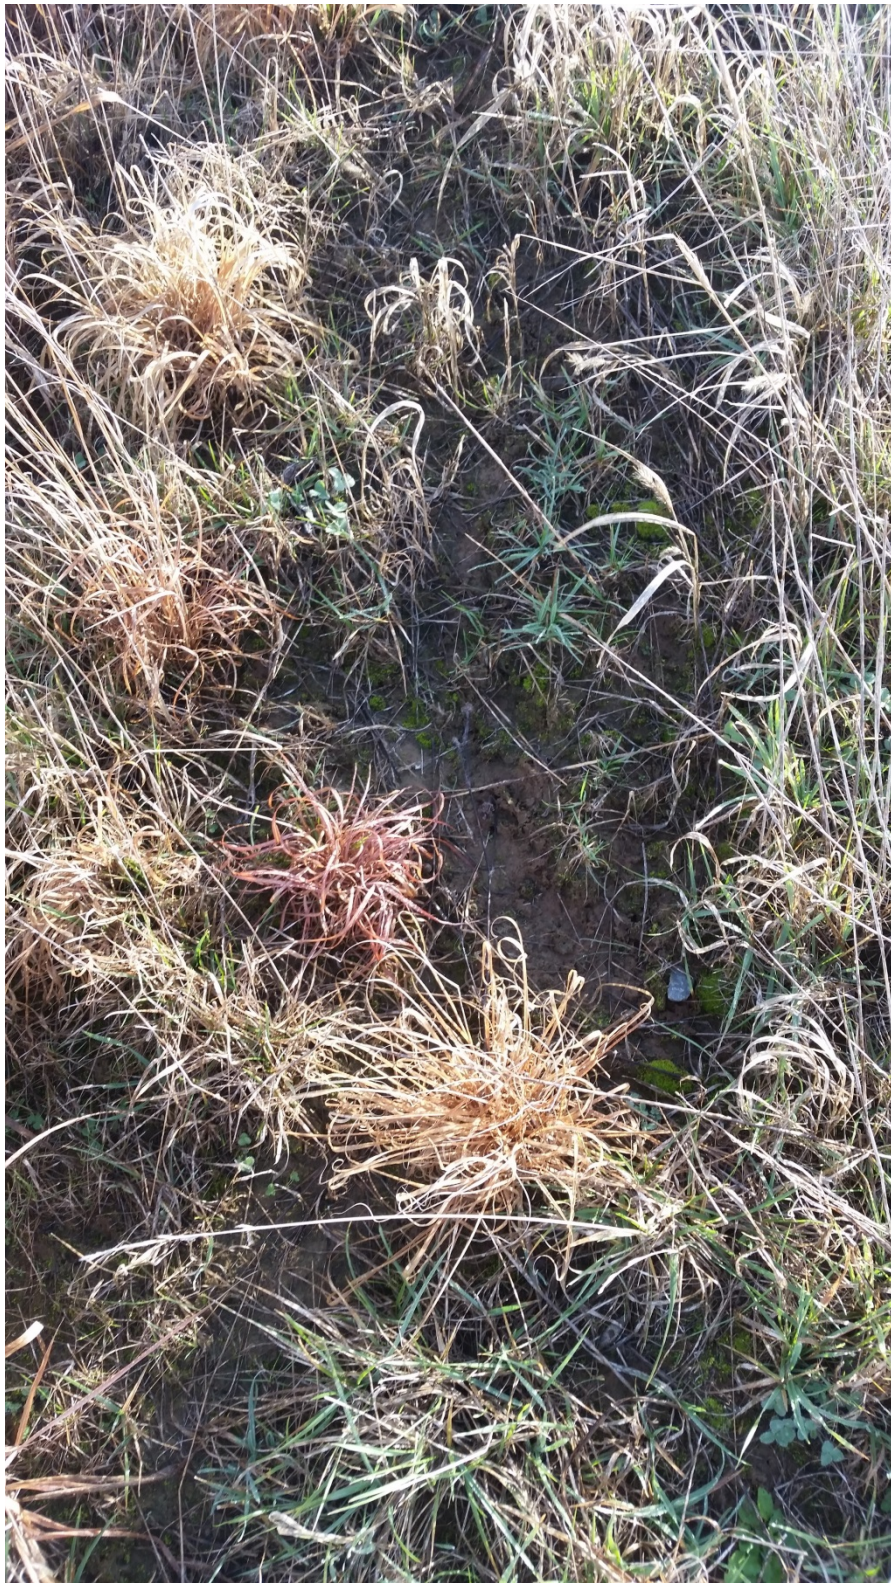
Photo 19: EV9 patchy vegetation.

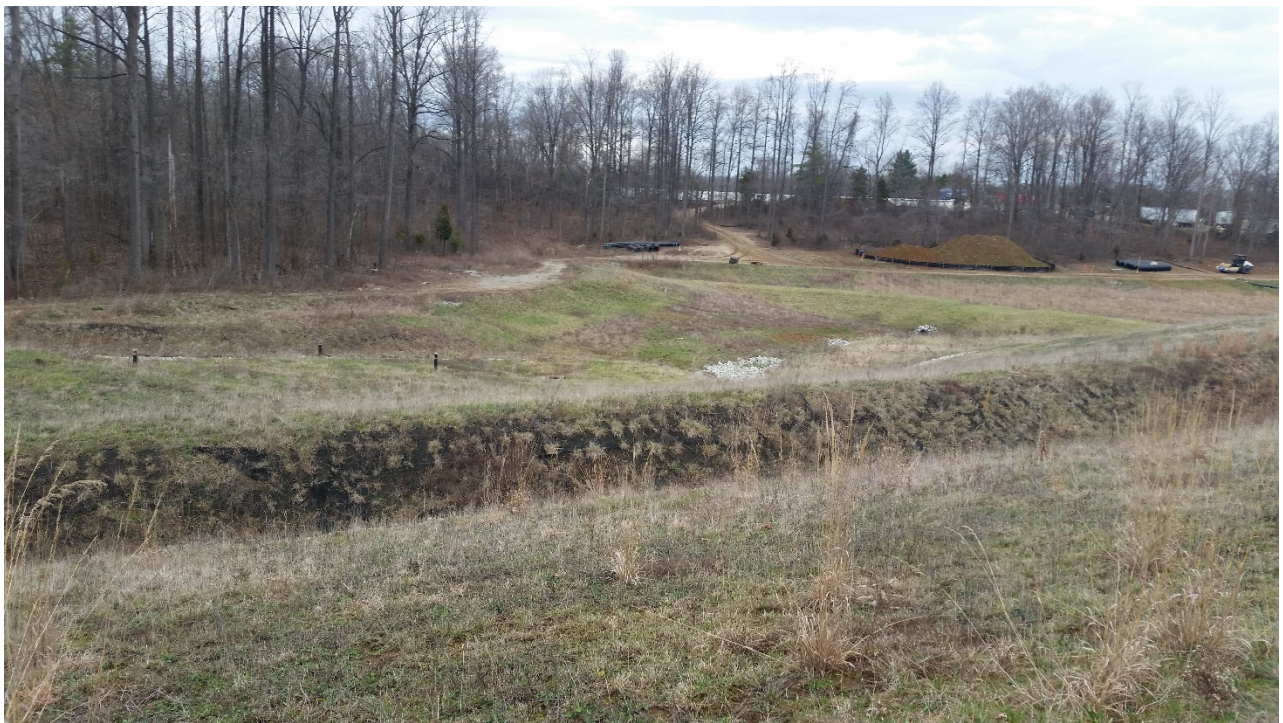
Photo 25: ES6 facing northeast.

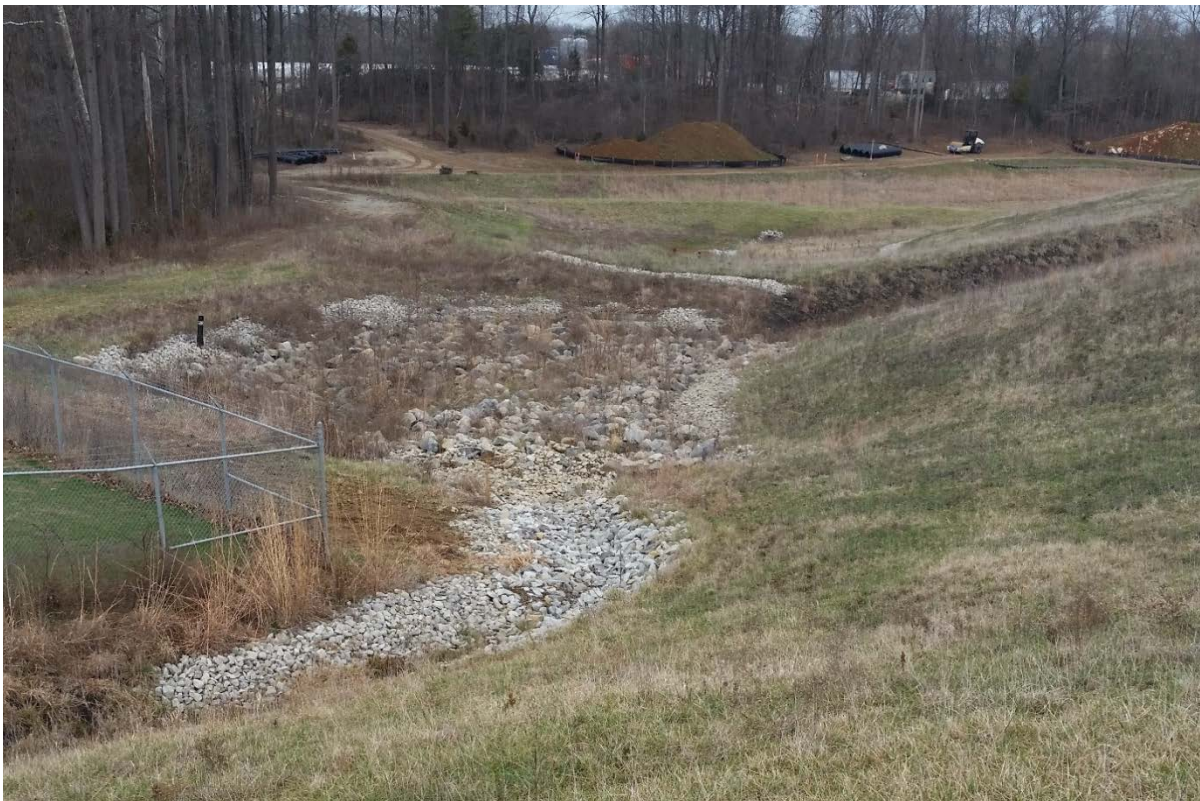
Photo 27: ES6 drainage swale facing east, repaired channel erosion.

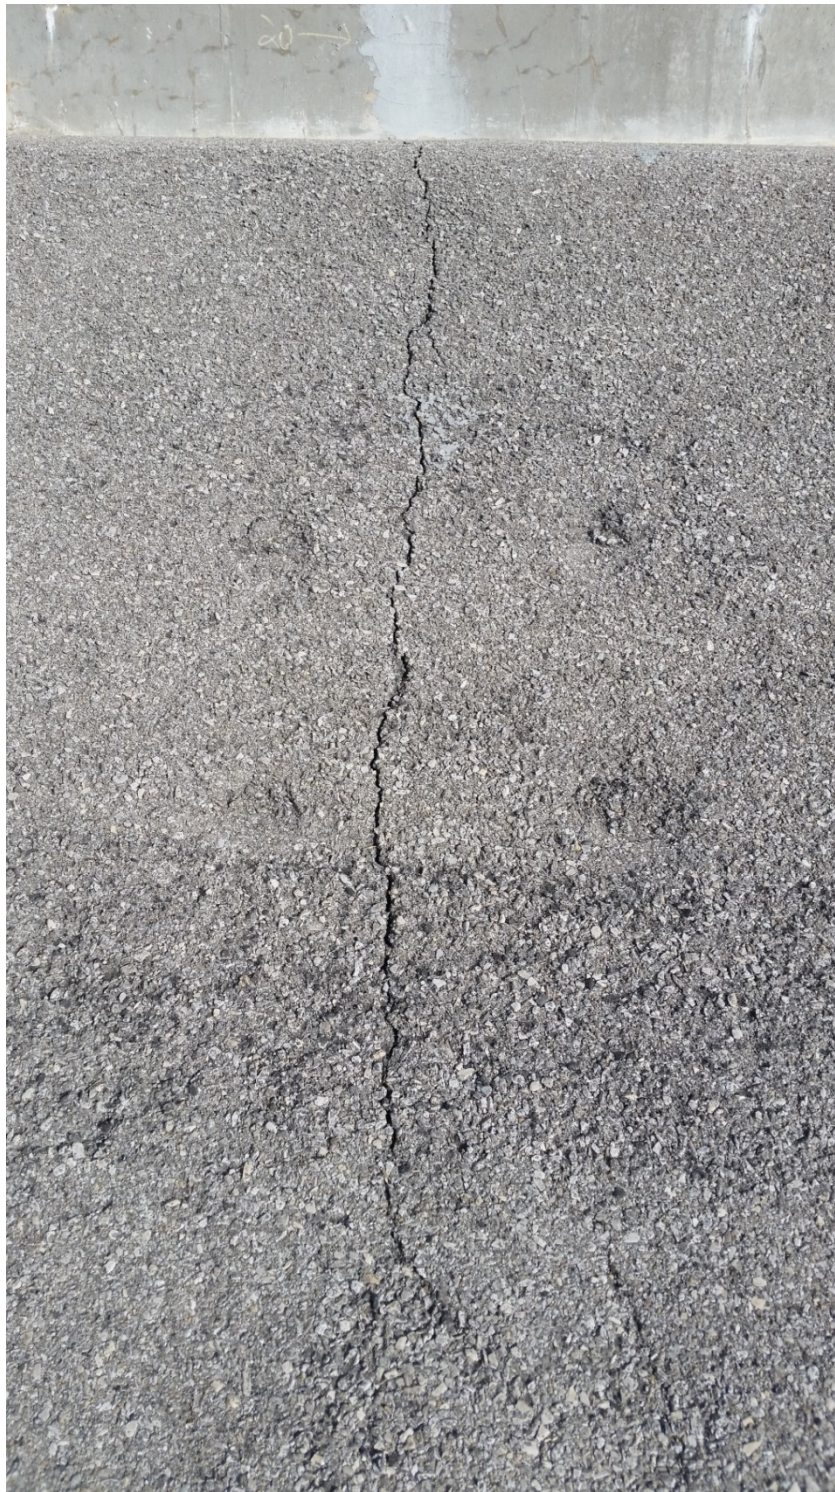
7. Minor cracks are present along some of the seams in the asphalt cover system. The cracks do not extend the full depth of the asphalt thickness. SES is seeking a contractor that can meet GMs safety requirements to complete the asphalt repairs. Resealing of the asphalt will be completed in the spring when construction of the groundwater treatment plant and Pilot Trench are complete.

Photo 33: EA2 crack near WWTP aeration basin facing north.

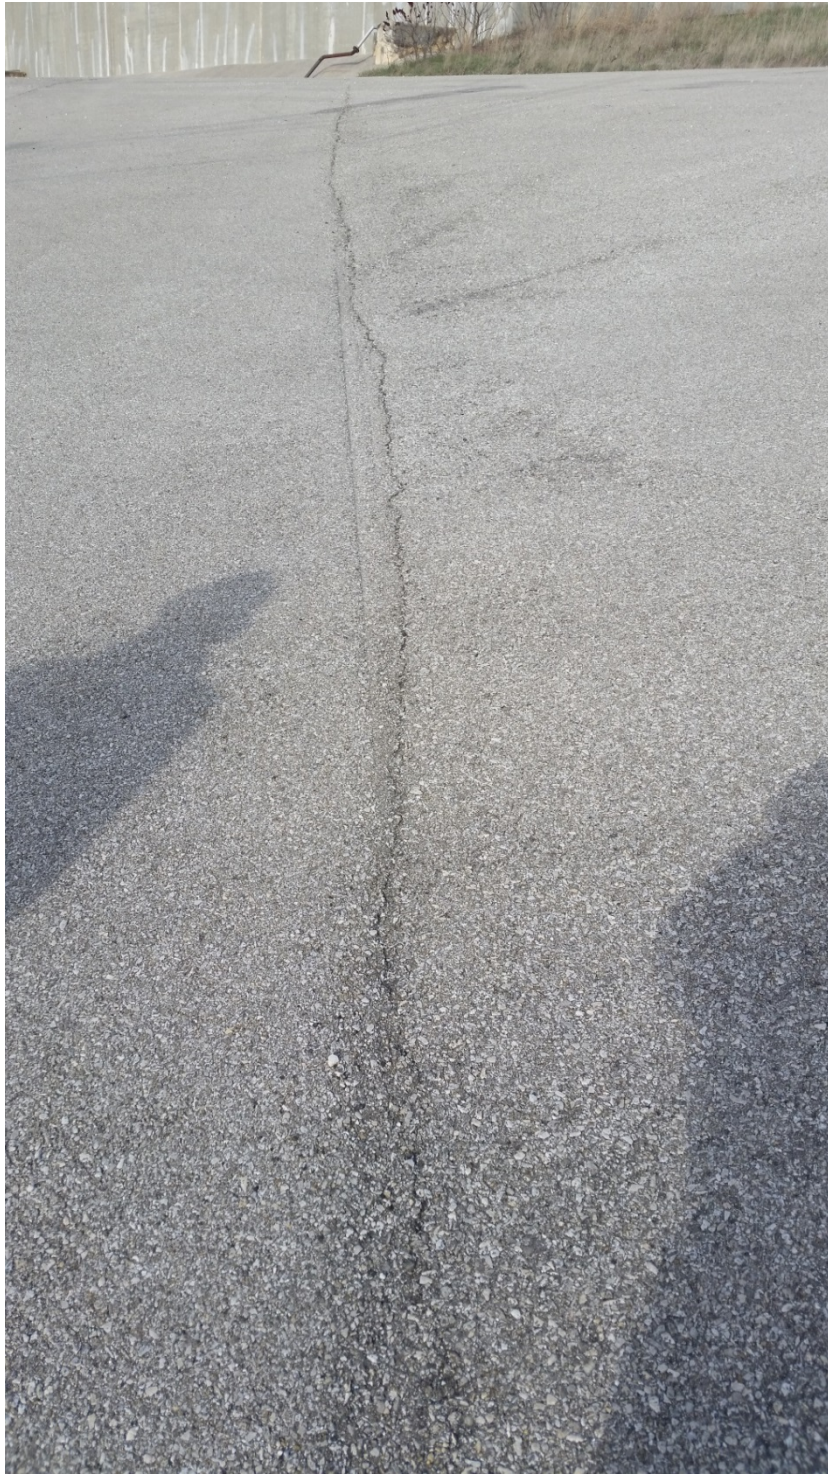
Photo 34: EA2 facing north, cracks in asphalt west of Parcel 205.

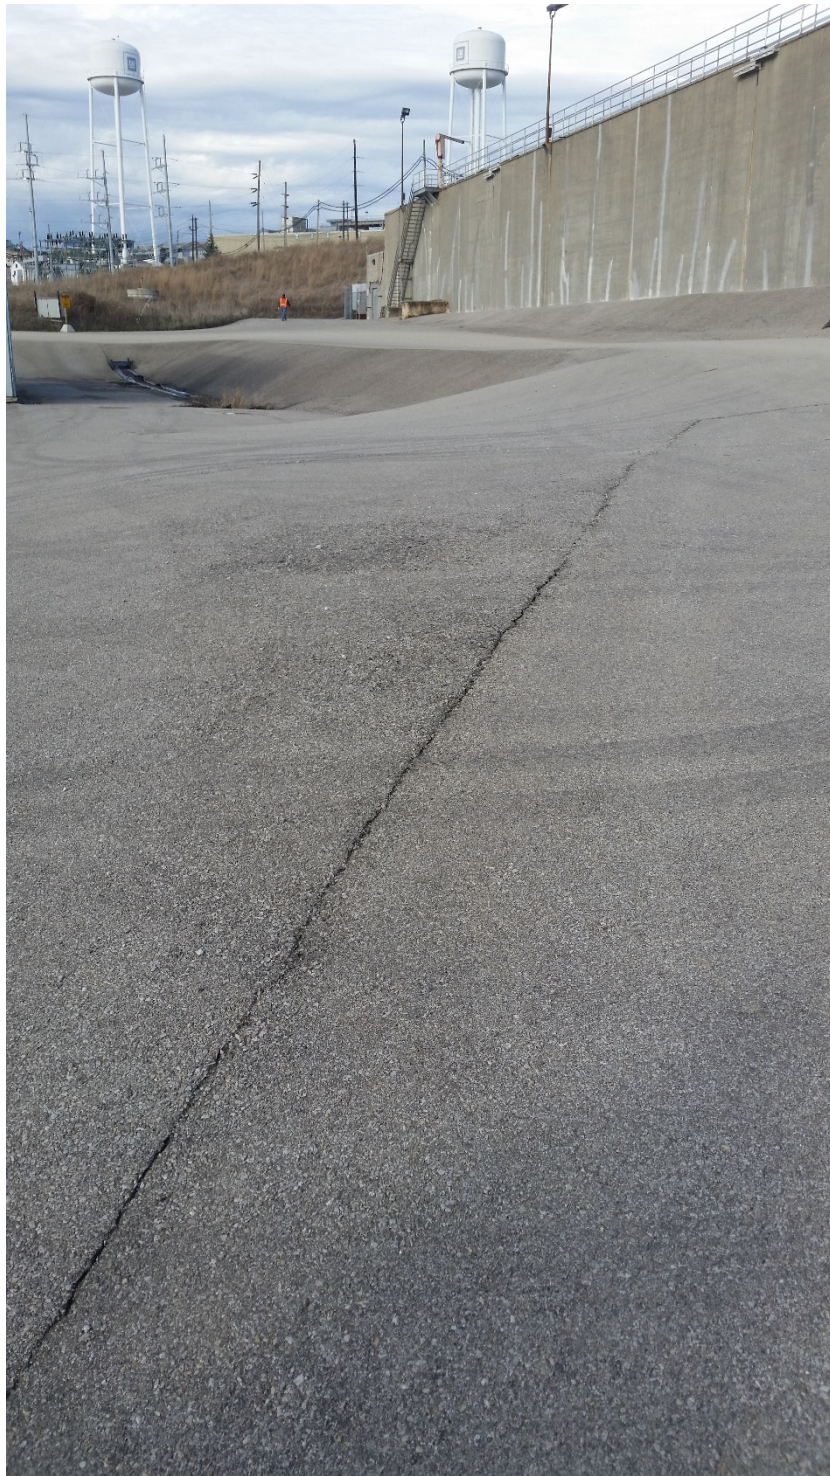
Photo 35: EA2 facing west, cracks in asphalt west of Parcel 205.
