Re: RCRA Corrective Action Administrative Order on Consent (AOC)  
Progress Report 68, First Quarter 2018  
GM GPS – Bedford Facility, IND 006036099, Docket No. RCRA 05 2014 0011  
Bedford, Indiana

## **First Quarter 2018 Progress Report 68**

GM GPS – Bedford Facility  
105 GM Drive  
Bedford, Indiana  
EPA ID# IND006036099  
AOC Docket No. RCRA 05 2014 0011

**Appendix A**  
**First Quarter 2018 Cover System Inspection:**  
**Photograph Log, Transect Figures,**  
**and Field Logs**

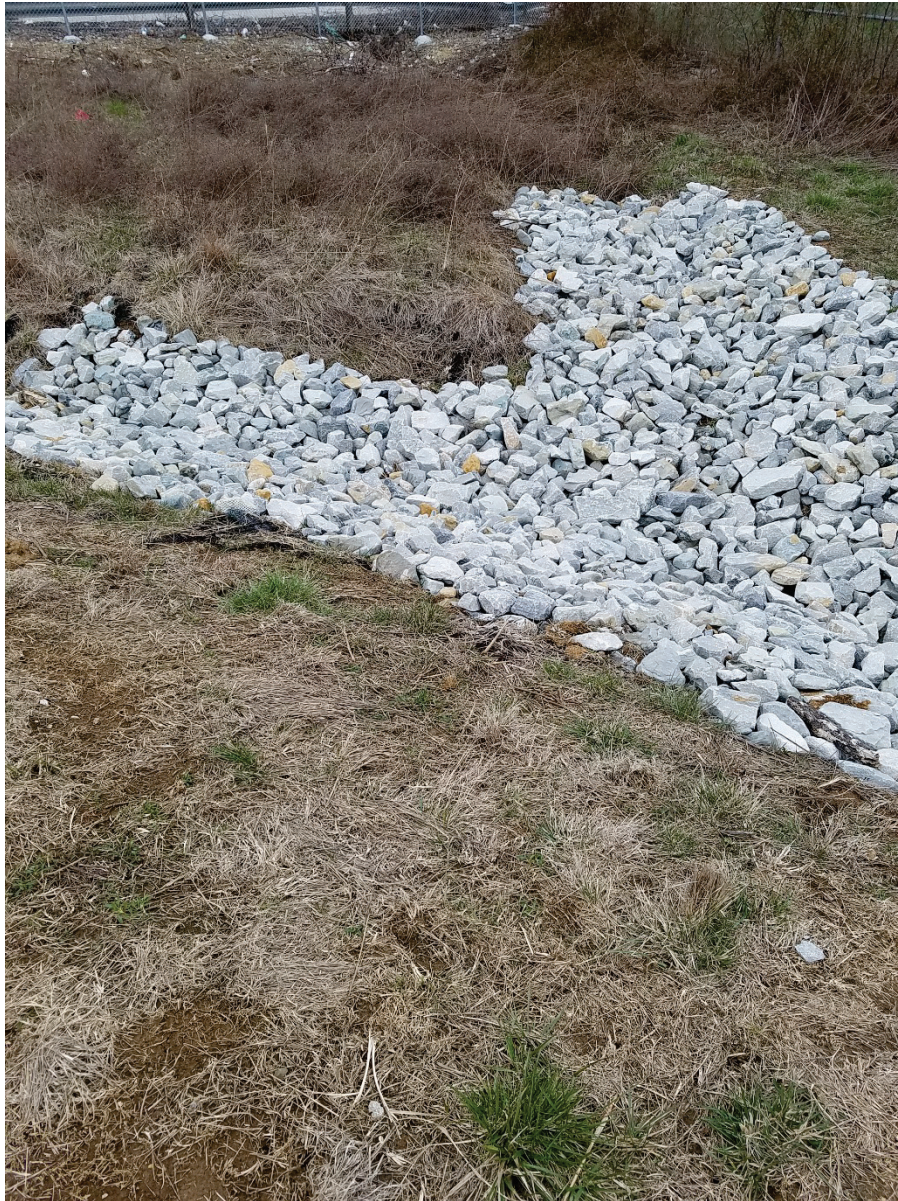
Photo 1: EV2 Drainage along ES6 facing west

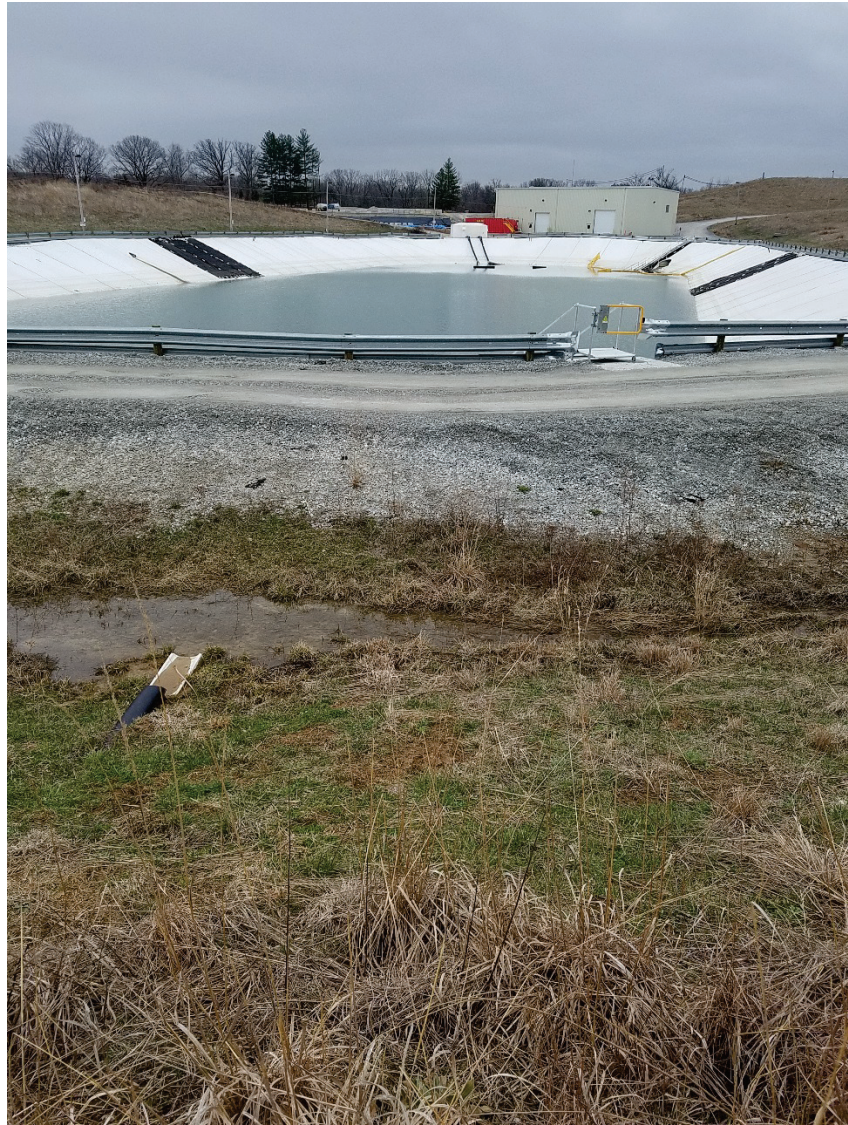
Photo 2: EV3 East Plant Cover facing south toward pond

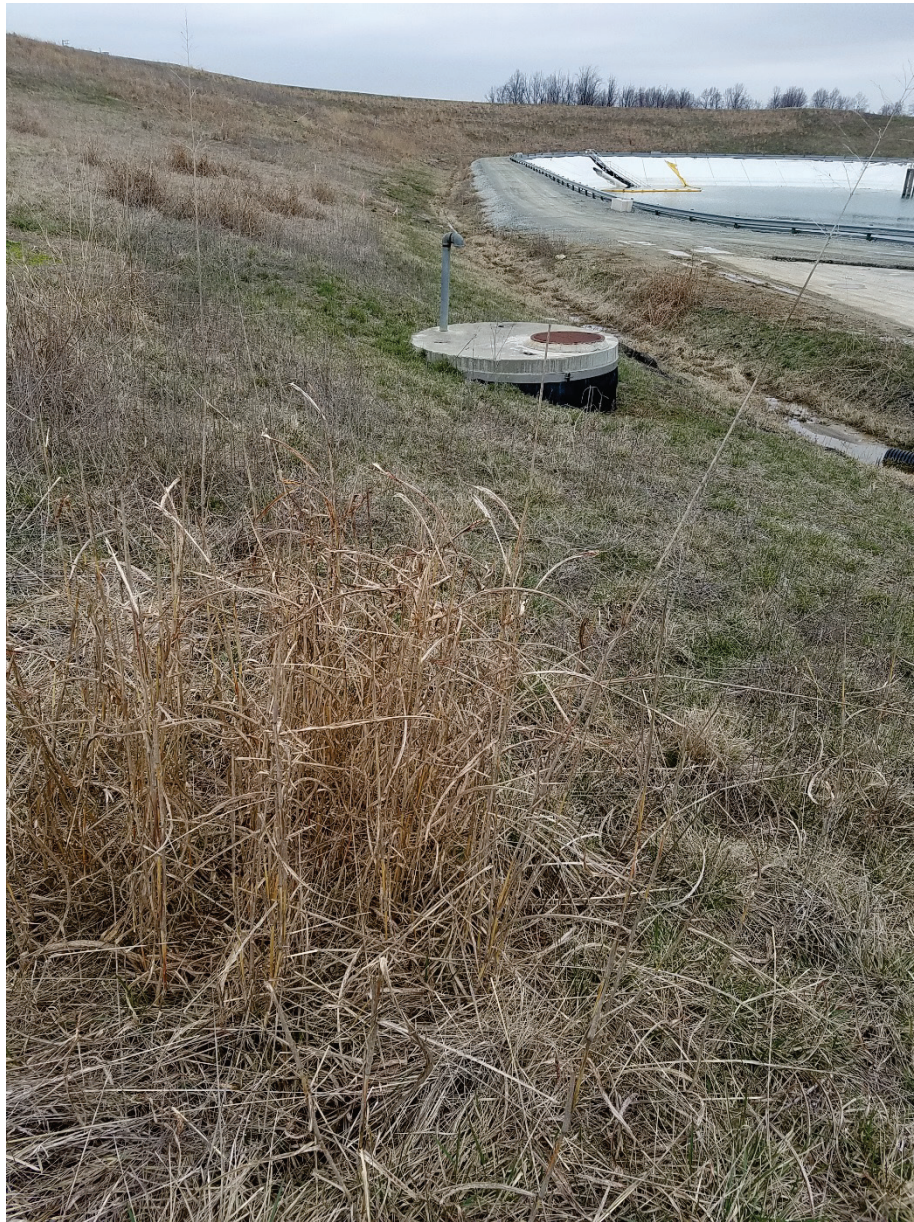
Photo 3: Vegetation at ES1 facing north

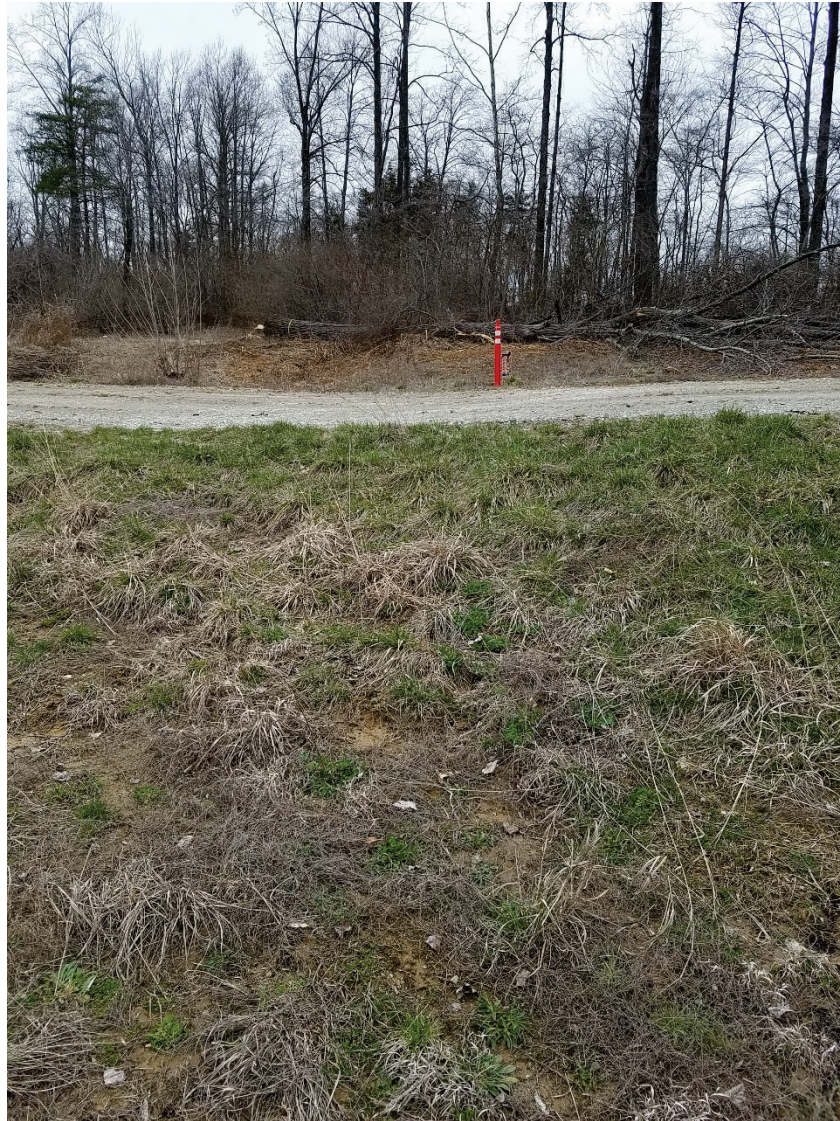
Photo 4: EV3 East Plant Cover area facing west

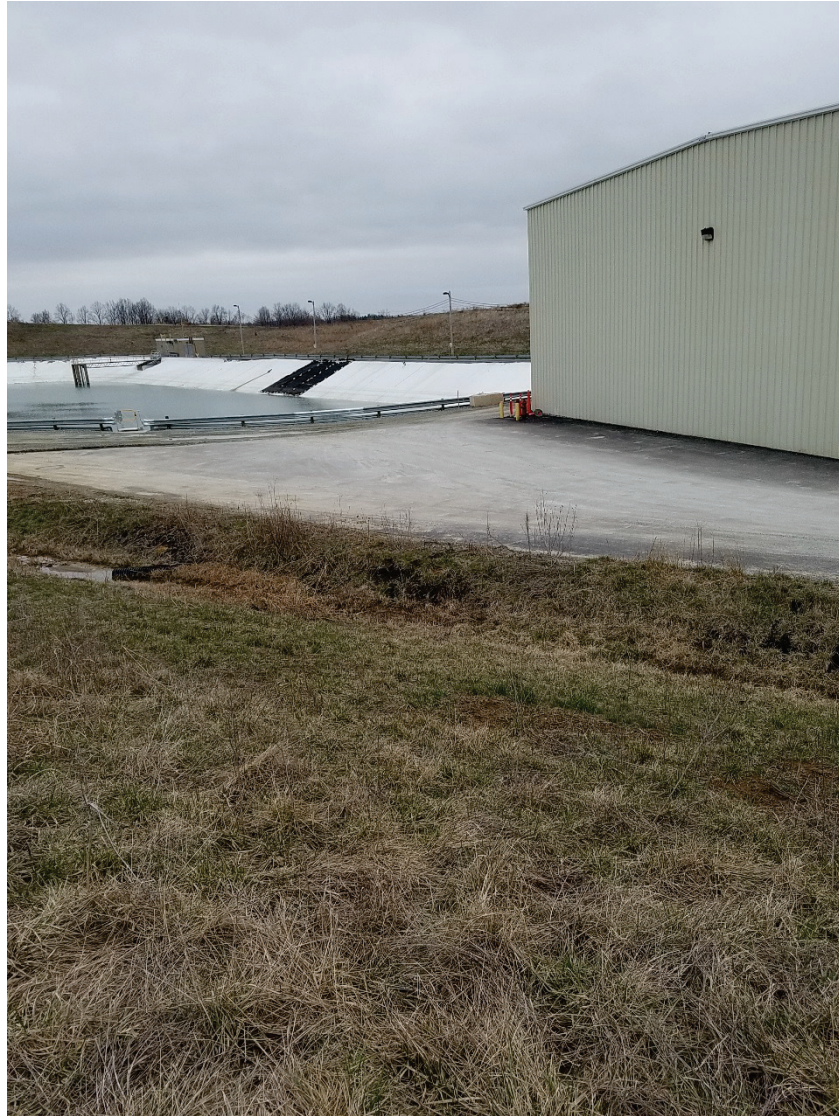
Photo 5: ES2 East Plant Area Cover facing north

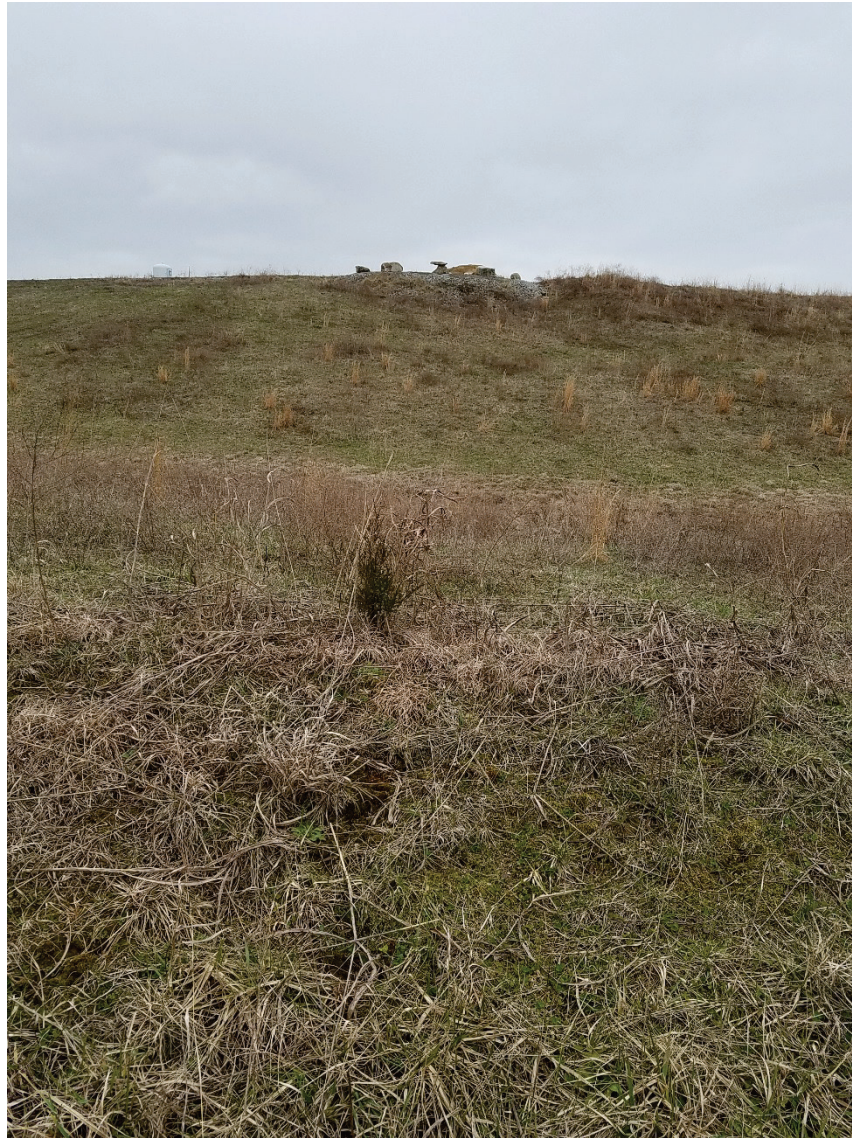
Photo 6: EV2 East Plant Cover area facing south

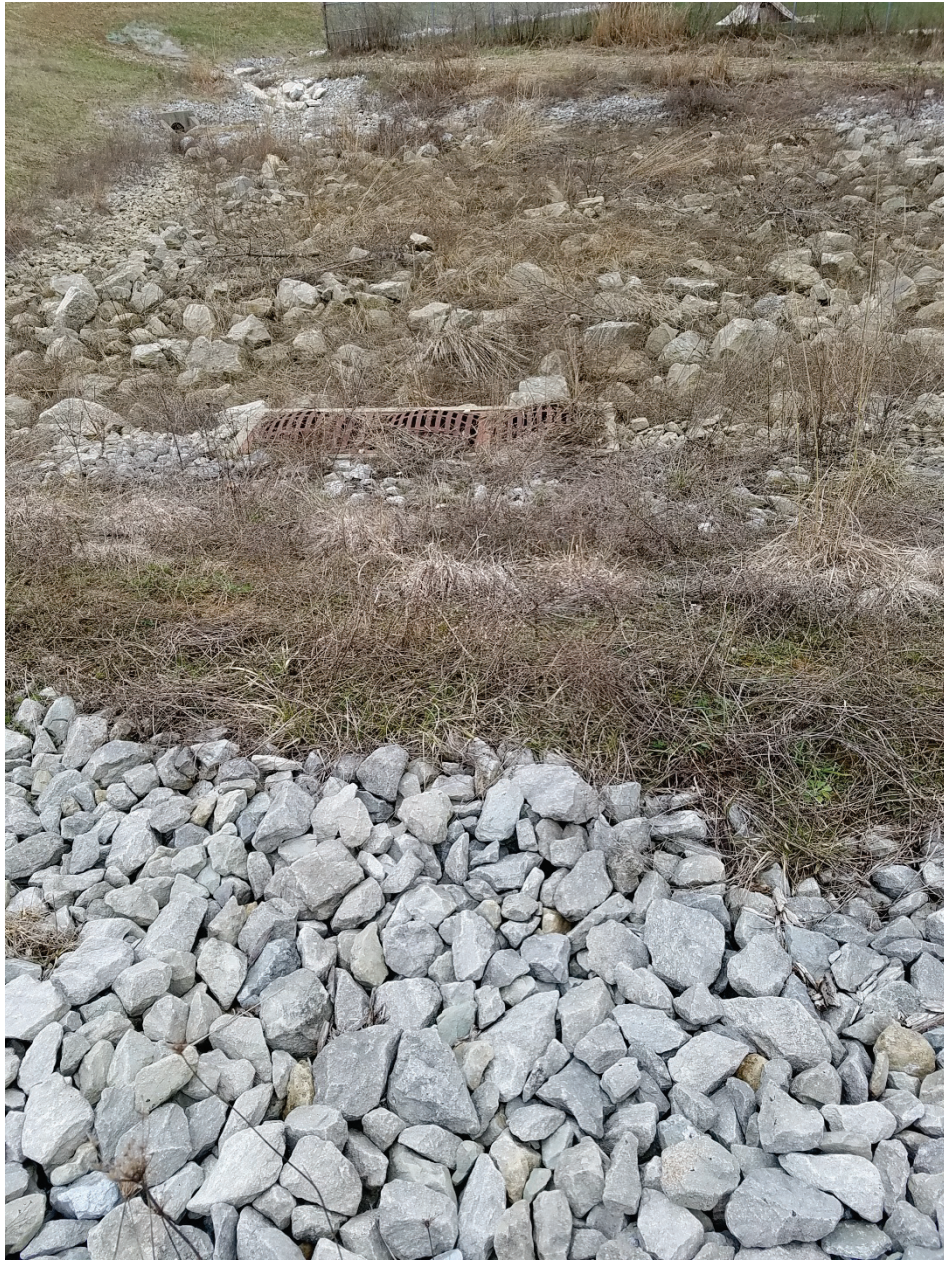
Photo 7: Drainage at ES6 facing west

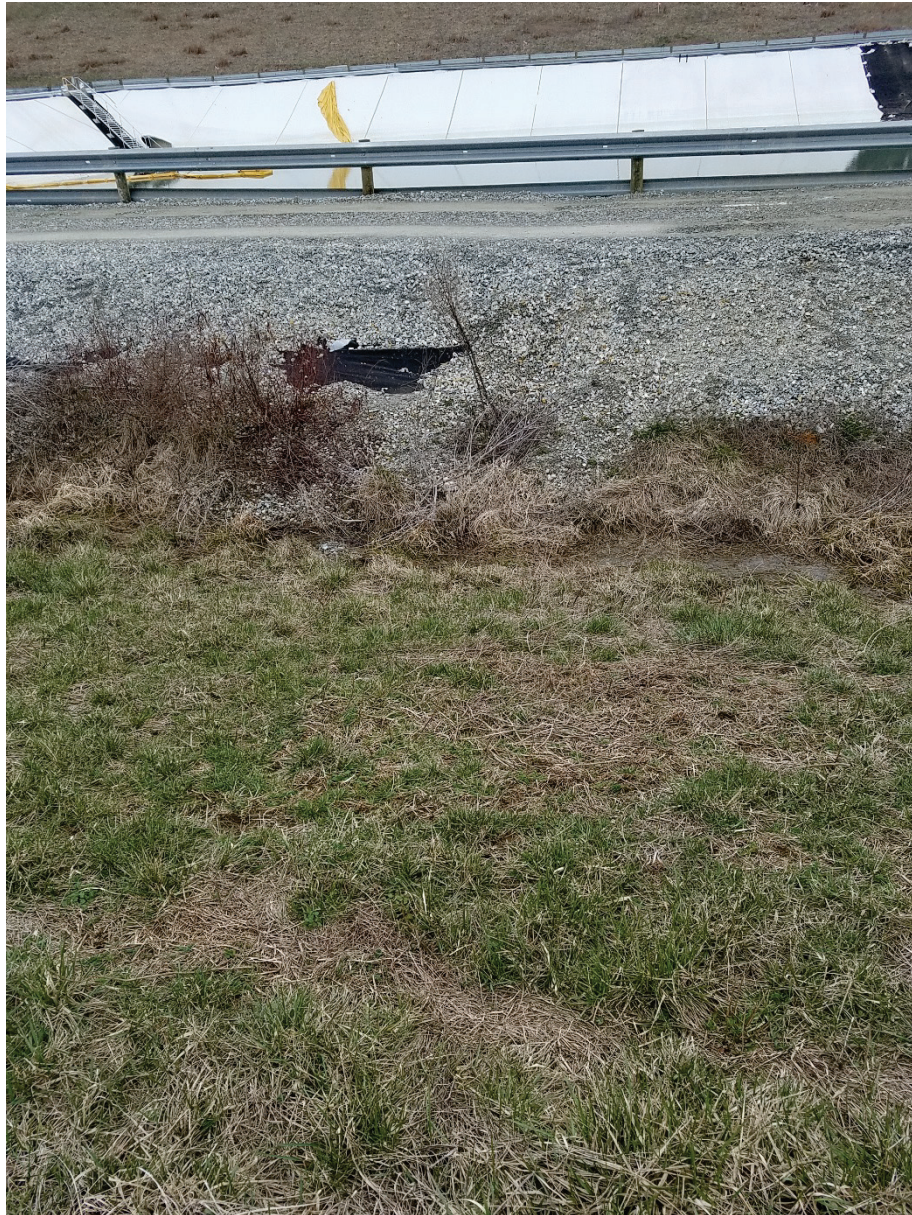
1. Weeds or clover growth were noted at most Transects in the East Plant Area and the West Plant Area, which is also typically accompanied by some bare patches.
2. Heavy weed growth and bare spots was identified at Transects EV1, EV2, EV3, EV4, EV5, EV6, EV7, EV8, EV9, and WV1.
3. Slight erosion reported at Transects EV4 and EV5.

Photo 8: Vegetation along EV5 East Plant Area Cover facing west

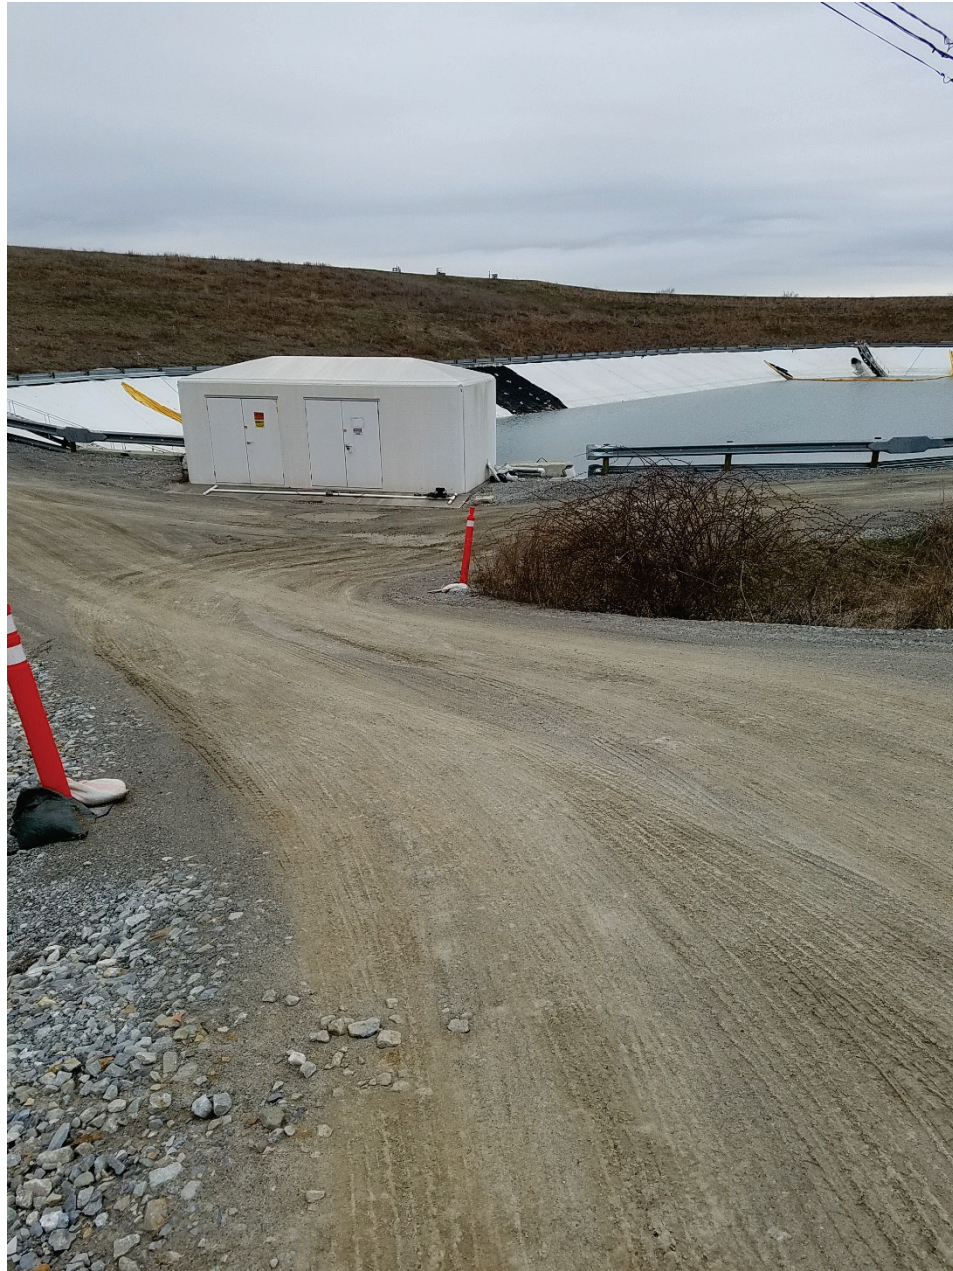
Photo 9: Stormwater pond facing northwest

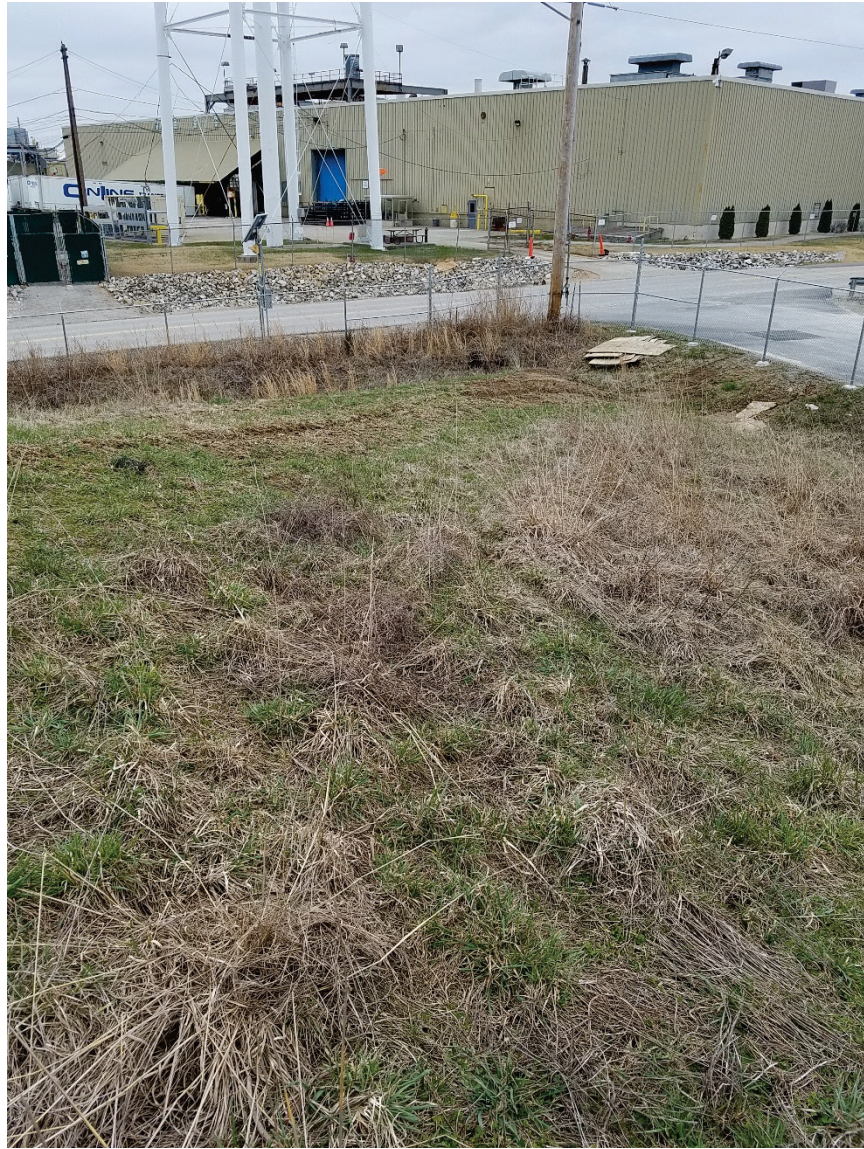
Photo 10: EV1 near ES2 East Plant Area Cover facing northwest

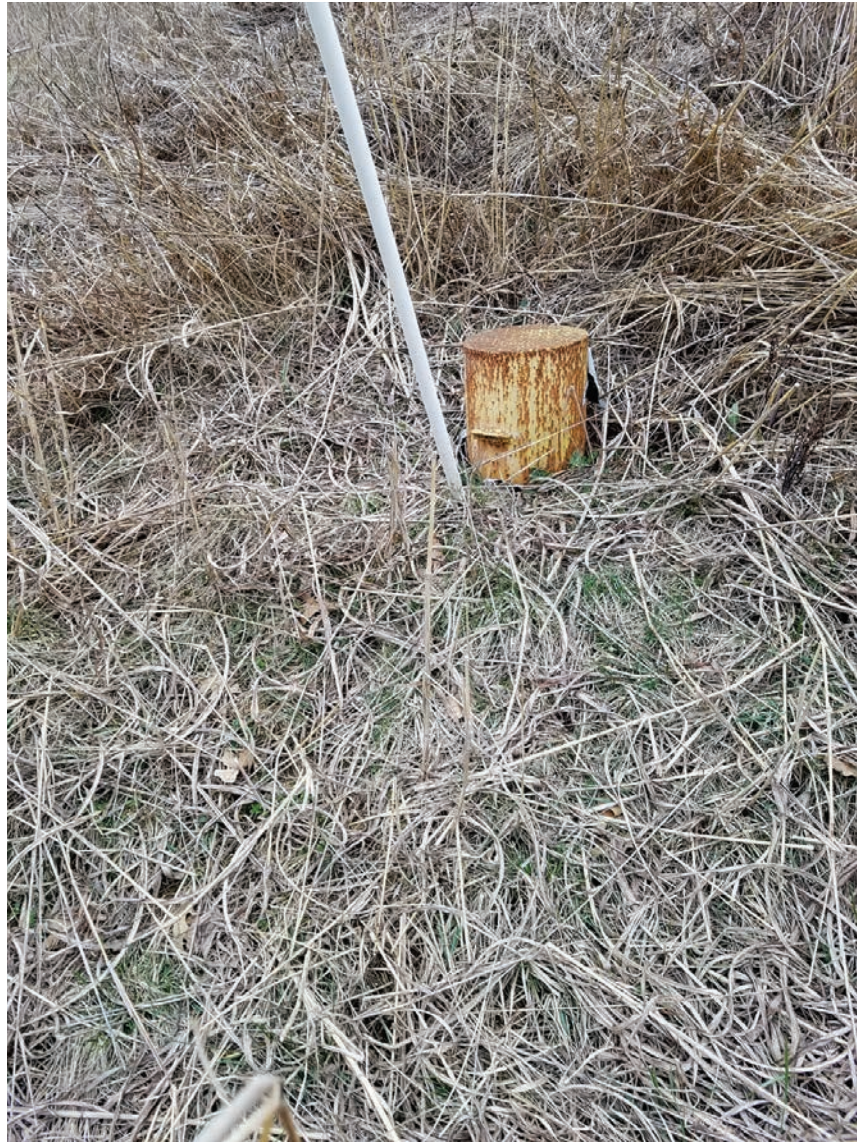
Photo 11:       Vegetation at EV8 East Plant Cover area facing north

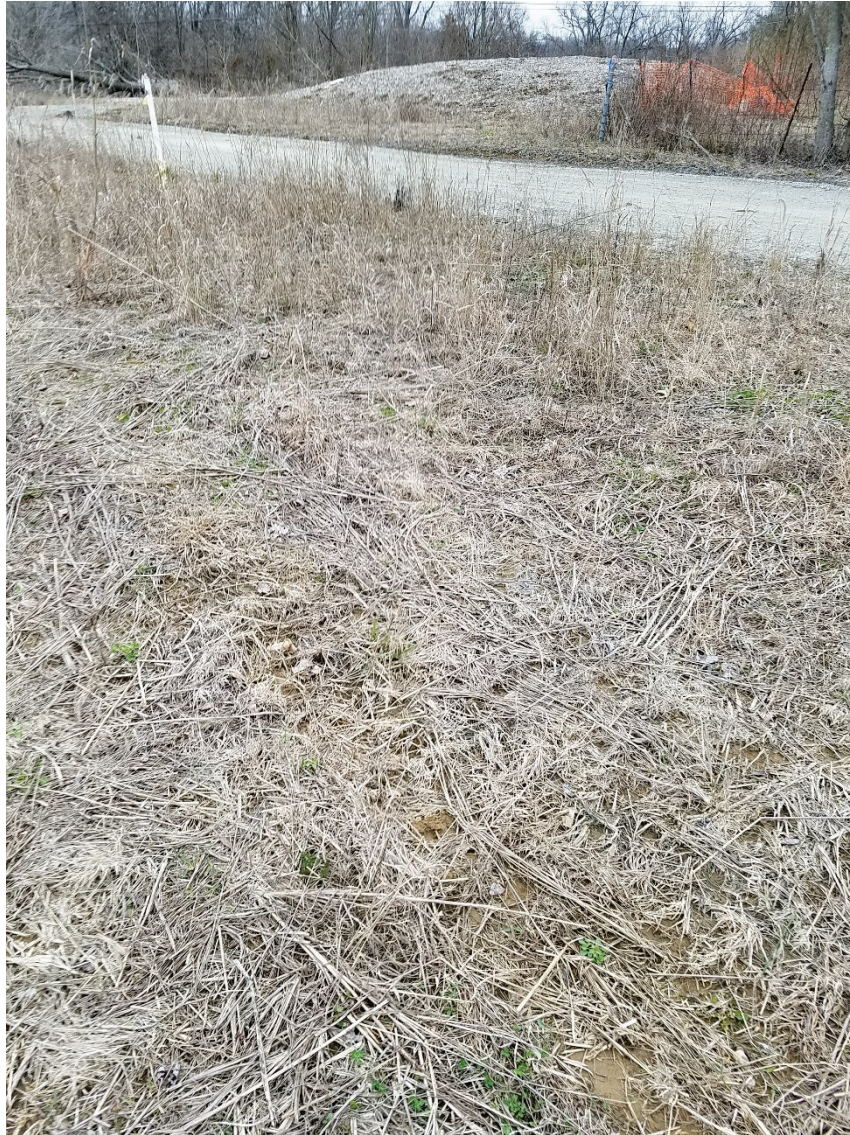
Photo 12: Vegetative growth along EV5 East Plant Area facing east

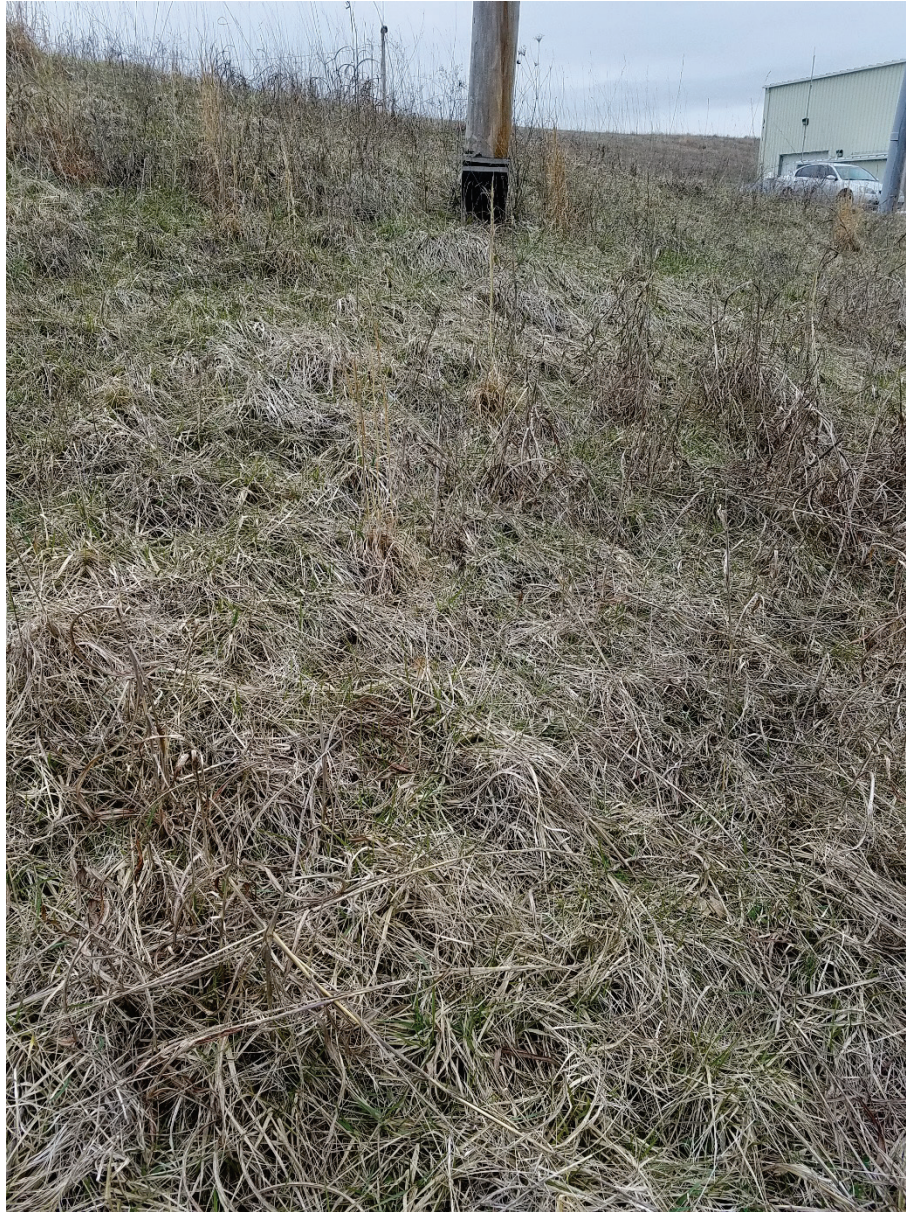
Photo 13: Vegetation growth at ES12 East Plant Area Cover facing northwest

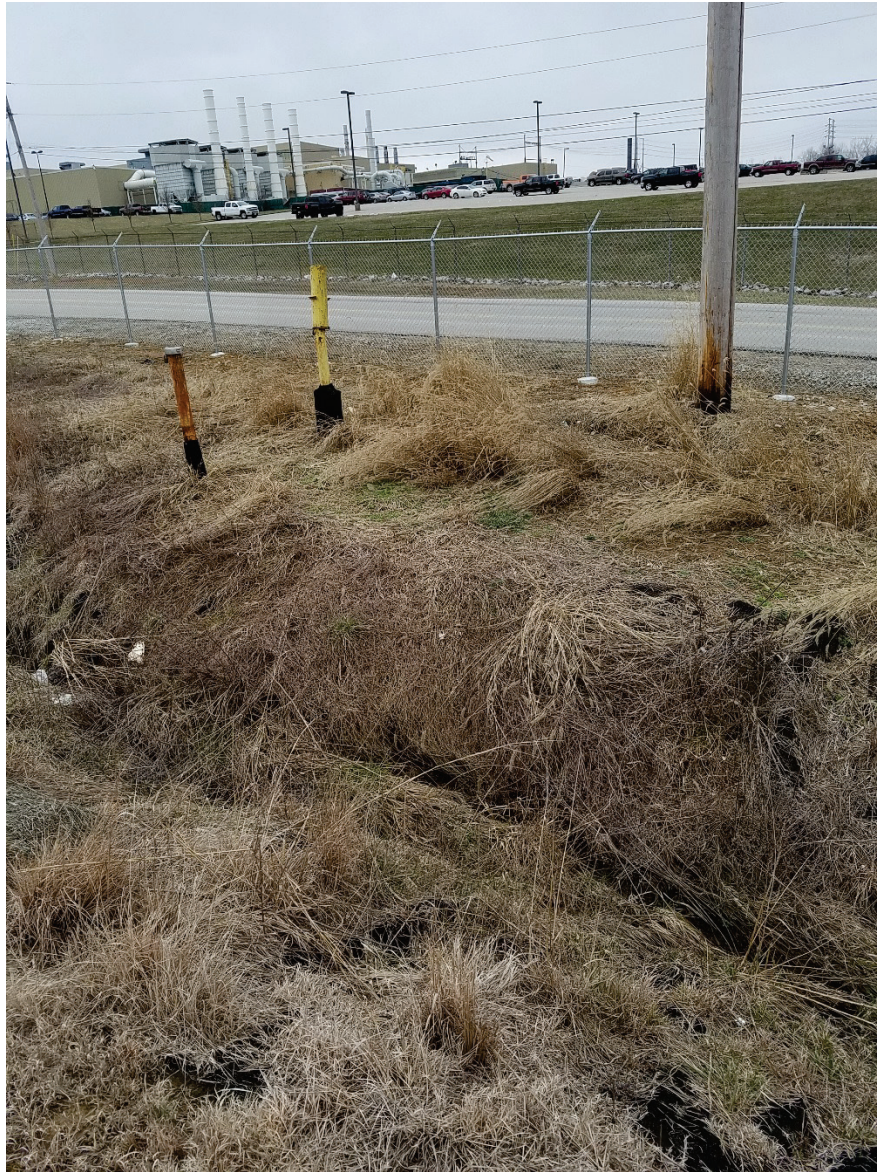
Photo 14: EV7 East Plant Cover facing southwest

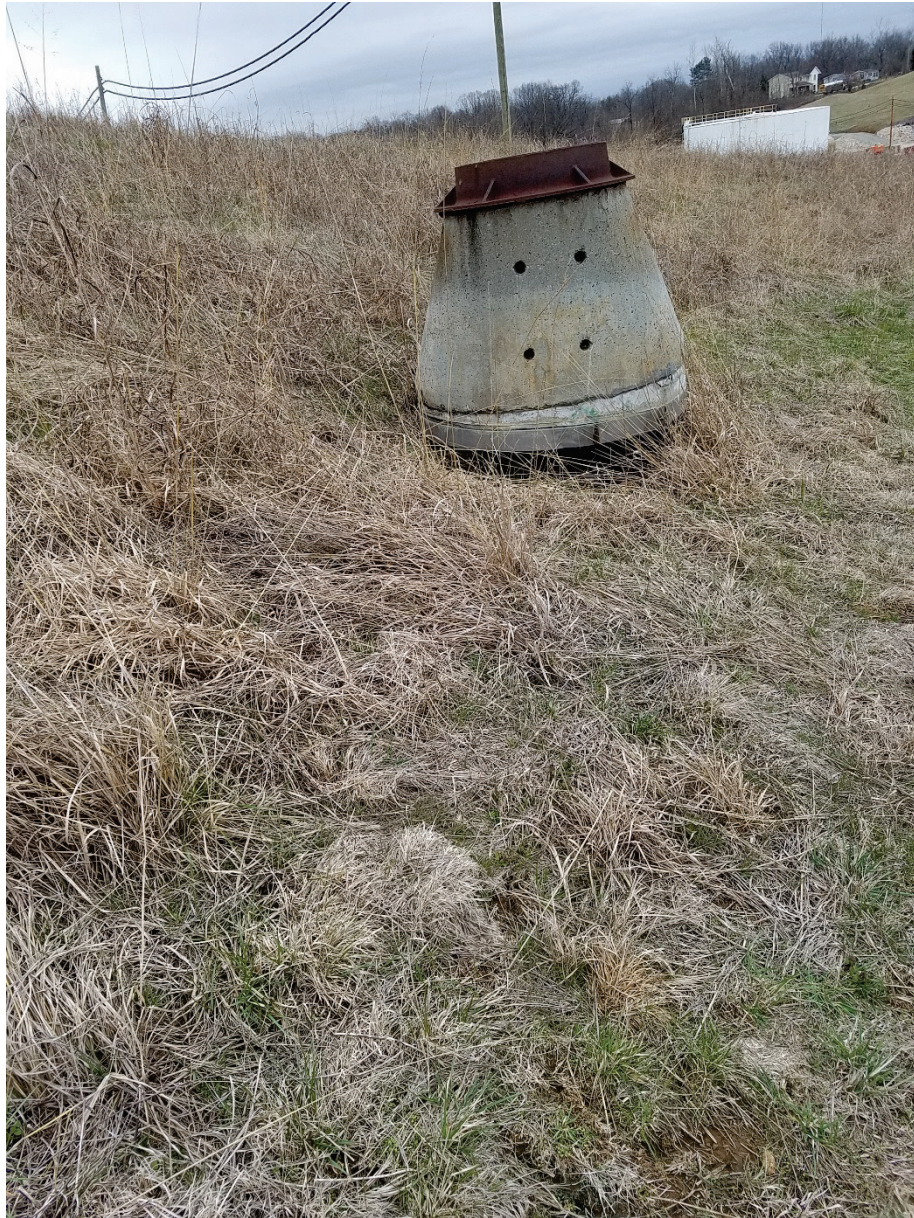
Photo 15: EV6 East Plant Area Cover area facing south

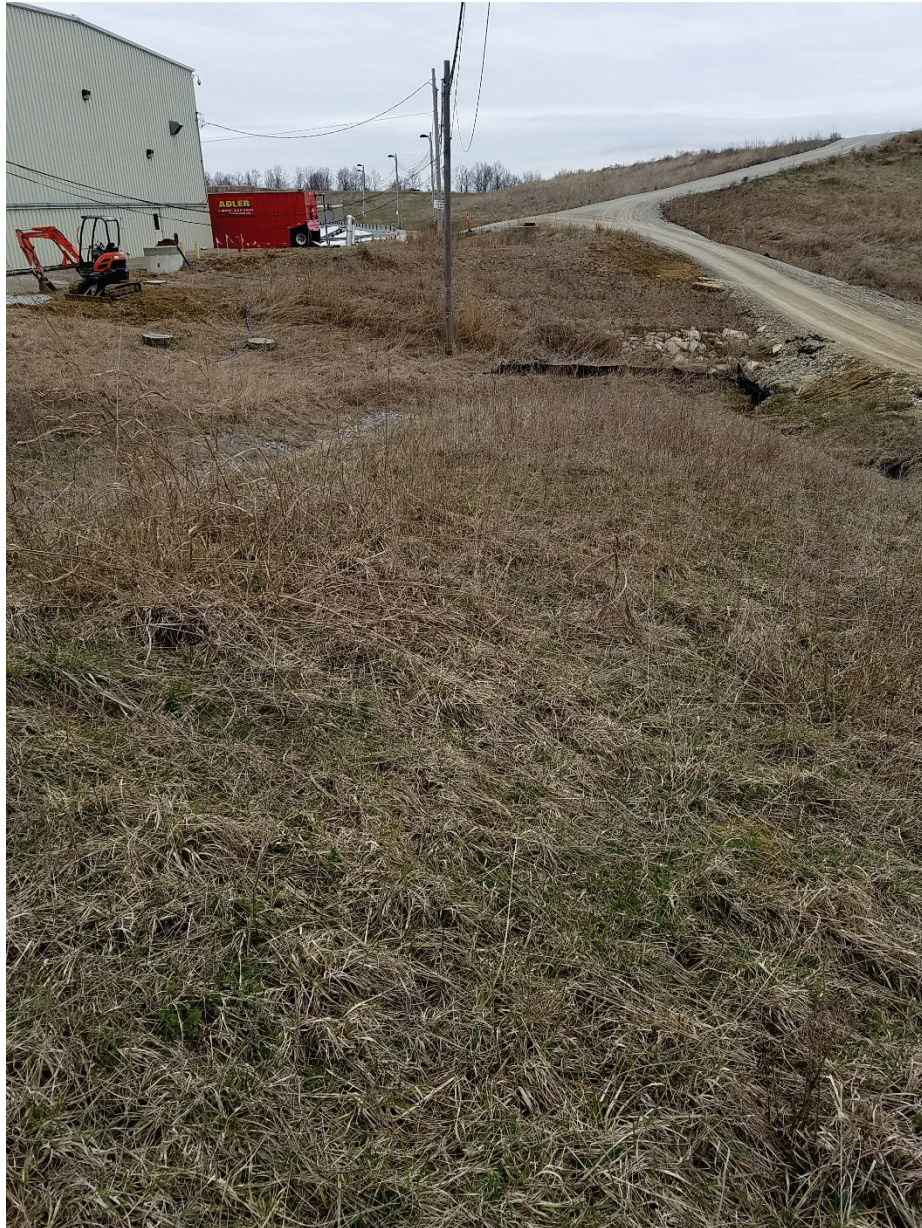
Photo 16: ES12 East Plant Area Cover facing north

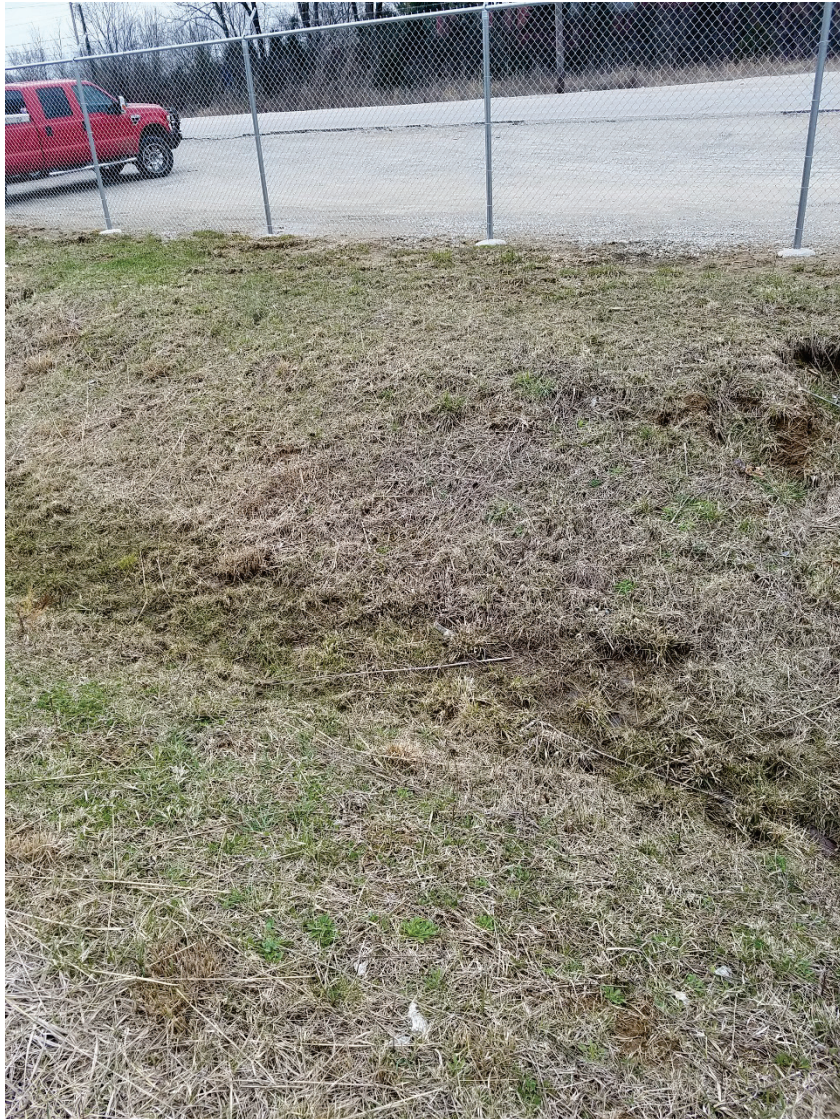
Photo 17: EV9 East Plant Area Cover facing southwest

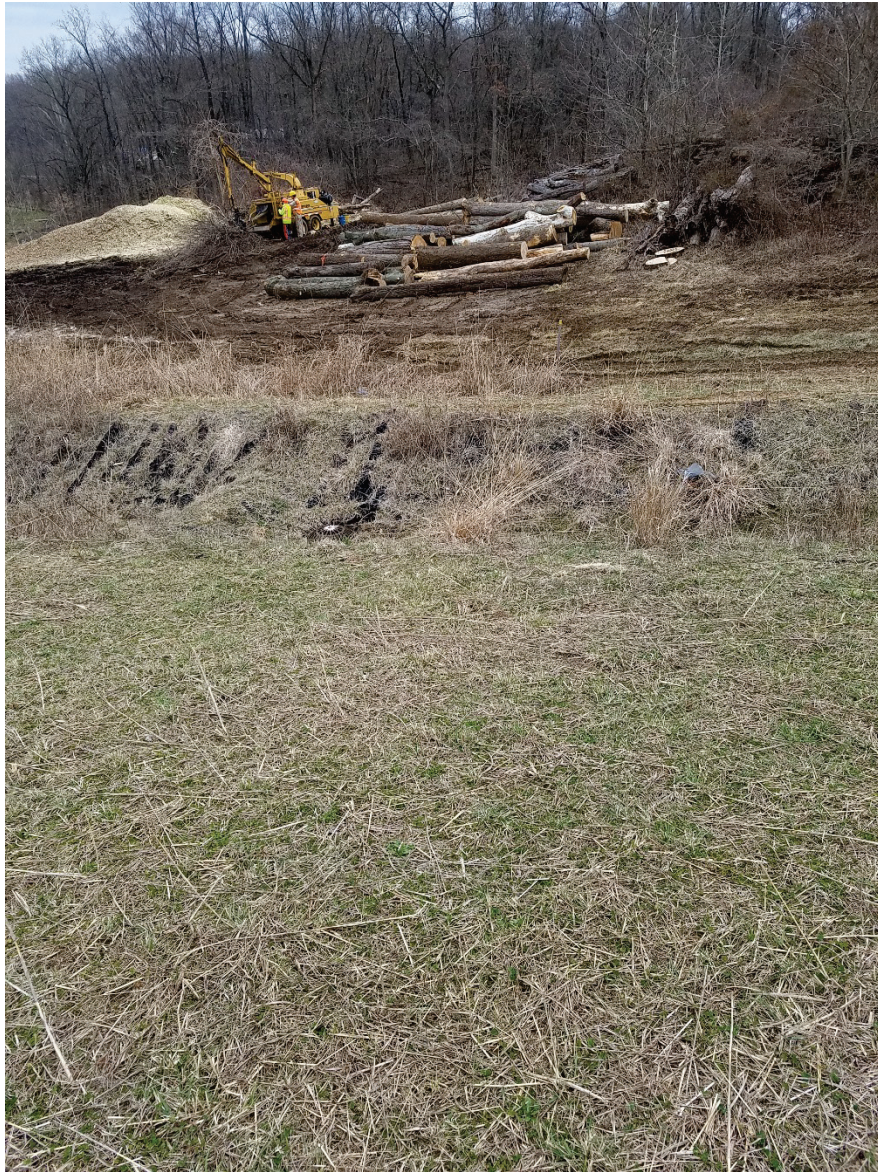
Photo 18: ES14 East Plant Area Cover facing east
