Fourth Quarter 2016 Progress Report 63

GM CET – Bedford Facility

Bedford, Indiana

Appendix A	Fourth Quarter 2016 Cover System Inspection: Field Logs, Transect Figures, and Photograph Log
------------	--

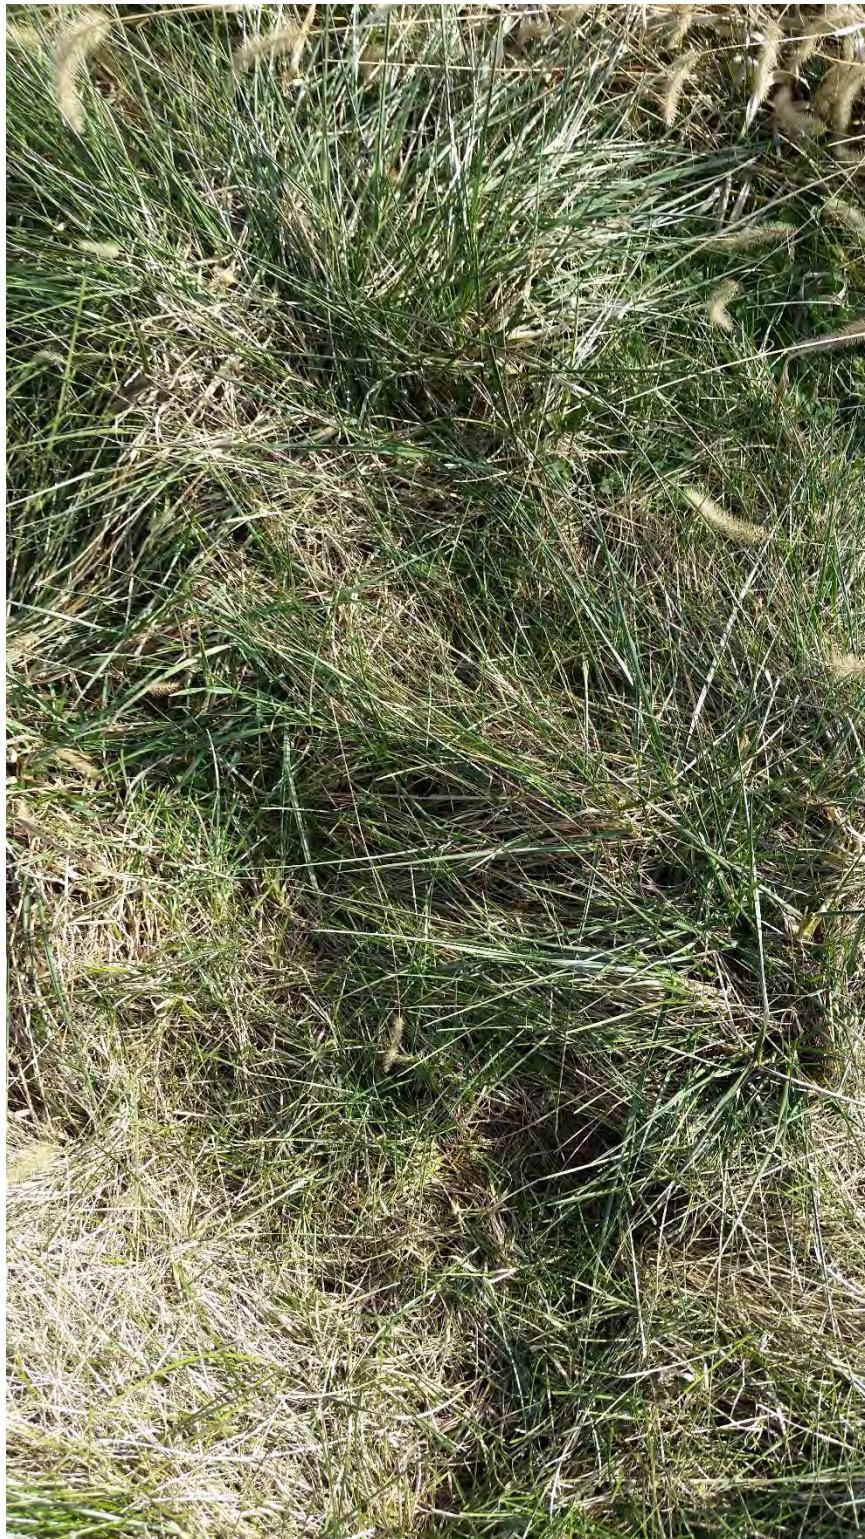
Photo 1: EV1 Vault Cover System west slope vegetation

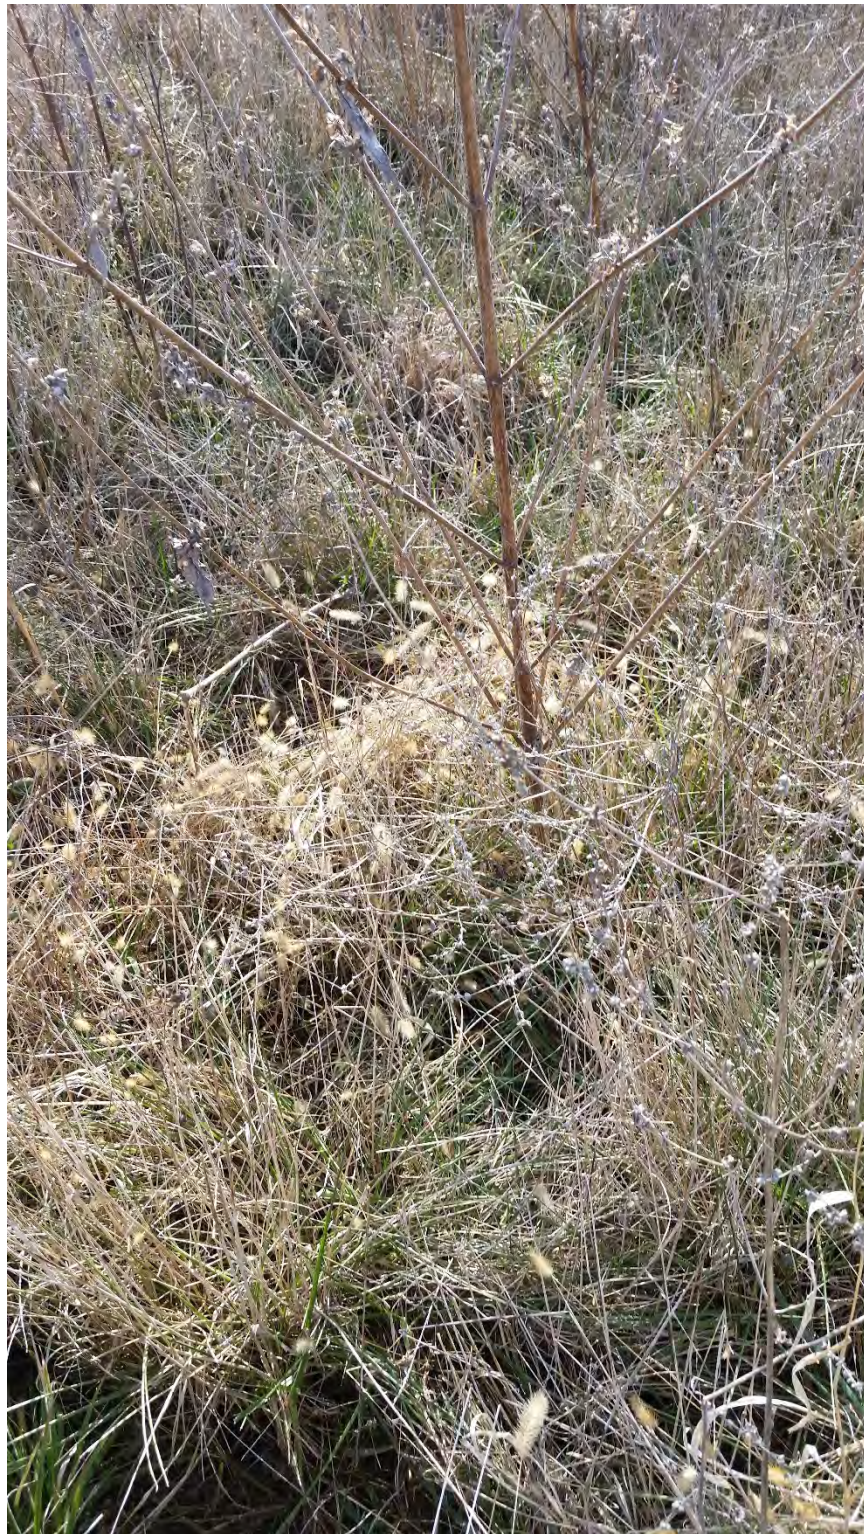
Photo 3: Tree at ES2

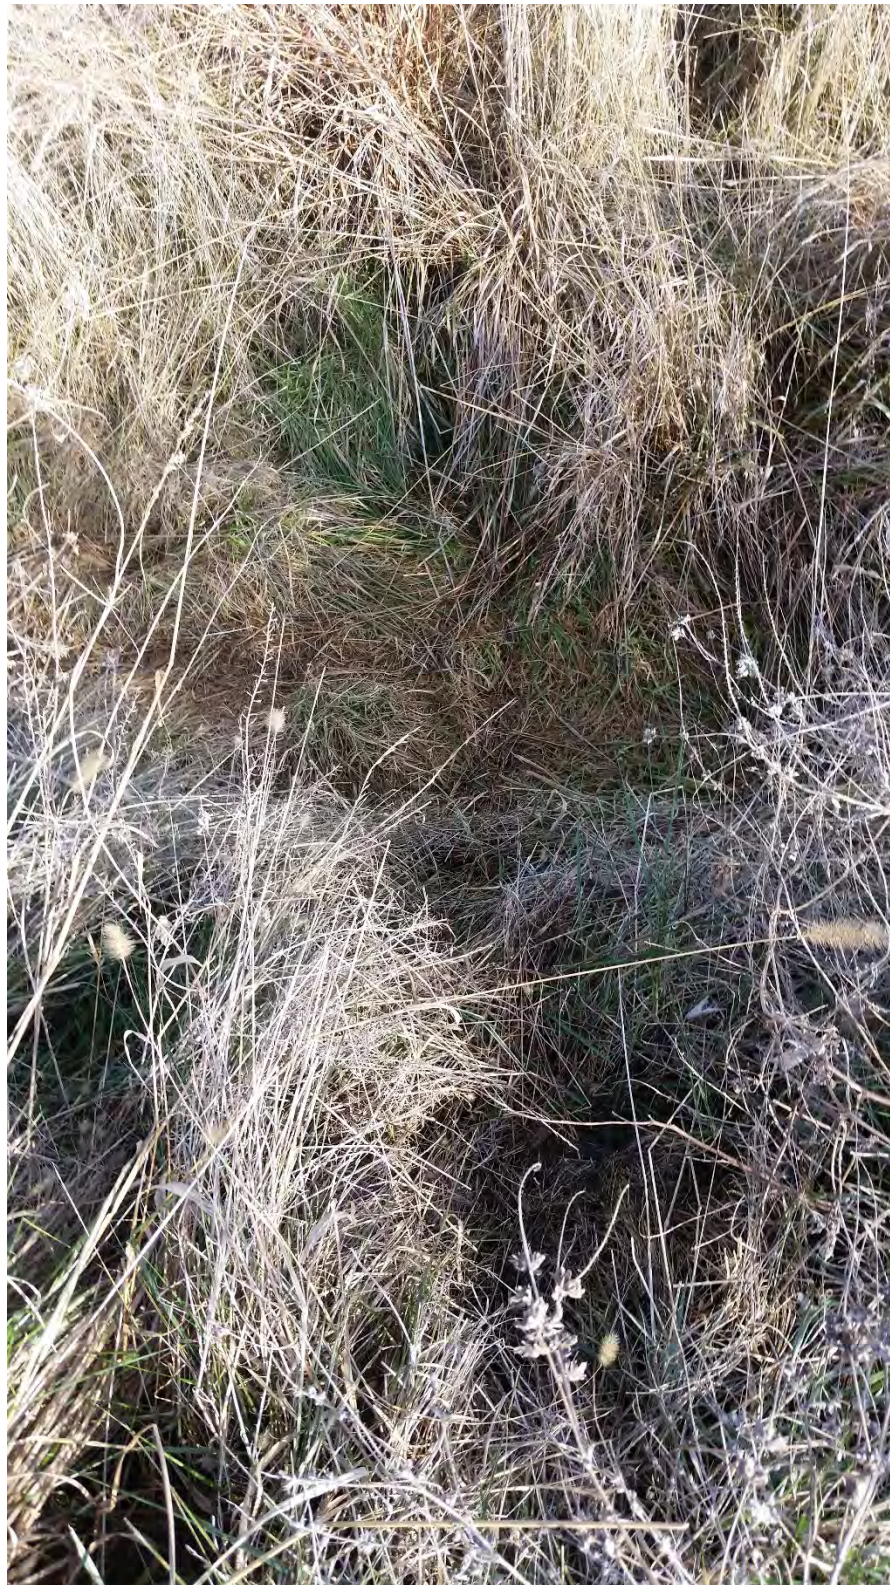
1. Weeds or clover growth was noted at most Transects in the East Plant Area and the West Plant Area, which is also typically accompanied by some bare patches.

Photo 4: Patchy vegetative growth at EV2

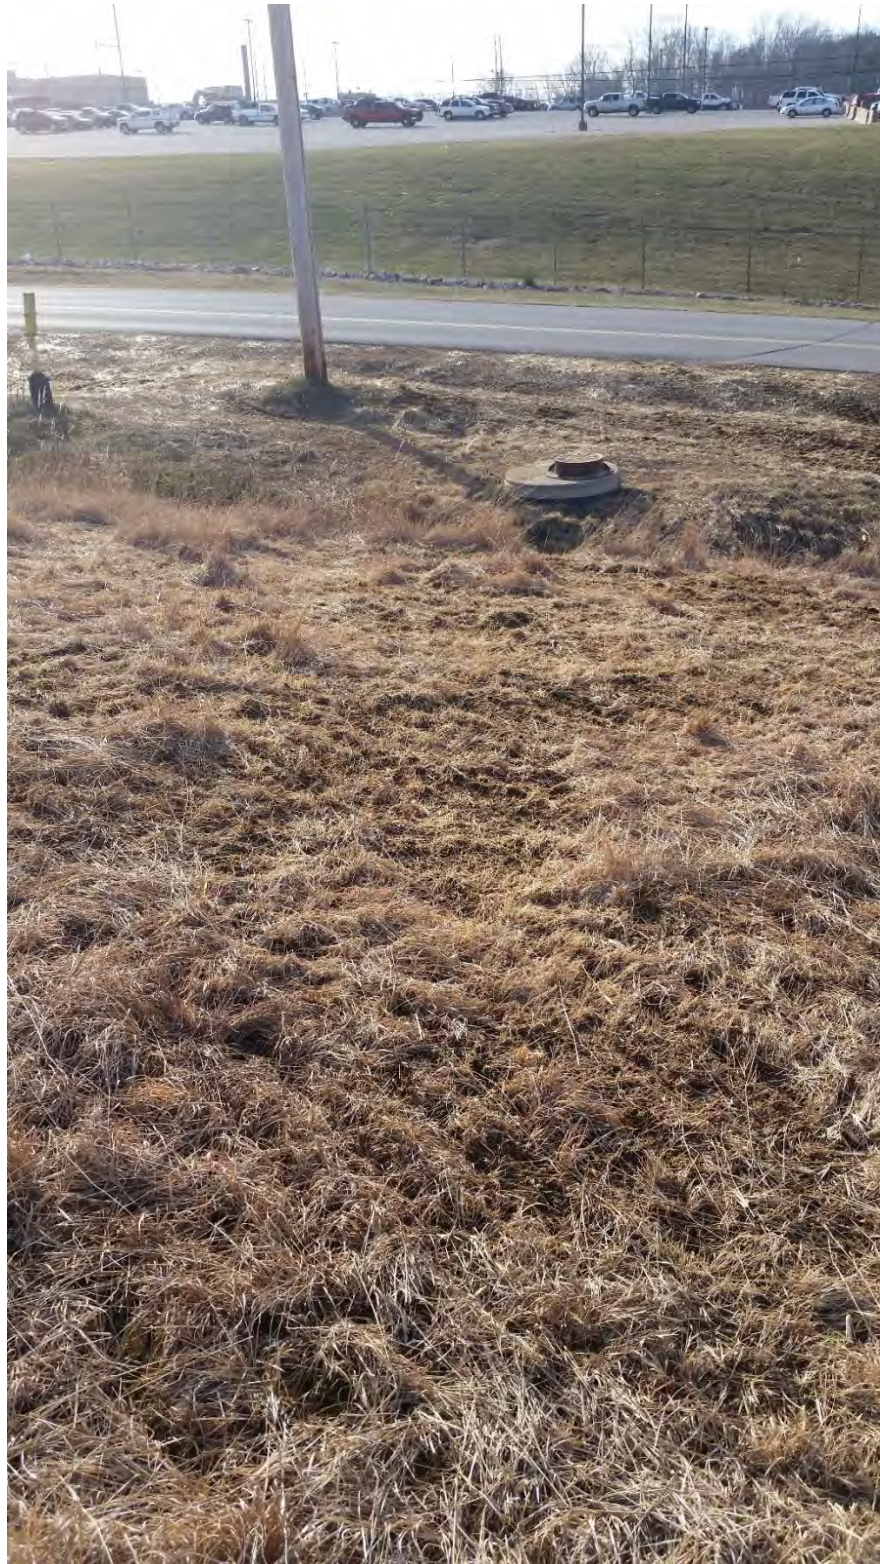
Photo 5: Vegetative growth along GM Drive, west of ES3 East Plant
Area Cover facing west

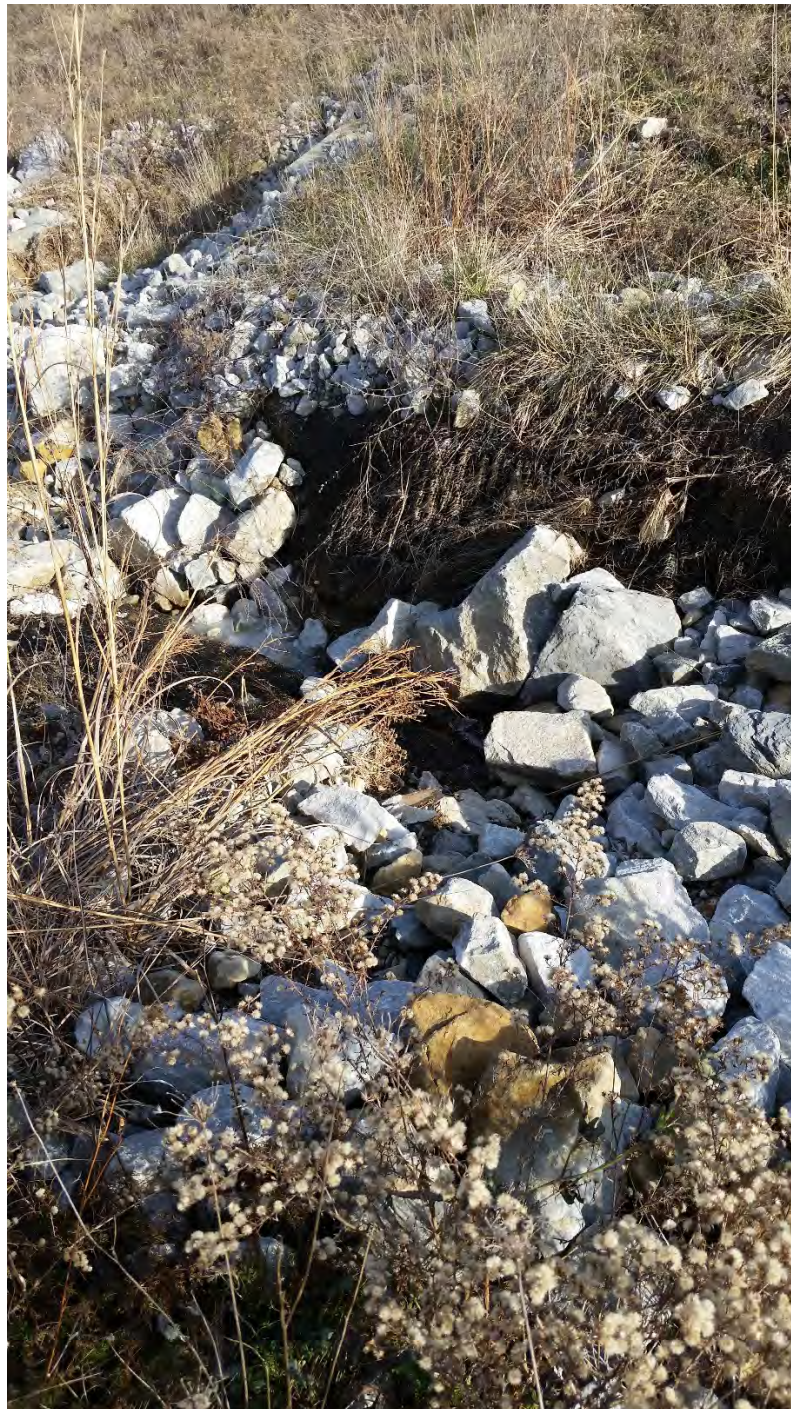
4. Light erosion was identified again along EV4, EV5, and in ES6. These areas will be monitored and re-seeded again as necessary in the second or third quarter of 2017.

Photo 7: Rip-rap erosion at ES6 East Plant Area Cover

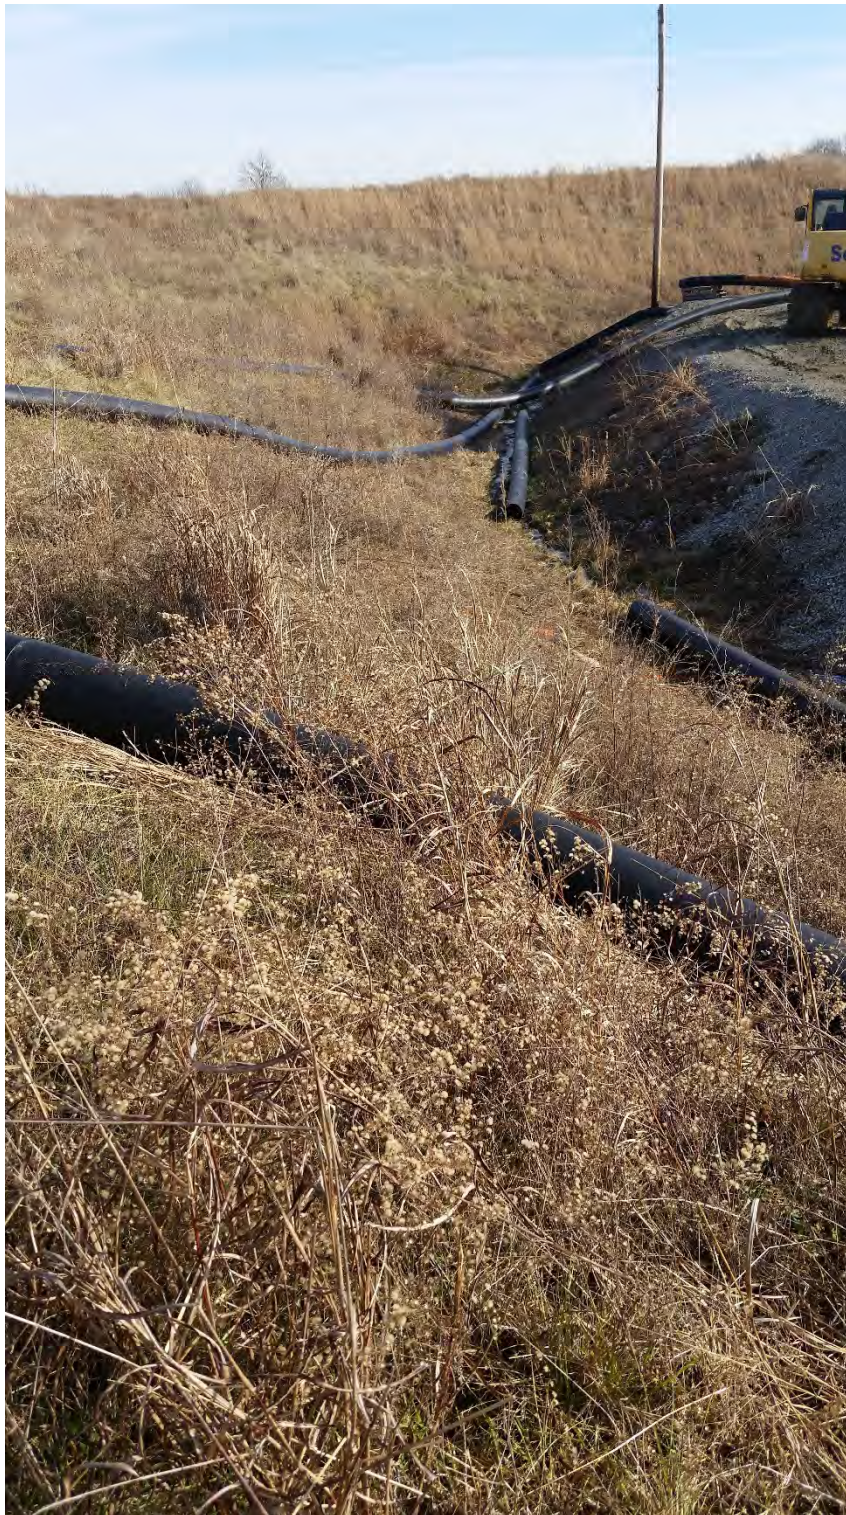
Photo 9: Temporary pumping lines in ES1 East Plant Area
Cover at north end of Pond

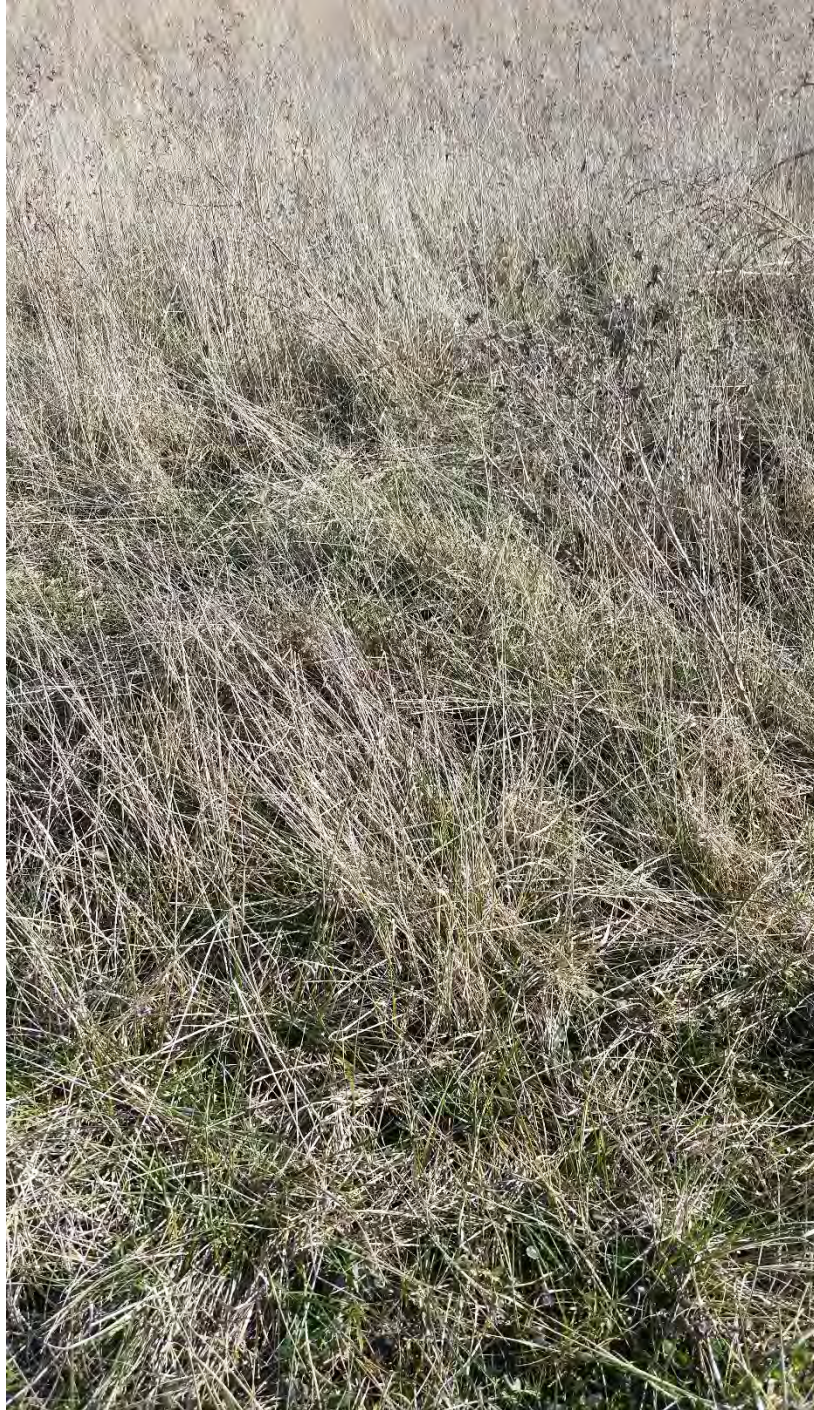
Photo 14: Vegetative growth along EV5 East Plant Area facing east, away from pond

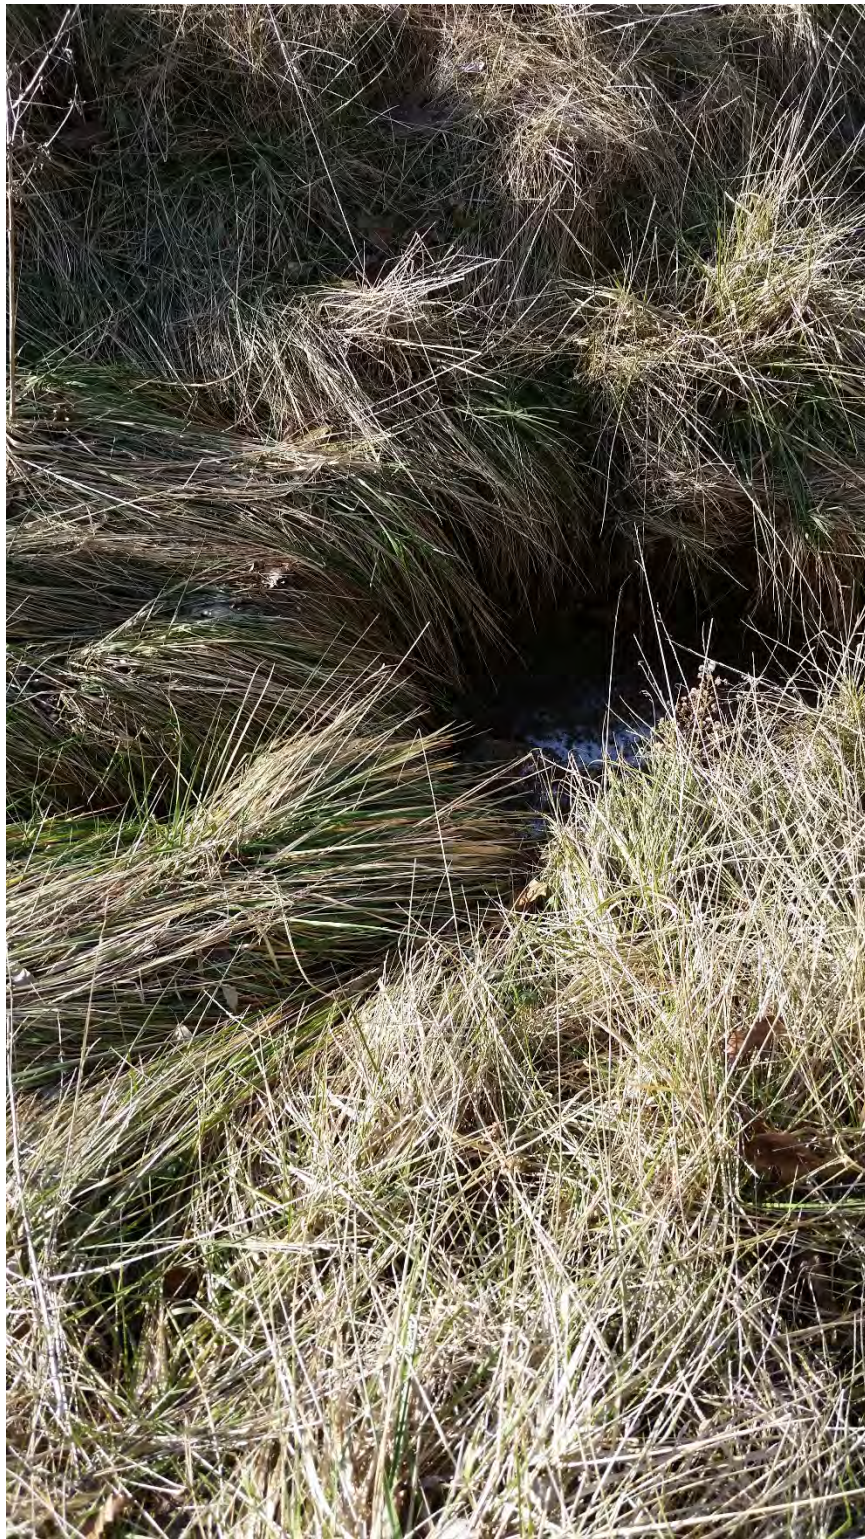
3. There was evidence of larger burrowing animals, which is believed to be attributed to woodchucks, near EV6 during the fourth quarter 2015 inspection. Indiana Department of Natural Resources (IDNR) has been consulted on identifying, and subsequently live trapping and relocating the animal(s), if necessary. The burrow appears to still be inactive during this quarter's inspection (see Photograph 15).

Photo 15: Former animal burrow near ES6 East Plant Area Cover

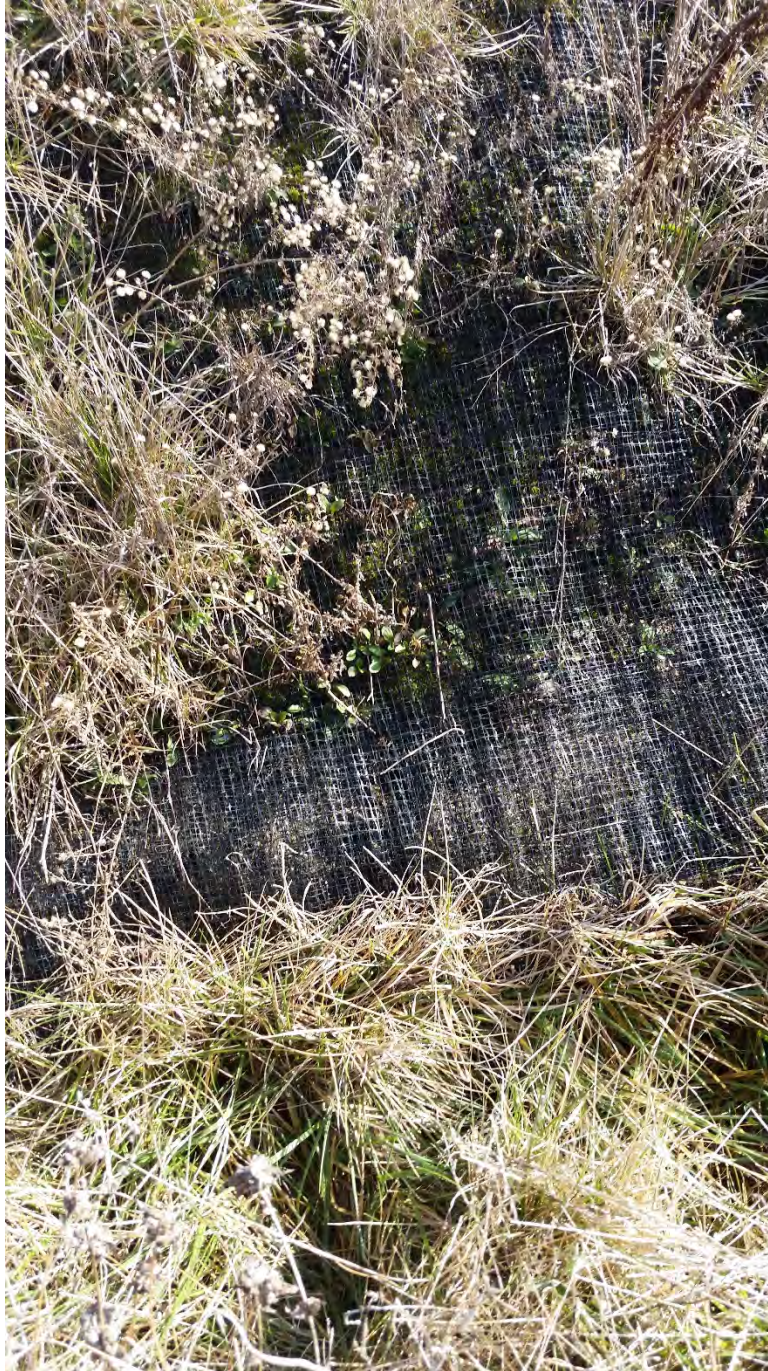
Photo 16: Patchy growth at ES12 East Plant Area Cover

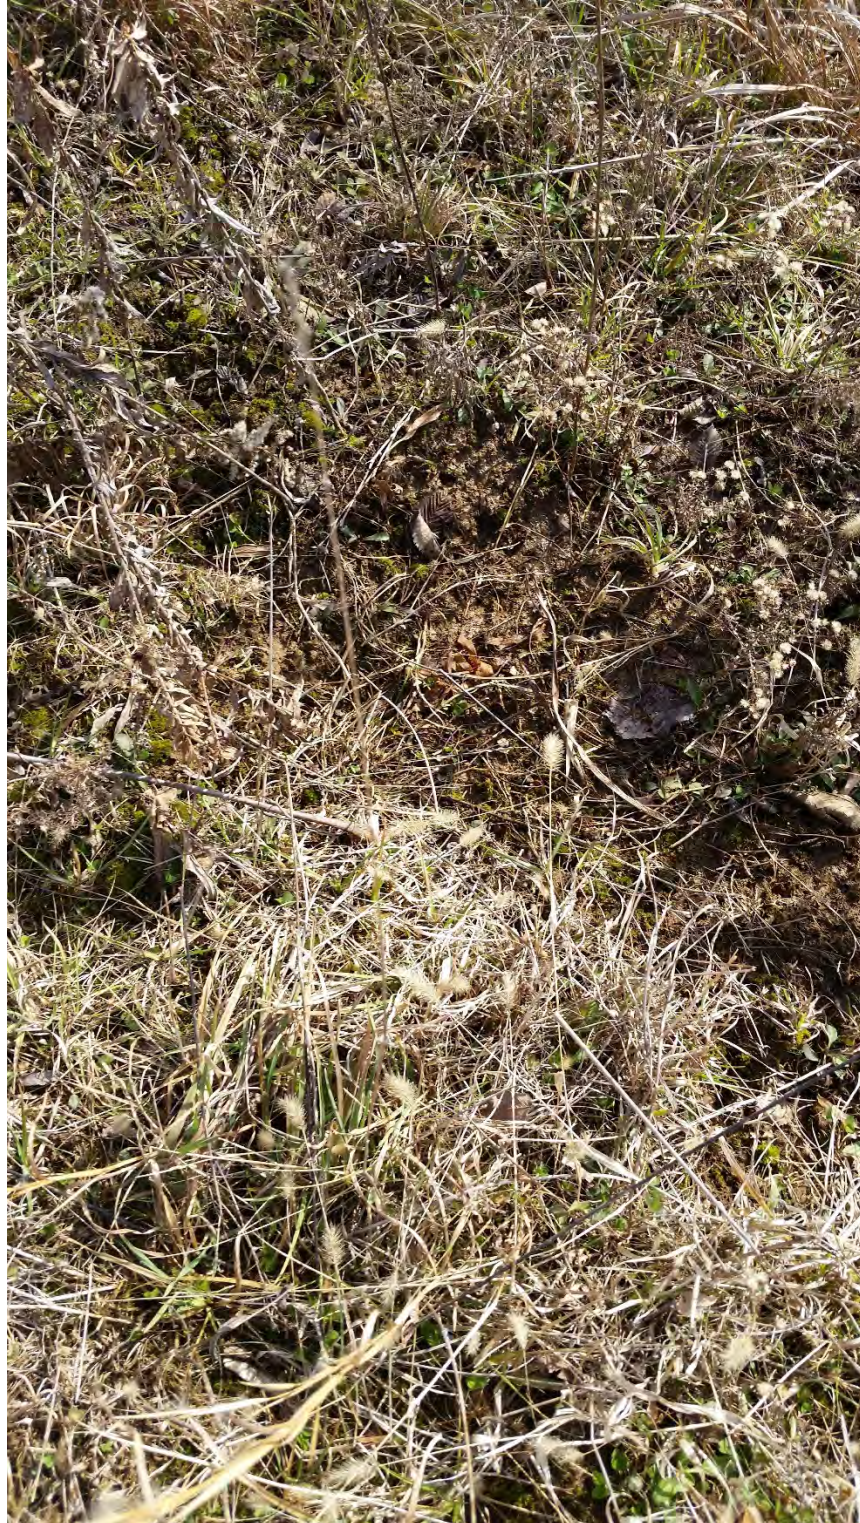
Photo 20: EV9 East Plant Area Cover patchy vegetation.
