Re: RCRA Corrective Action Administrative Order on Consent (AOC)  
Progress Report 58, Third Quarter 2015  
GM CET – Bedford Facility, IND 006036099, Docket No. RCRA 05-2014-0011  
Bedford, Indiana

## **Third Quarter 2015 Progress Report 58**

GM CET – Bedford Facility

## Third Quarter 2015 Cover System Inspection: Field Logs, Transect Figures, and Photograph Log

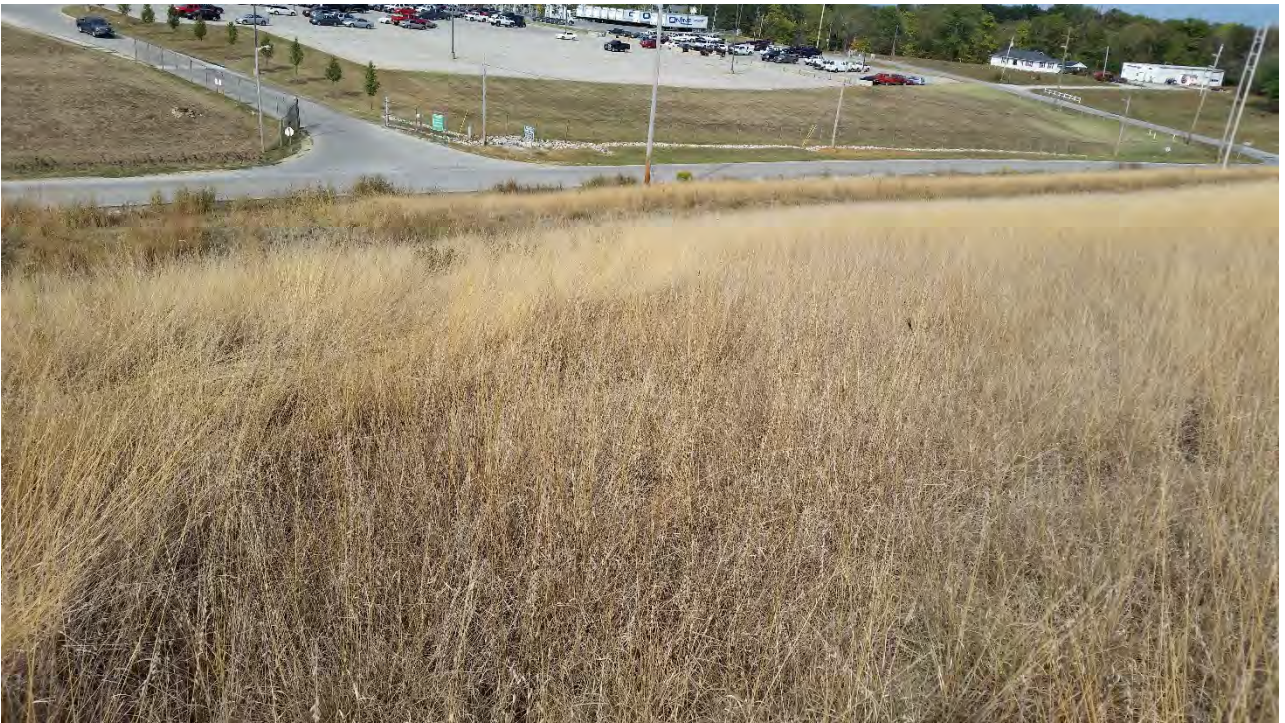
Photo 1: EV1 Vault cover facing northwest

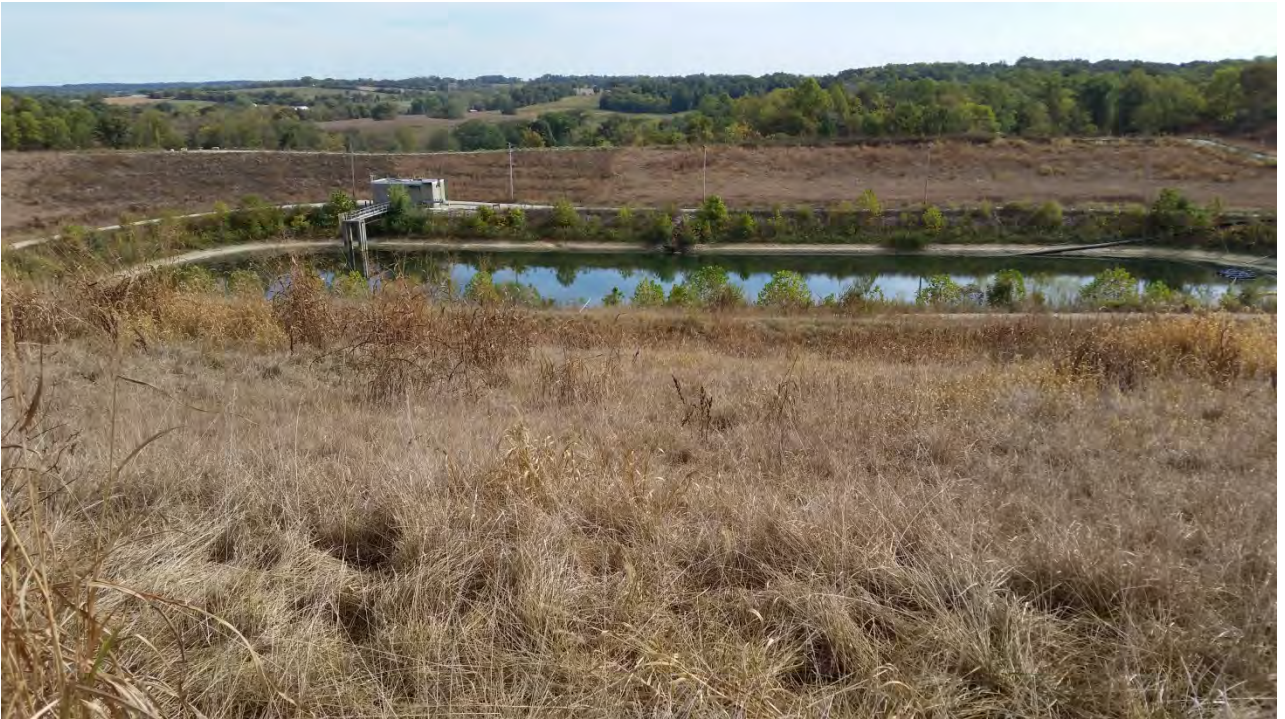
Photo 2: EV1 Vault cover (and East Plant Area cover beyond) facing east

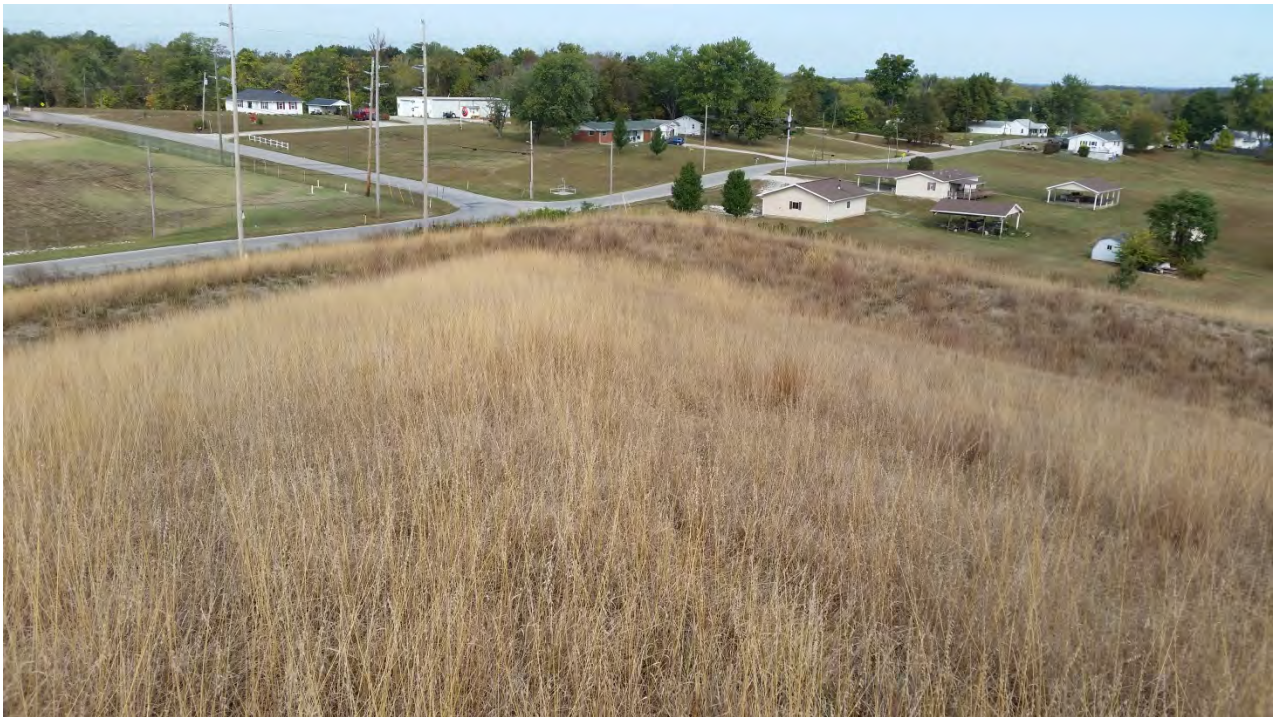
Photo 3: EV2 East Plant Area cover facing northwest

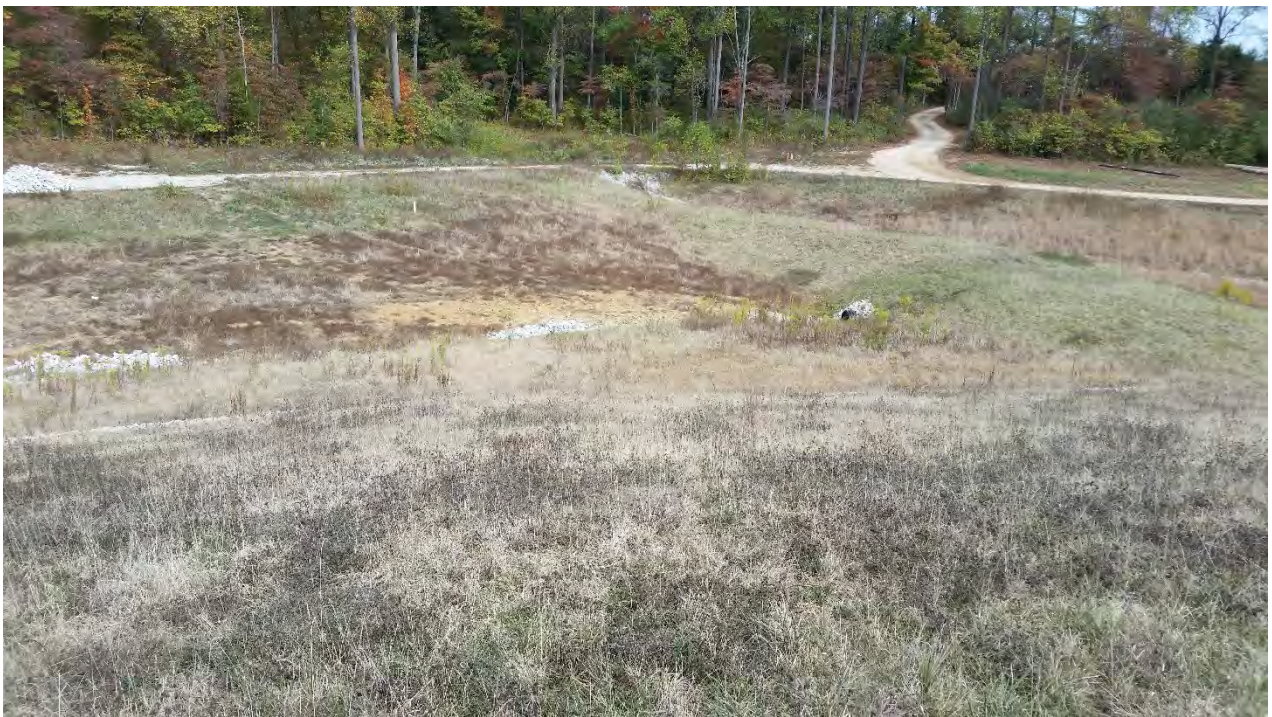
Photo 4: EV3 East Plant Area cover facing north

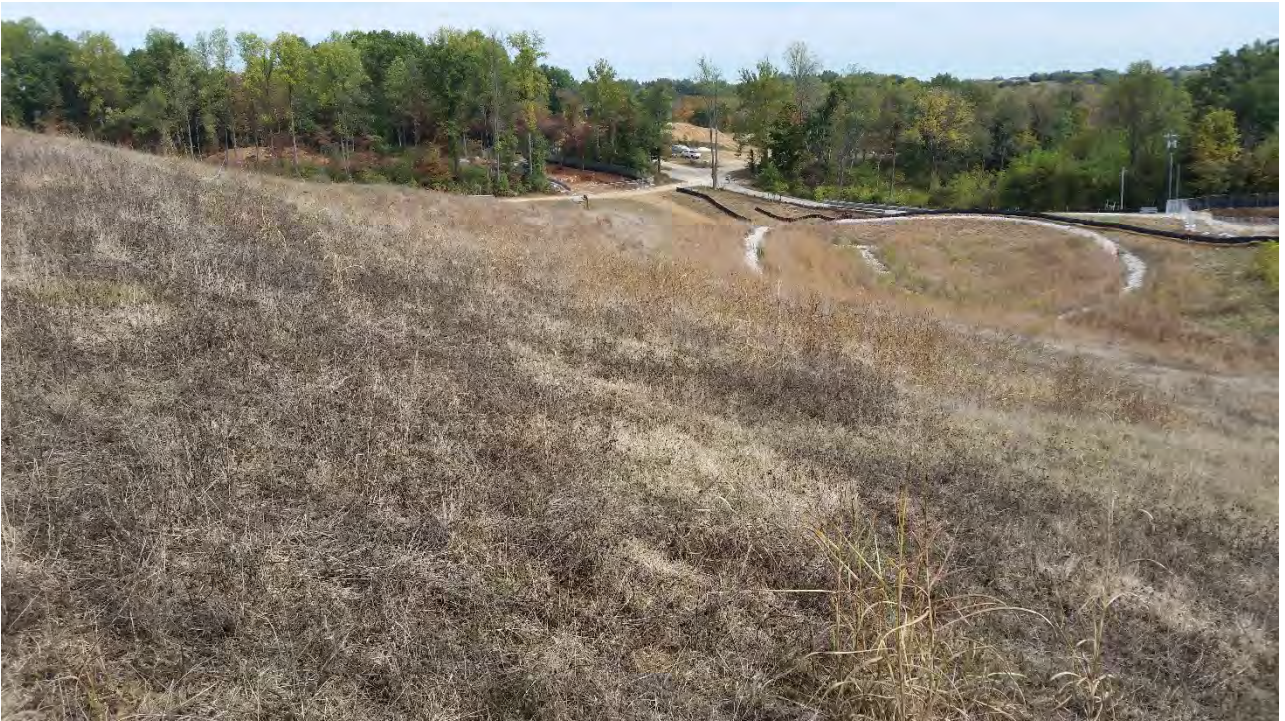
Photo 5: EV4 East Plant Area cover facing northeast

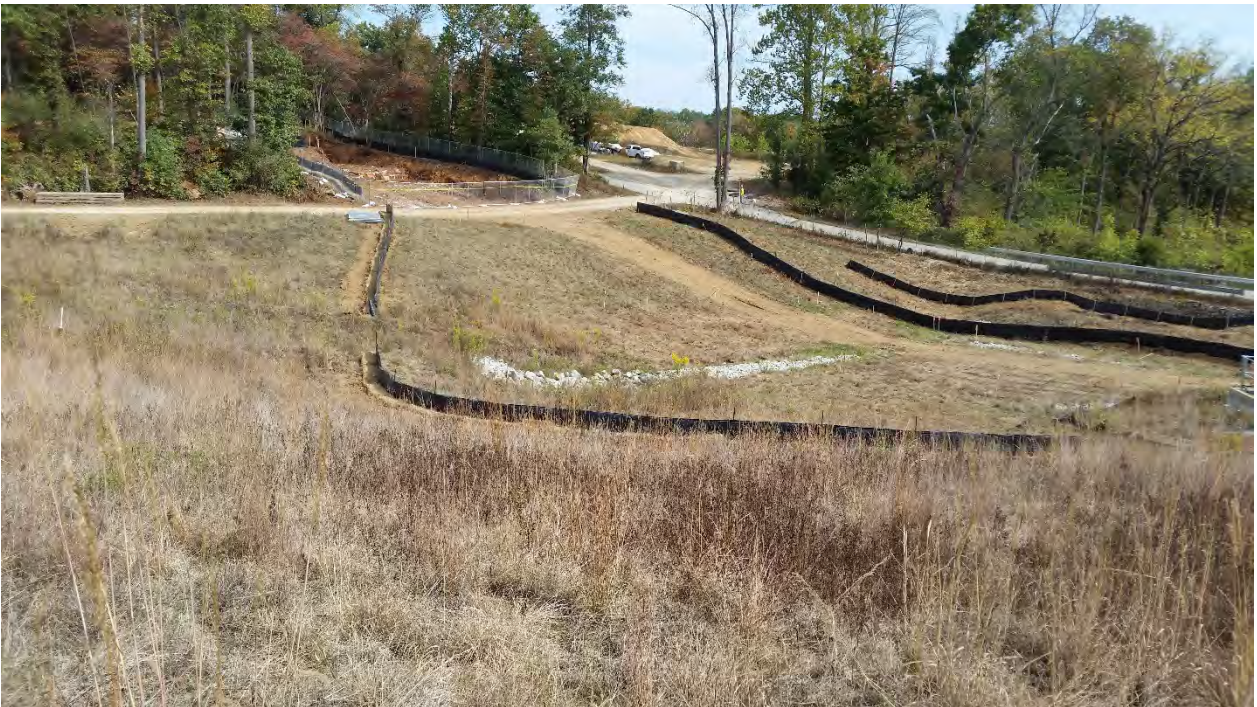
Photo 6: EV4 East Plant Area cover facing northeast across Pilot Trench alignment

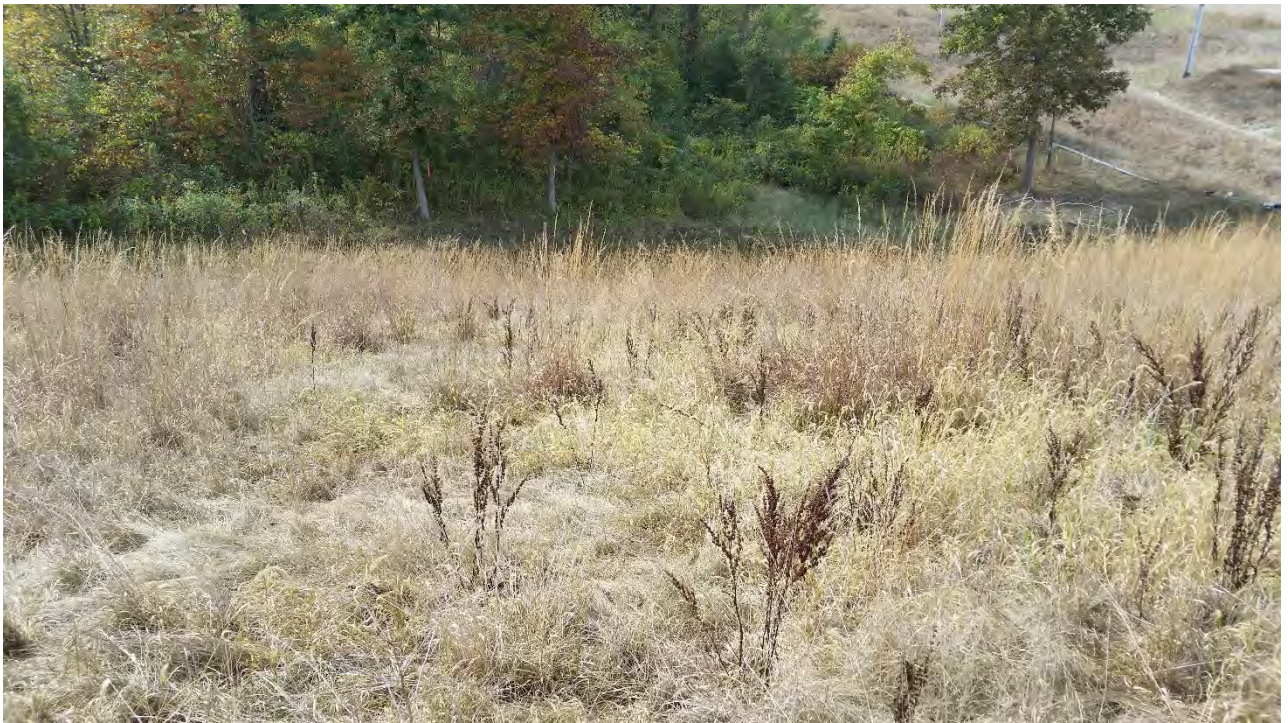
Photo 7: EV5 East Plant Area cover facing northeast

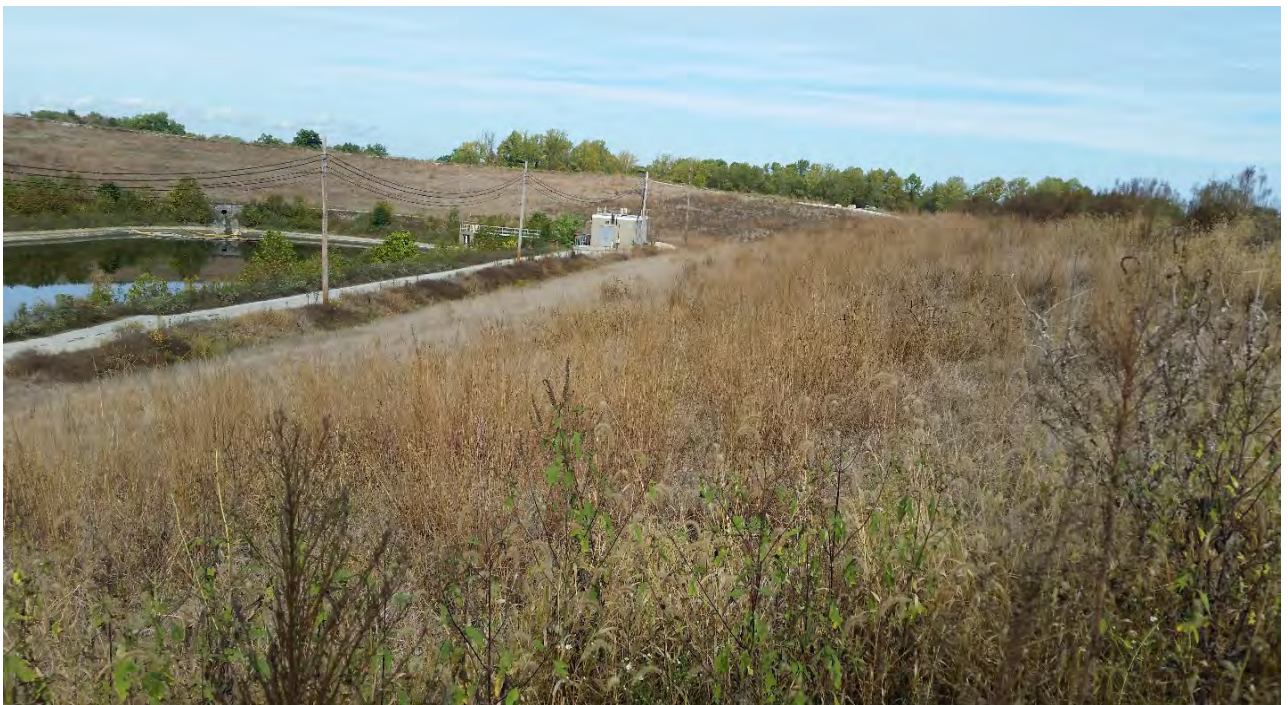
Photo 8: EV5 East Plant Area cover facing northwest

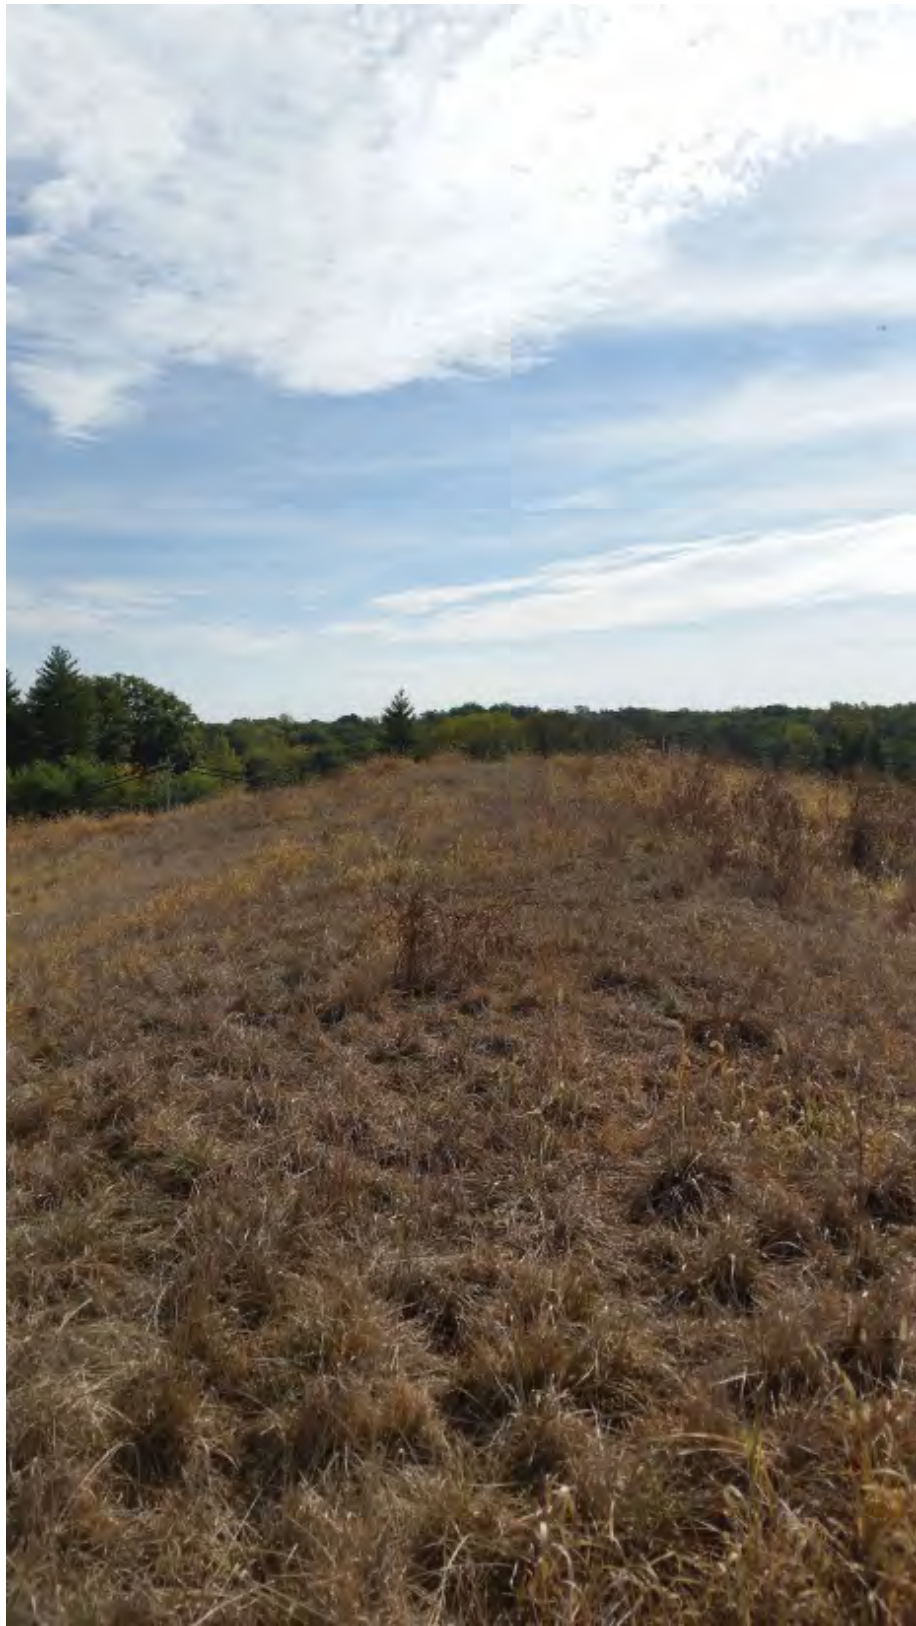
Photo 9: EV6 East Plant Area cover facing east

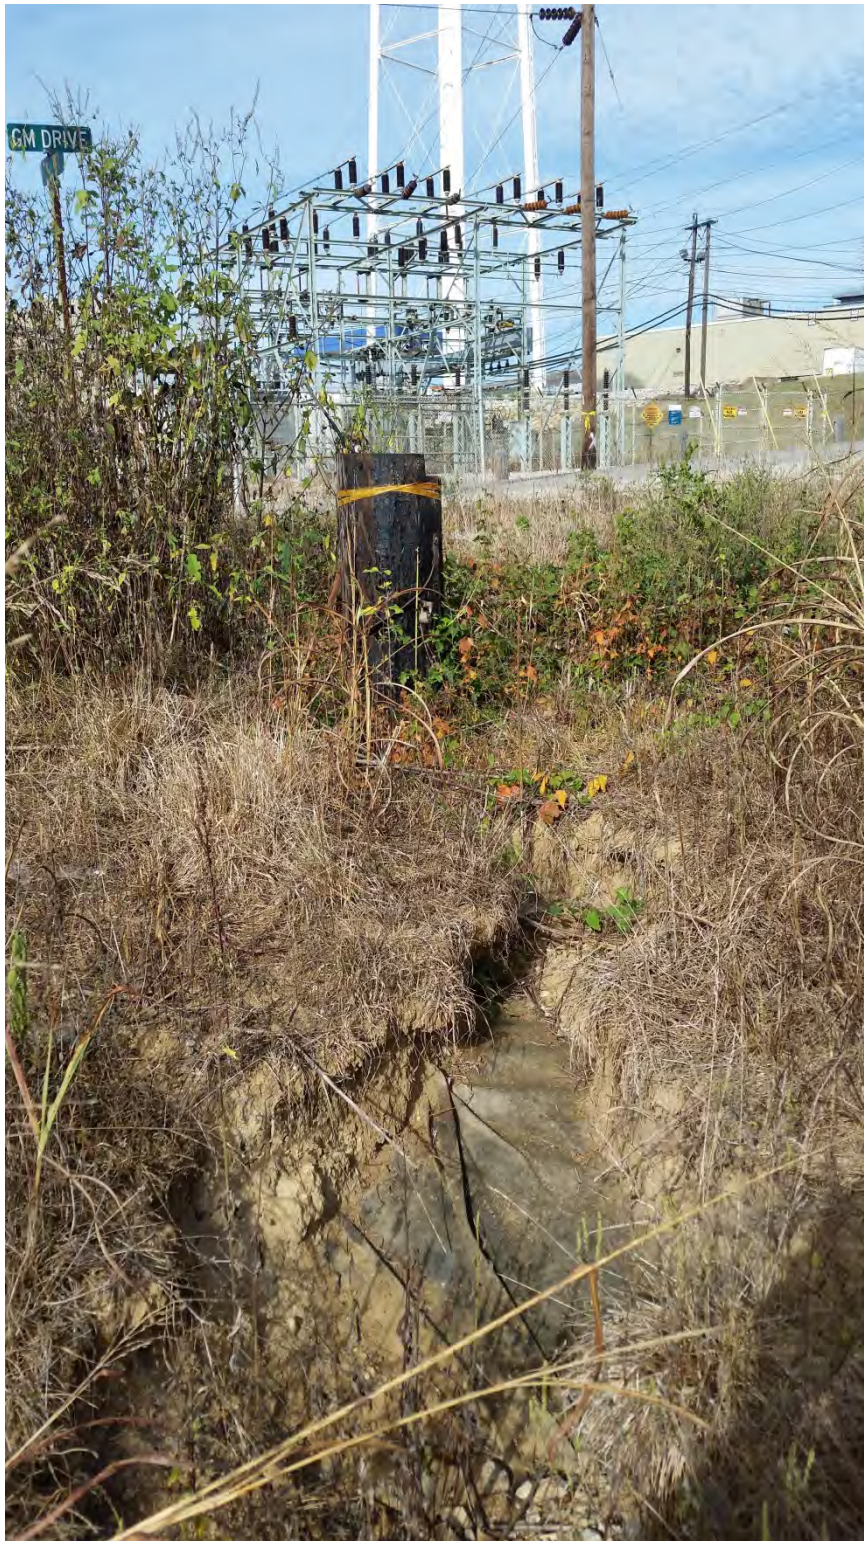
6. There are some erosion ruts along the east side of GM Drive, outside the cover system area adjacent to power poles. This does not appear to be due to any on-Site RCRA activities, but could have an impact on the liner system in the ditch. Work will be conducted on power poles in this area and so any work in the area will not be addressed until after this work is completed.

Photo 10: EV6 erosion rut outside cap limit

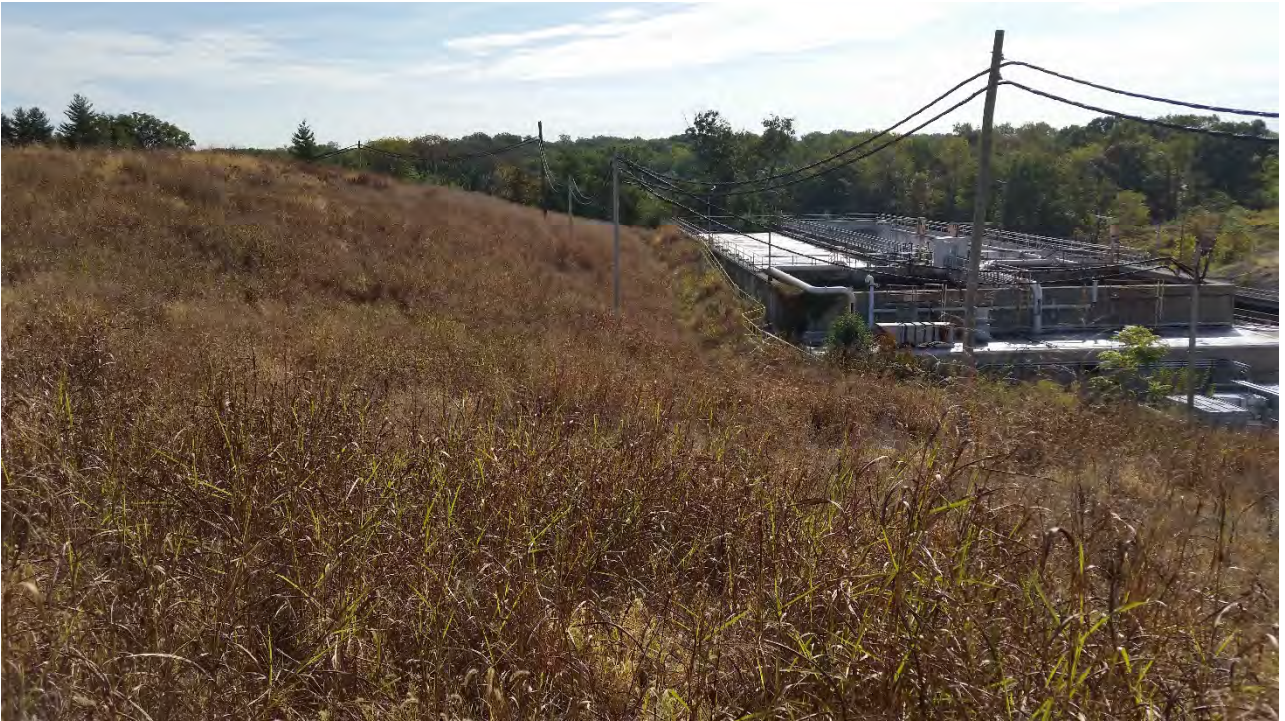
Photo 11: EV6 East Plant Area cover facing southwest

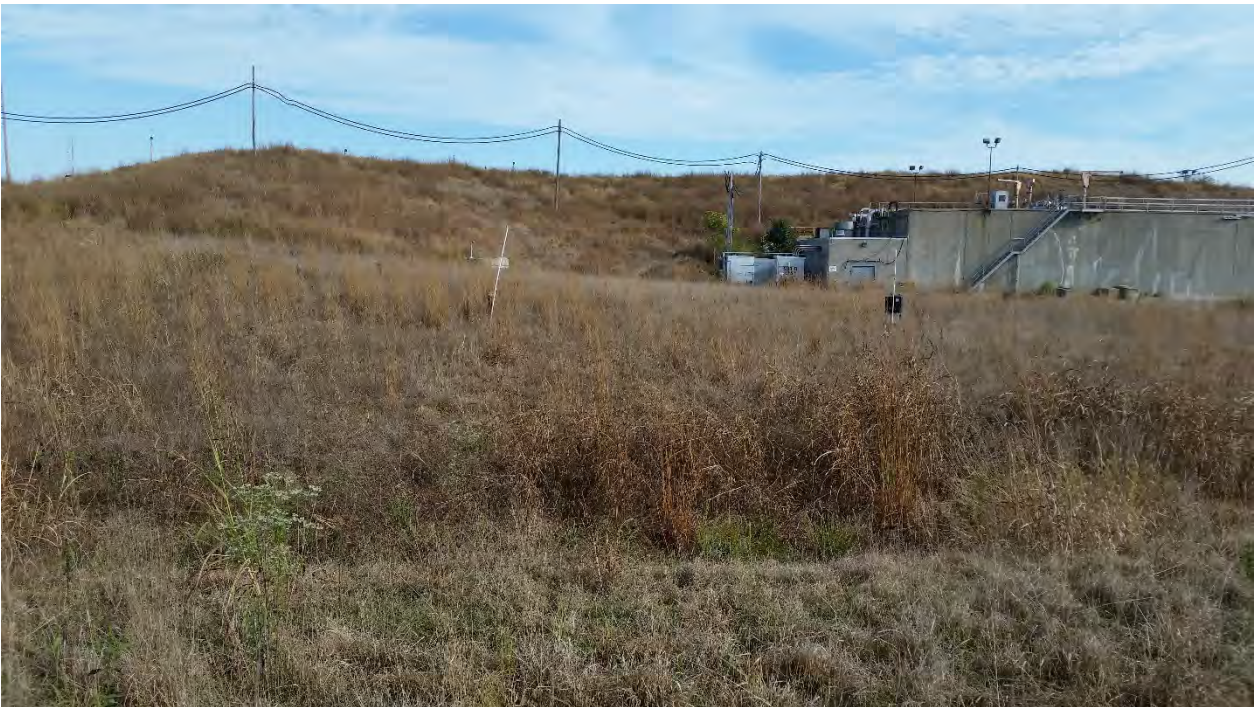
Photo 12: EV7 East Plant Area cover facing north

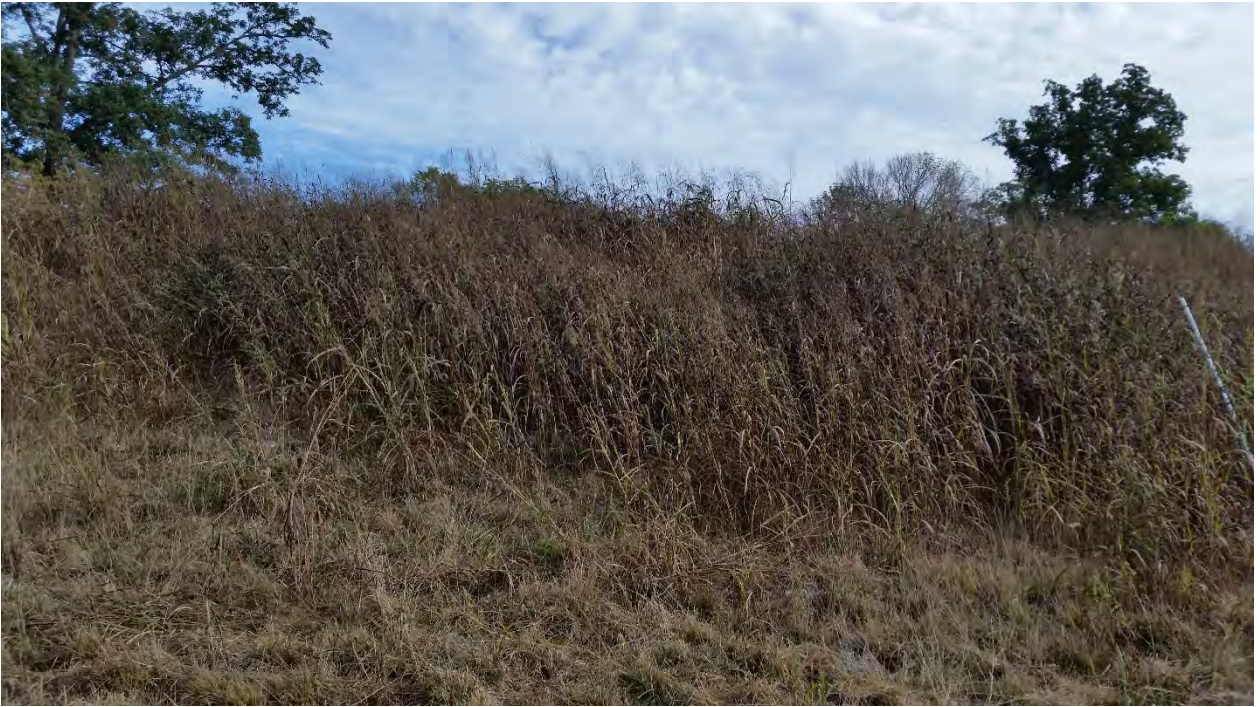
Photo 13: EV8 East Plant Area cover (Parcel 205) facing north

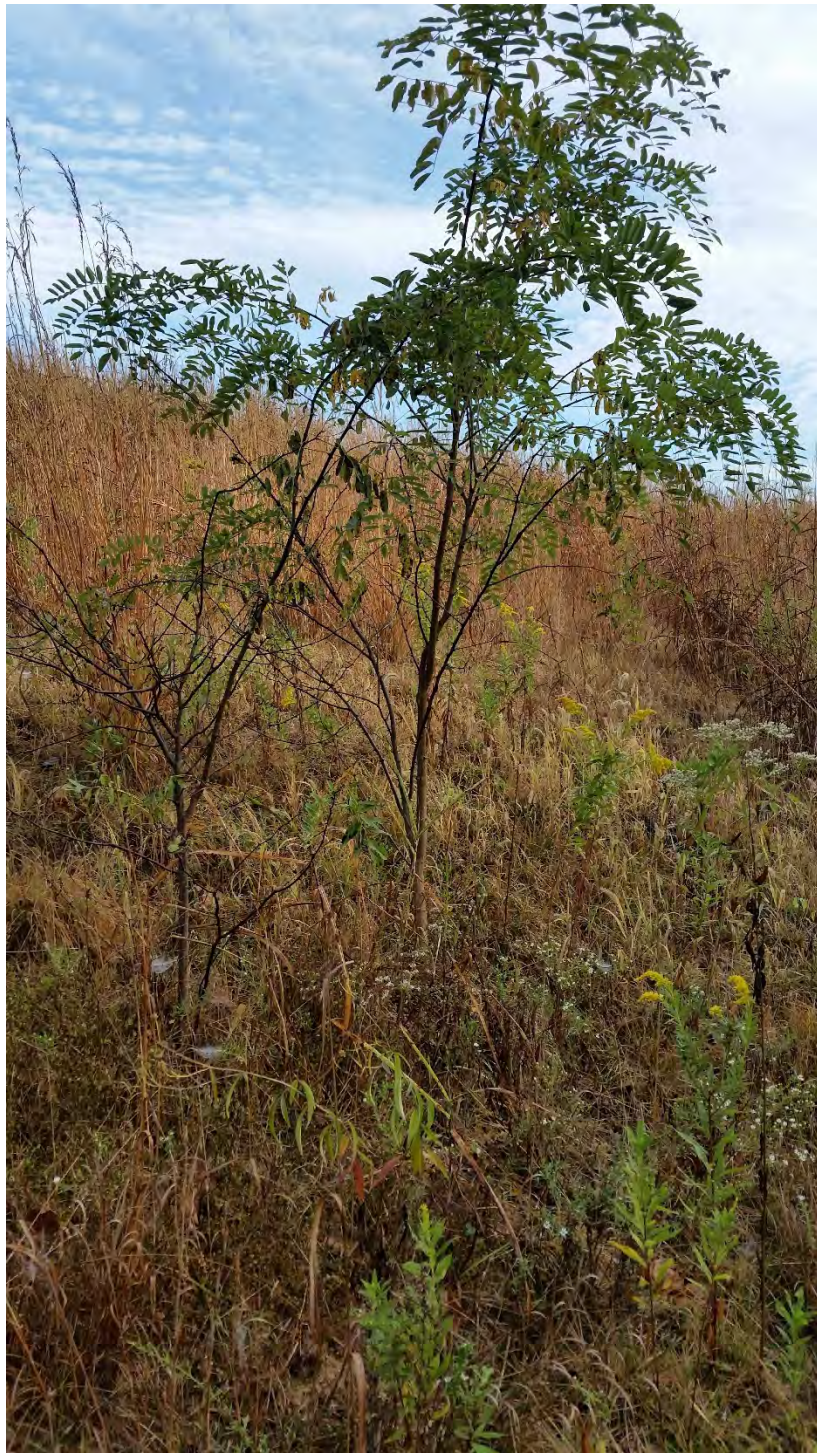
Photo 14: EV9 East Plant Area cover facing south (removed tree growth at time of inspection)

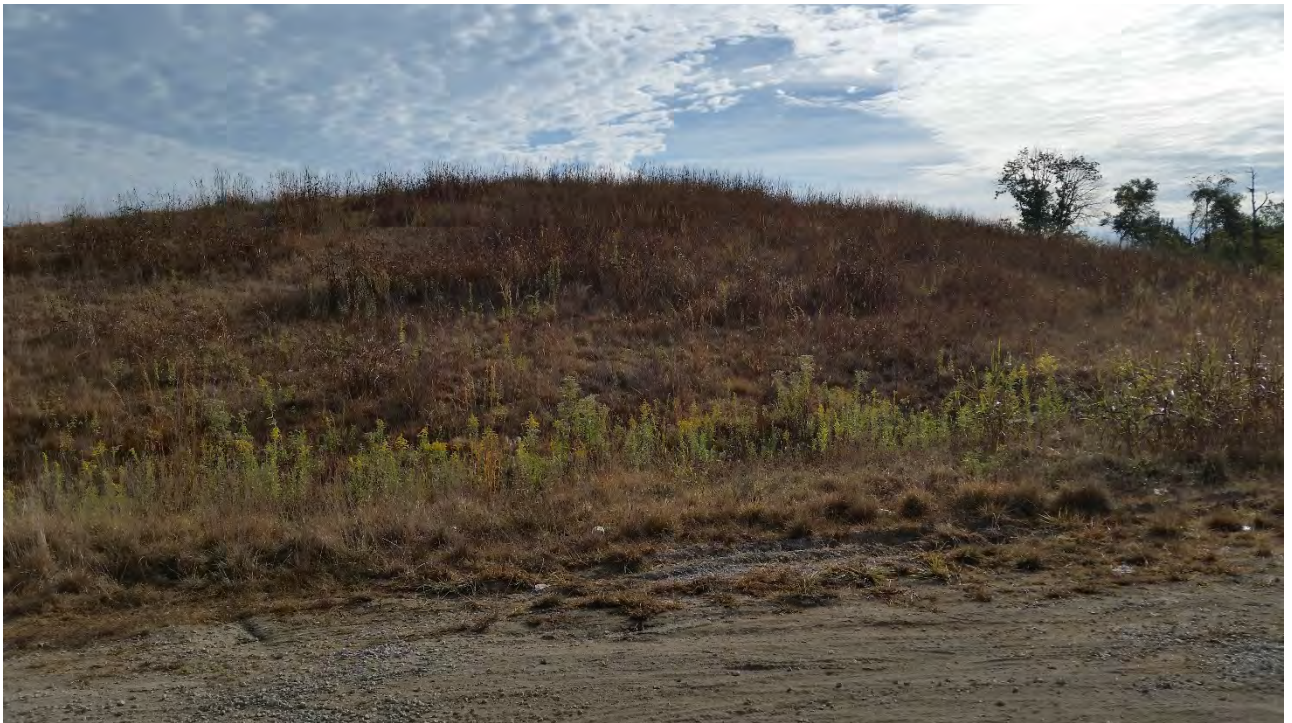
Photo 15: EV9 East Plant Area cover facing south (at base of slope)

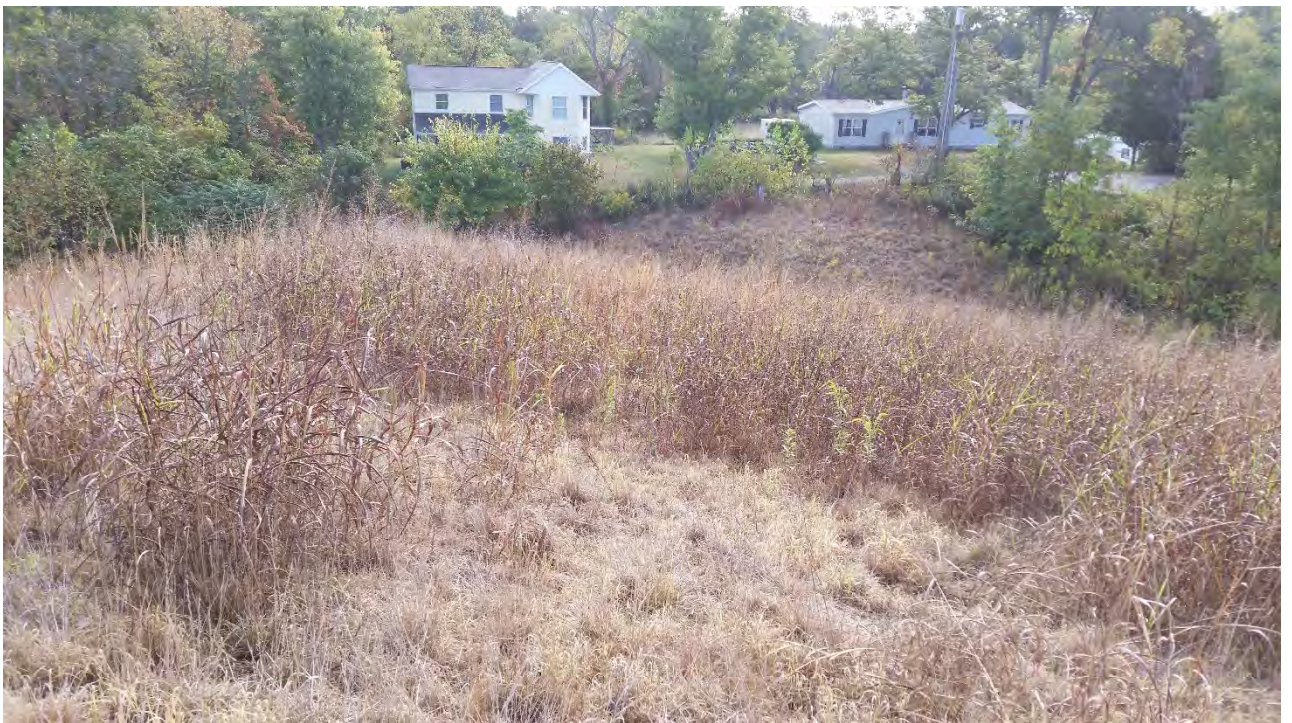
Photo 16: EV9 East Plant Area cover facing east

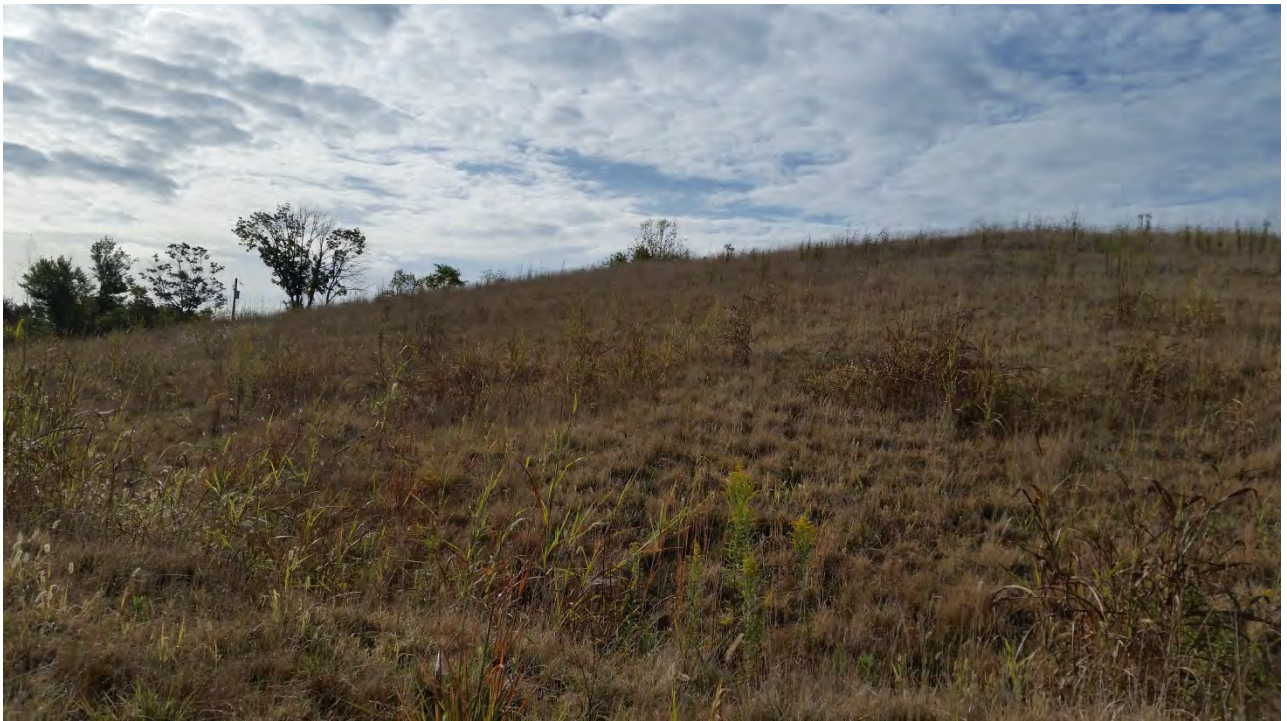
Photo 17: EV9 East Plant Area cover facing south

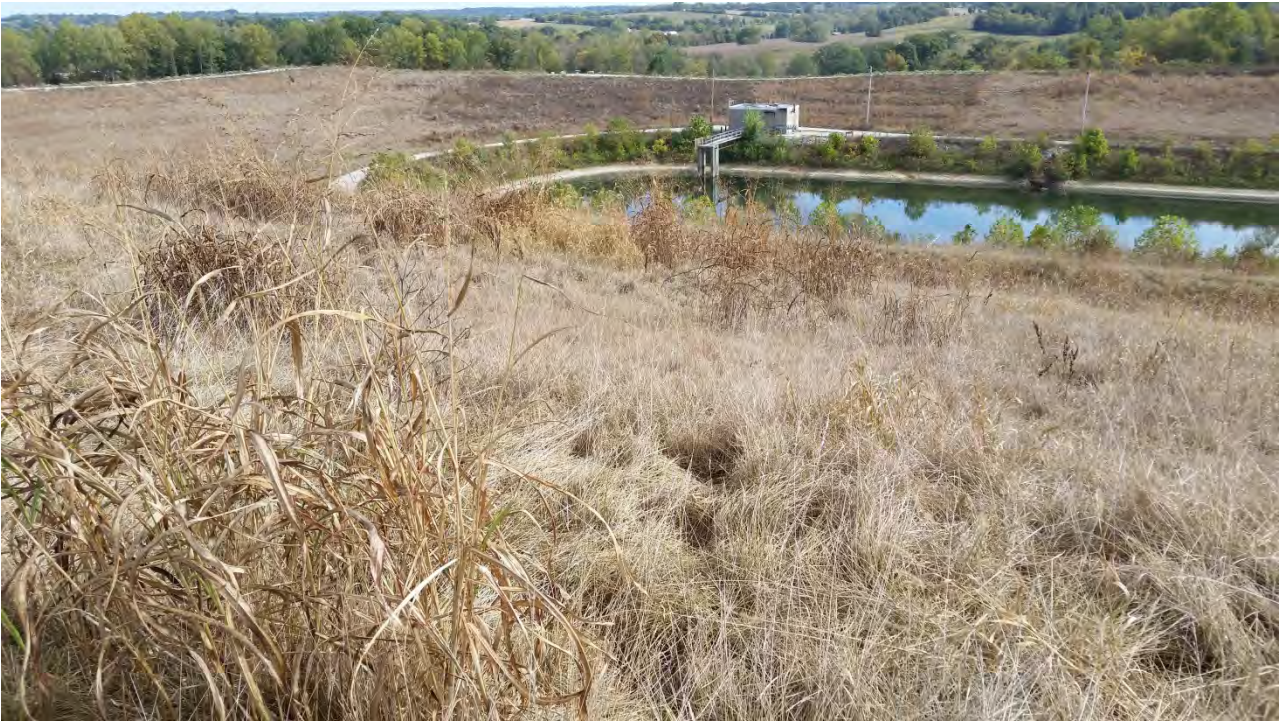
Photo 19: ES2 drainage swale facing north

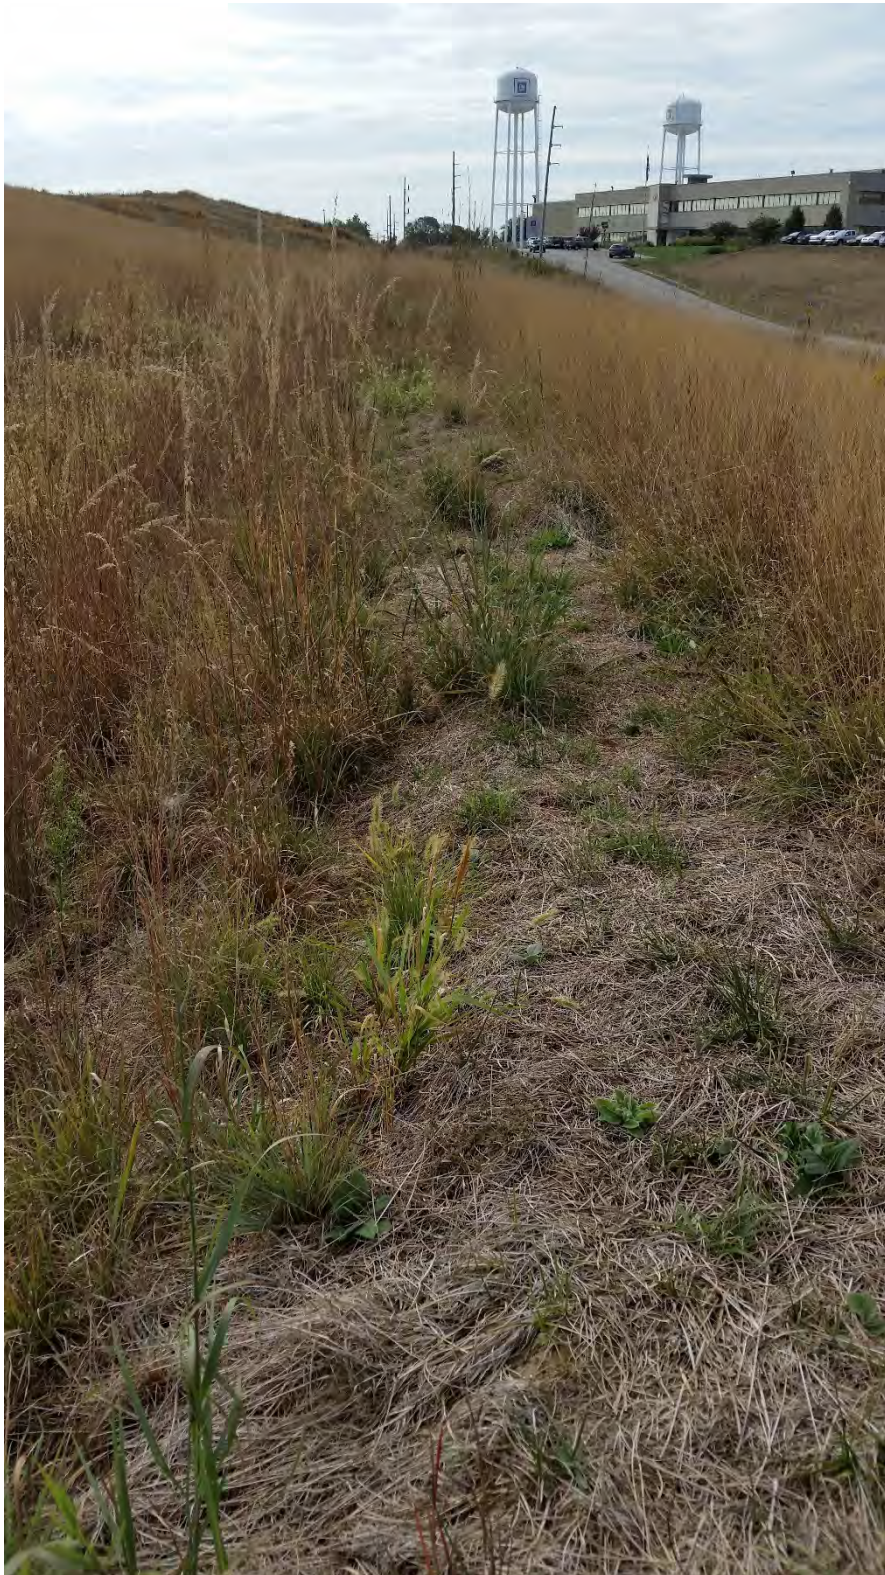
Photo 20: ES3 channel facing south.

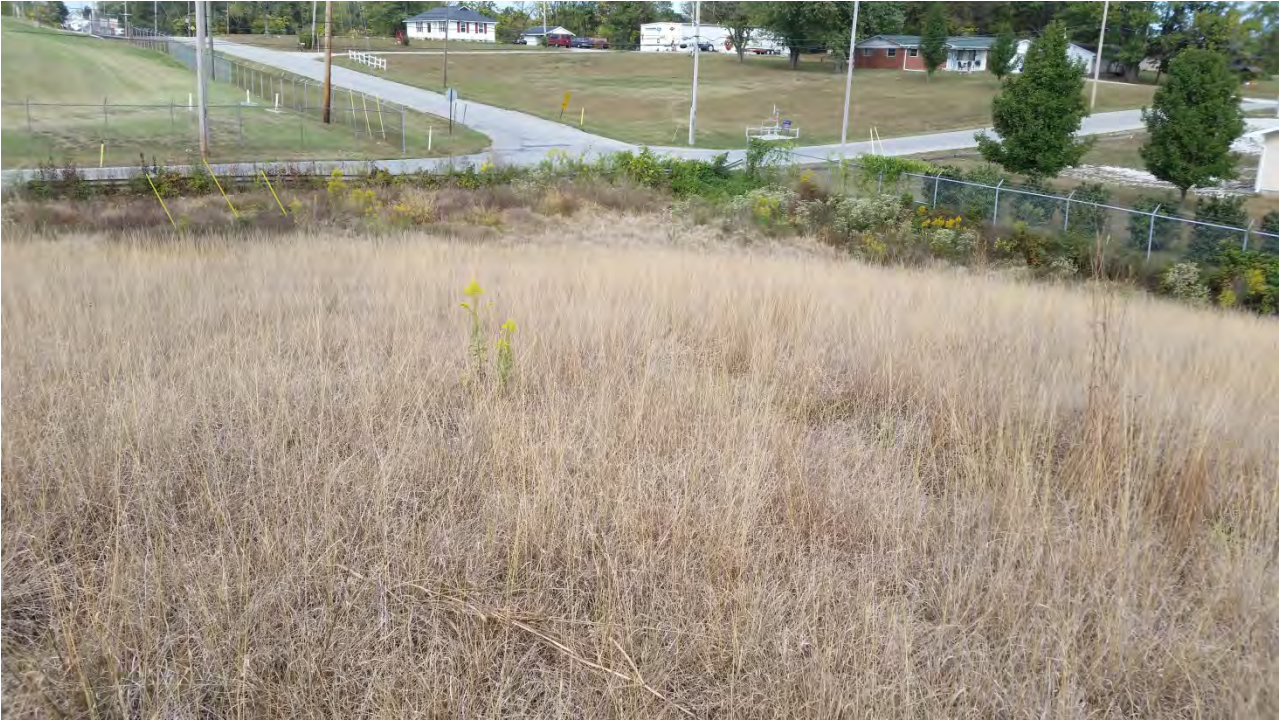
Photo 21: ES5 drainage swale facing west

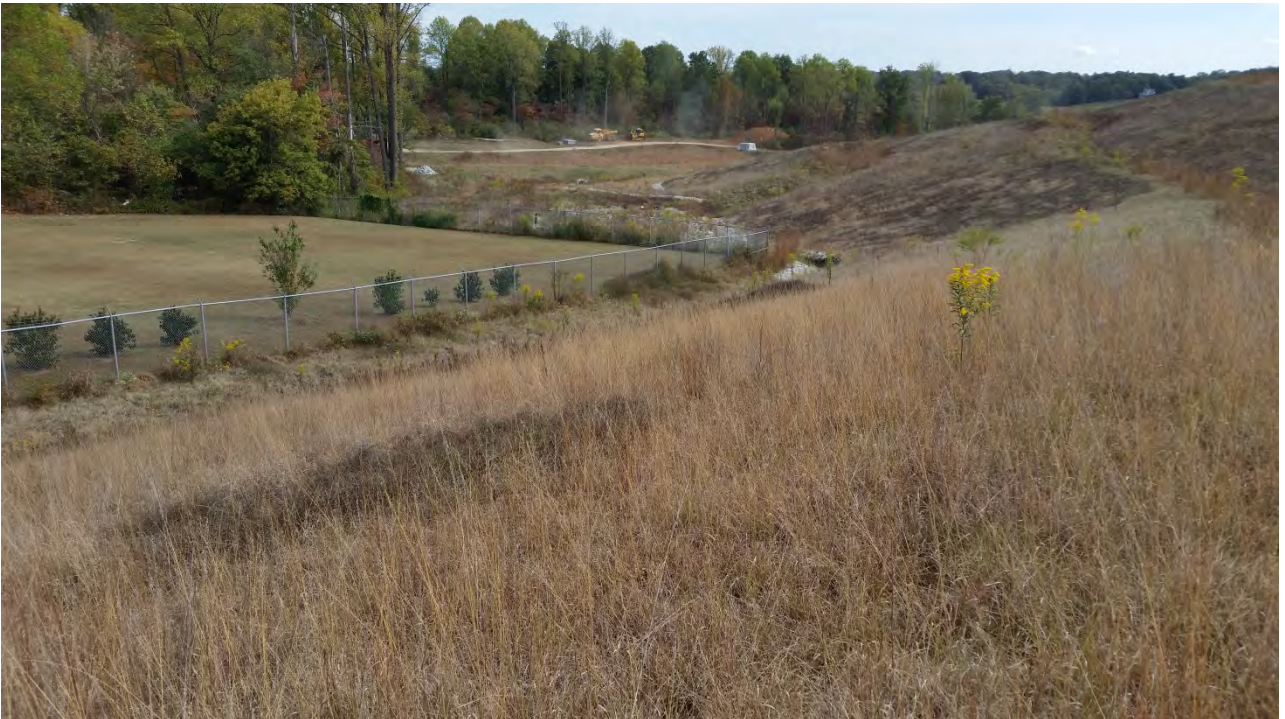
Photo 22: ES5 drainage swale facing northeast

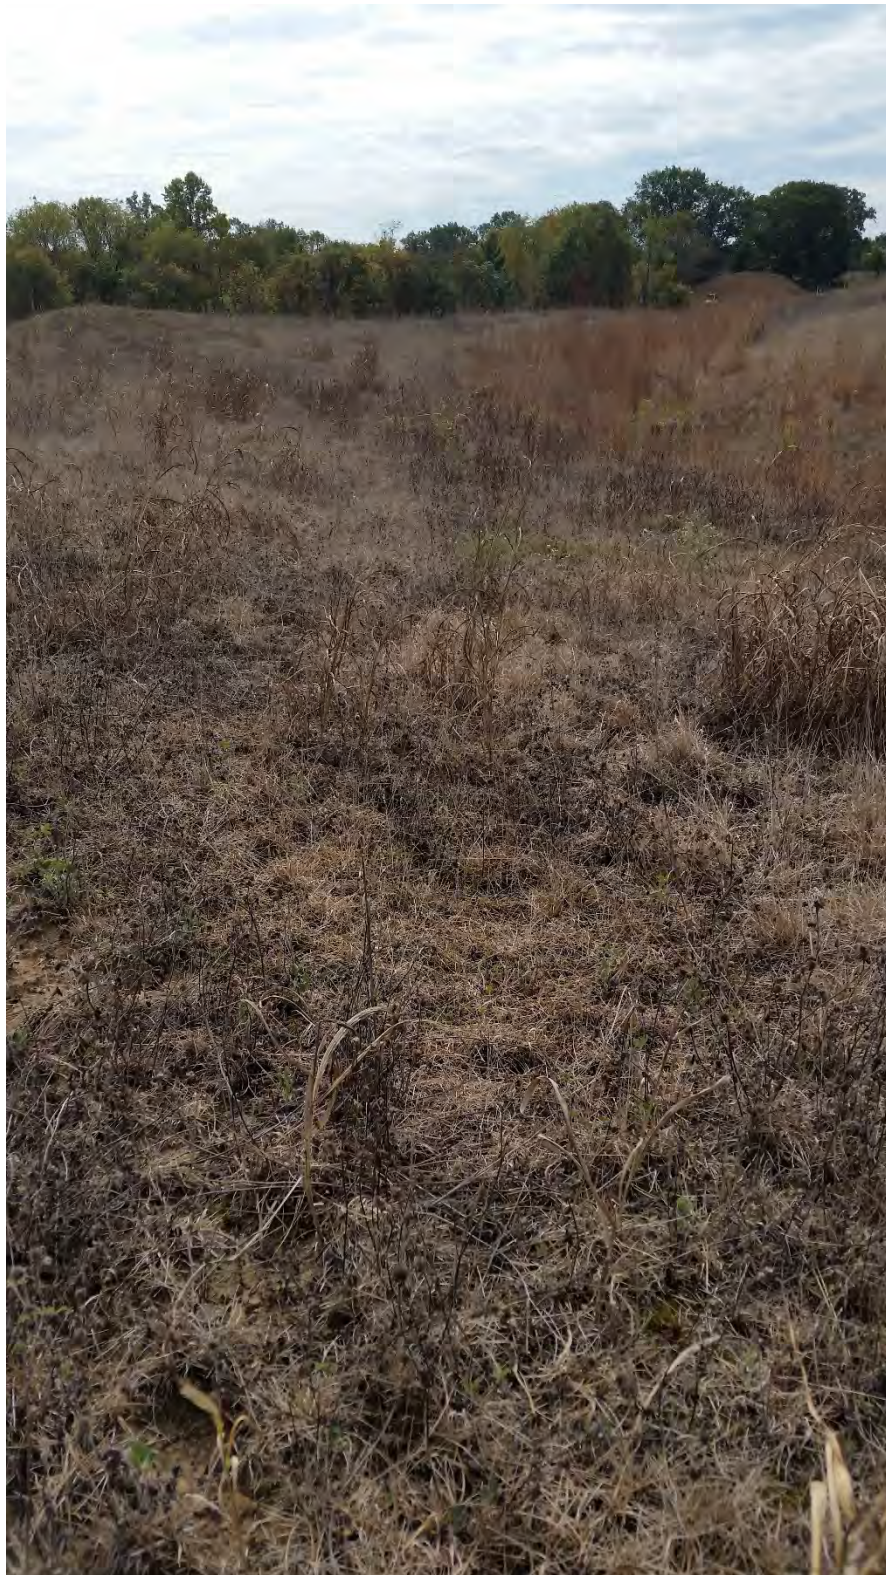
Photo 23: ES6 facing southeast
