Re: RCRA Corrective Action Administrative Order on Consent (AOC)  
Progress Report 58, Third Quarter 2015  
GM CET – Bedford Facility, IND 006036099, Docket No. RCRA 05-2014-0011  
Bedford, Indiana

## **Third Quarter 2015 Progress Report 58**

GM CET – Bedford Facility

## Third Quarter 2015 Cover System Inspection: Field Logs, Transect Figures, and Photograph Log

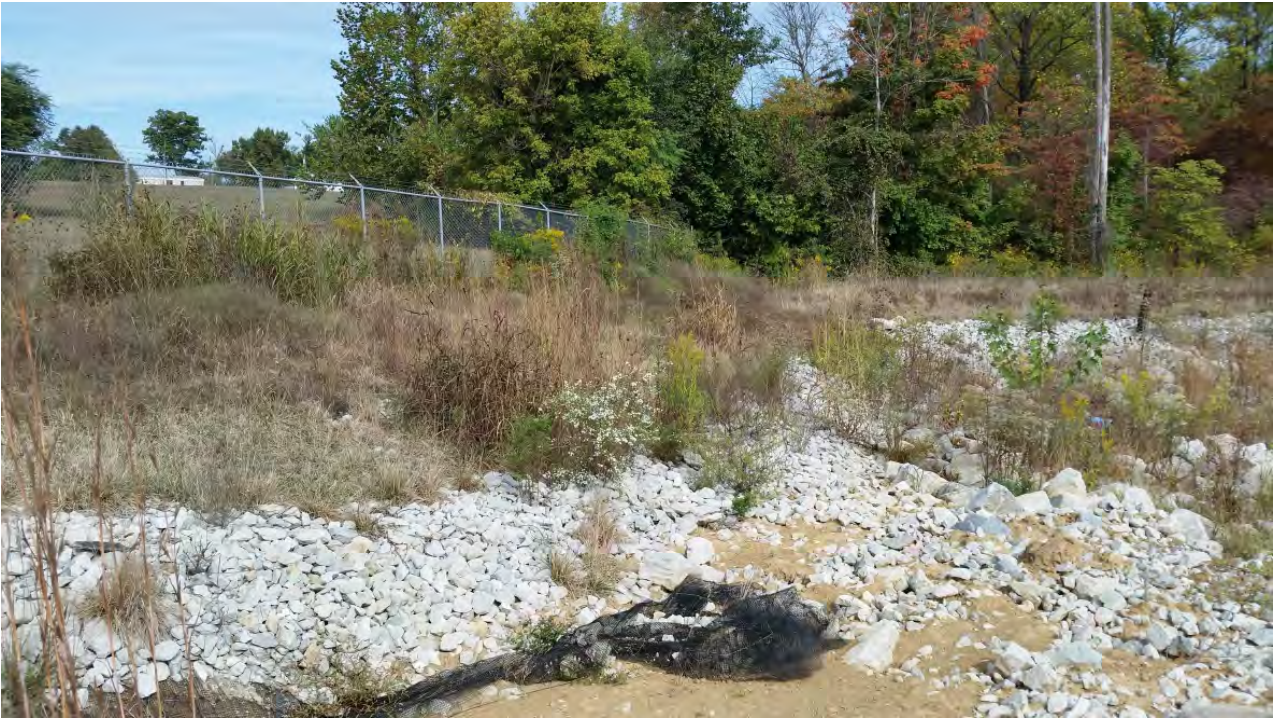
Photo 24: ES6 drainage swale facing west, channel erosion.

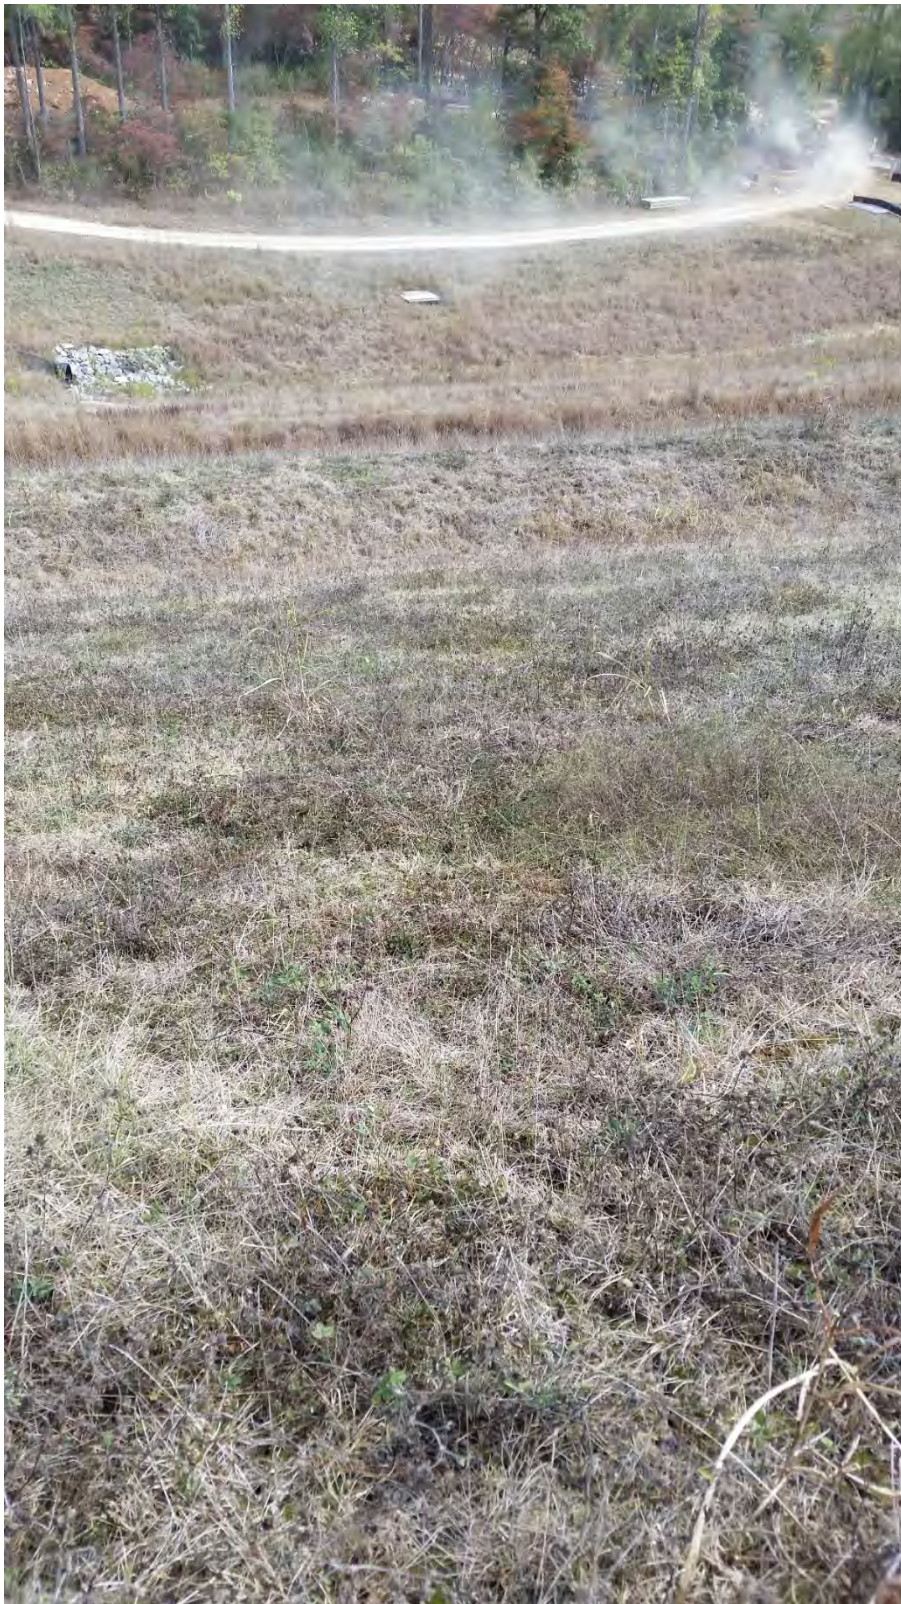
Photo 25: ES8 and ES10 facing north across detention basin 3

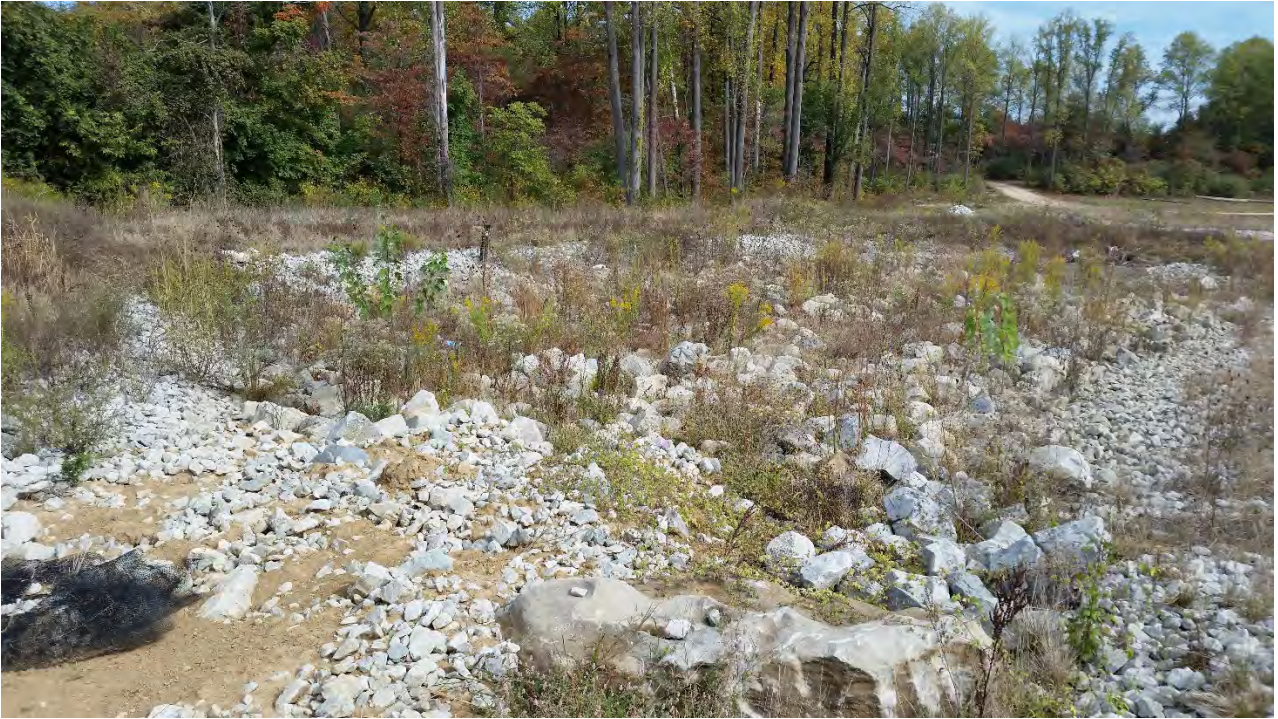
8. During the previous inspections it was noted that the velocity of the water coming from Detention Basin 1 (DB1) into DB2 has at times been strong enough to displace the riprap at the point the water enters the basin, exposing about a 5 foot length of the channel, including the underlying liner. Repair work was completed along the drainage channel in July, however some additional erosion persisted upstream of DB1. Additional erosion control measures for this area are being evaluated.

Photo 26: ES9 rip rap erosion at storm drain into detention basin #2 facing west

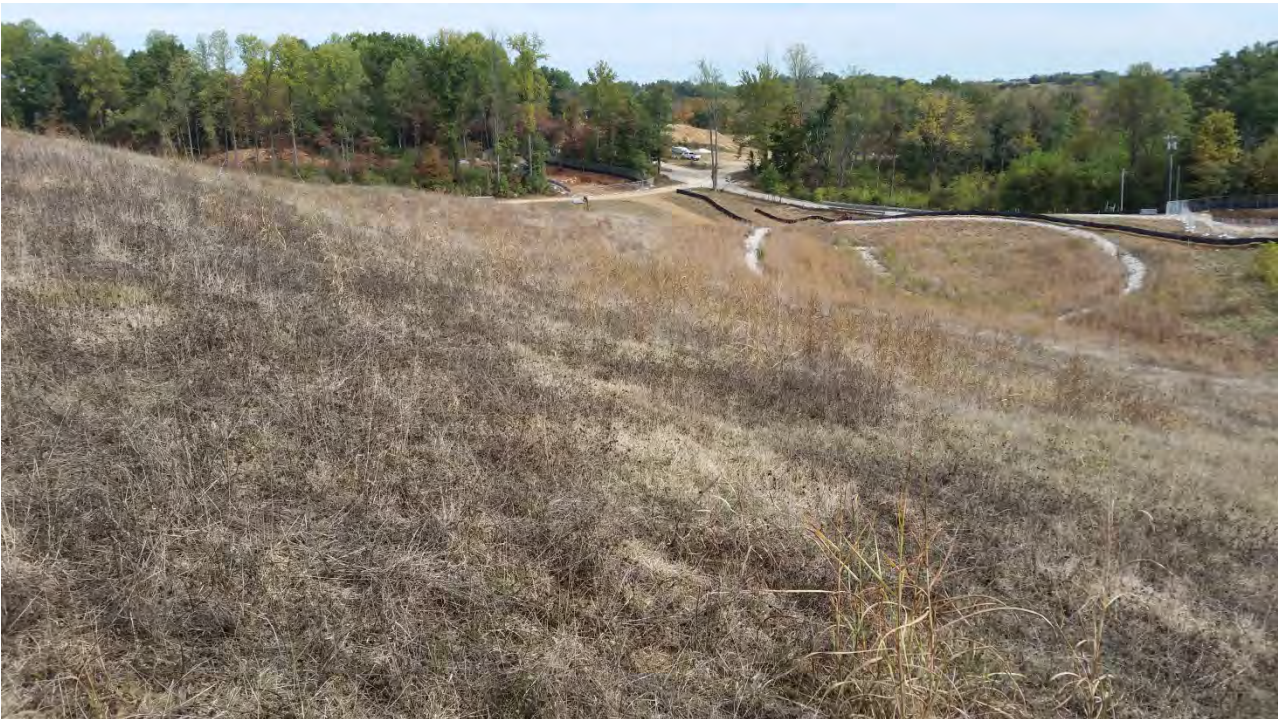
Photo 27: ES11 detention basin #5 facing north

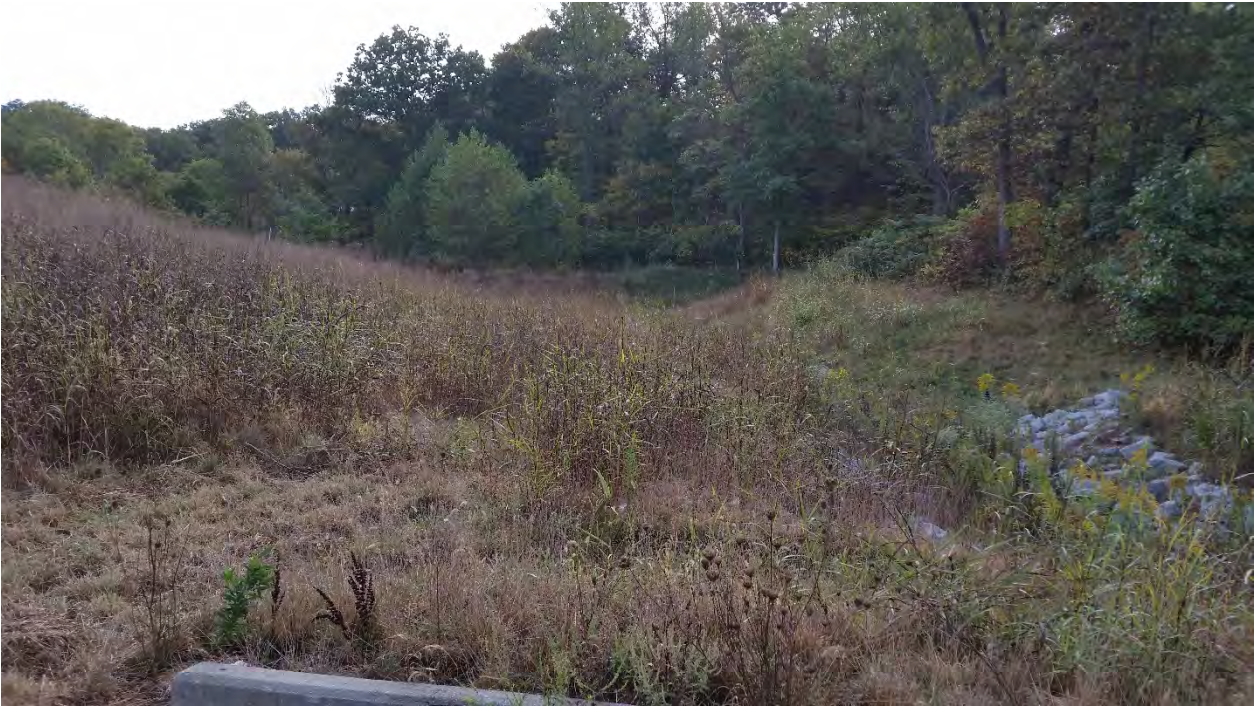
Photo 28: ES13 detention basin 6 facing east

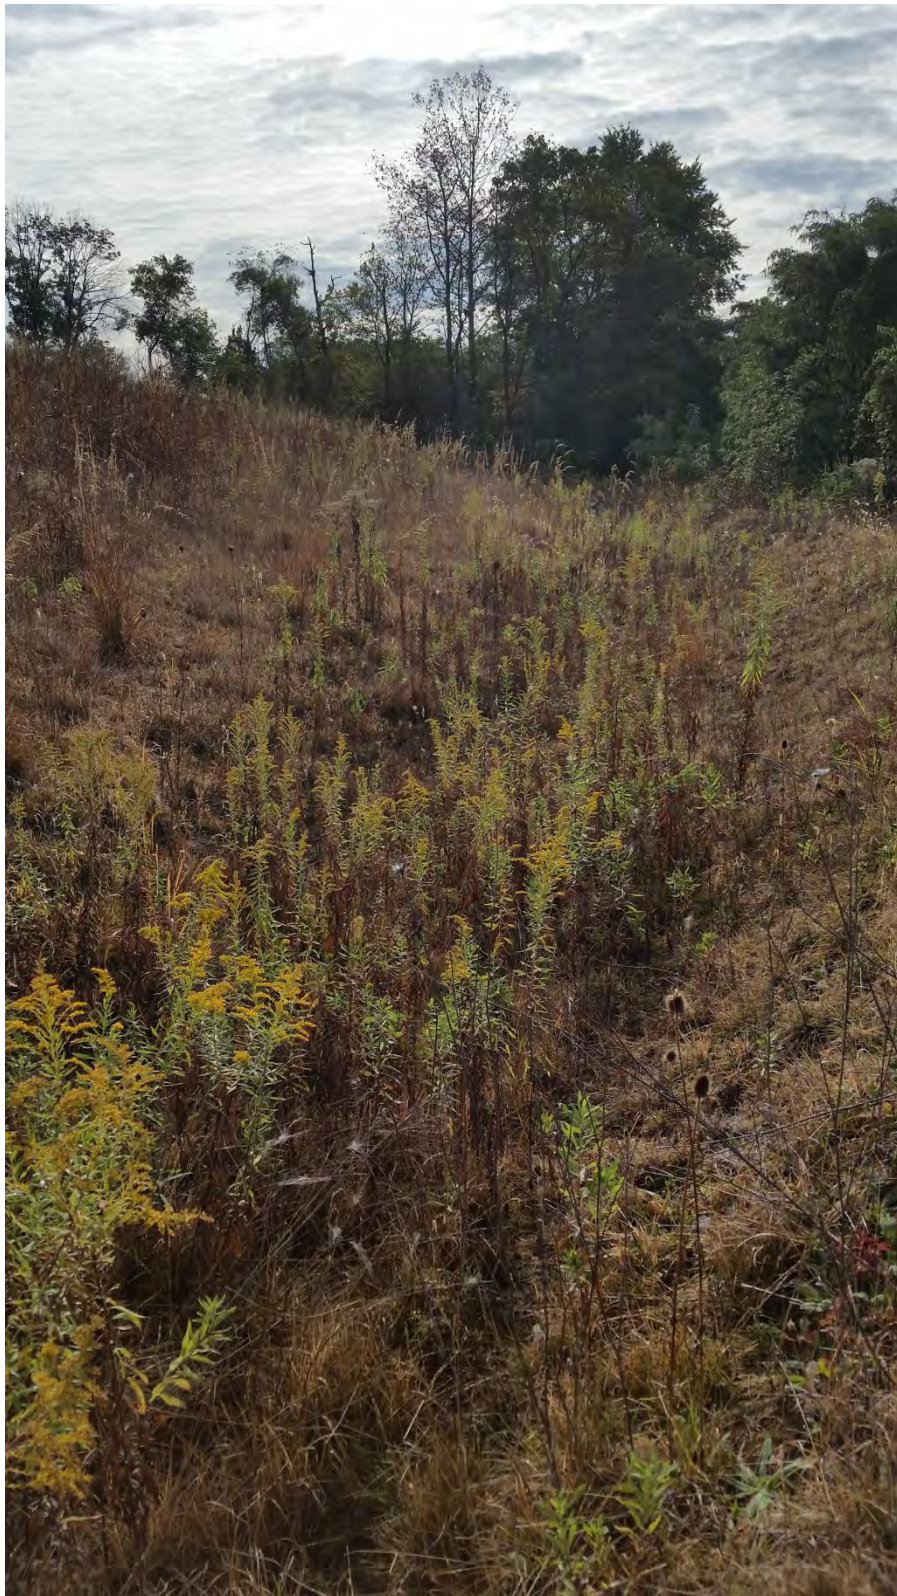
Photo 29: ES14 drainage swale facing east

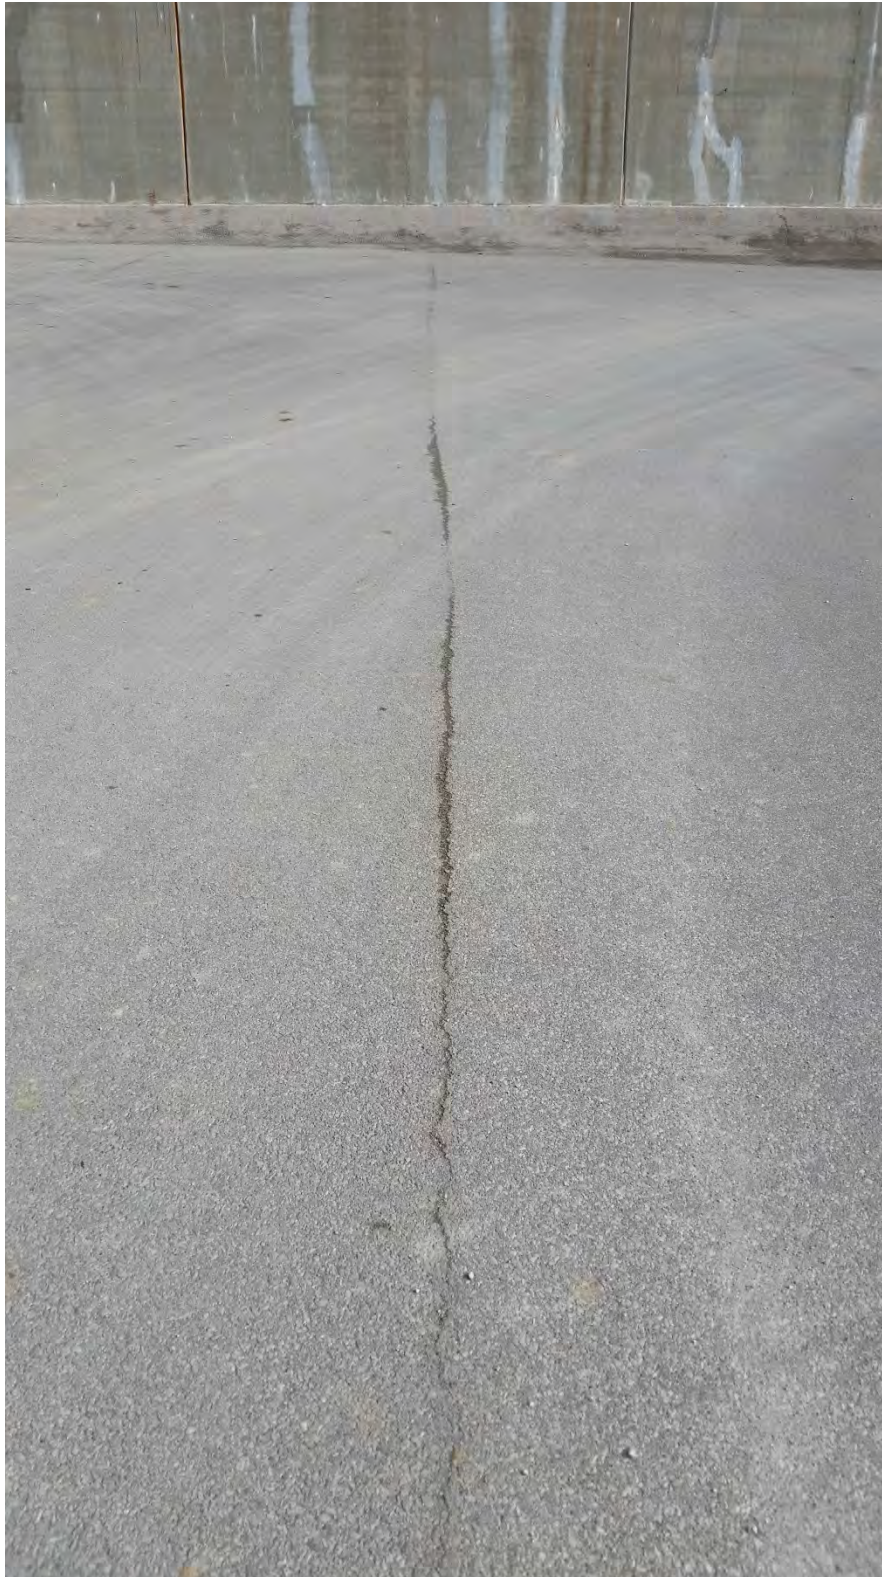
7. Minor cracks are present along the seams in the asphalt cover system. The cracks do not extend the full depth of the asphalt thickness. SES is seeking a contractor that can meet GMs safety requirements to complete the asphalt repairs. Resealing of the asphalt will be completed when construction of the groundwater treatment plant and Pilot Trench are complete.

Photo 30: EA2 crack near WWTP aeration basin facing north

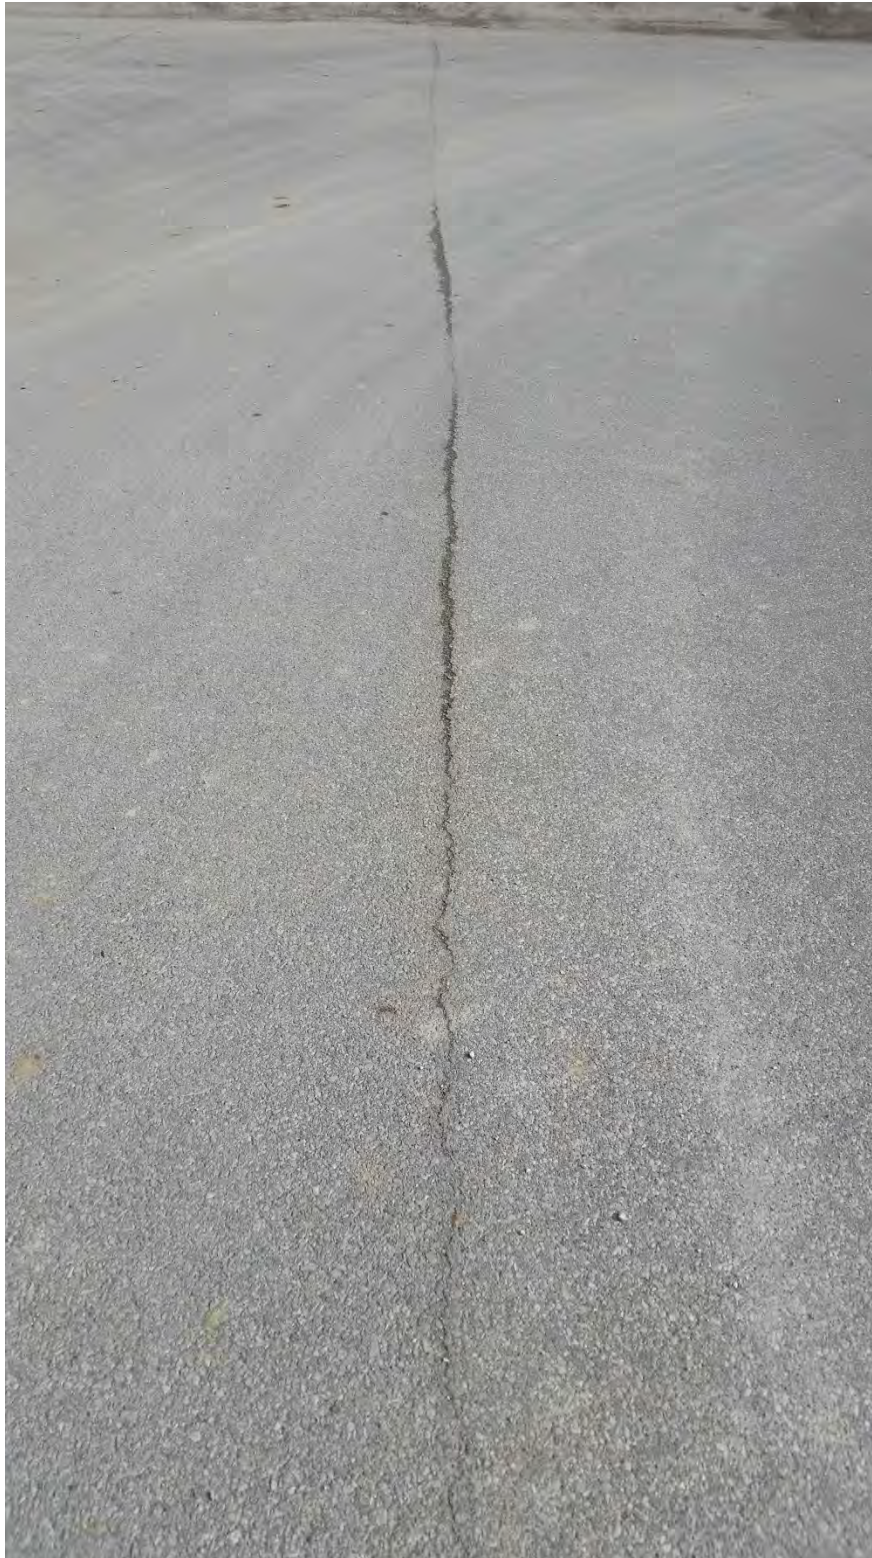
Photo 31: EA2 facing east, cracks in asphalt west of Parcel 205

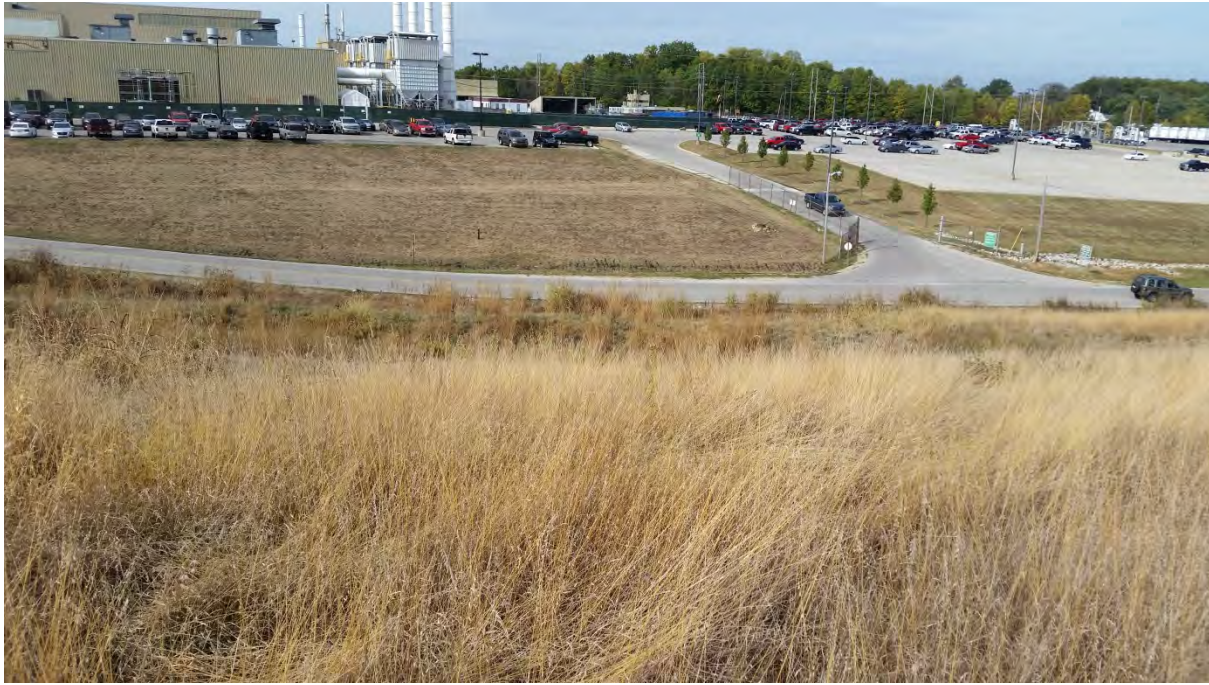
Photo 32: WV1 West Plant Area cover facing west
