First Quarter 2016 Progress Report 60

GM CET – Bedford Facility
105 GM Drive
Bedford, Indiana
EPA ID# IND006036099
AOC Docket No. RCRA-05-2014-0011

Re: RCRA Corrective Action Administrative Order on Consent (AOC)
Progress Report 60, First Quarter 2016
GM CET – Bedford Facility, IND 006036099, Docket No. RCRA 05-2014-0011
Bedford, Indiana

Appendix A
First Quarter 2016 Cover System Inspection:
Field Logs, Transect Figures,
and Photograph Log

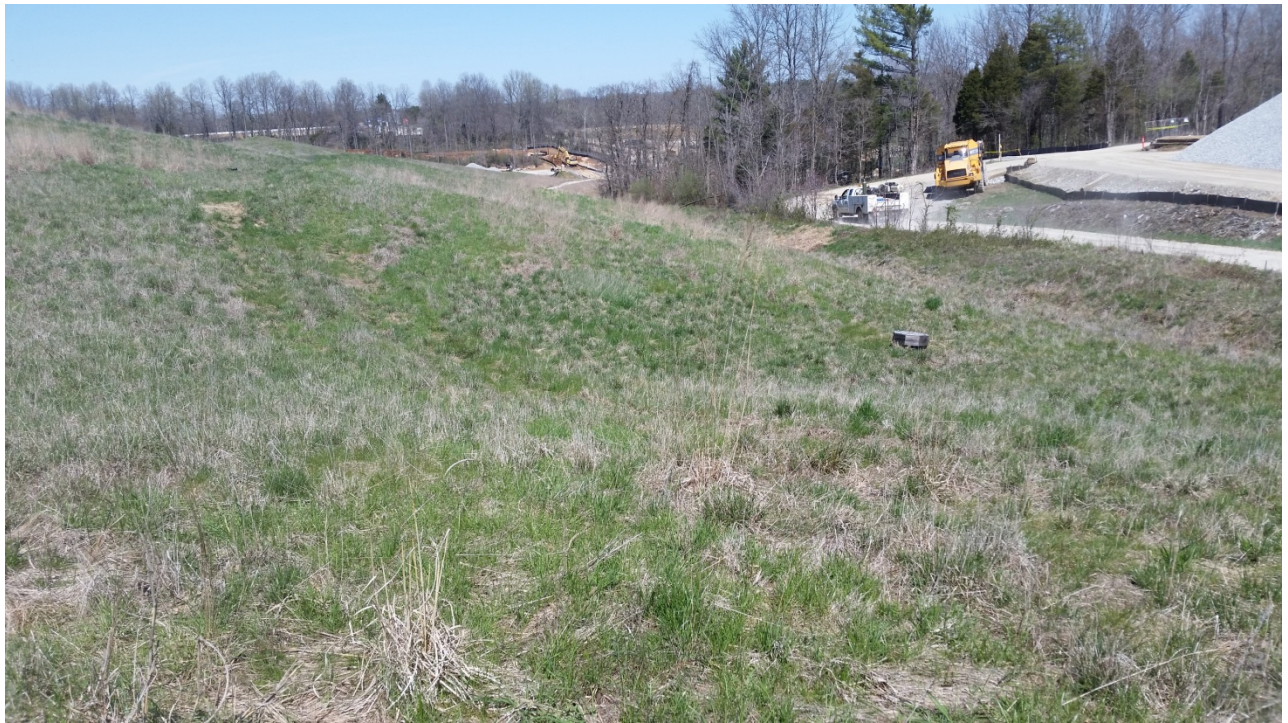
4. Light erosion was identified along EV4, EV5, and in ES6. These areas will be re-seeded this spring.
5. There are some erosion ruts along the east side of GM Drive, outside the cover system area adjacent to power poles. This does not appear to be due to any on-Site RCRA activities, but could have an impact on the liner system in the ditch. Work is still to be conducted on power

Photo 1: ES6 south of EV5 East Plant Area Cover facing North

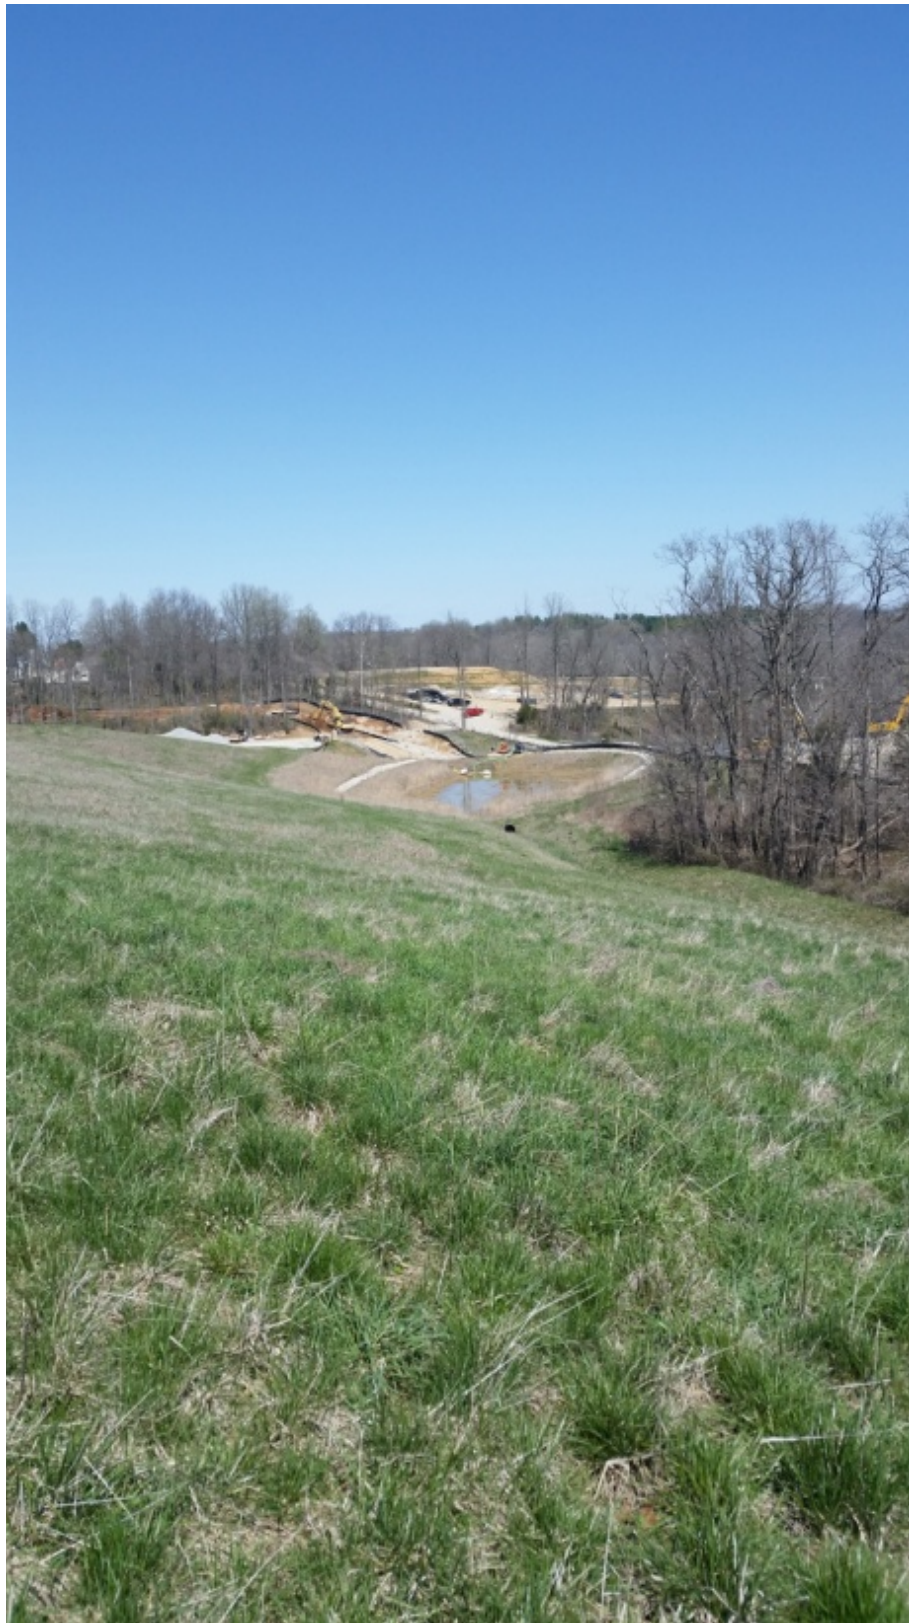
Photo 2: Looking north toward ES11 East Plant Area Cover

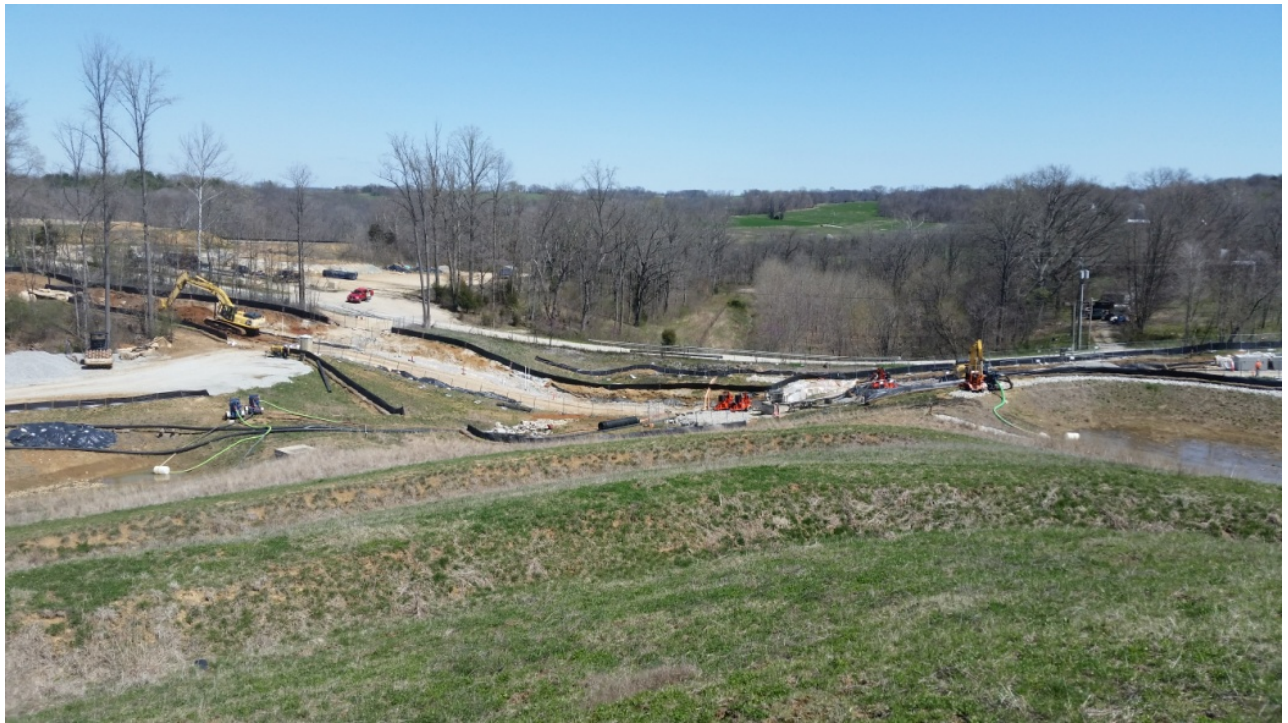
Photo 3: Looking Northeast along EV4 East Plant Area Cover toward ES7, ES8, ES10, and ES11

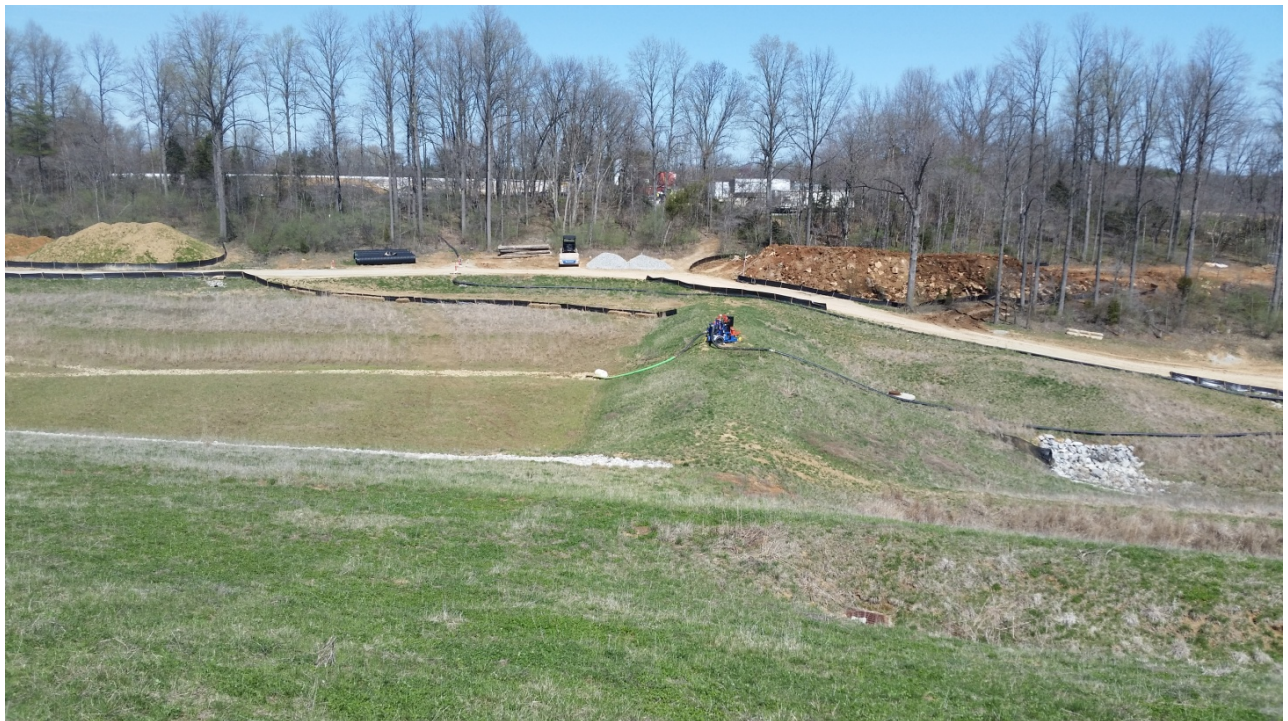
- EXPOSURE OF LINER				
	- EROSION	X		slight erosion	
	- LOCALIZED SETTLEMENT/SLUMPING				
	- PONDING OF WATER/DRAINAGE				
	- SIGNS OF BURROWING BY ANIMALS	X		mole holes

Photo 4: Looking Northeast along EV4 East Plant Area Cover

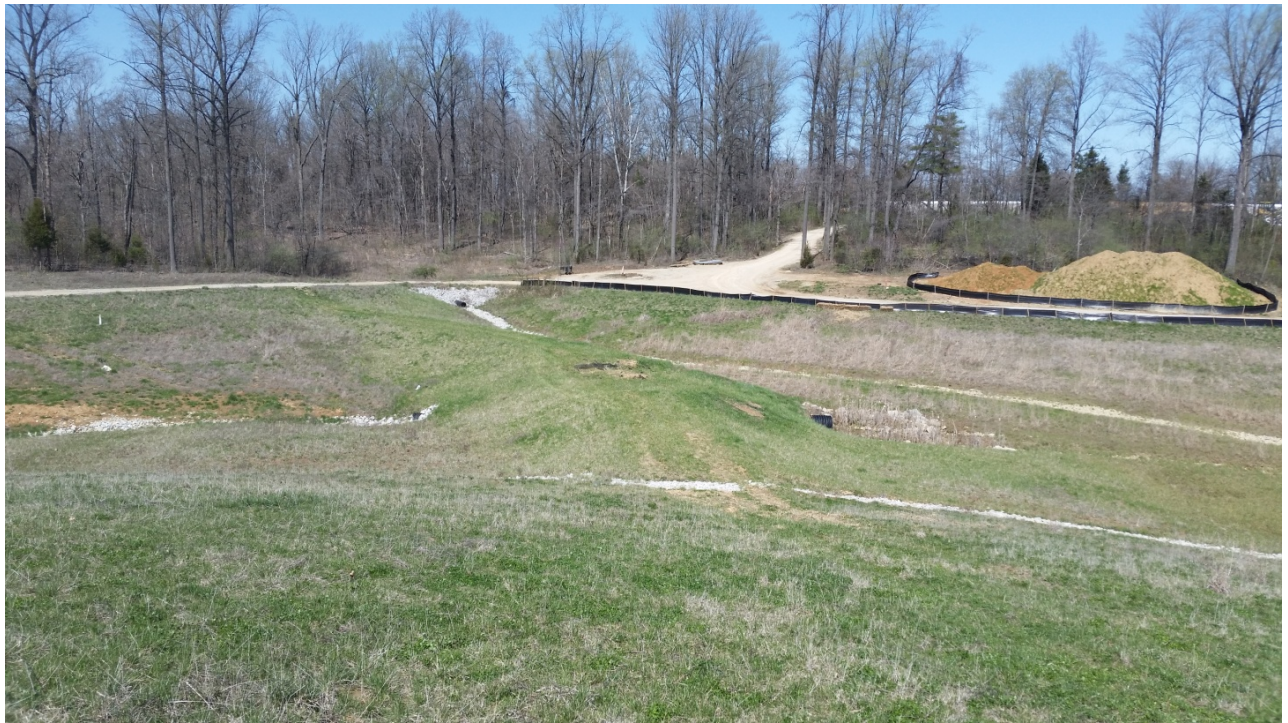
Photo 5: EV3 East Plant Area Cover facing North toward ES9 (Detention Basins 1 and 2) and ES6

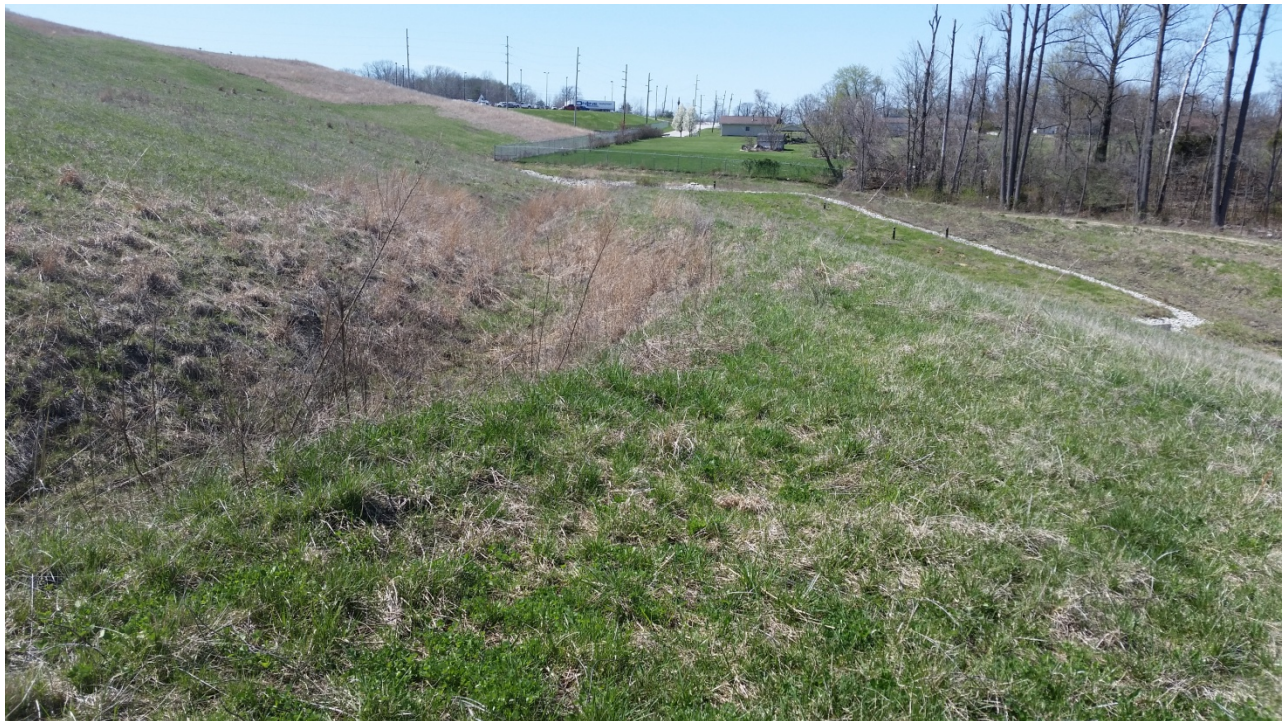
Photo 6: Looking along ES5 East Plant Area Cover facing West

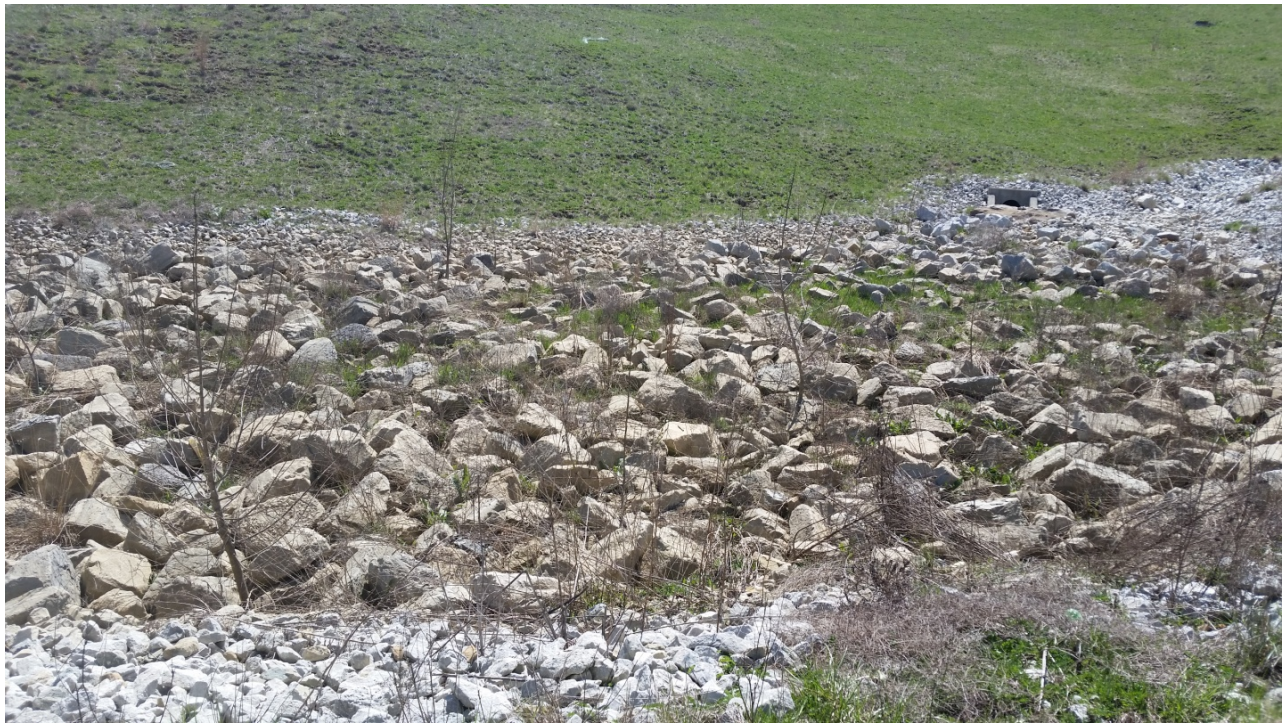
Photo 7: ES6 East Plant Area Cover facing South

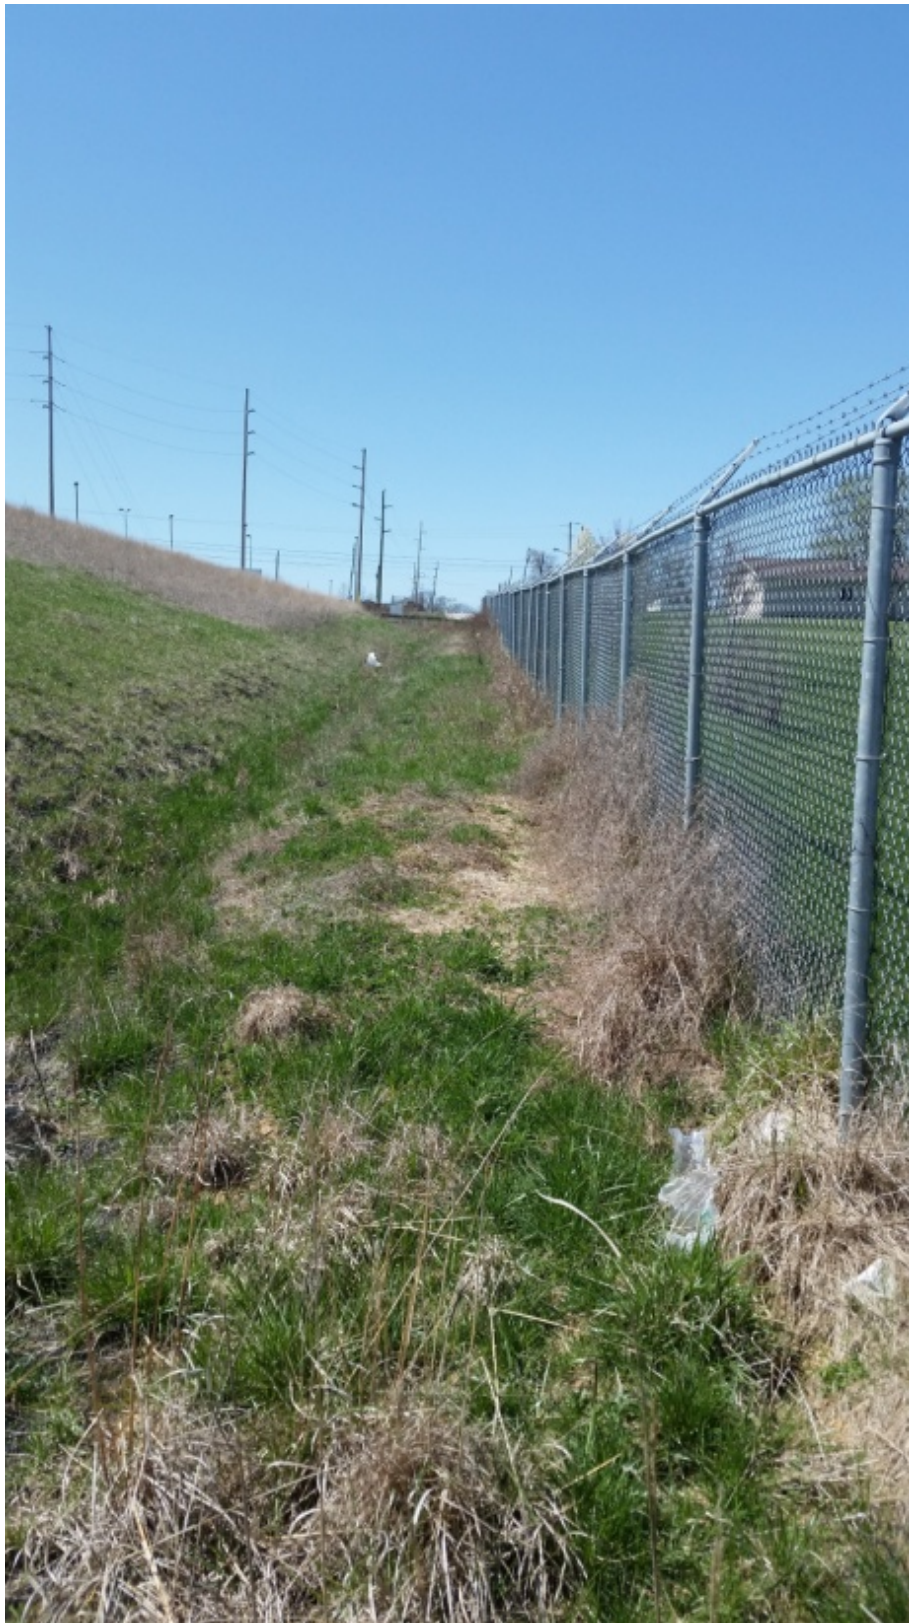
Photo 8: ES5 East Plant Area Cover, east of EV2, facing West

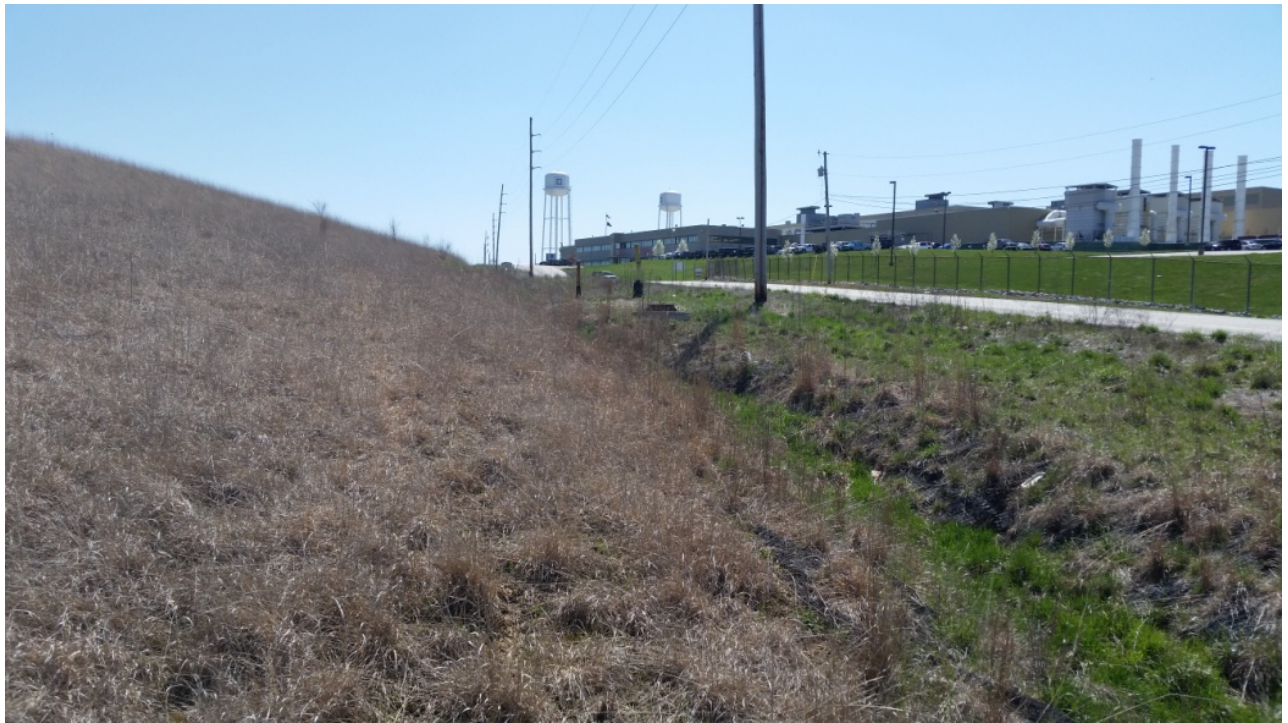
Photo 9: EV1 Vault Cover System, looking South along ES3

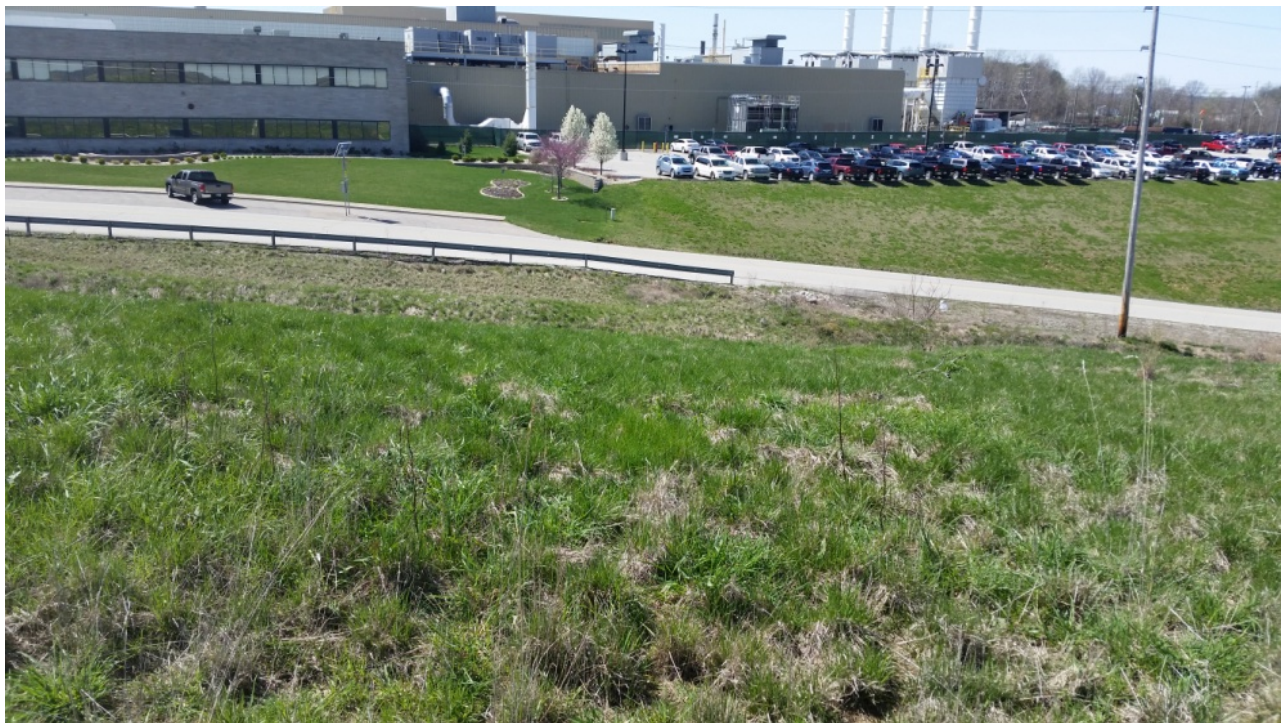
Photo 10: Looking West at WV1 West Plant Area Cover System

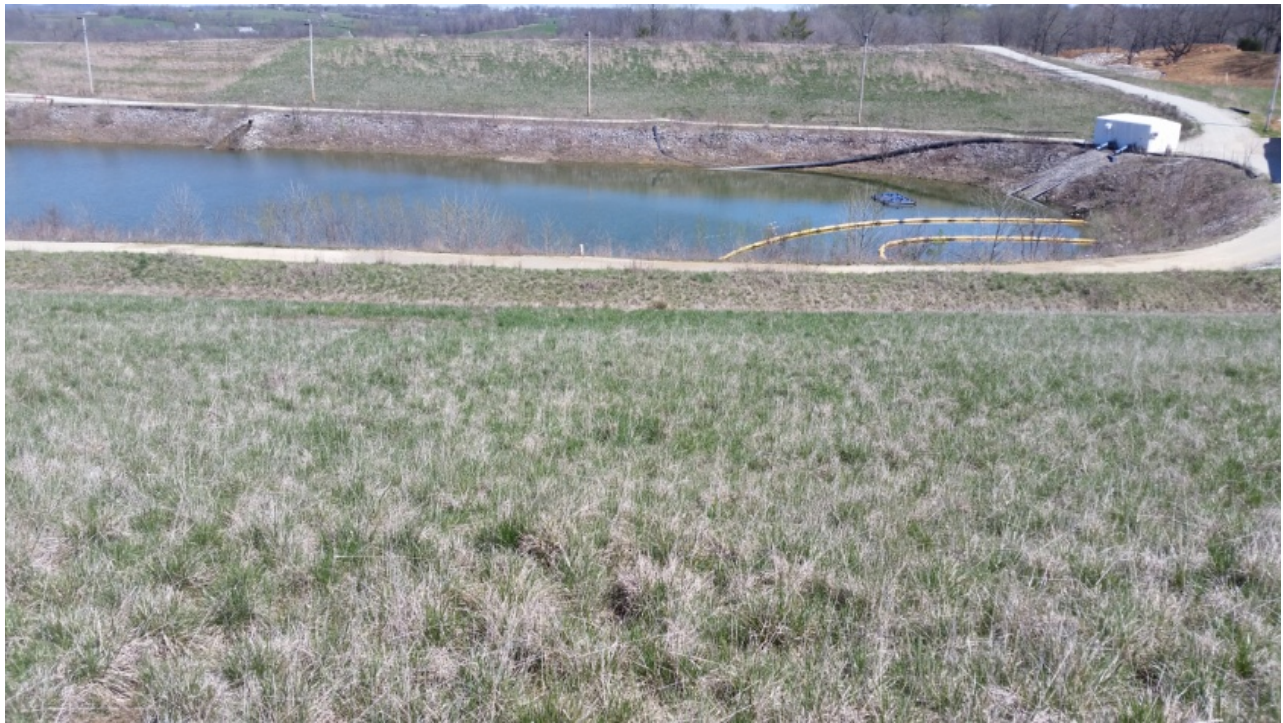
Photo 11: Facing East toward ES1 East Plant Area Cover

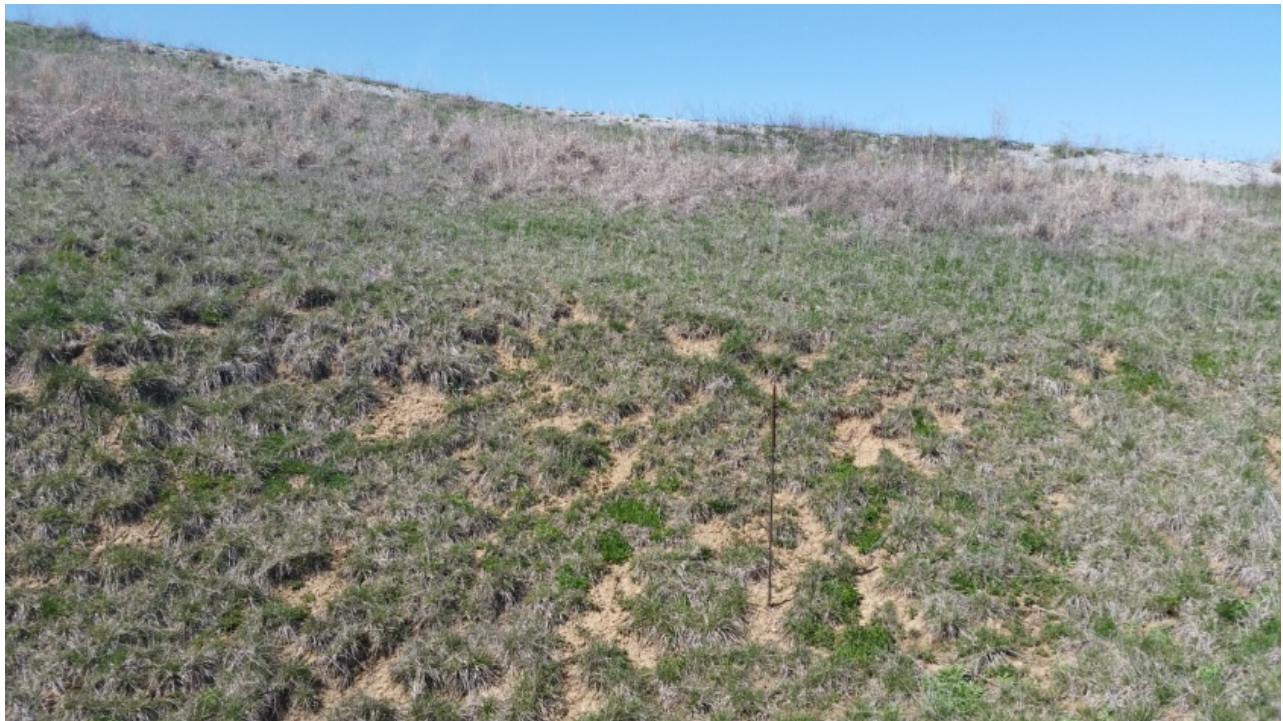
1. Weeds or clover growth was noted at most Transects in the East Plant Area and the West Plant Area. This is also typically accompanied by some bare patches.

Photo 12: Bare spots near ES2 East Plant Area Cover System facing West

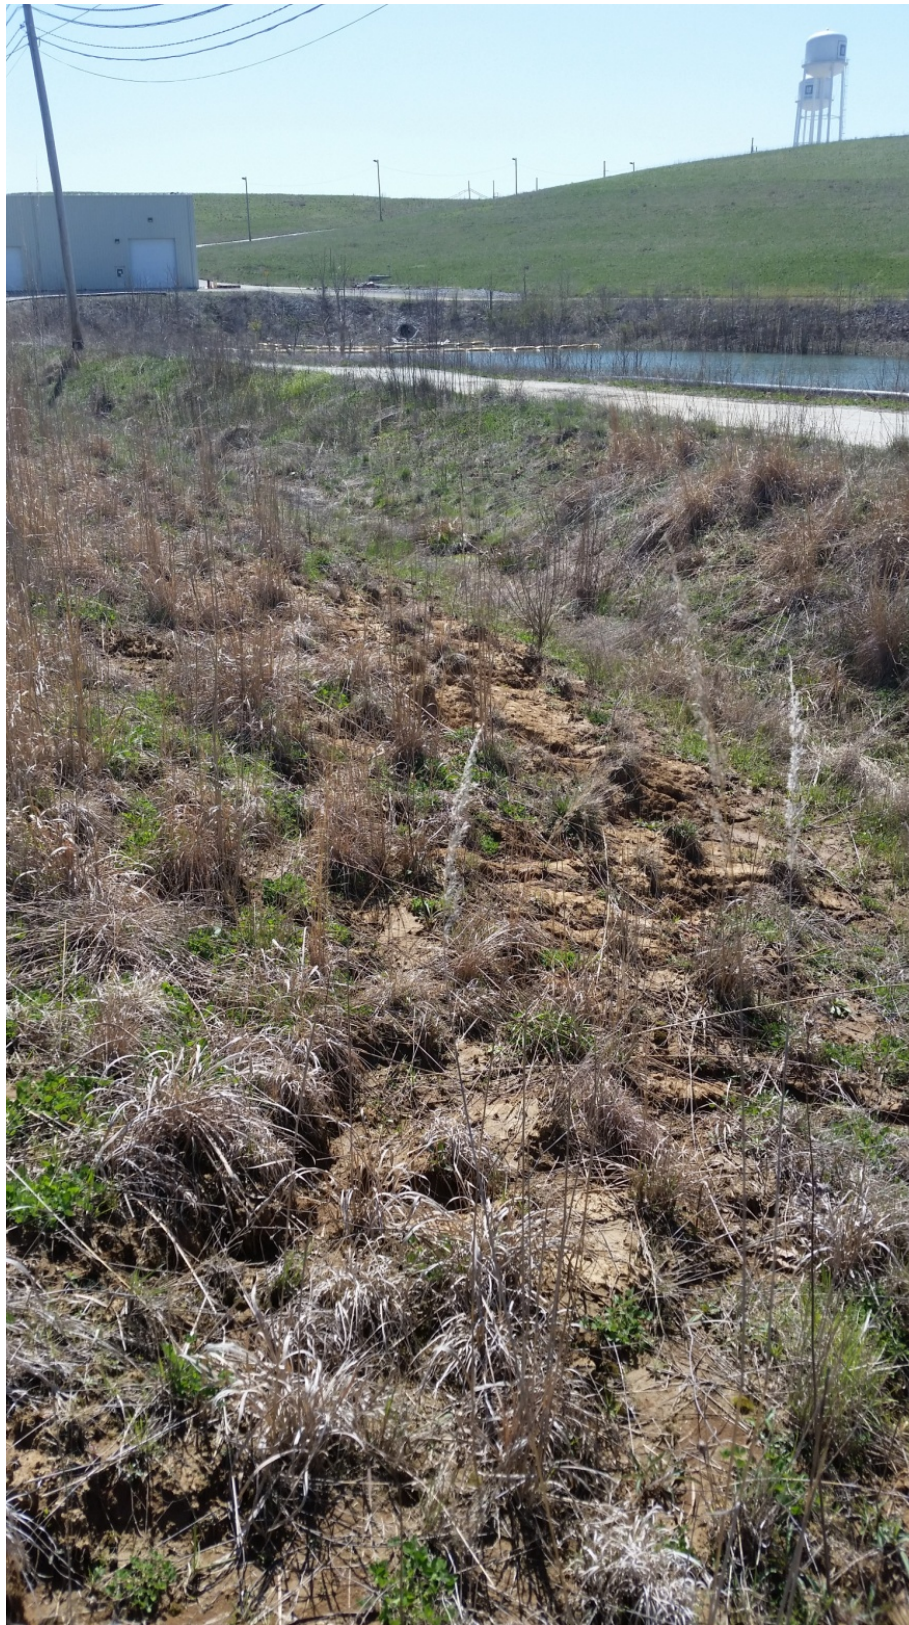
Photo 13: Weed growth and bare spots along ES1 East Plant Area Cover System facing South

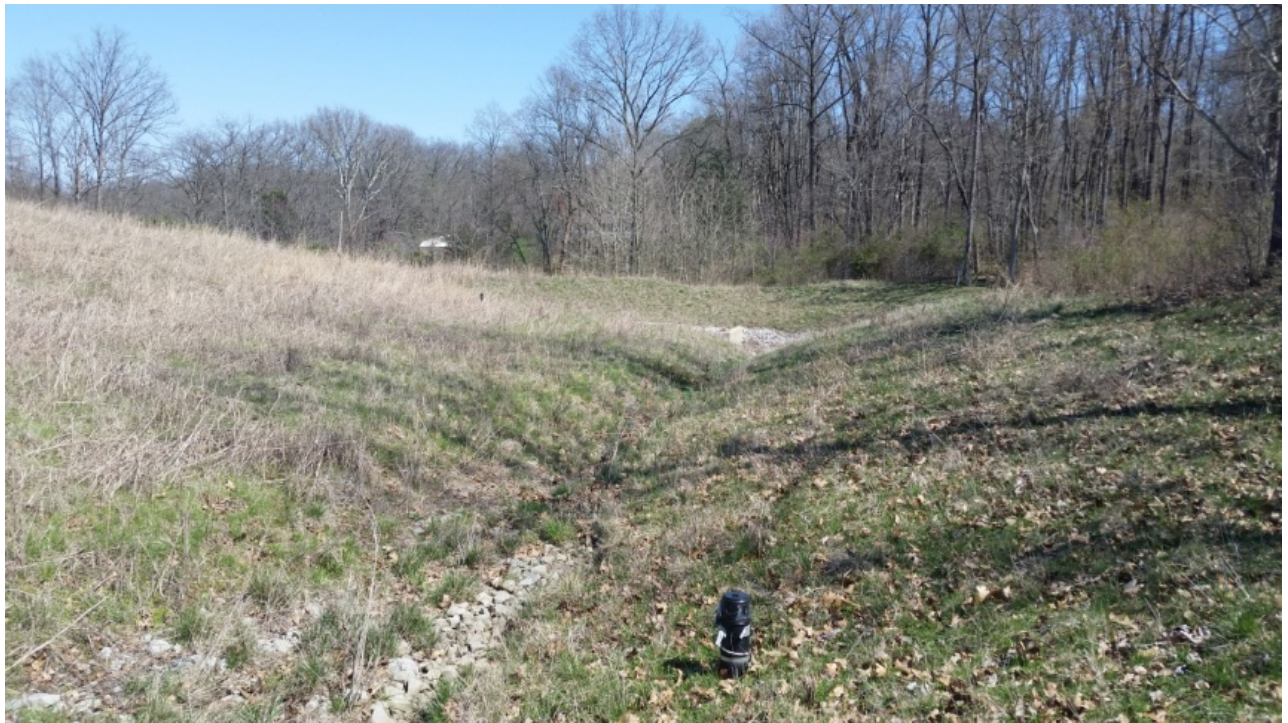
Photo 14: EV8 East Plant Area cover (Parcel 205) facing East

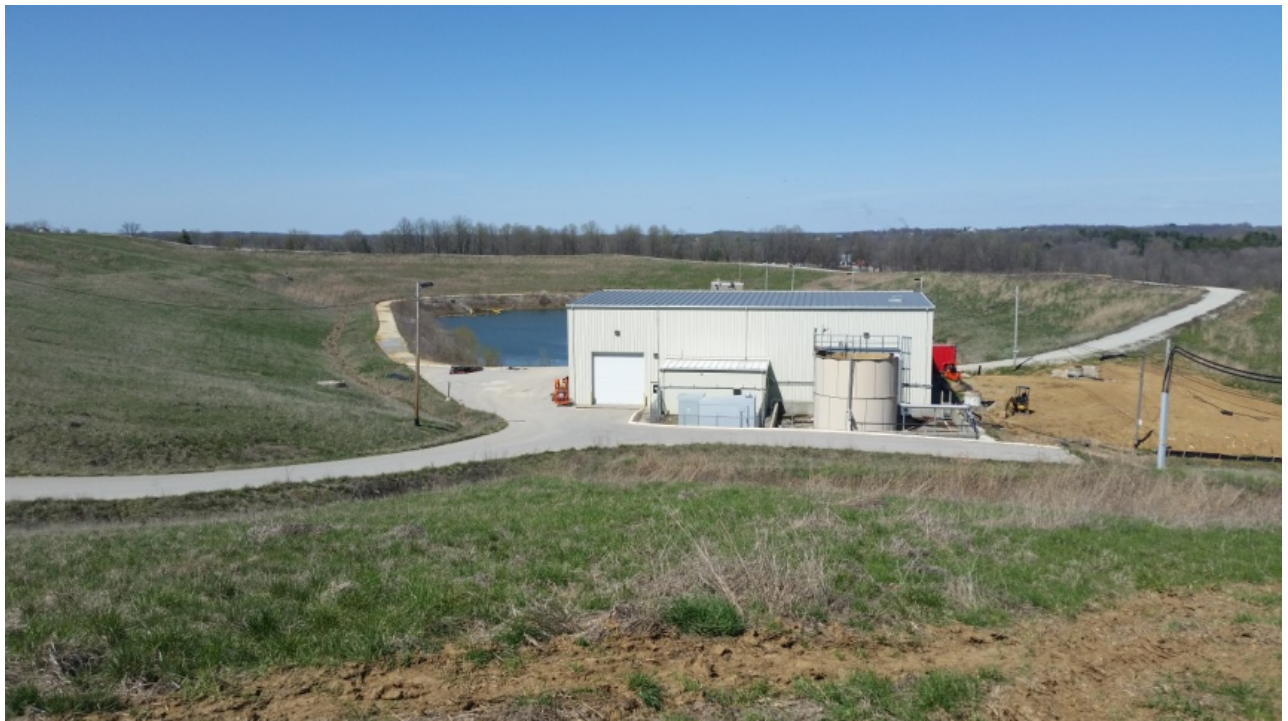
Photo 15: ES12 East Plant Area Cover System looking North

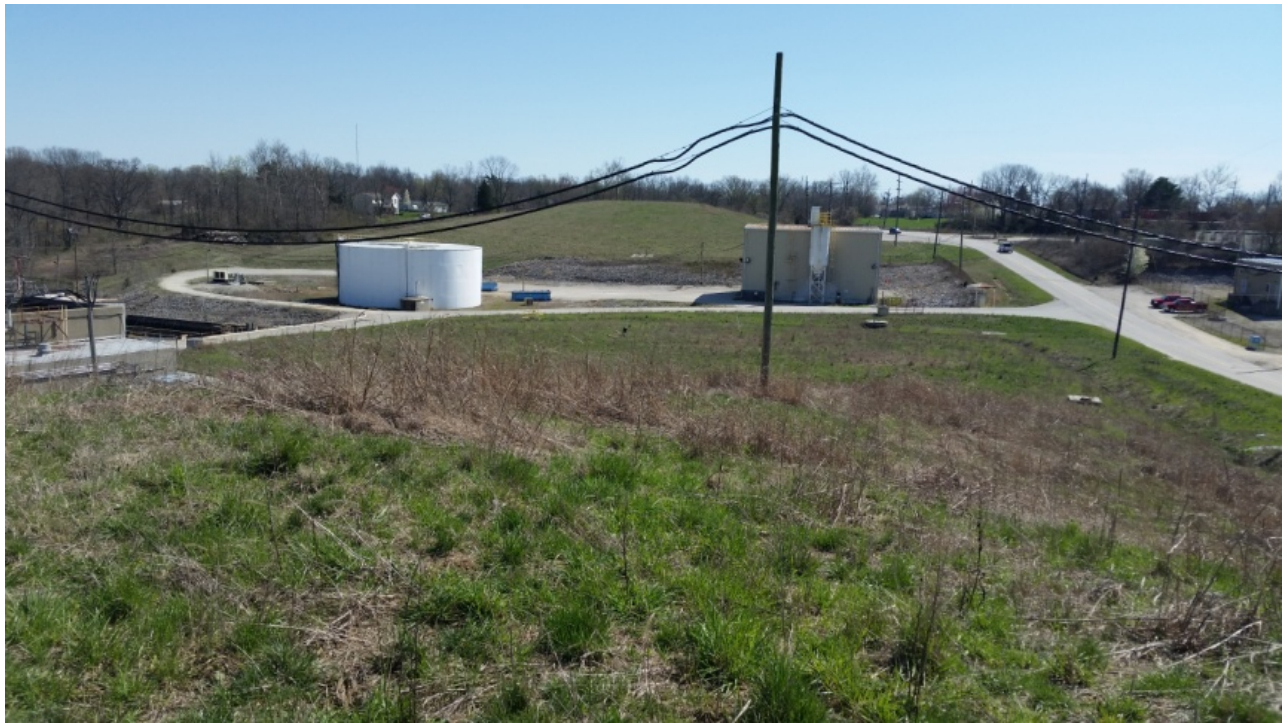
Photo 16: Looking South toward EA2 East Plant Area Cover at EV7

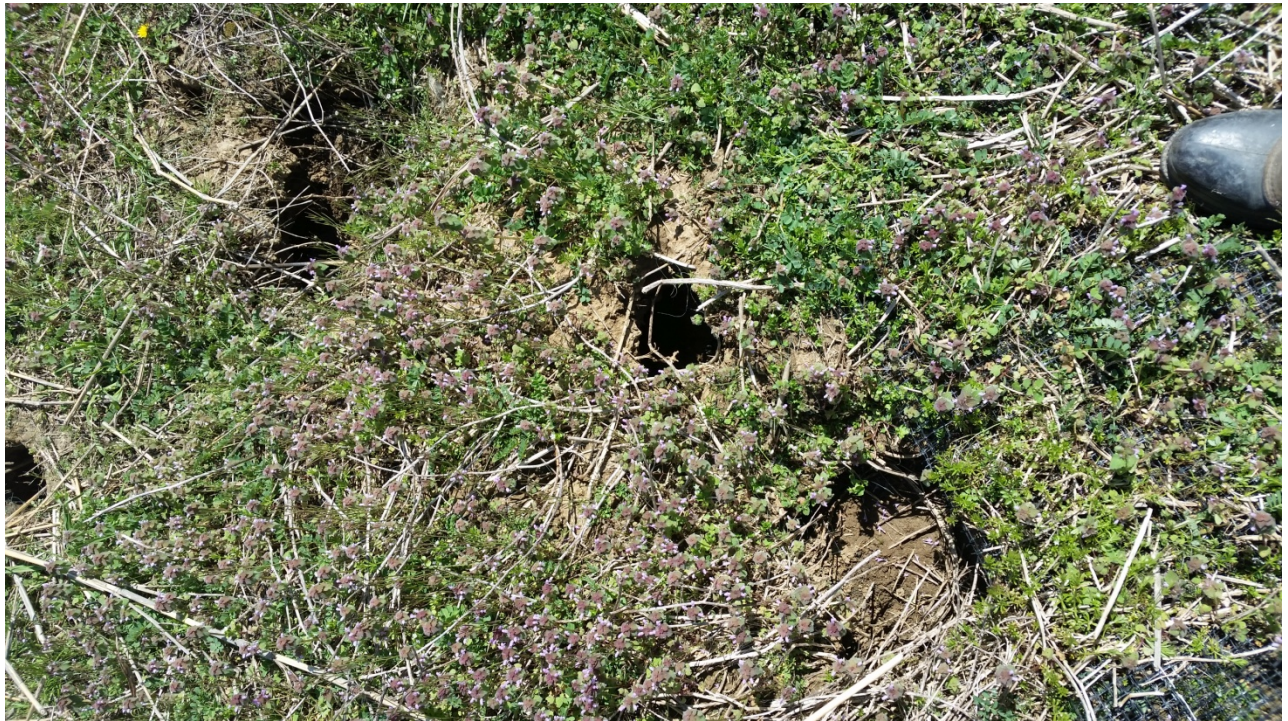
- EXPOSURE OF LINER				
	- EROSION				
	- LOCALIZED SETTLEMENT/SLUMPING				
	- PONDING OF WATER/DRAINAGE				
	- SIGNS OF BURROWING BY ANIMALS	X		mole holes

Photo 17: Evidence of burrowing at EV7 East Plant Area Cover

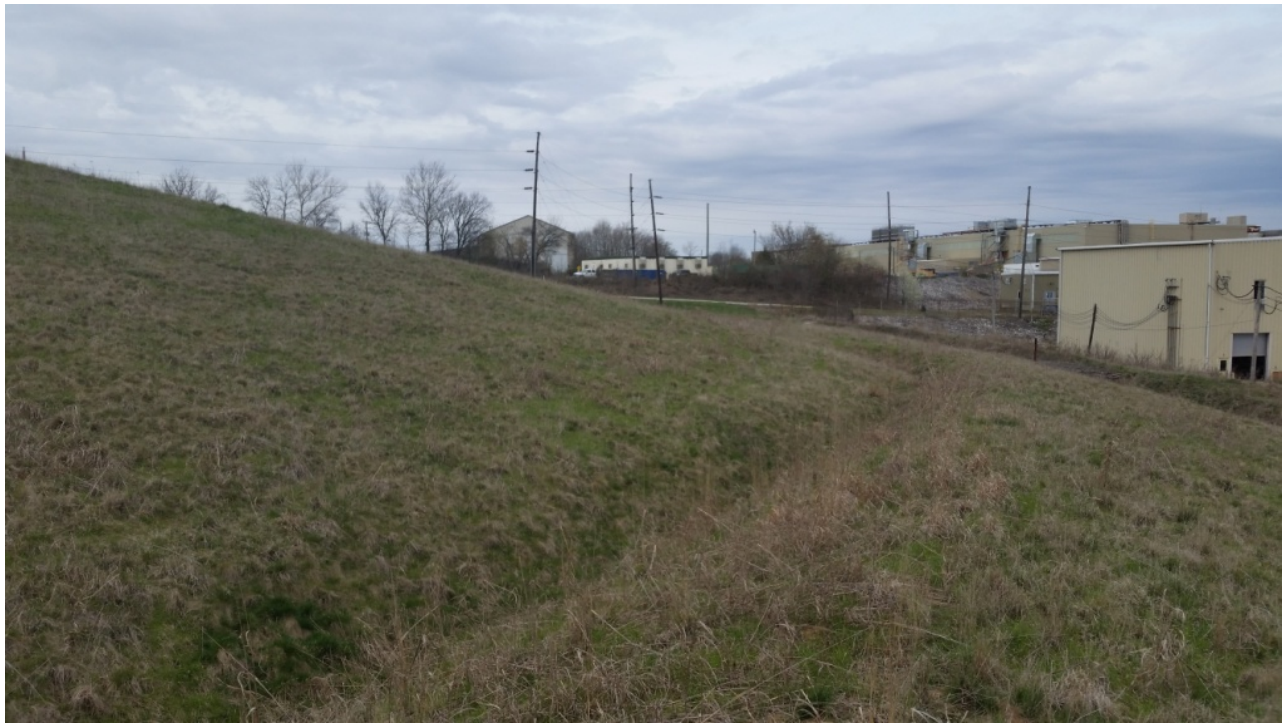
Photo 18: EV9 East Plant Area Cover System at ES14

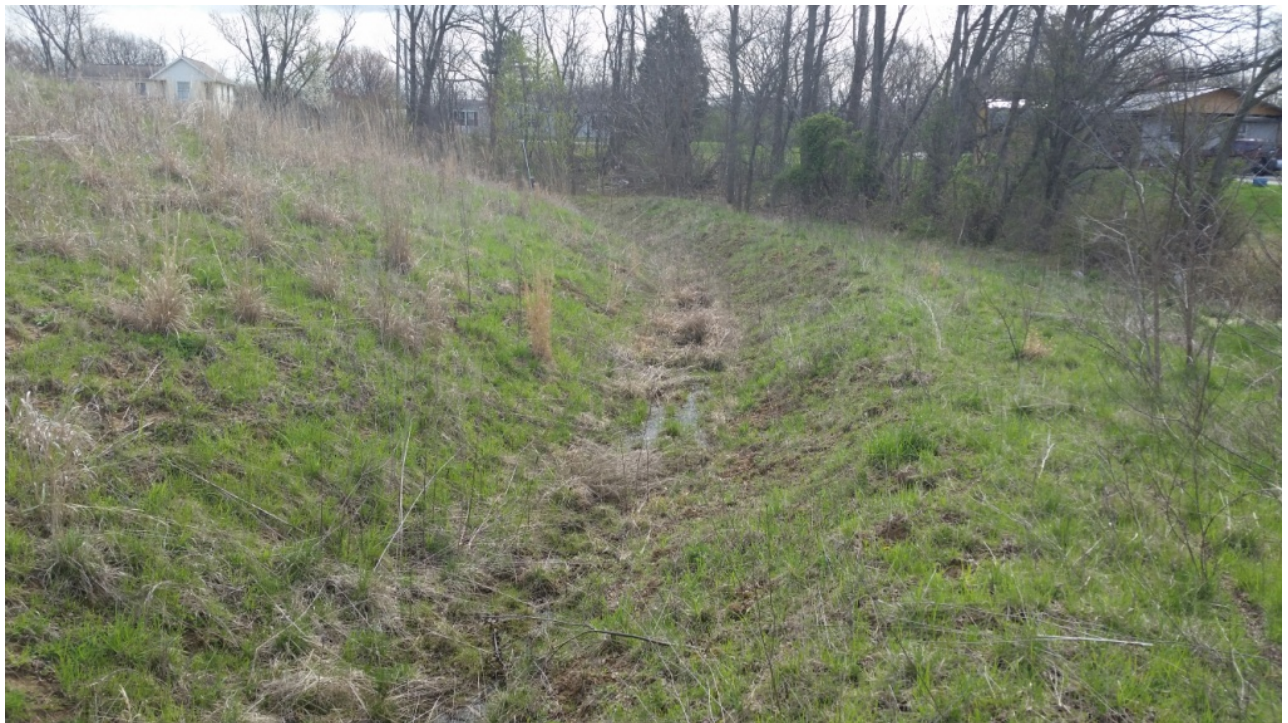
Photo 19: EV9 (Parcel 201) East Plant Area Cover looking East
