Second Quarter 2016 Progress Report 61

GM CET – Bedford Facility
105 GM Drive
Bedford, Indiana
EPA ID# IND006036099
AOC Docket No. RCRA-05-2014-0011

651 Colby Drive Waterloo Ontario N2V 1C2 Canada
013968 | Report No 397 | July 15, 2016

Second Quarter 2016 Cover System Inspection: Field Logs, Transect Figures, and Photograph Log

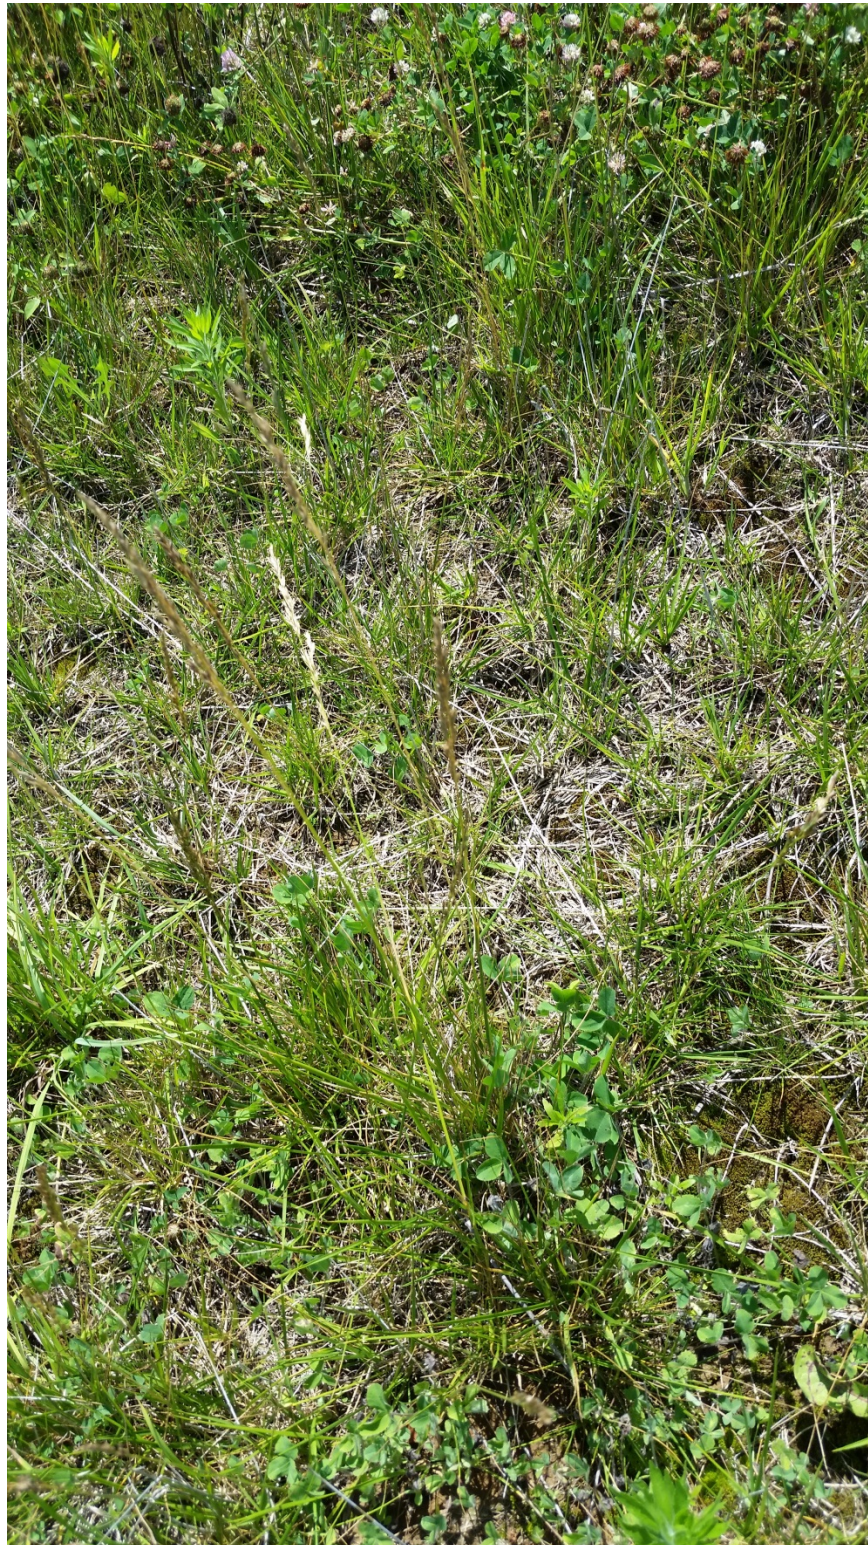
4. Light erosion was identified again along EV4, EV5, and in ES6. These areas will be monitored and re-seeded again in the third or fourth quarter during the less dry season to promote new growth.

Photo 5: Patchy vegetative growth ES6 East Plant Area Cover.

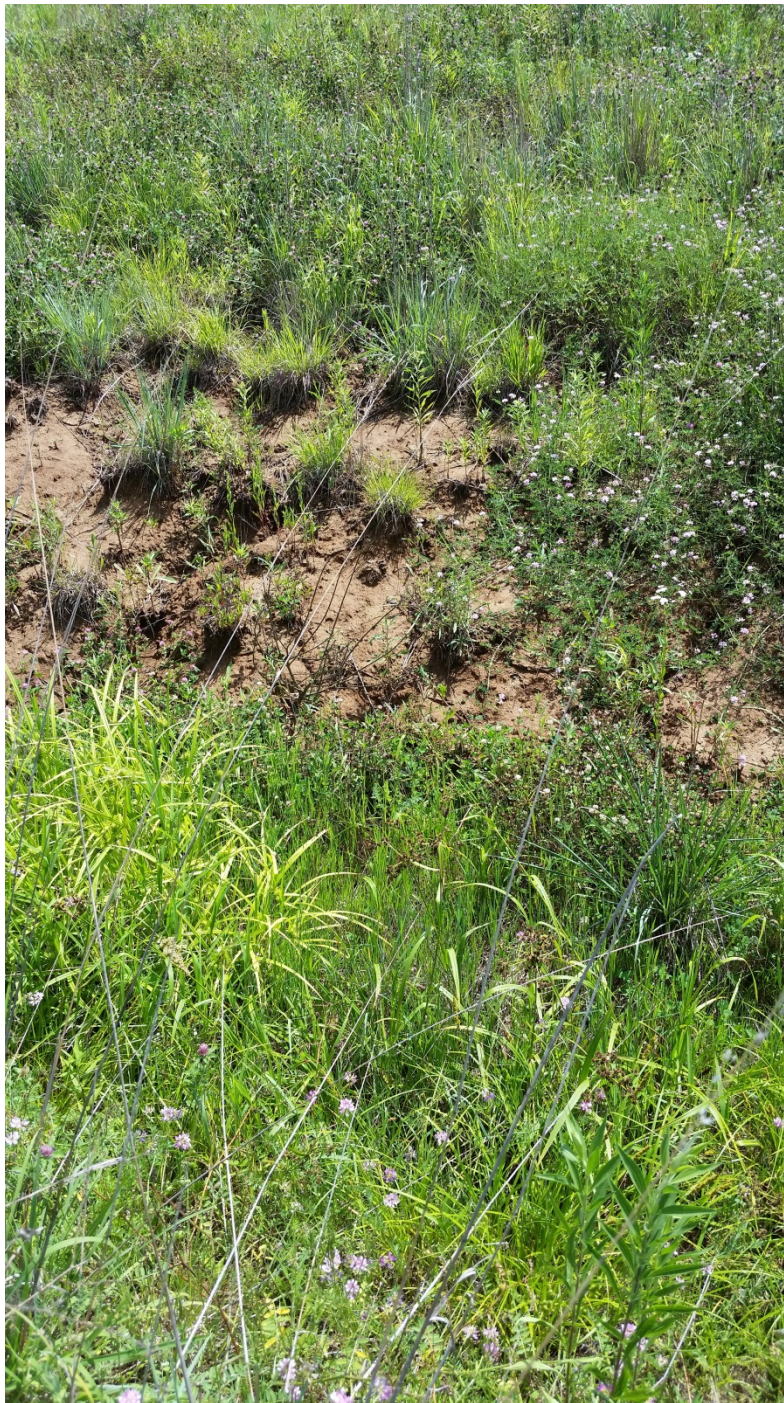
Photo 8: Patchy vegetative growth at EV5.

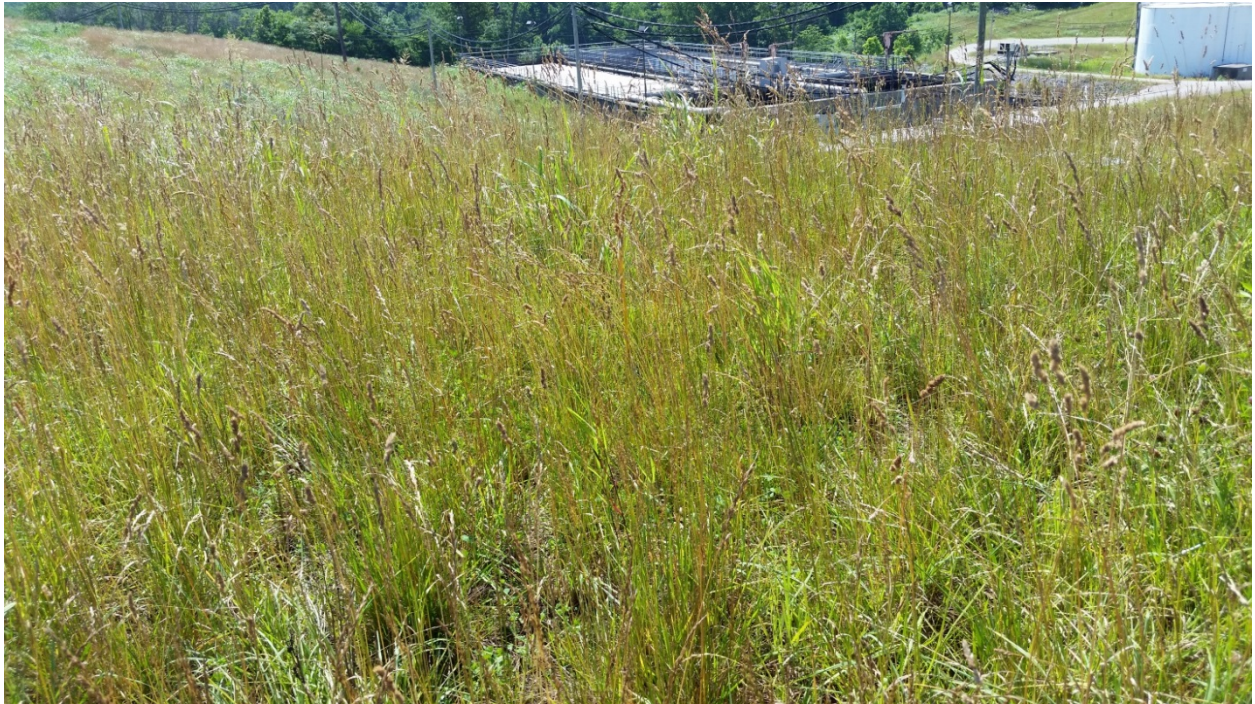
Photo 10: EV6 East Plant Area Cover facing southeast.

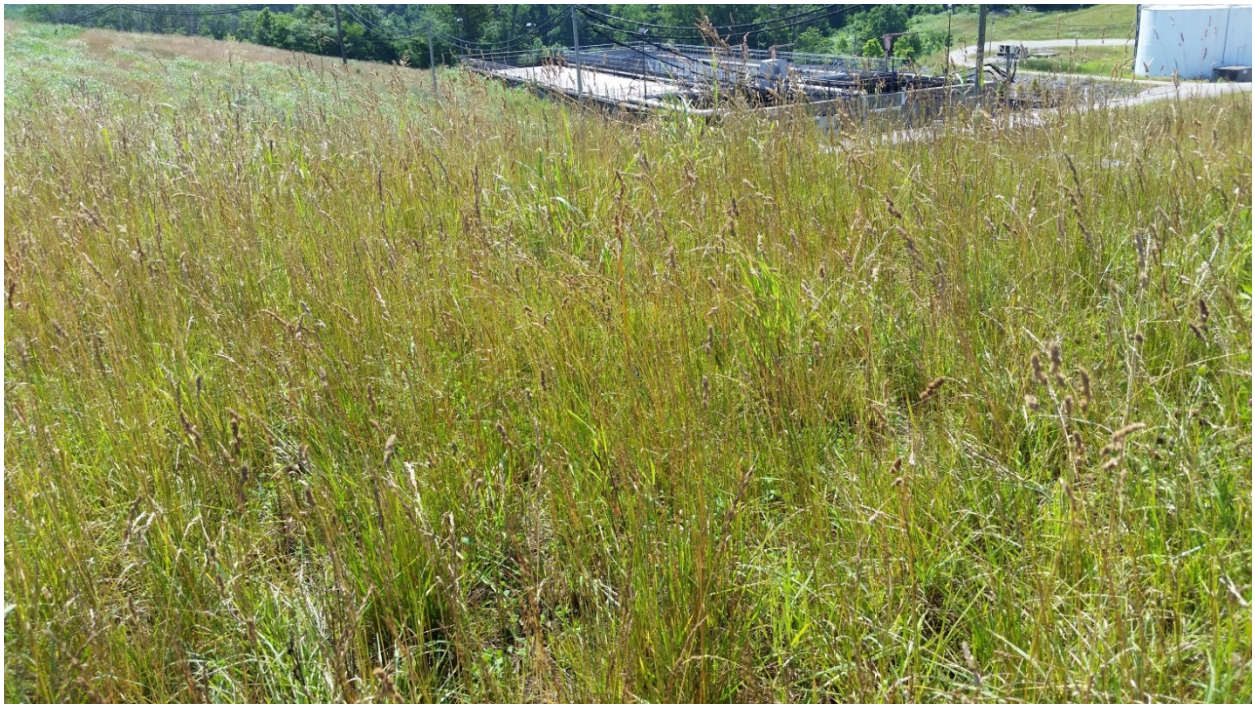
Photo 11: EV6 East Plant Area cover facing southeast.

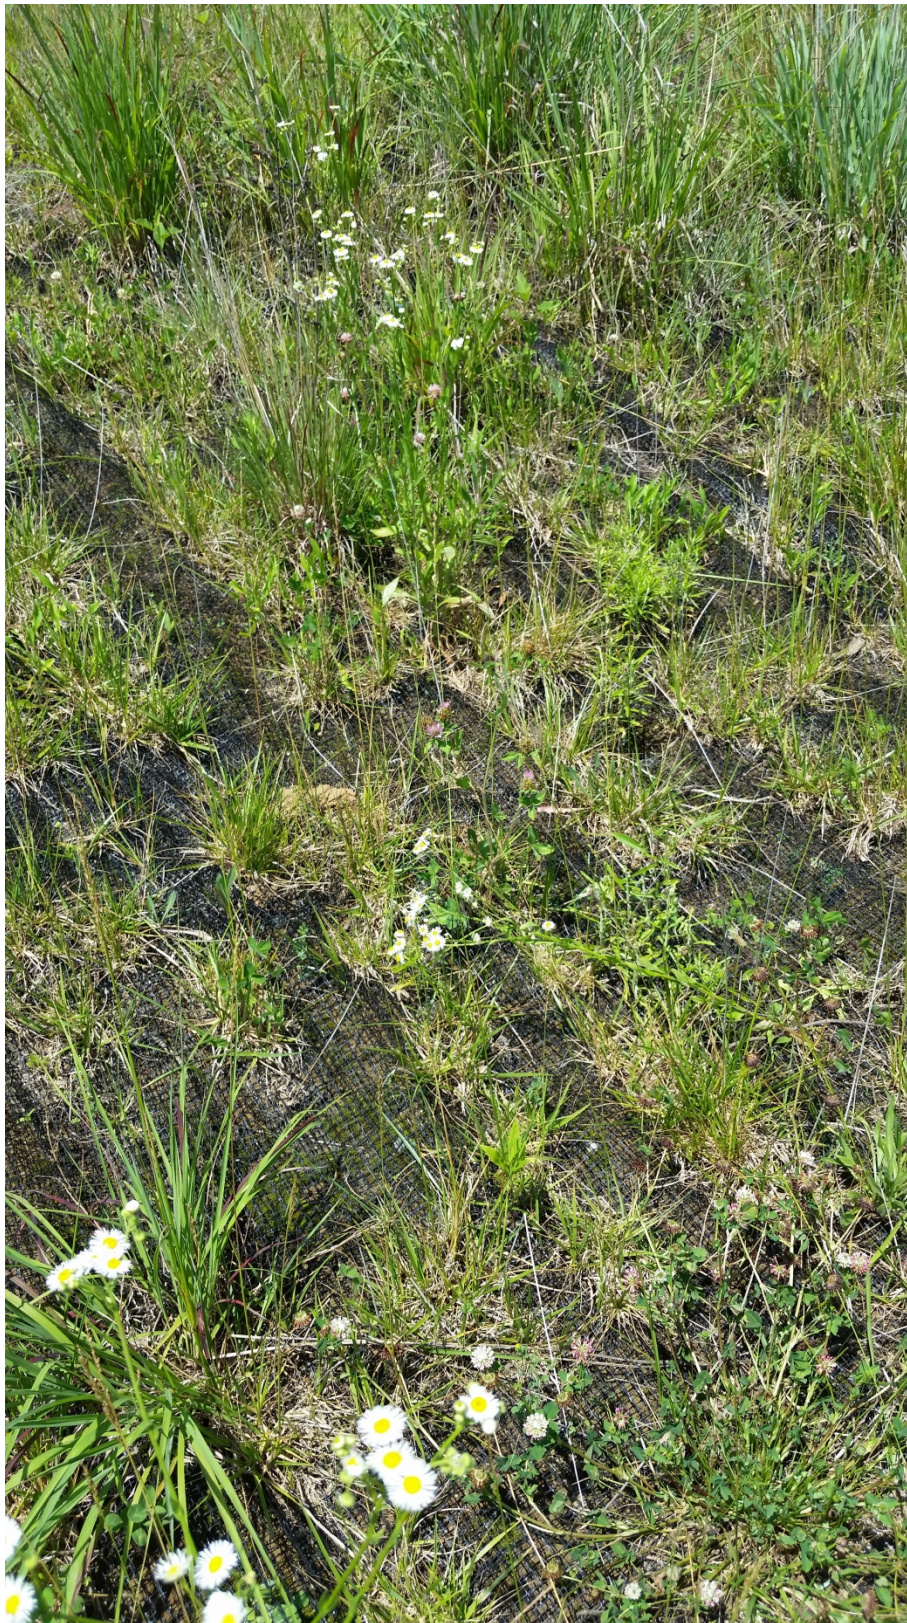
1. Weeds or clover growth was noted at most Transects in the East Plant Area and the West Plant Area, which is also typically accompanied by some bare patches.

Photo 12: Weed growth and patchy spots along ES1 East Plant Area
Cover System facing South.

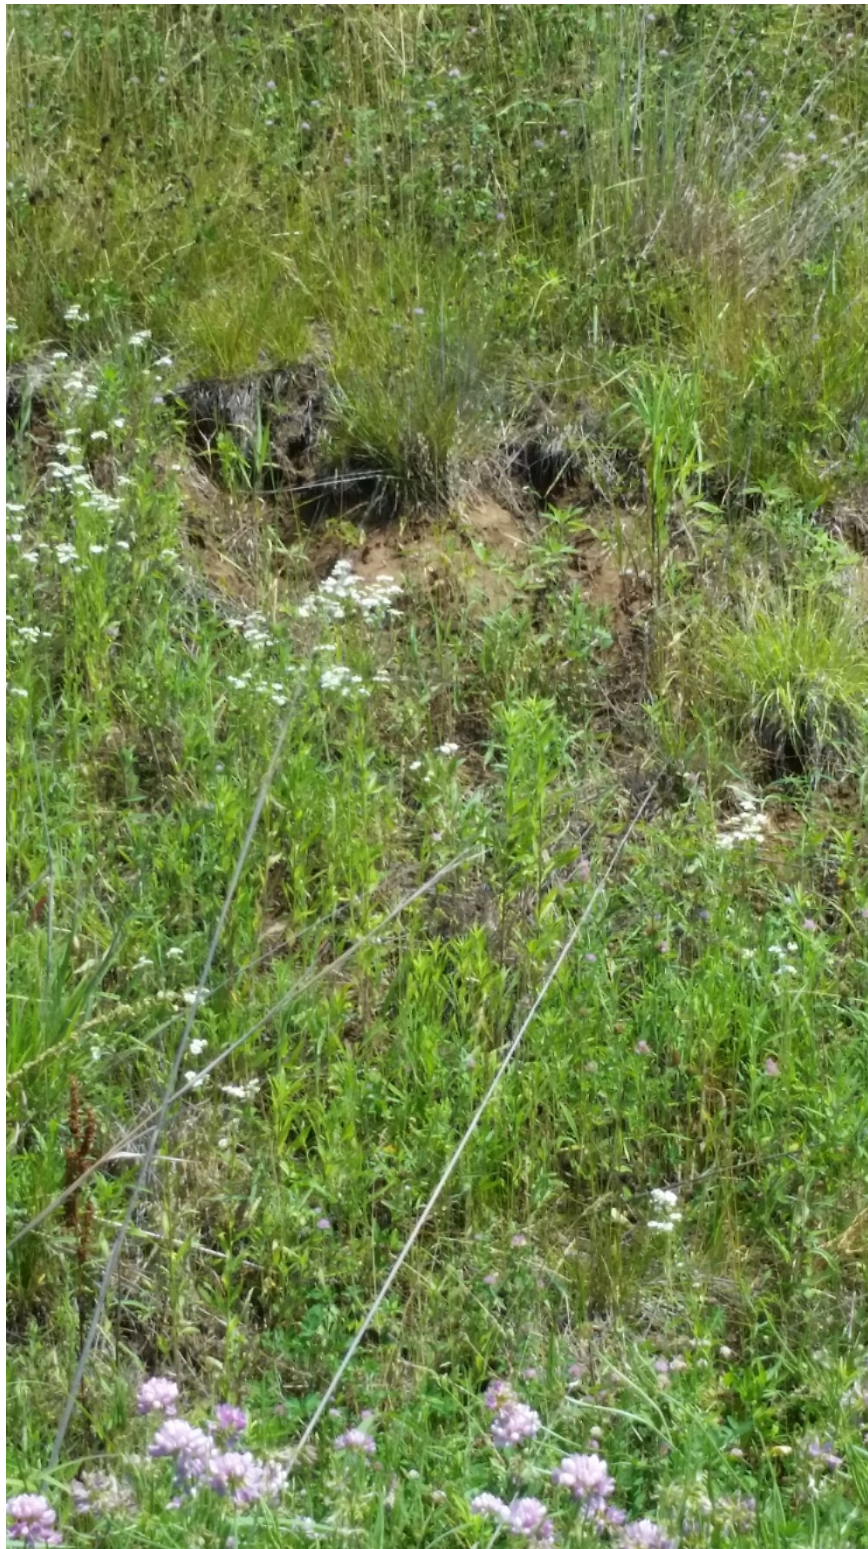
3. There is also evidence of larger burrowing animals, which is believed to be attributed to woodchucks, near EV6 during the fourth quarter 2015 inspection. Indiana Department of Natural Resources (IDNR) has been consulted on identifying, and subsequently live trapping and relocating the animal(s), if necessary. Traps were placed this spring and checked daily while deployed with no success. It is thought the animals may have moved on. Traps will be redeployed in the third quarter to confirm. Soil and vegetation repairs will be made as necessary.

Photo 17: Woodchuck of burrowing at EV7 East Plant Area Cover.
