Re: RCRA Corrective Action Administrative Order on Consent (AOC) Pilot Perimeter Groundwater Collection Trench Construction Certification Report GM GPS - Bedford Facility, IND 006036099, Docket No. RCRA 05-2014-0011 Bedford, Indiana

Construction Certification Report

Pilot Perimeter Groundwater Trench Collection System

General Motors LLC

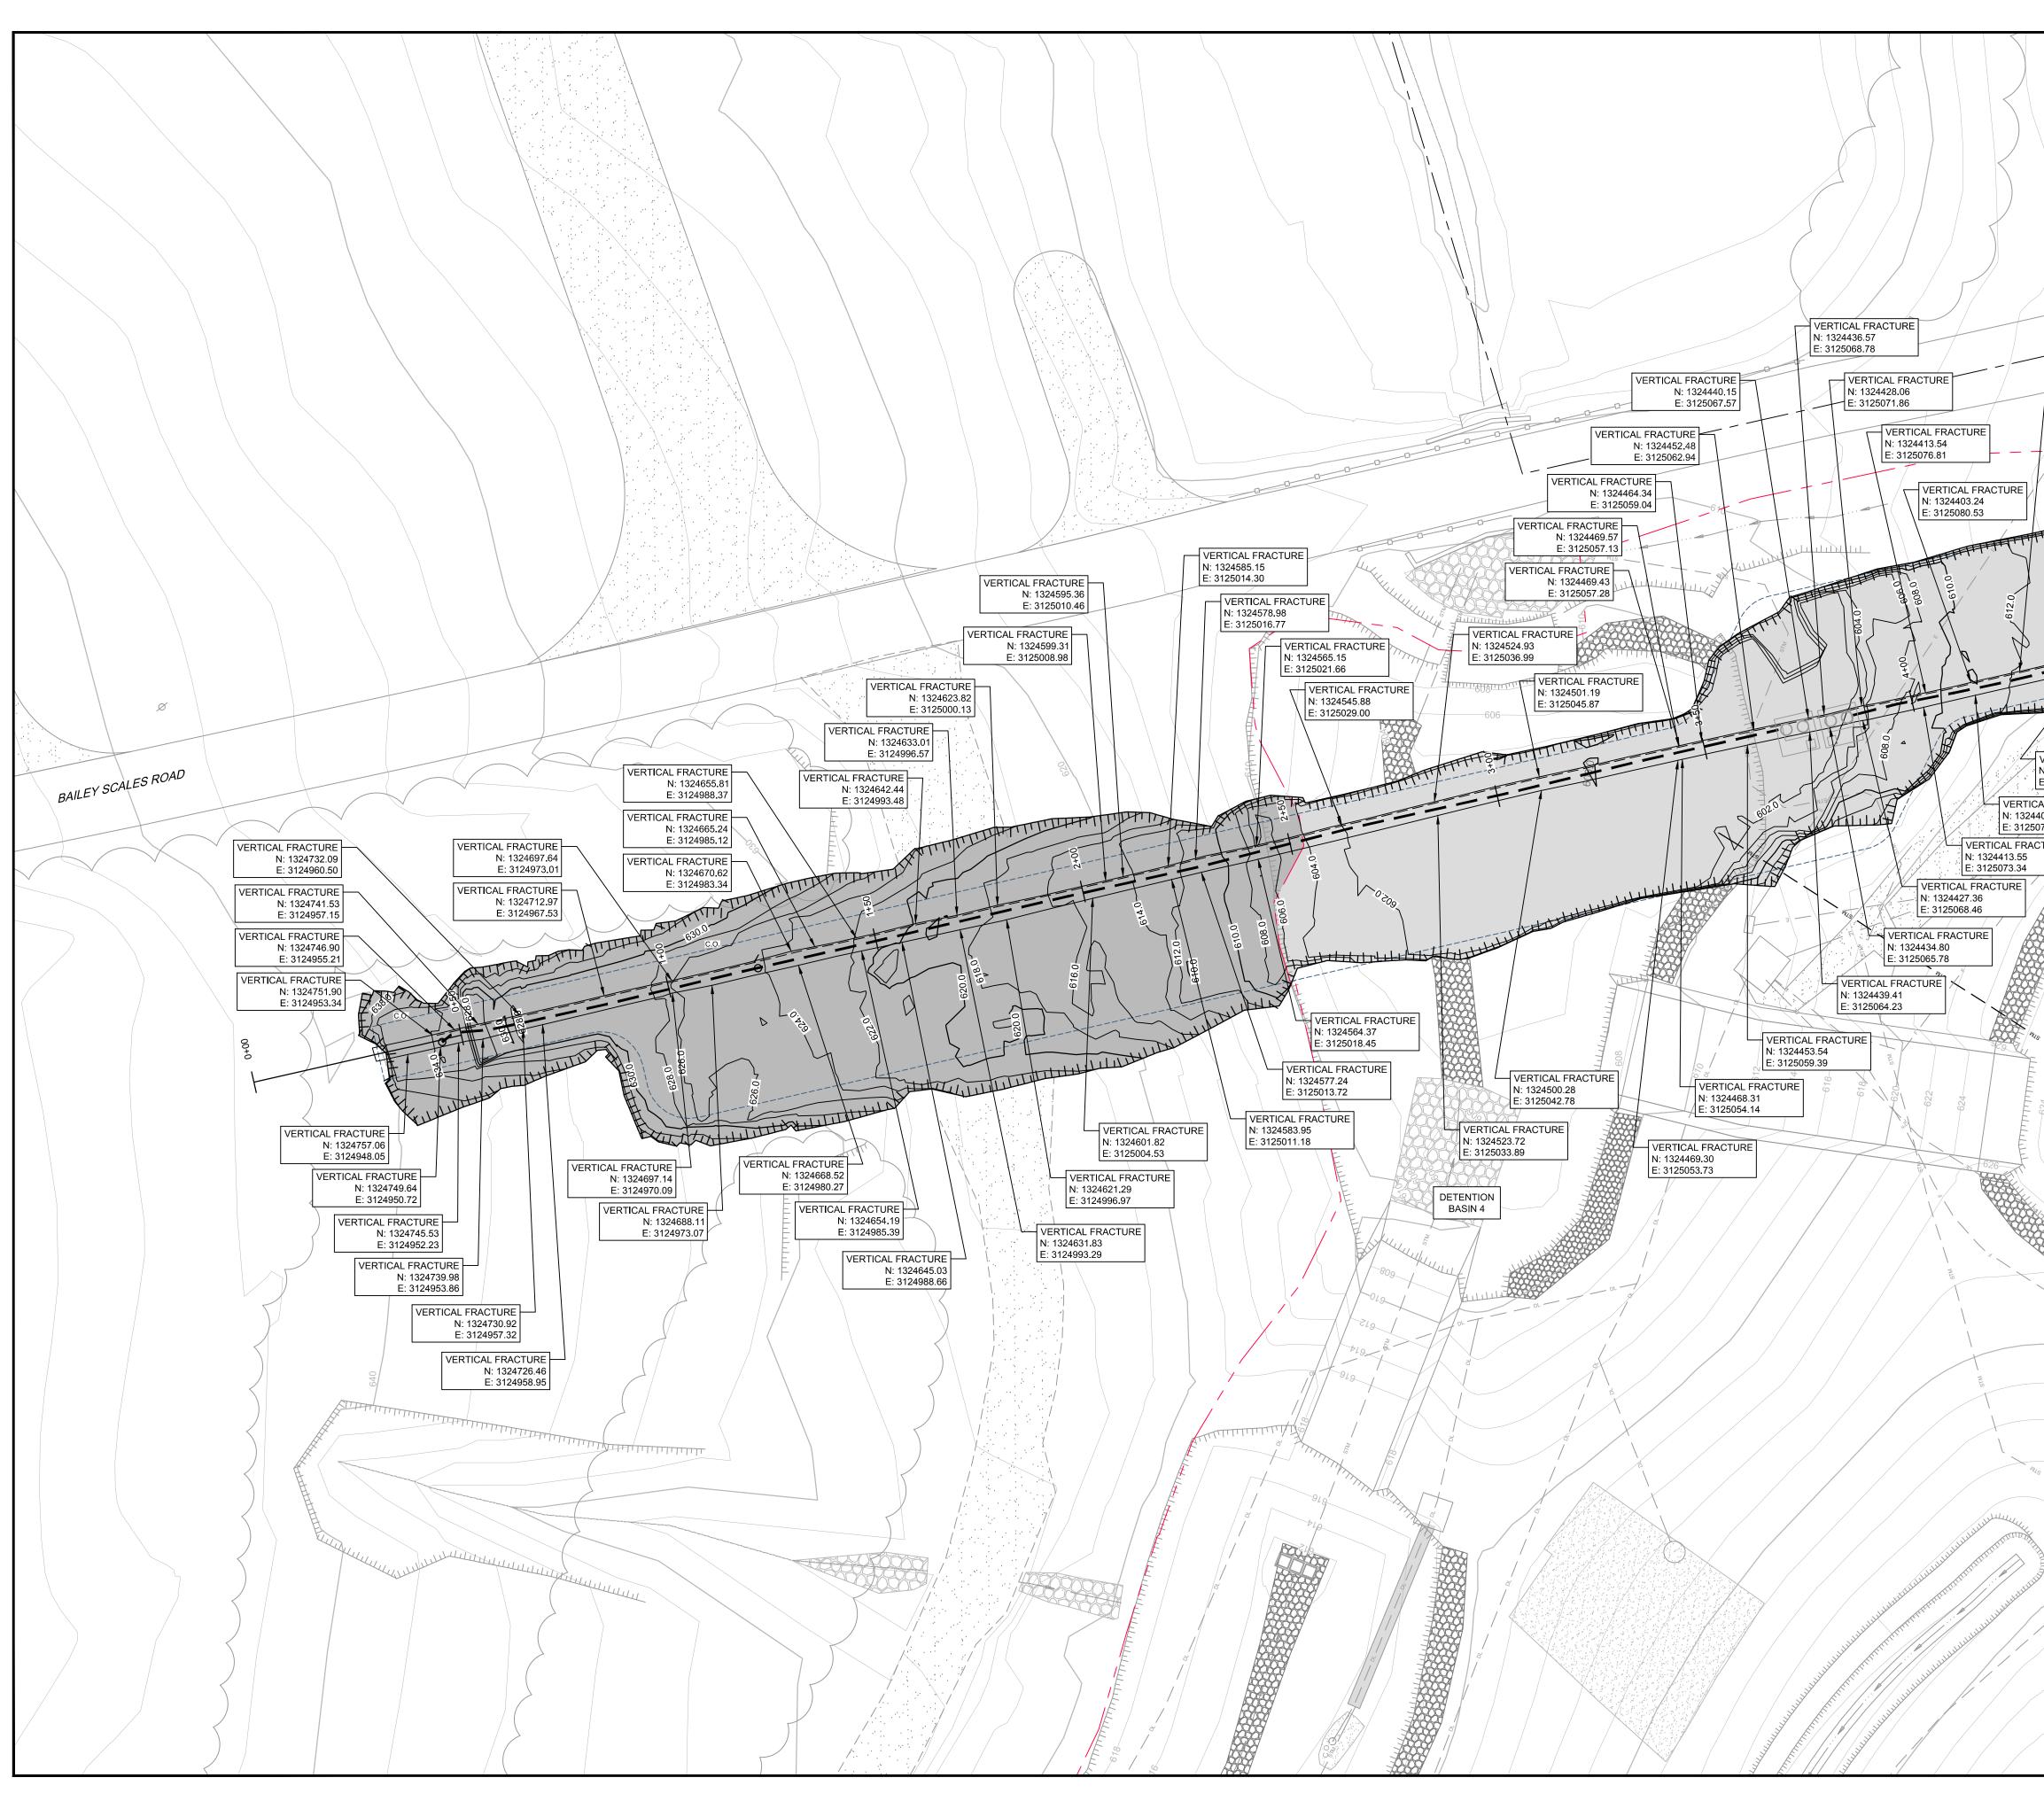
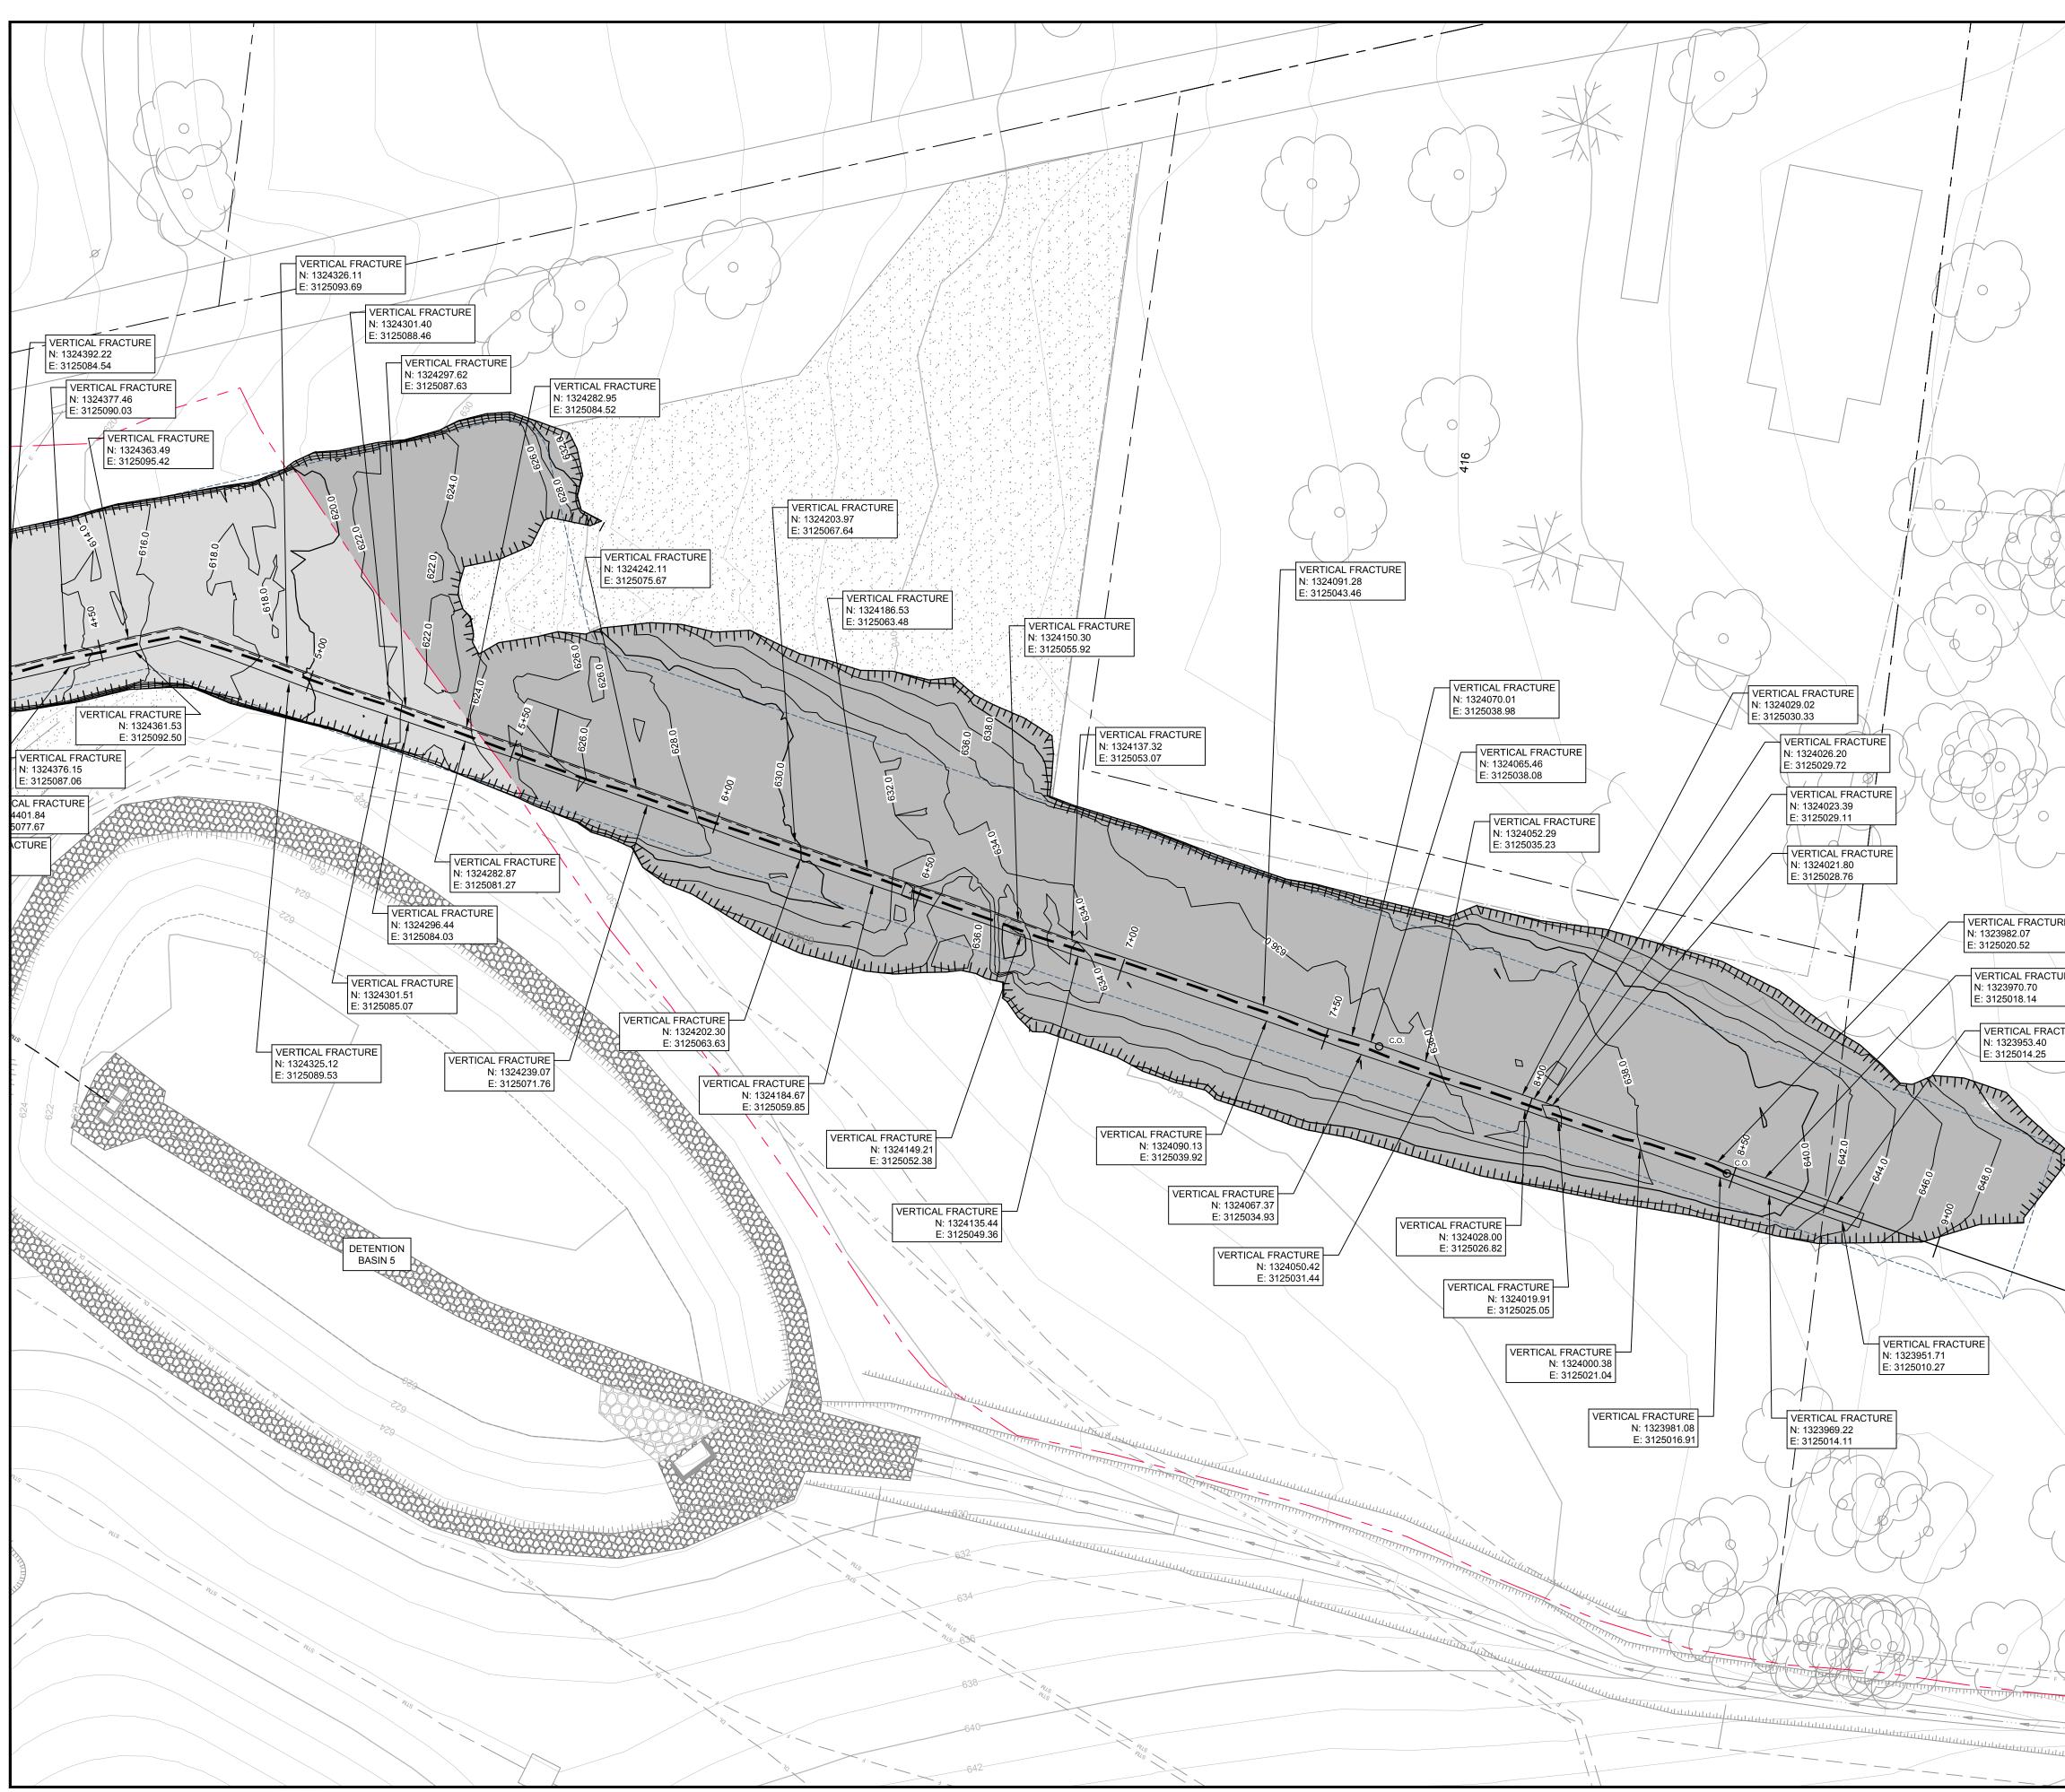
Vertical fractures located at Stations 1+00 (VF9), 1+55 (VF15), 2+00 (VF19), 2+20 (VF22), 8+05 (VF55), and 8+10 (VF56) were identified as water bearing fractures. The majority of the vertical fractures terminated before the bottom of the trench, with the bedrock at the base of the trench generally observed to be in sound condition. Two of the water bearing vertical fractures (those at Stations 1+00 and 8+05) carried to the base of the trench but, narrowed significantly to very thin fractures as they approached the base of the trench. The vertical fracture locations are presented on Drawings C-06 and C-07 in Appendix D.

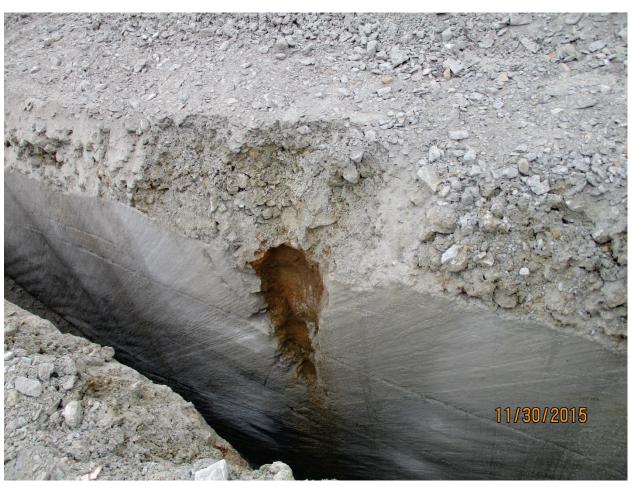
Photo 14: East side of vertical fracture at 6+70. Nov. 2015

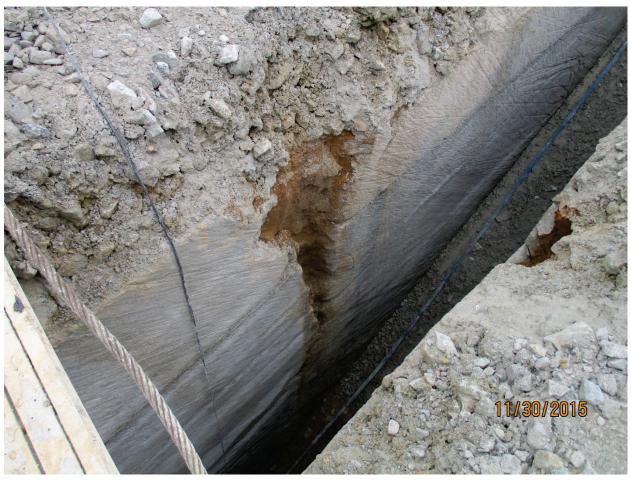
Photo 15: West side of vertical fracture at 6+70. Nov. 2015

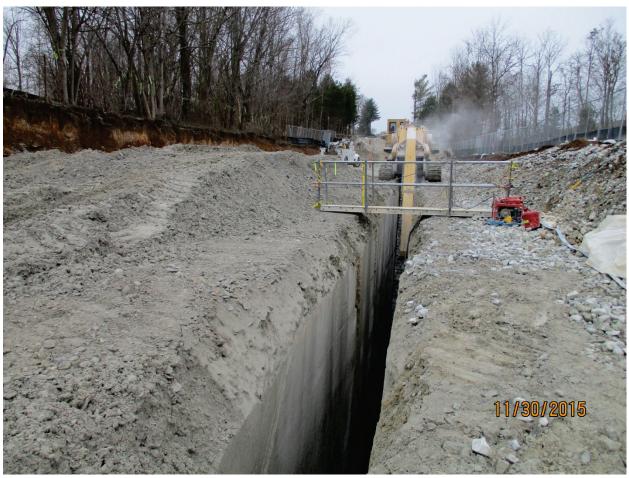
Photo 16: Vertical fracture at 6+90. Nov. 2015

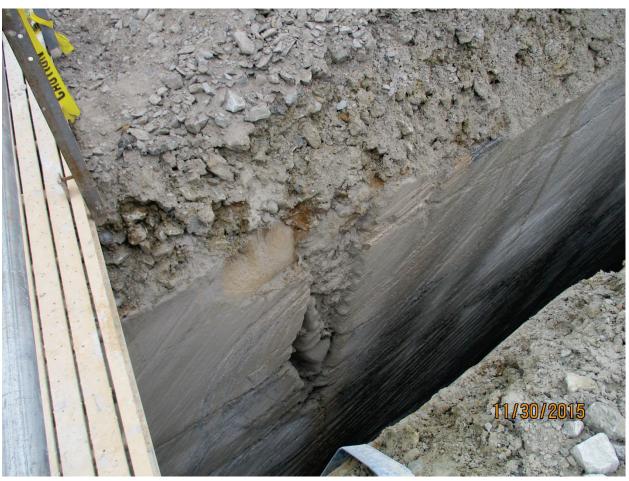
Photo 17: East side of vertical fracture at 6+90. Nov. 2015

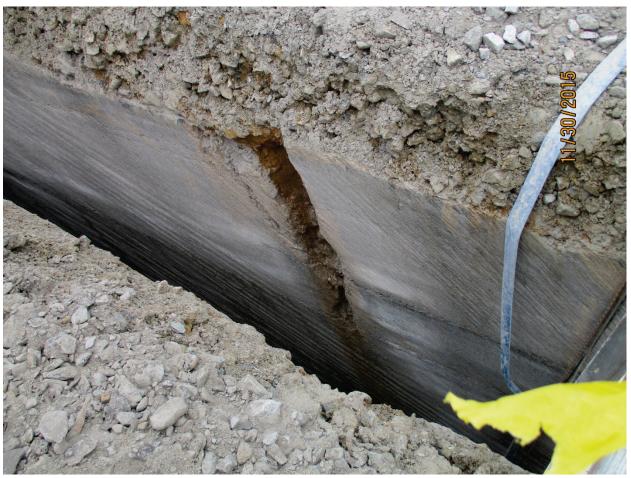
Photo 18: West side of vertical fracture at 6+90. Nov. 2015

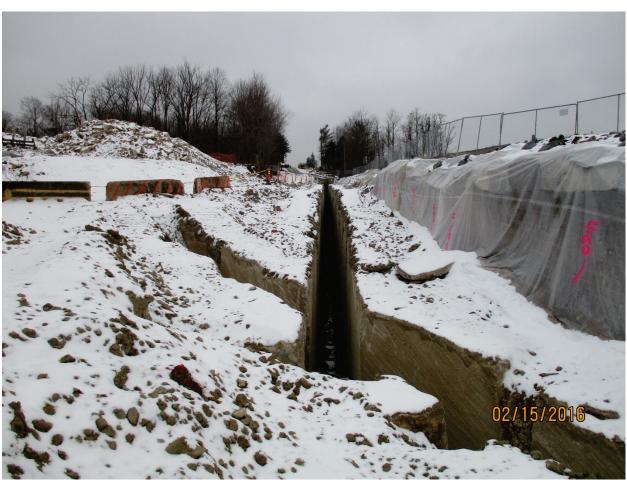
Photo 52: Clay-infused fracture as trench turns north. Feb. 2016

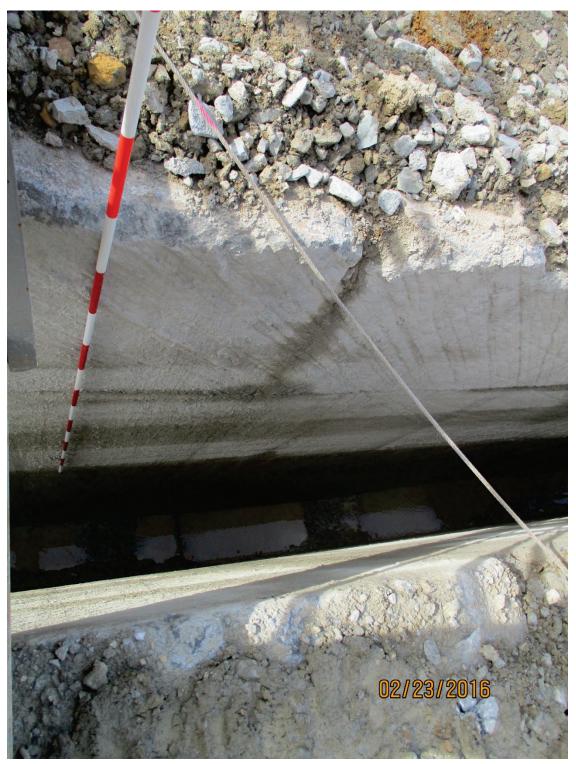
Photo 59: Horizontal fracture from 8+00 to 8+65. Feb. 2016
