Re: RCRA Corrective Action Administrative Order on Consent (AOC)
Progress Report 57, Second Quarter 2015
GM CET – Bedford Facility, IND 006036099, Docket No. RCRA-05-2014-0011
Bedford, Indiana

Second Quarter 2015 Progress Report 57

GM CET – Bedford Facility

Cover System Inspection 2nd Quarter 2015

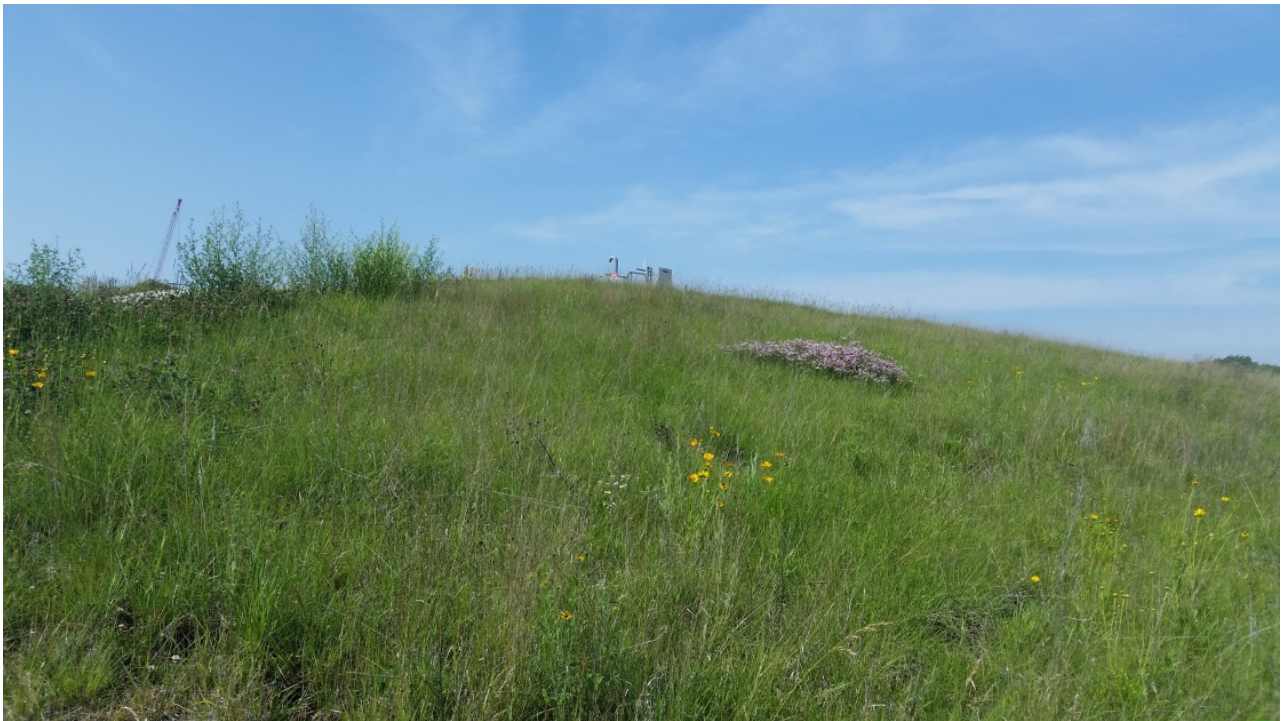
Photo 1: EV1 Vault cover facing northwest

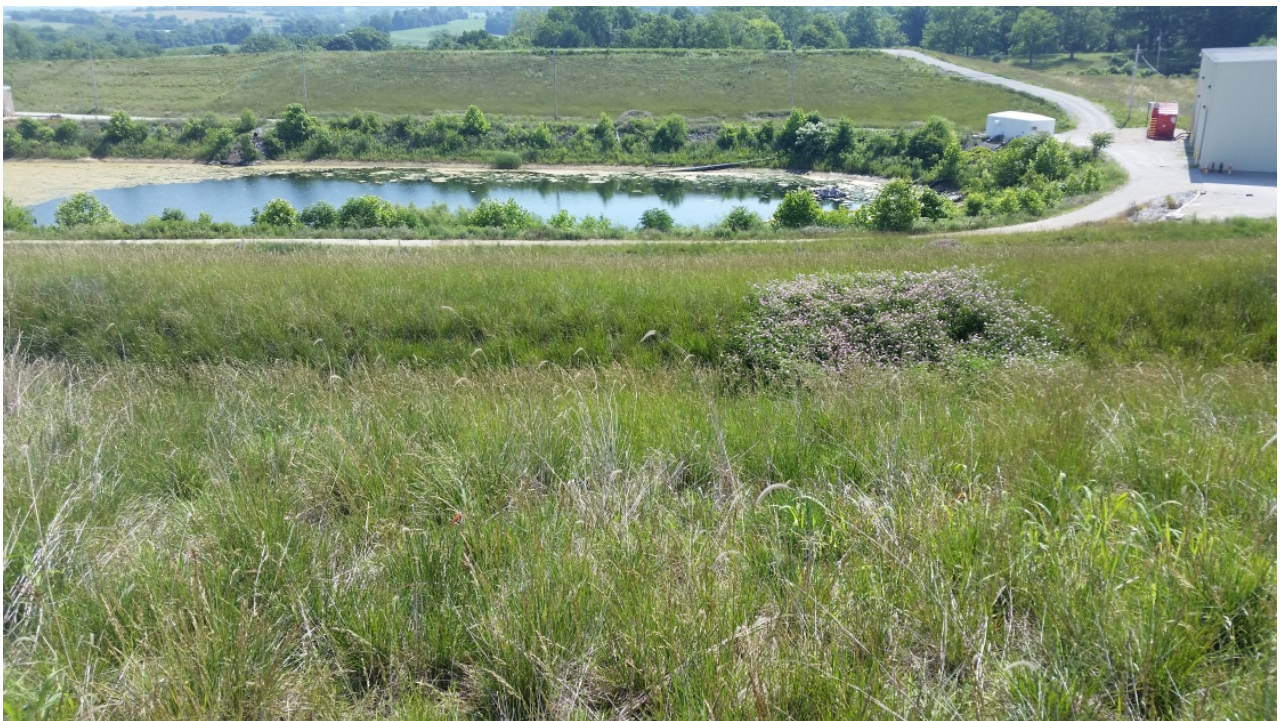
Photo 2: EV1 Vault cover (and East Plant Area cover beyond) facing east

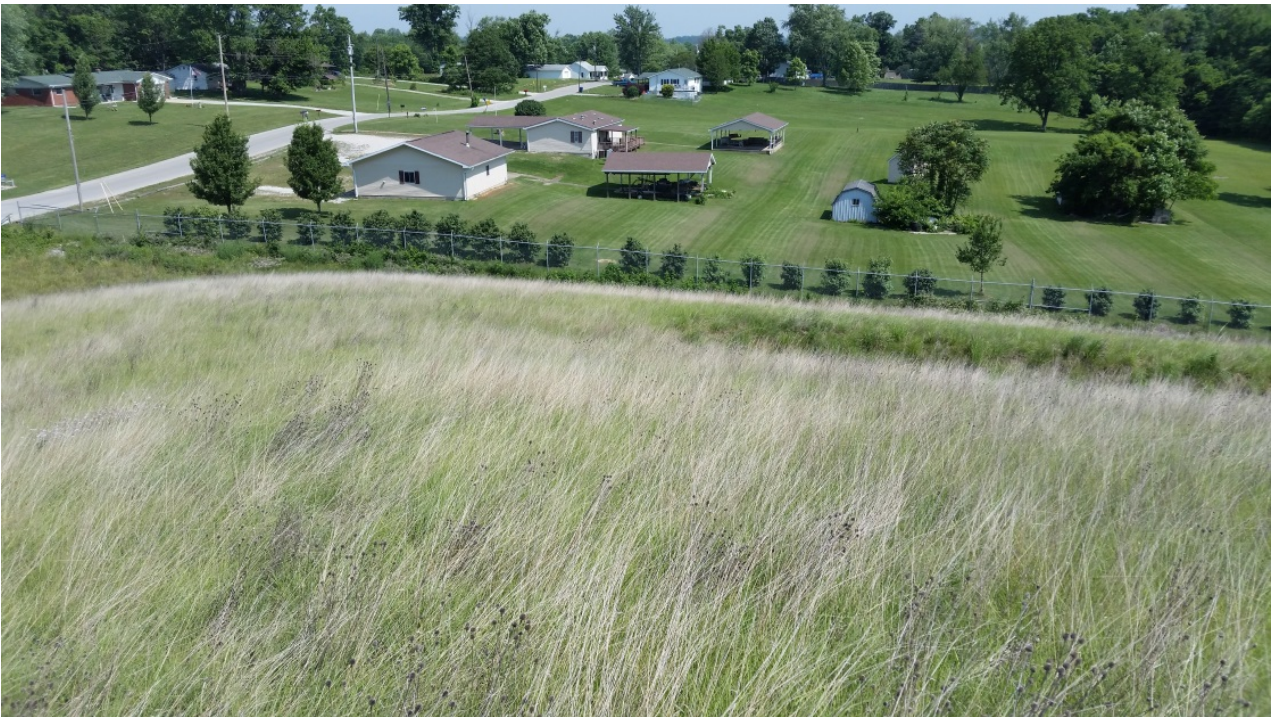
2. Numerous mole holes were identified on the west and north and east side of the east plant cover system (EV2, EV3, EV4, EV5, and EV6). Moles typically burrow 8-12 inches, however, they tend to damage root growth in their quest for grubs. CRA has been in contact with the liner companies to see if there is any concern for damage to the geocomposite drainage layer. In the meantime, an exterminator for the grubs has been contacted to assess removal of the moles food source (the grubs).

Photo 3: EV2 East Plant Area cover facing northwest

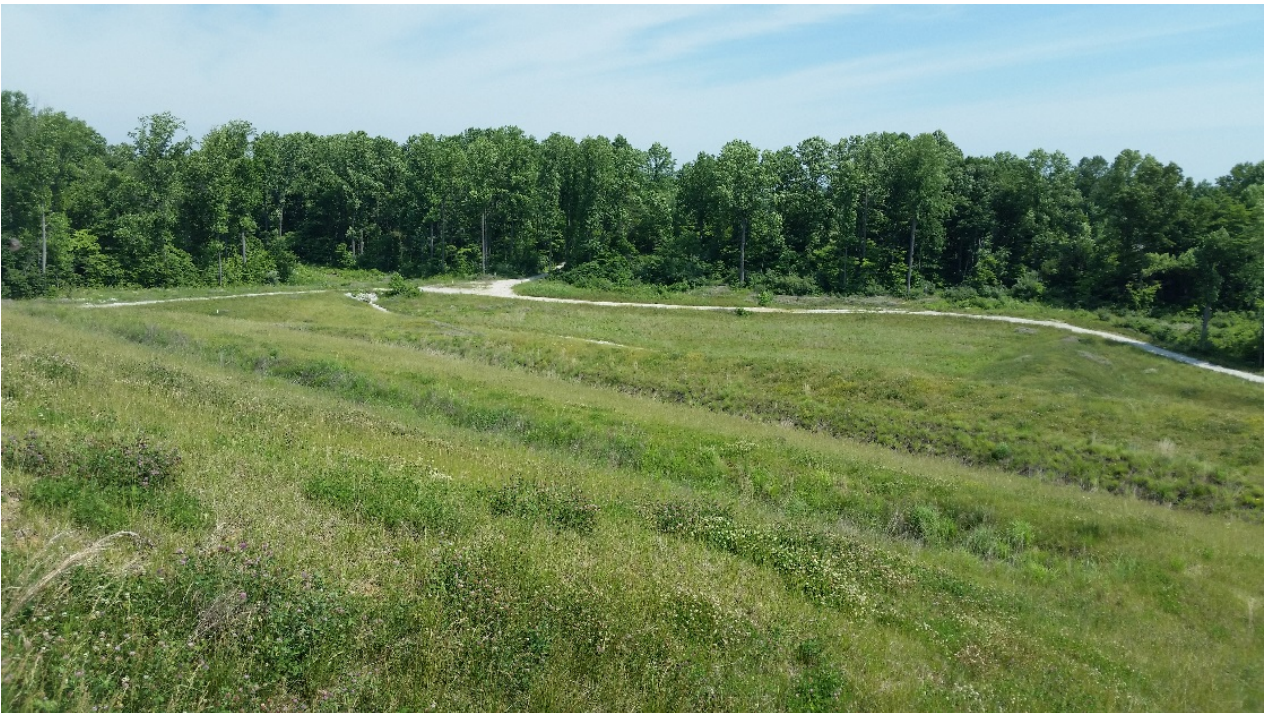
Photo 4: EV3 East Plant Area cover facing northwest

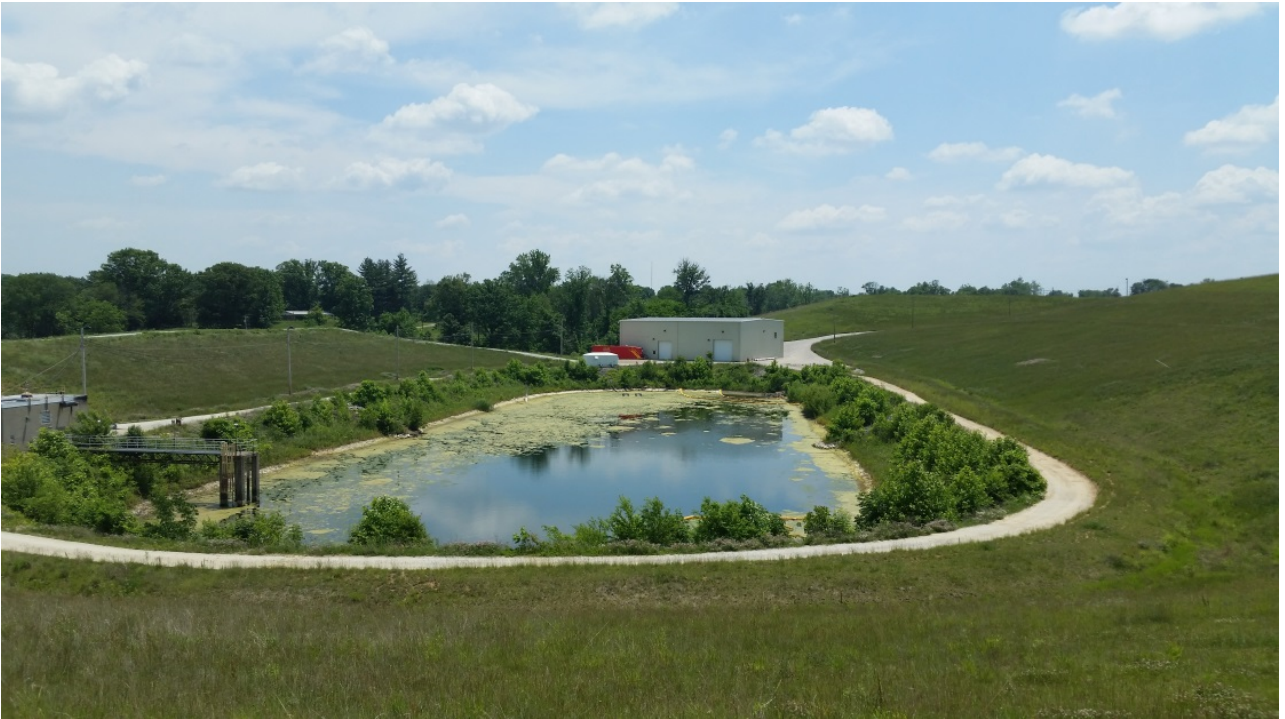
Photo 5: EV3 East Plant Area cover facing south

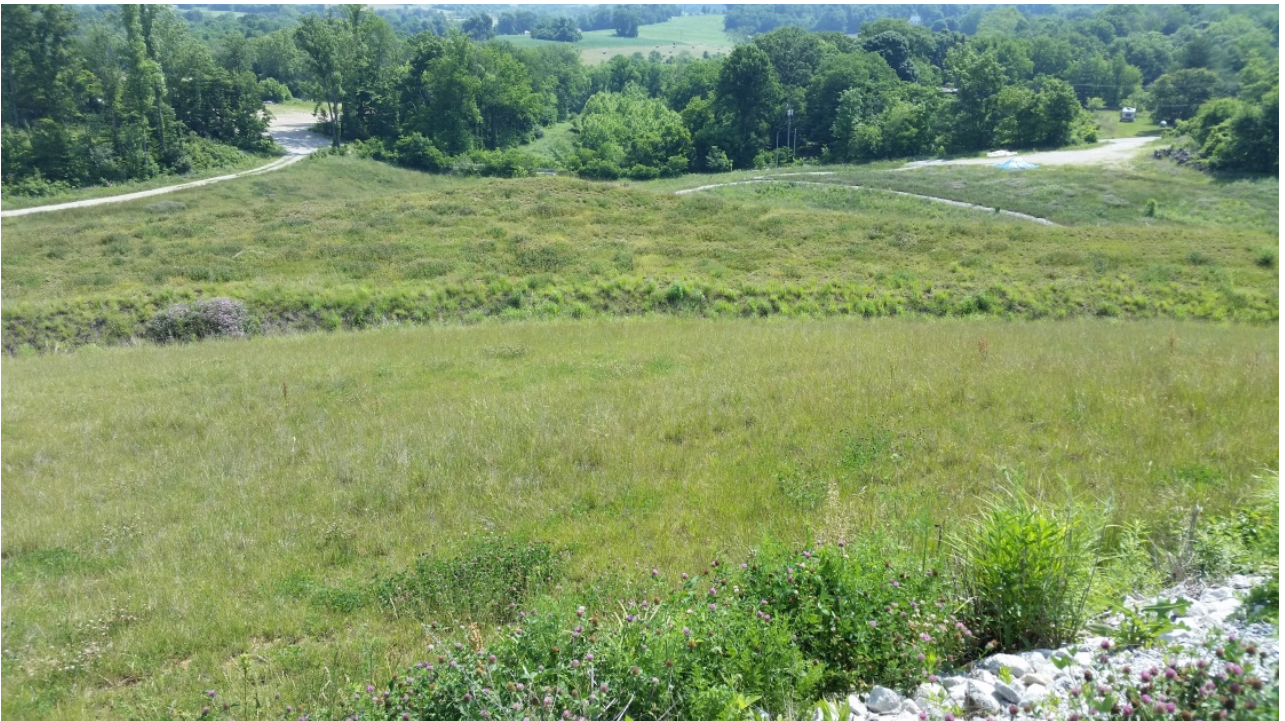
Photo 6: EV4 East Plant Area cover facing northeast

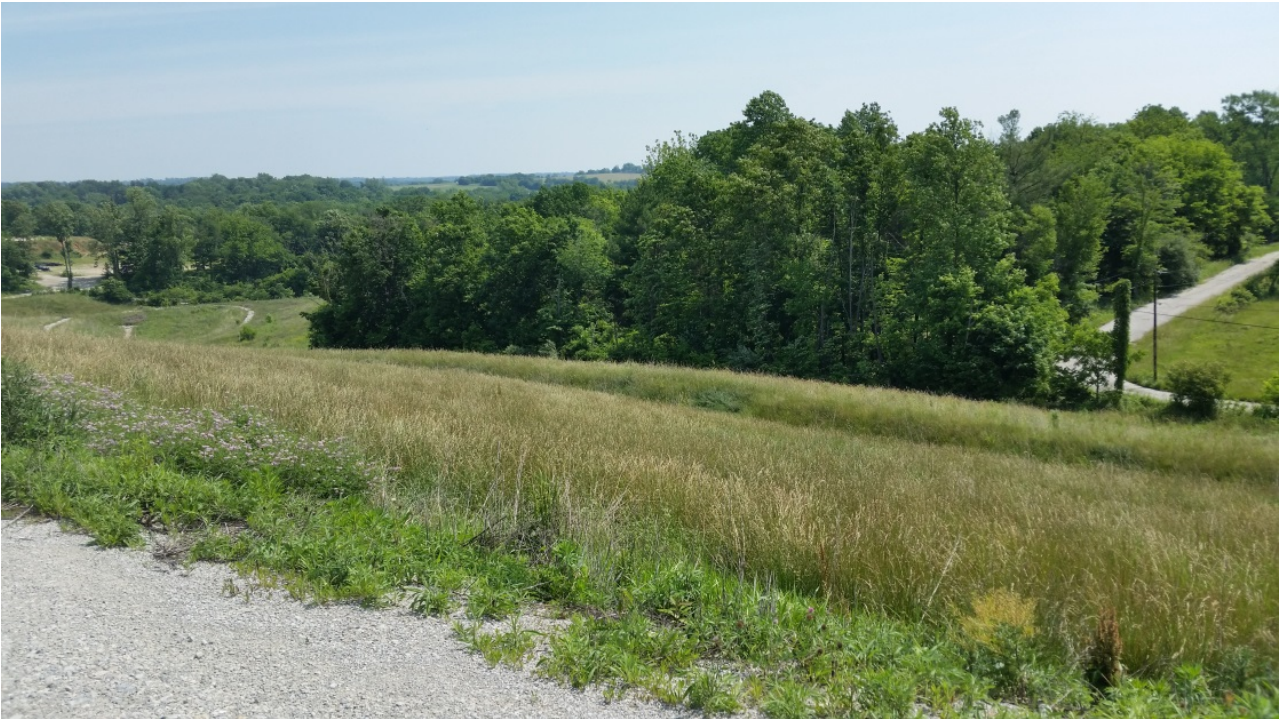
Photo 7: EV5 East Plant Area cover facing northeast

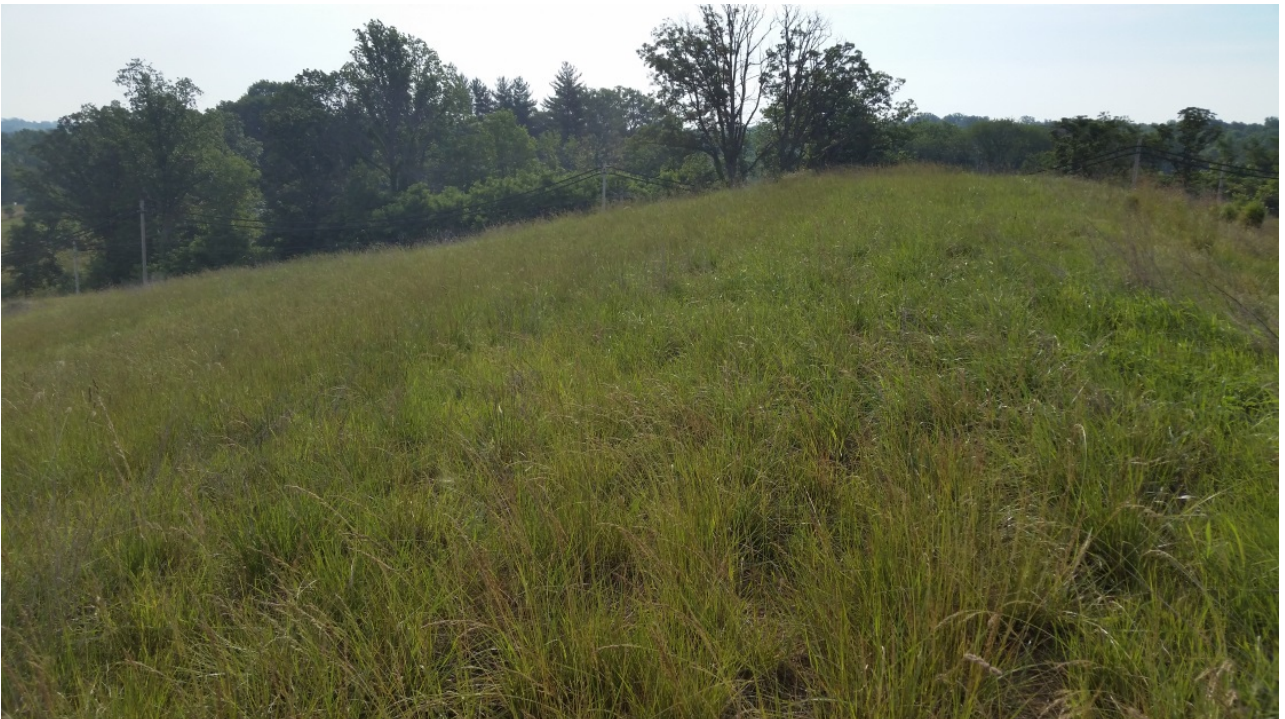
Photo 8: EV6 East Plant Area cover facing east

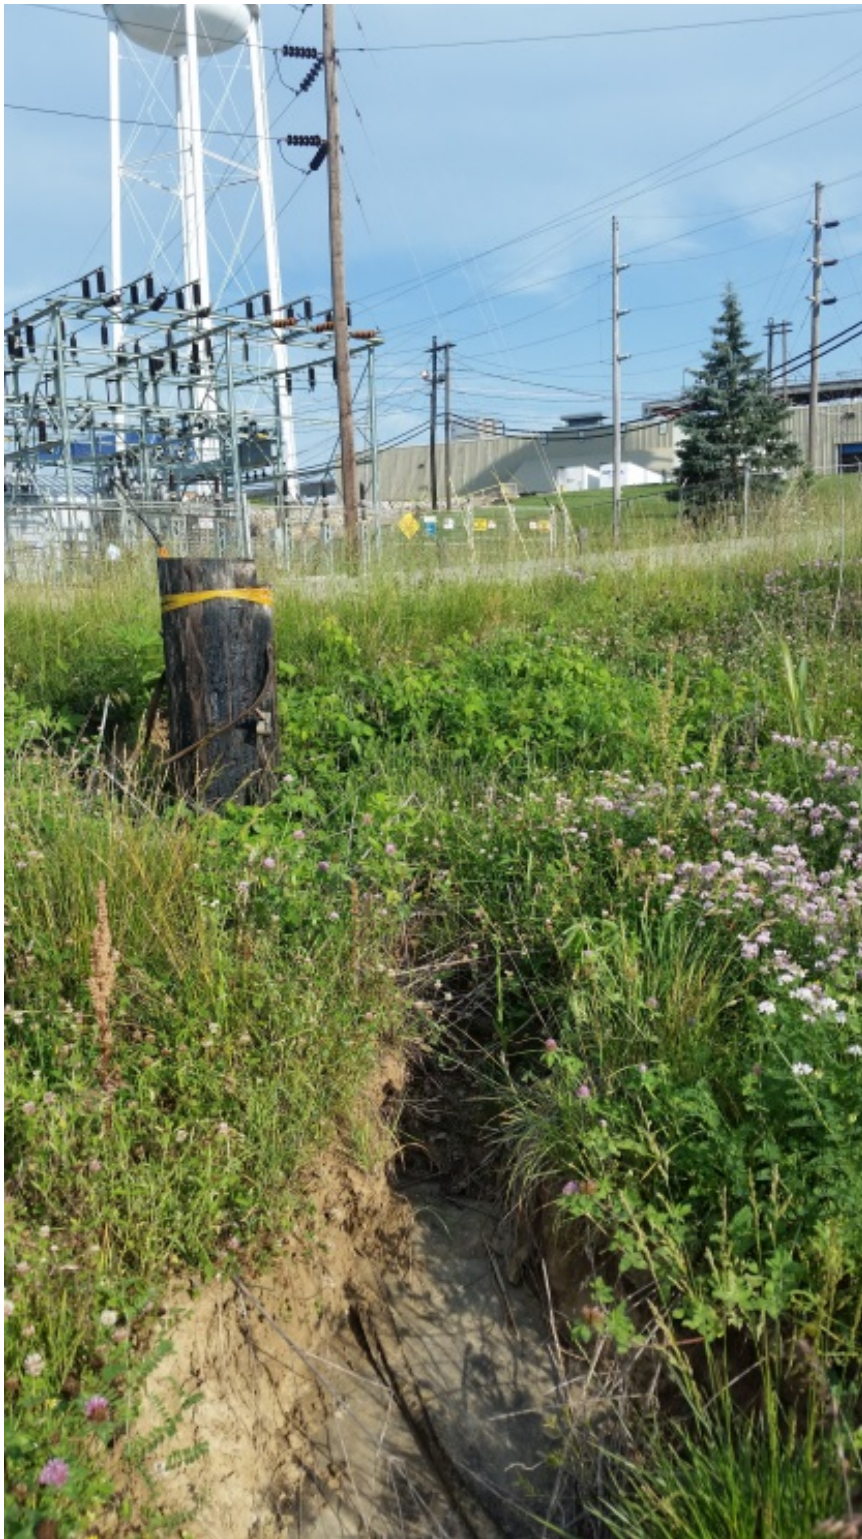
3. There were some erosion ruts along the east side of GM Drive, outside the cover system area adjacent to power poles. This does not appear to be due to any on-Site RCRA activities, but could have an impact on the liner system in the ditch and so will be addressed by filling and grading and seeding.

*Erosion along GM power poles, outside cap limits, across from Substation

Photo 9: EV6 erosion rut outside cap limit

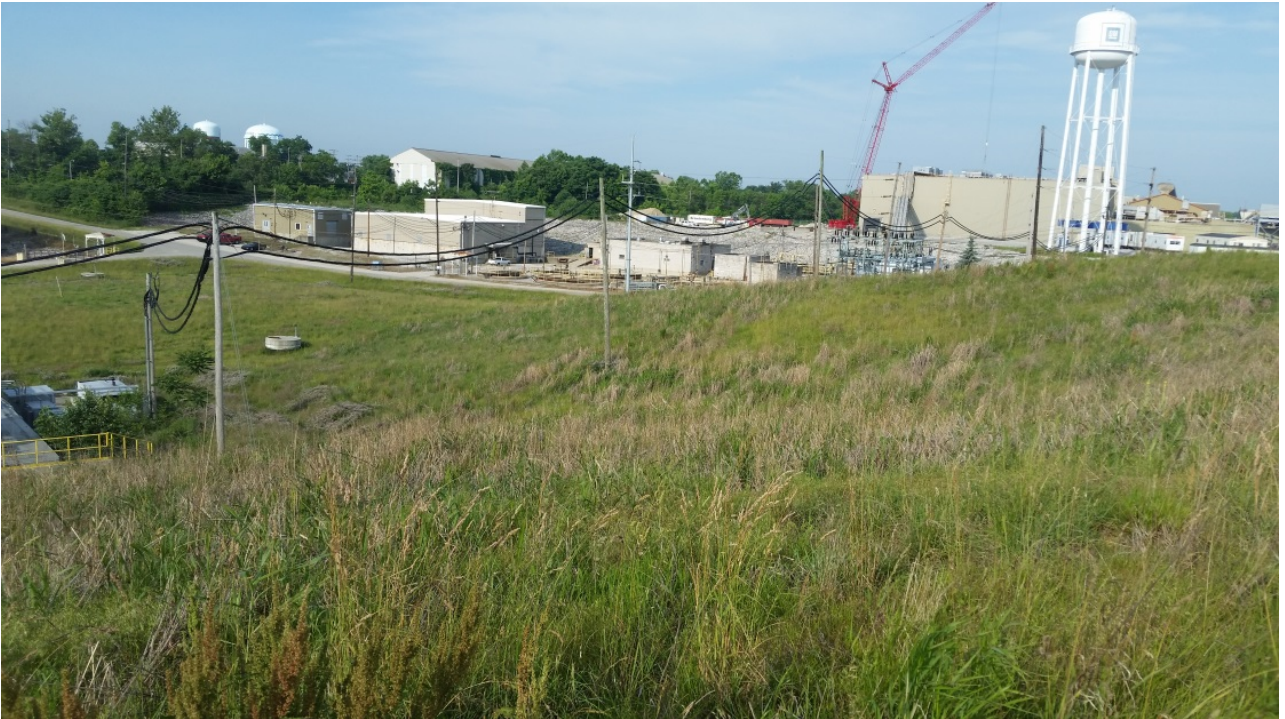
Photo 10: EV6 East Plant Area cover facing southwest

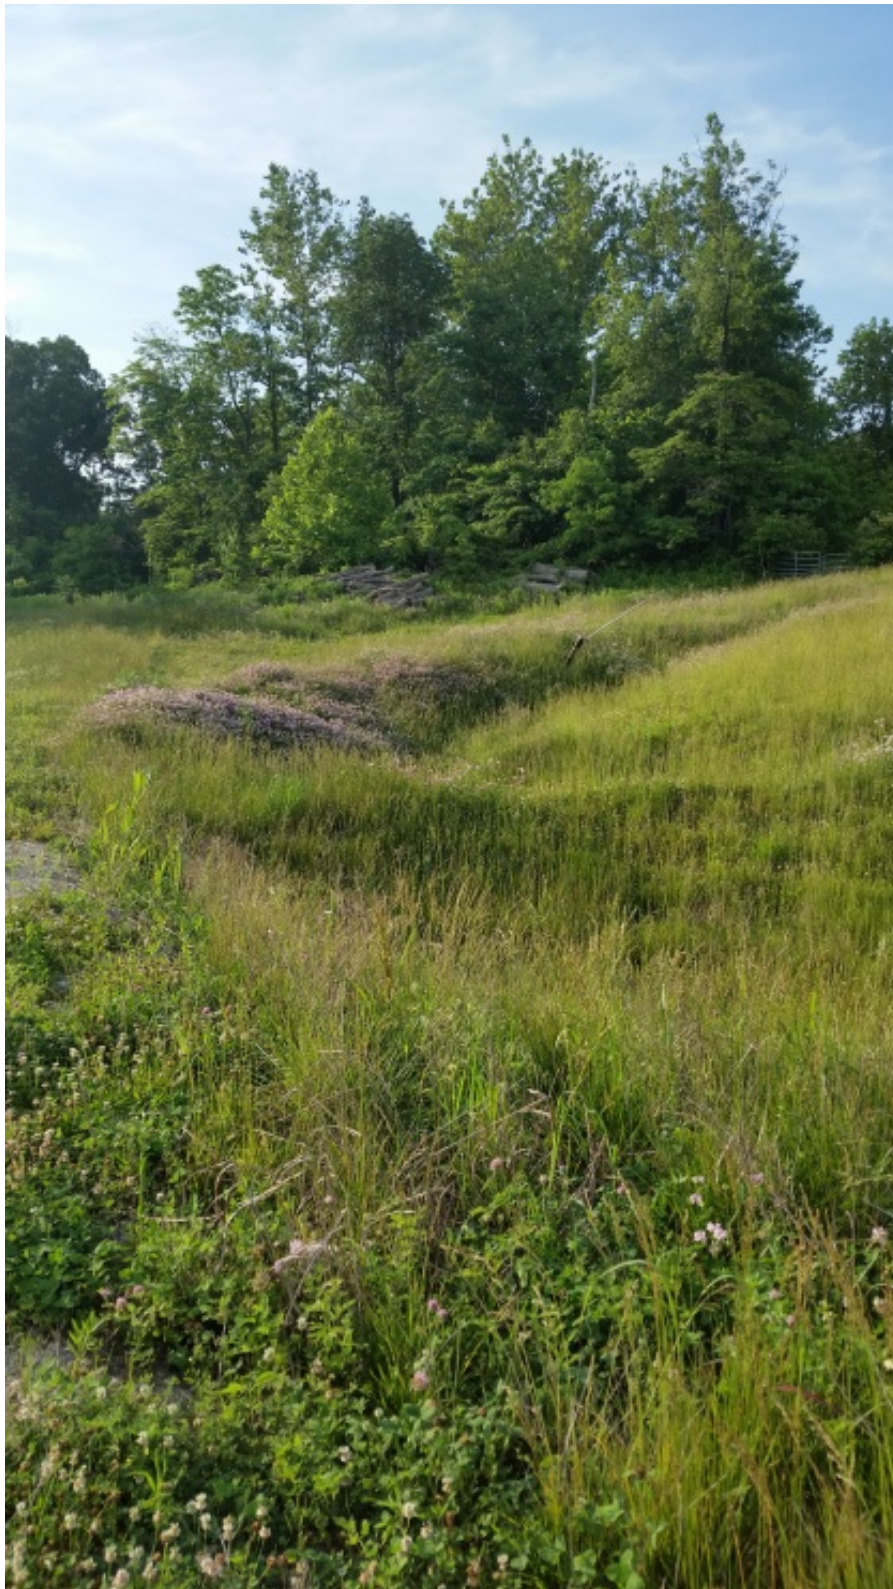
Photo 11: ES14 drainage swale facing east

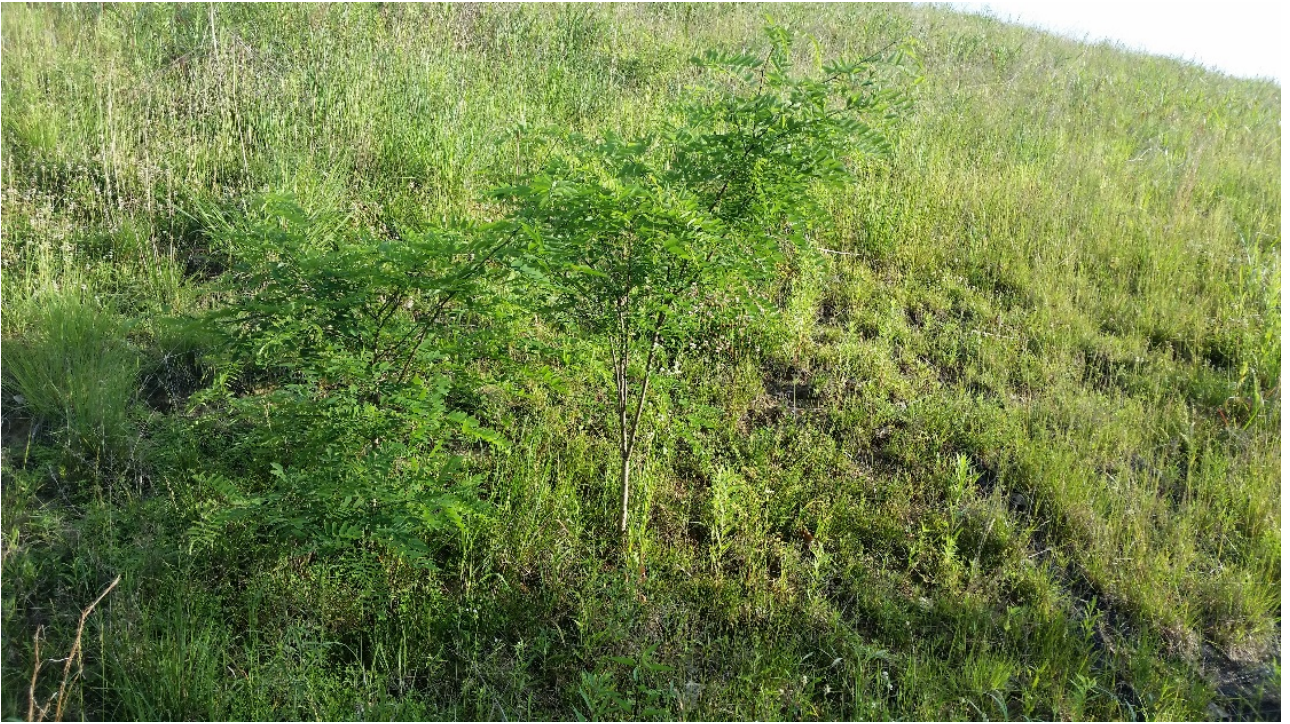
1. In the exterior ditch, adjacent to wooded areas (south side of Parcel 201 and the east side of the cover system along Parcels 205, 207, 412 and 413), saplings were noted starting to grow in the first quarter, which were removed. A few new saplings were identified during the second quarter inspection and have also been removed.

Photo 12: EV9 East Plant Area cover facing south (removed tree growth at time of inspection)

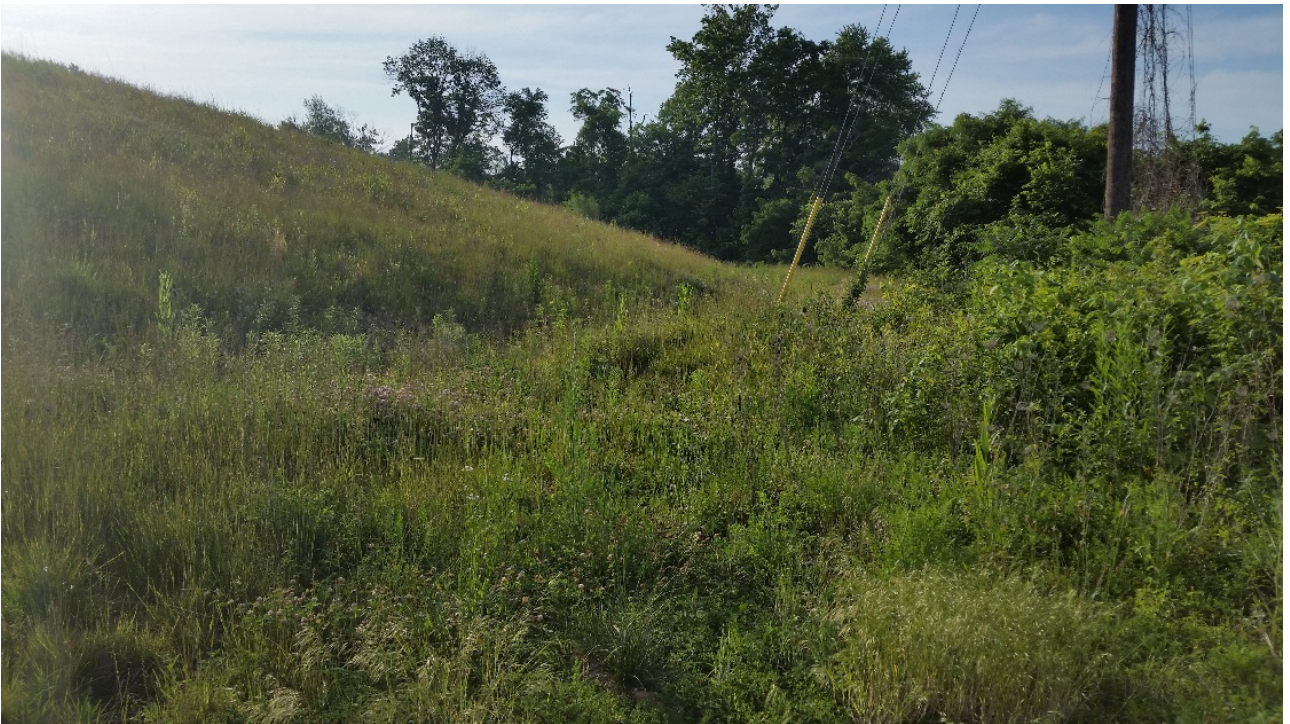
Photo 13: EV9 East Plant Area cover facing east (at base of slope)

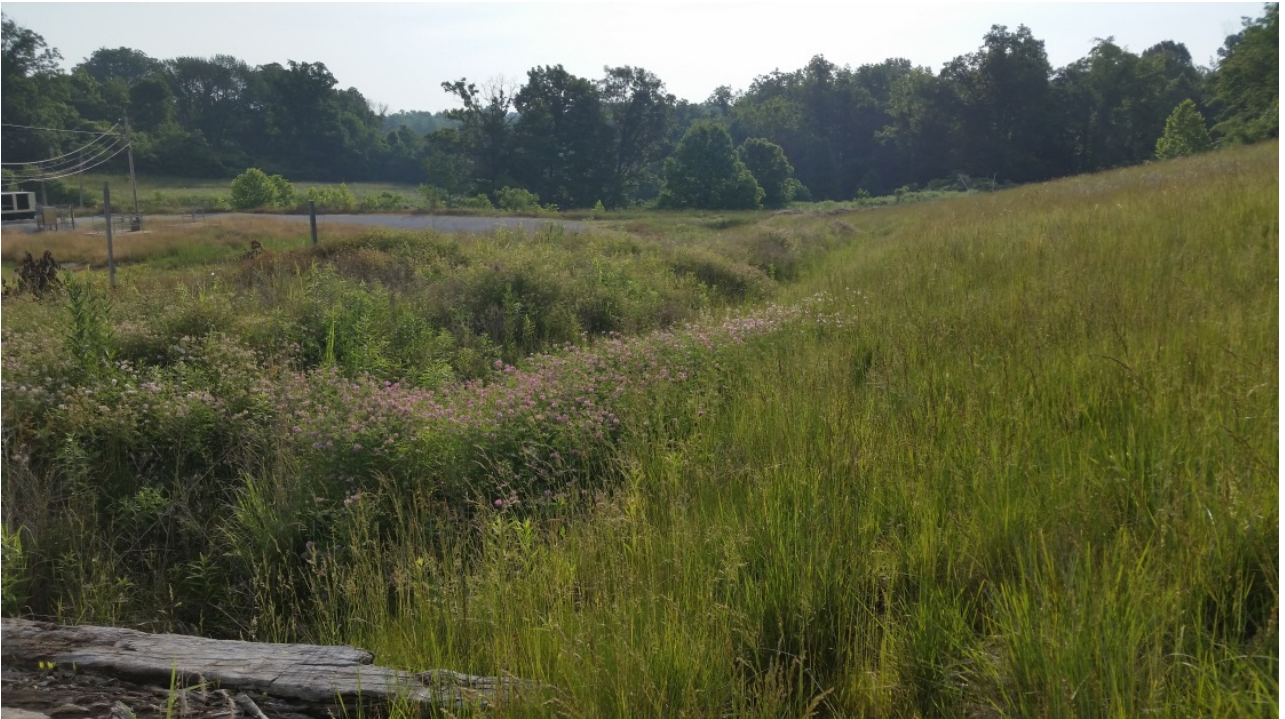
Photo 14: ES14 East Plant Area cover facing northwest

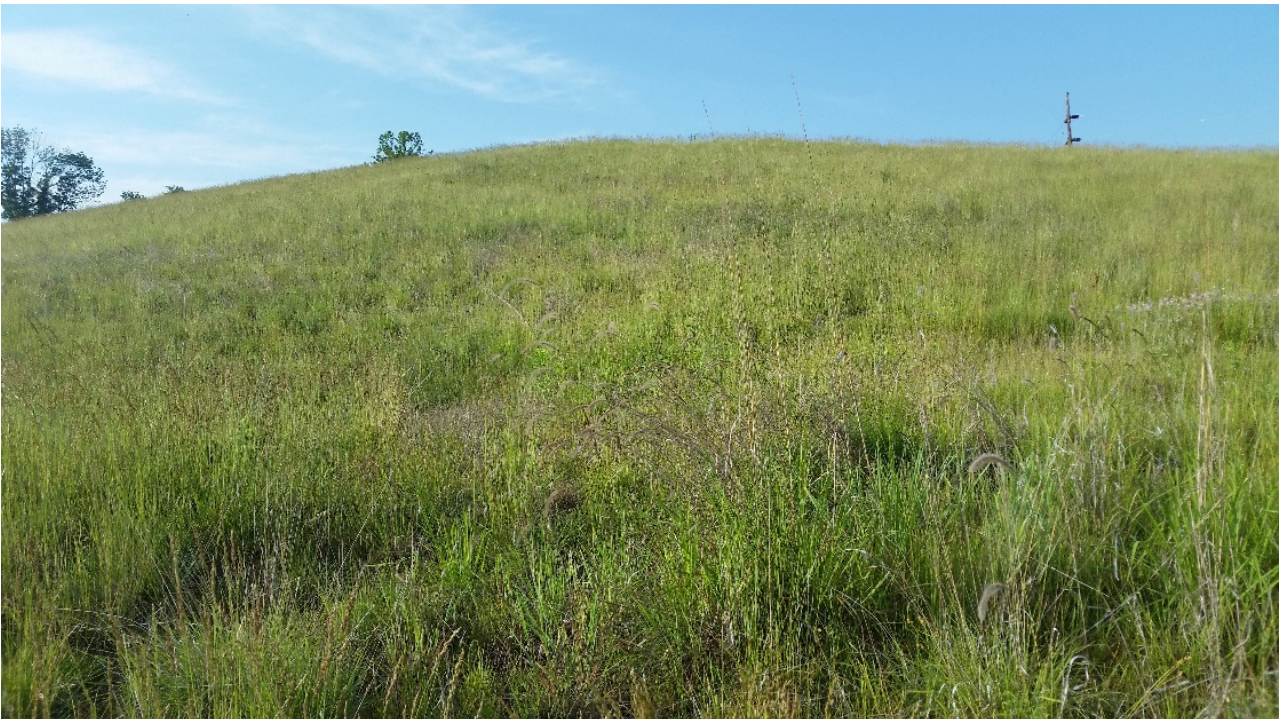
Photo 15: EV9 East Plant Area cover facing south

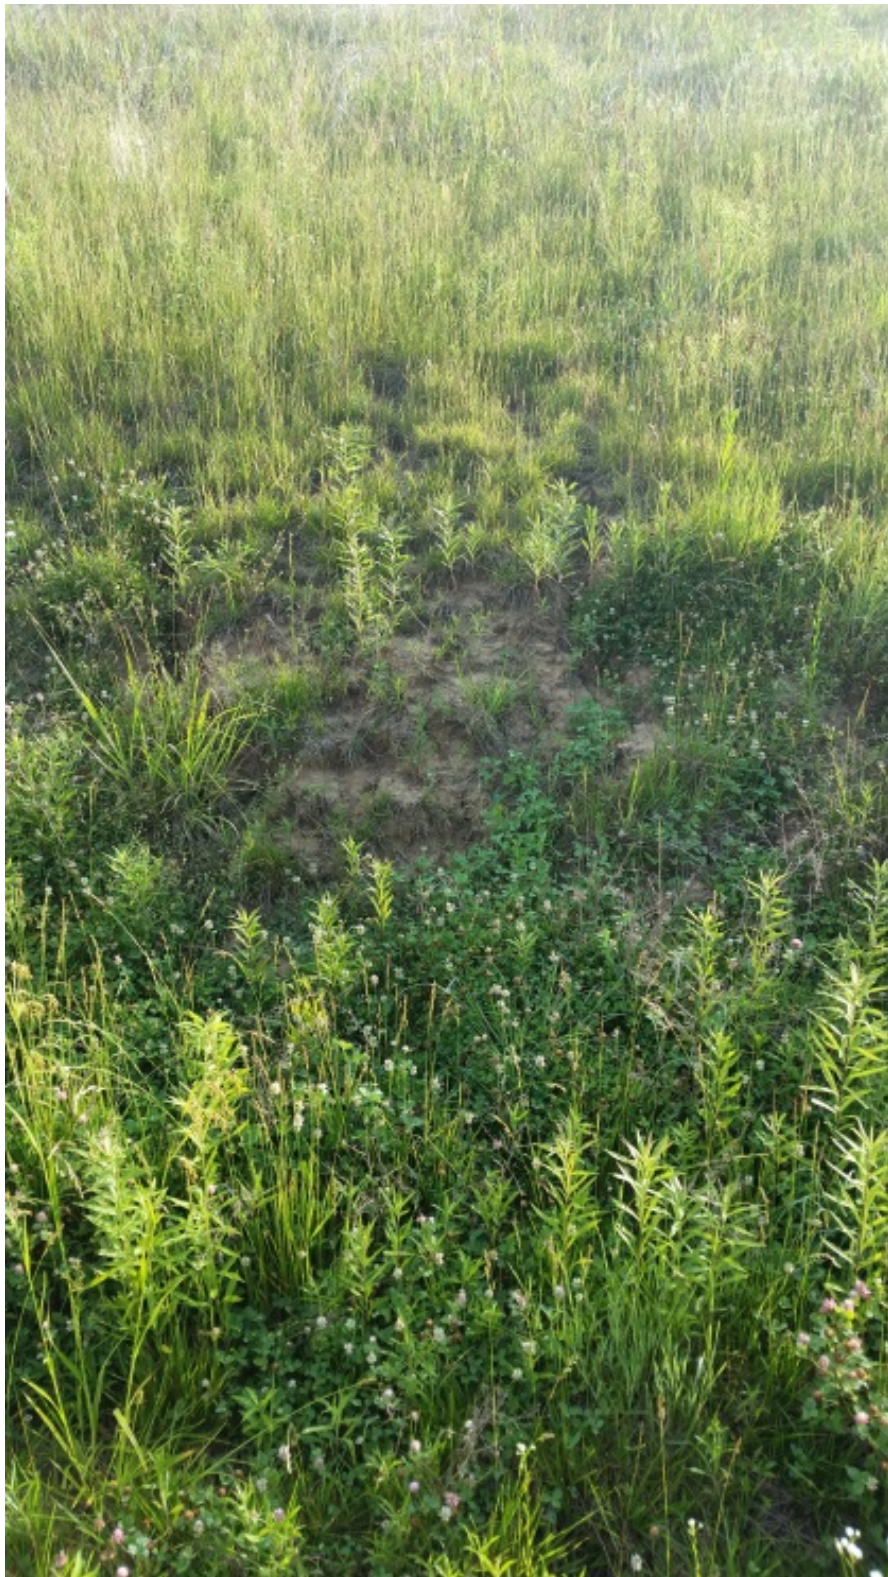
4. There were some minor bare patches, and clover/weed growth noted along various transects however, these minor issues were not found in areas where erosion was occurring and will continue to be monitored.

Photo 16: EV9 patchy vegetation

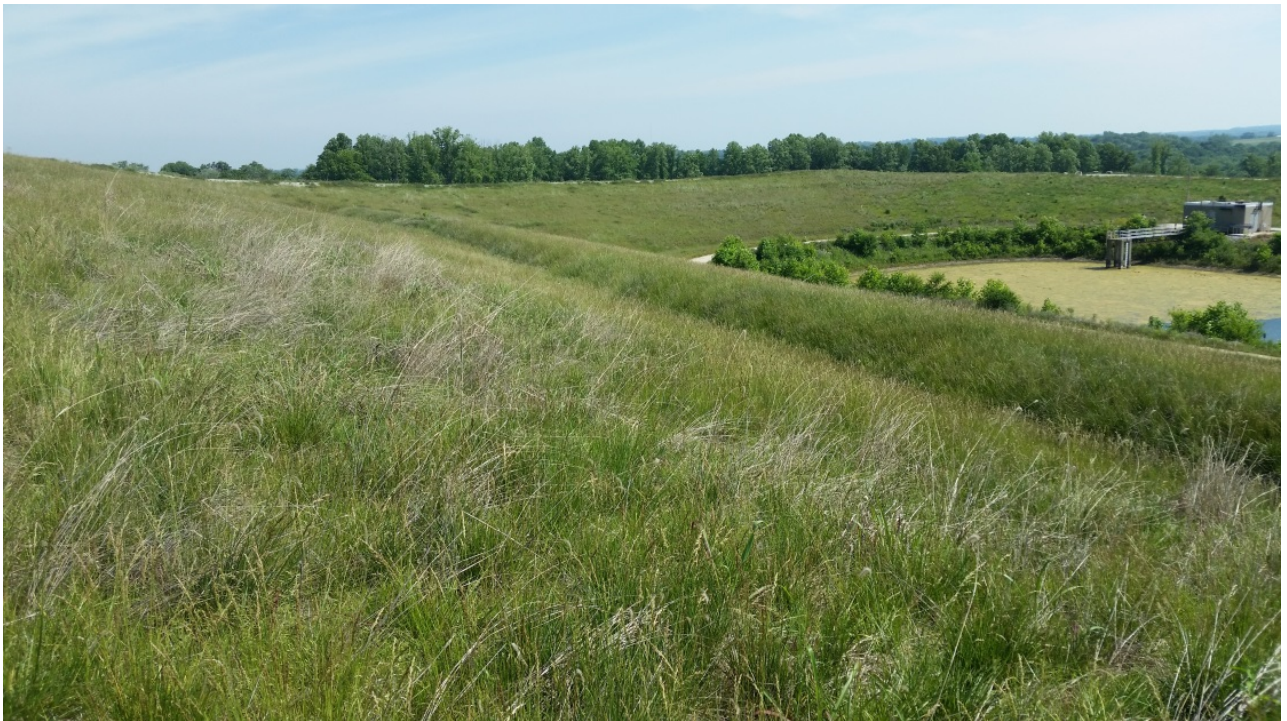
Photo 17: ES2 drainage swale facing north

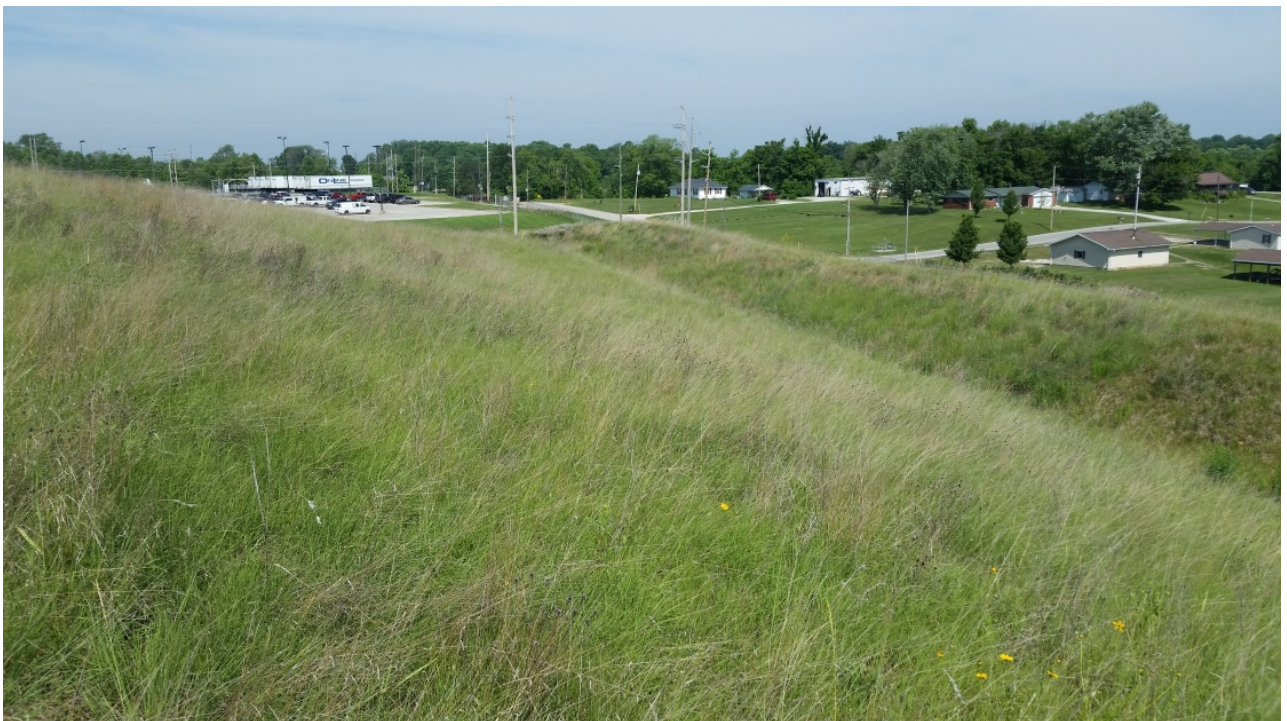
Photo 18: ES5 drainage swale facing west

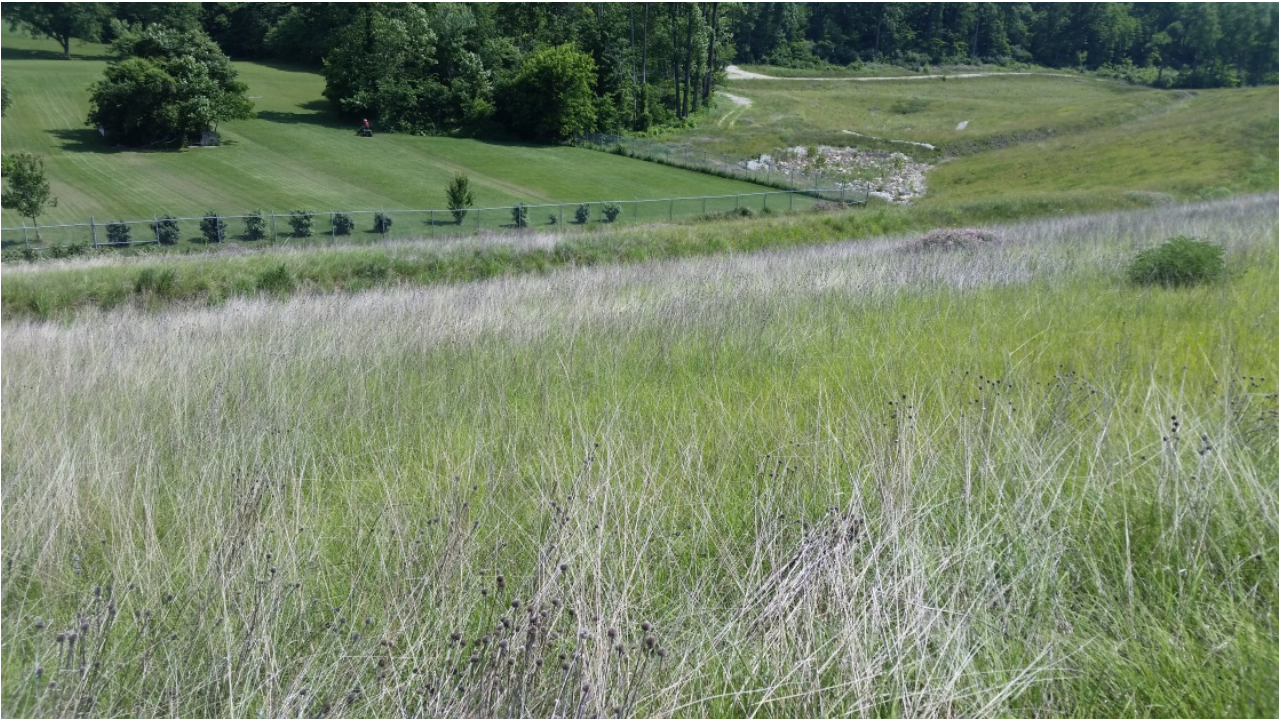
Photo 19: ES5 drainage swale facing northeast

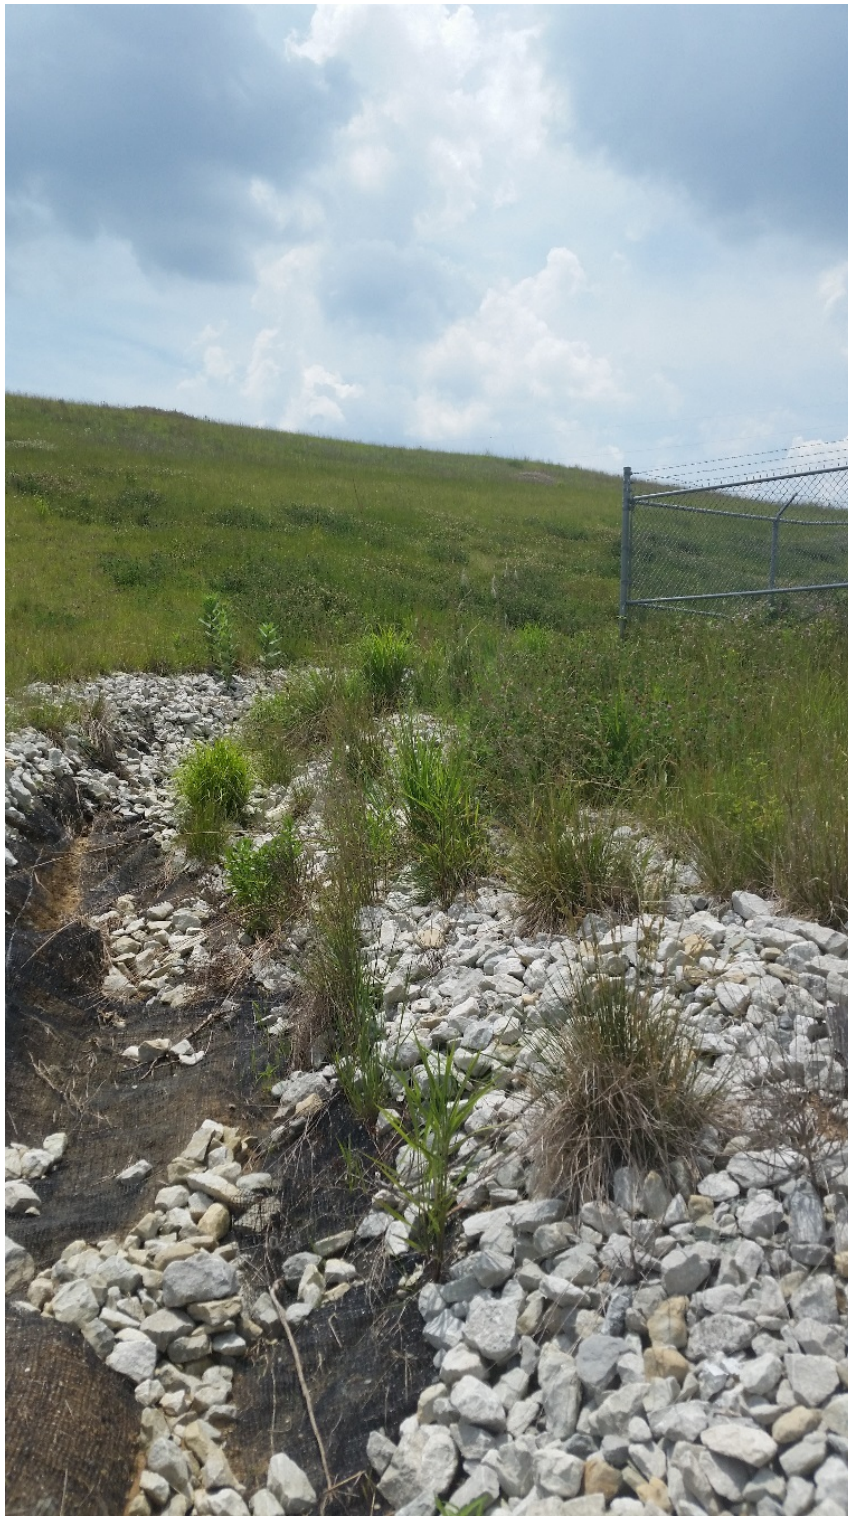
6. During the inspection it was noted that the velocity of the water coming from Detention Basin 1 (DB1) into DB2 displaced the riprap at the point the water enters the basin, exposing about a 5 foot length of the channel, including the underlying liner. The riprap will be replaced with larger diameter stone as used in DB1. The problem was also identified in the channel further upgradient as well (ES6) in the channel south and adjacent to Parcel 401.

Photo 20: ES6 drainage swale facing southwest, channel erosion.

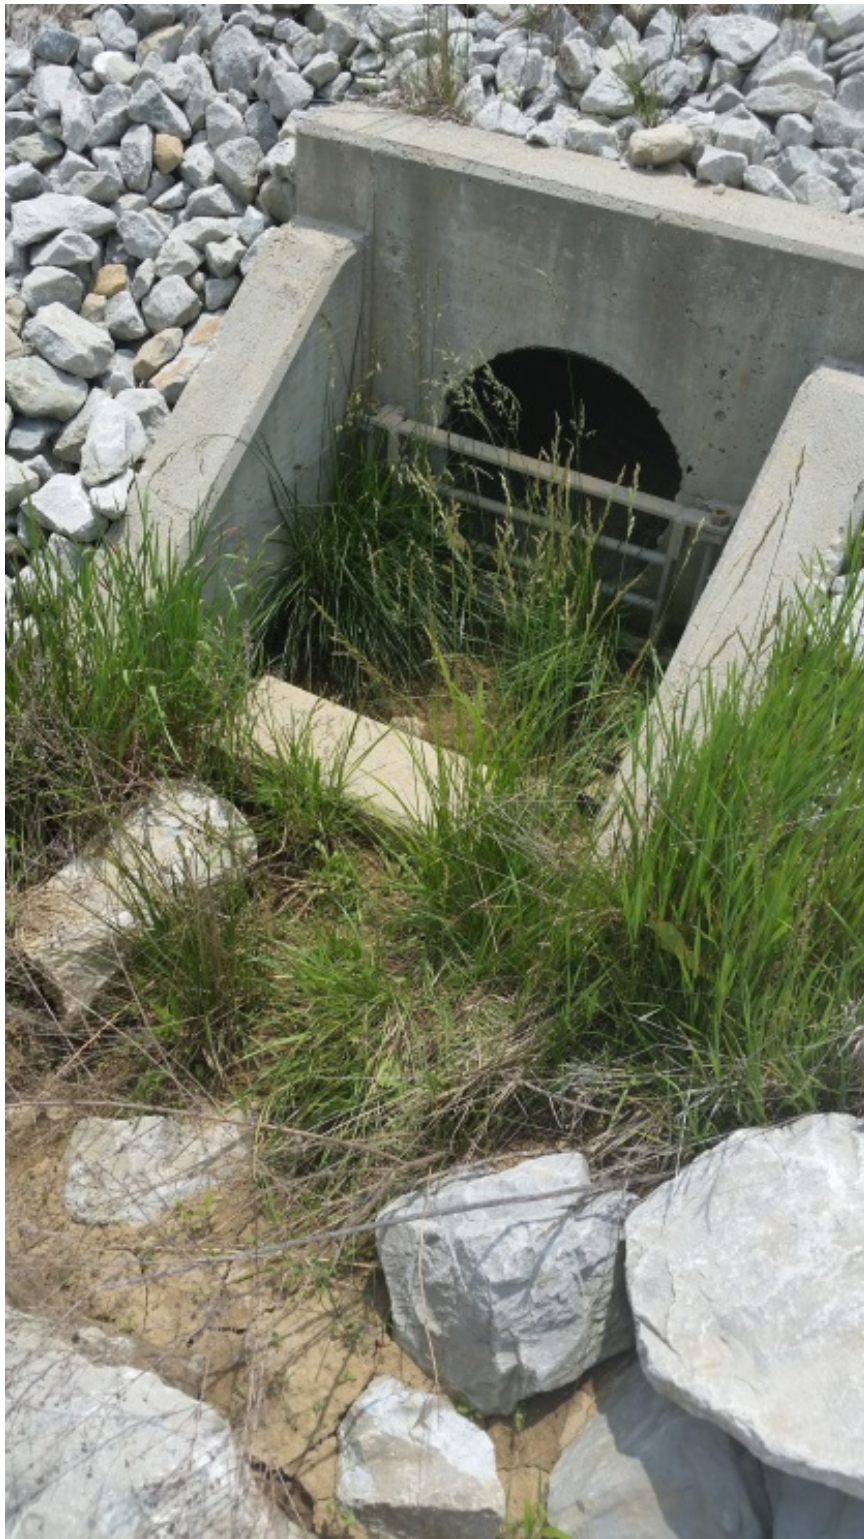
Photo 21: EV9 rip rap erosion at storm drain into detention basin #2 facing west
