Re: RCRA Corrective Action Administrative Order on Consent (AOC)
Progress Report 57, Second Quarter 2015
GM CET – Bedford Facility, IND 006036099, Docket No. RCRA-05-2014-0011
Bedford, Indiana

Second Quarter 2015 Progress Report 57

GM CET – Bedford Facility

Cover System Inspection 2nd Quarter 2015

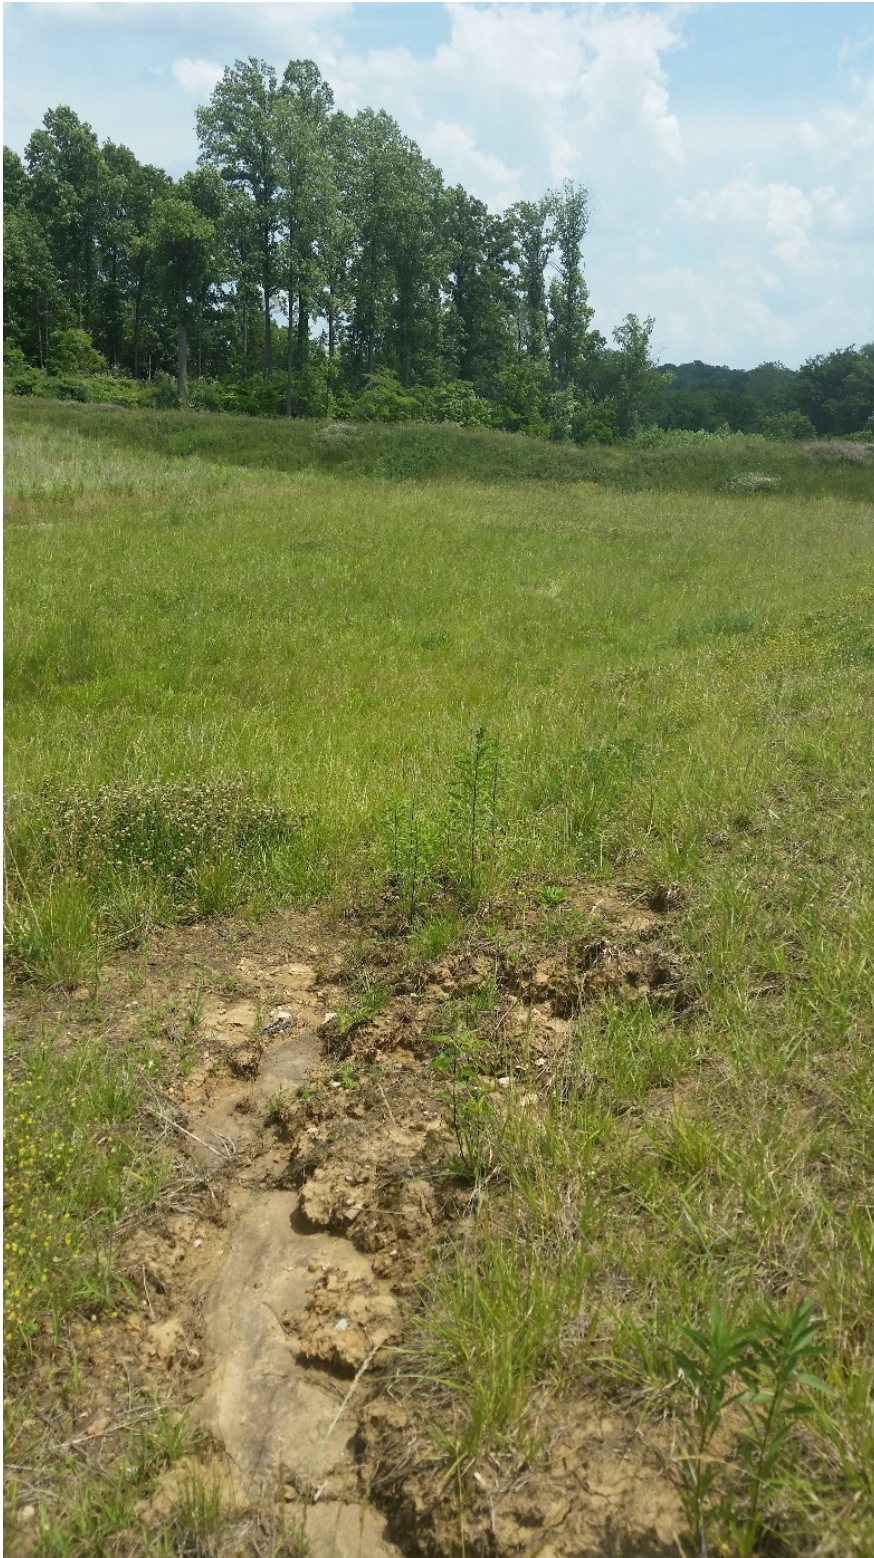
Photo 22: ES10 channel through detention basin #3 facing east

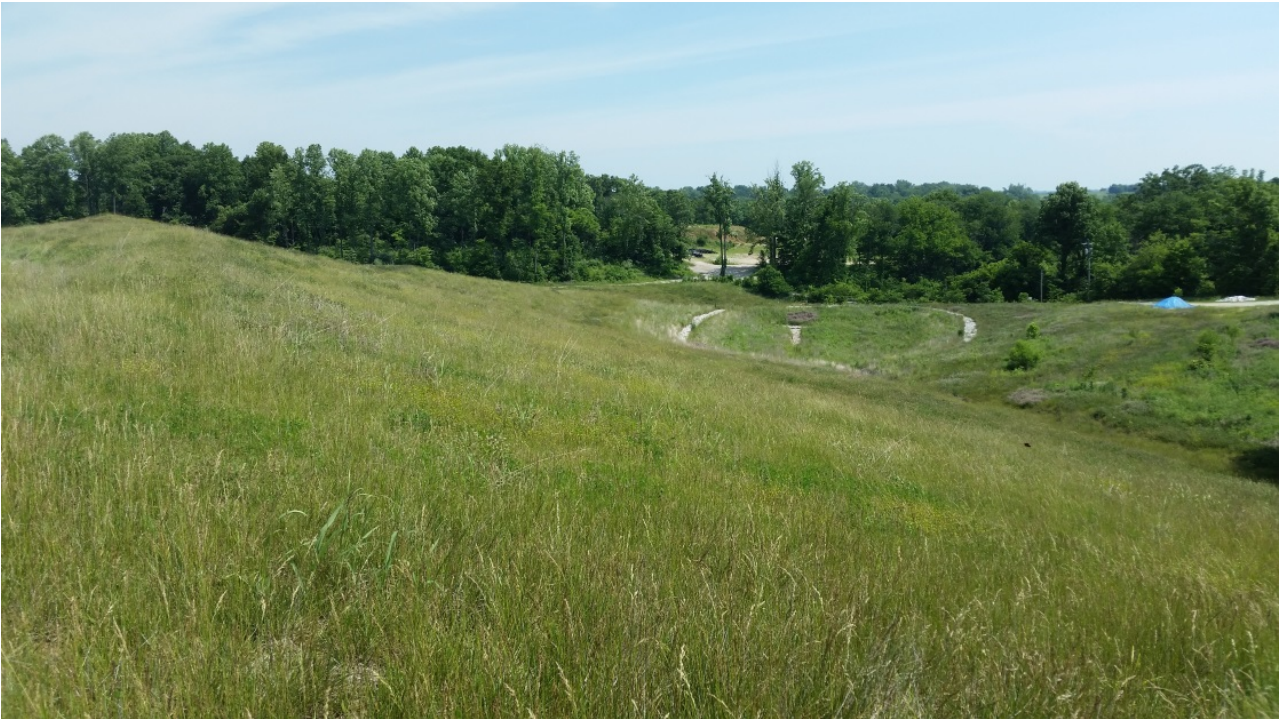
Photo 23: ES11 detention basin #5 facing north

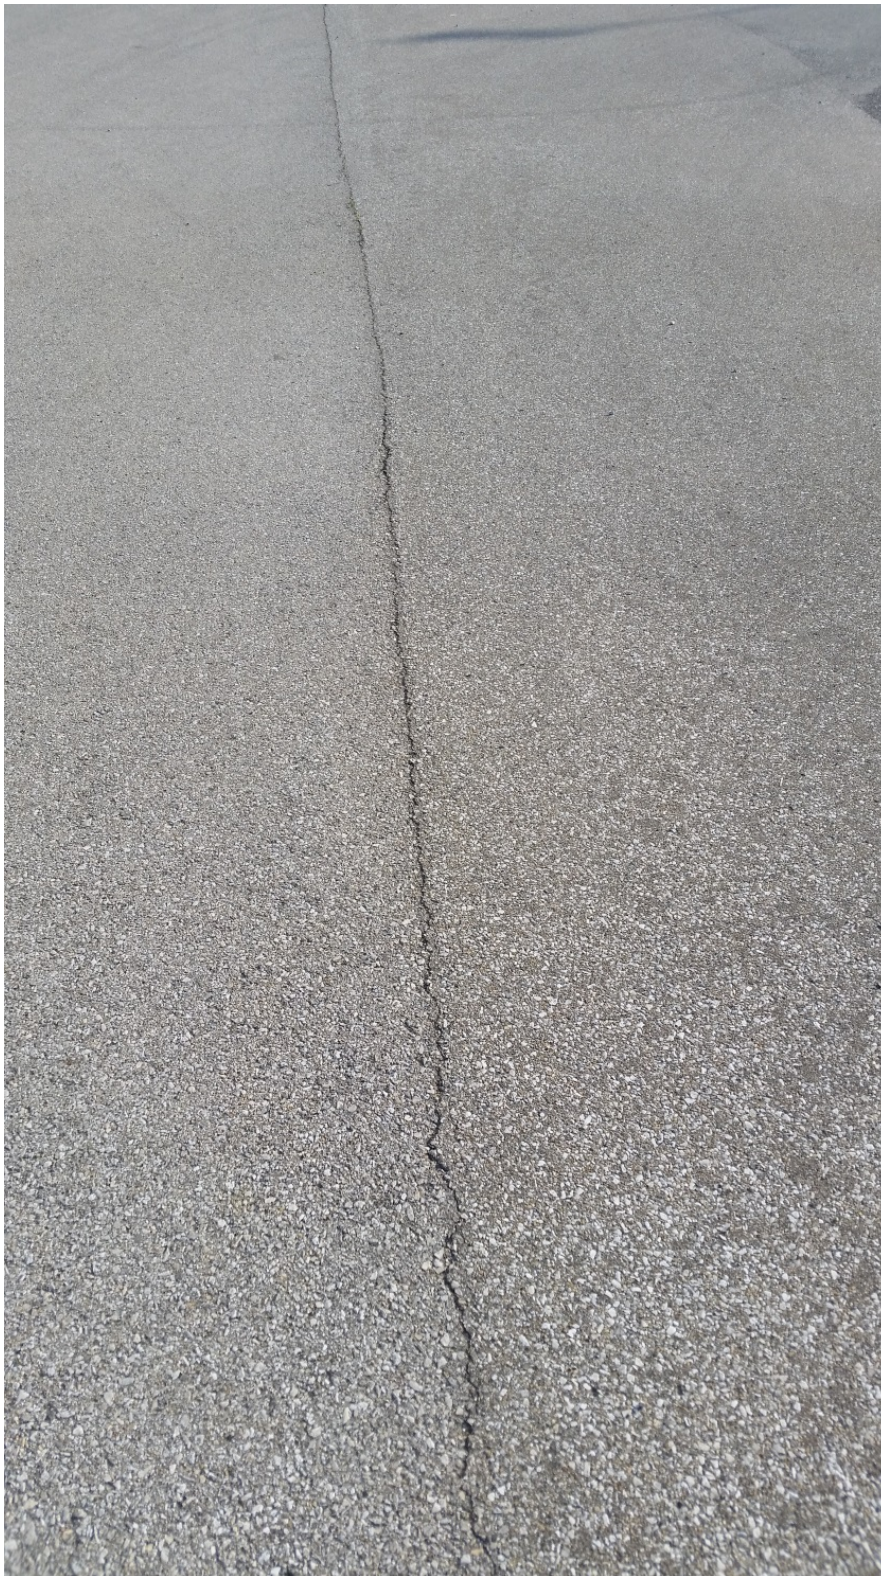
5. A few minor cracks were present along the seams in the asphalt cover system. The cracks do not extend the full depth of the asphalt thickness. O'Mara Paving will be addressing the cracks in the third quarter 2015.

Photo 24: EA2 crack near WWTP aeration basin facing north

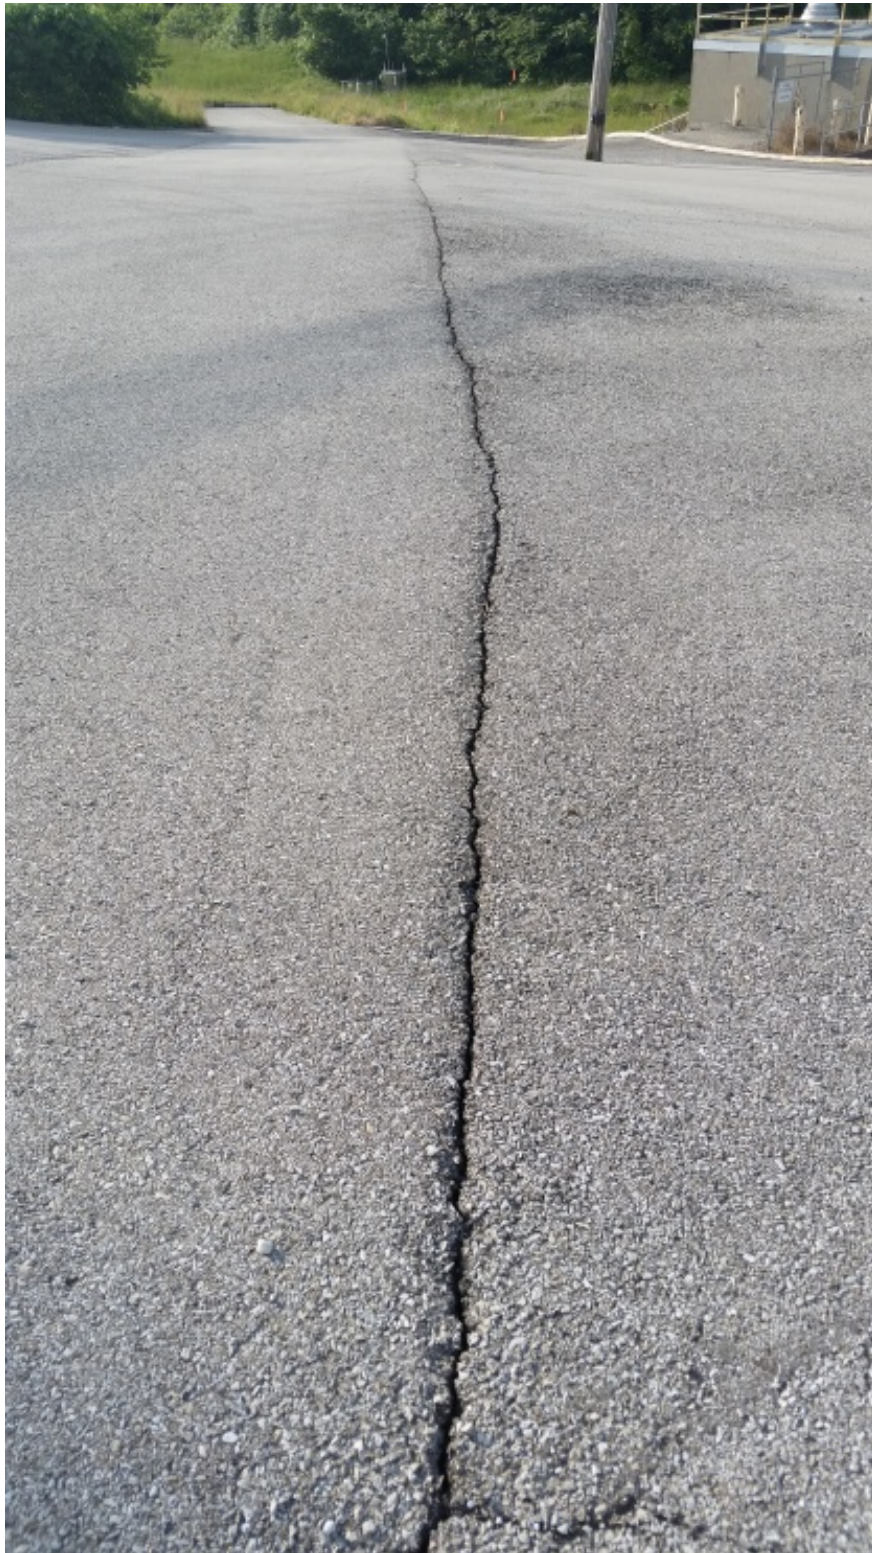
Photo 25: EA2 facing east, cracks in asphalt west of Parcel 205

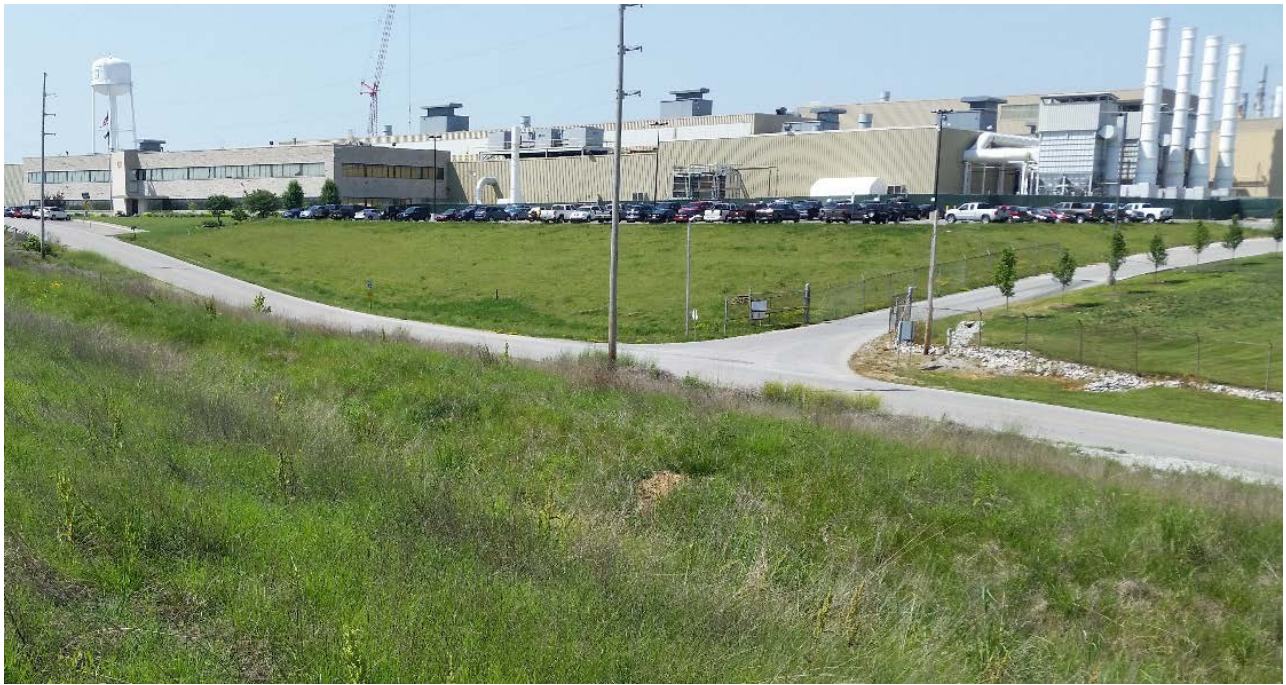
Photo 26: WV1 West Plant Area cover facing southwest

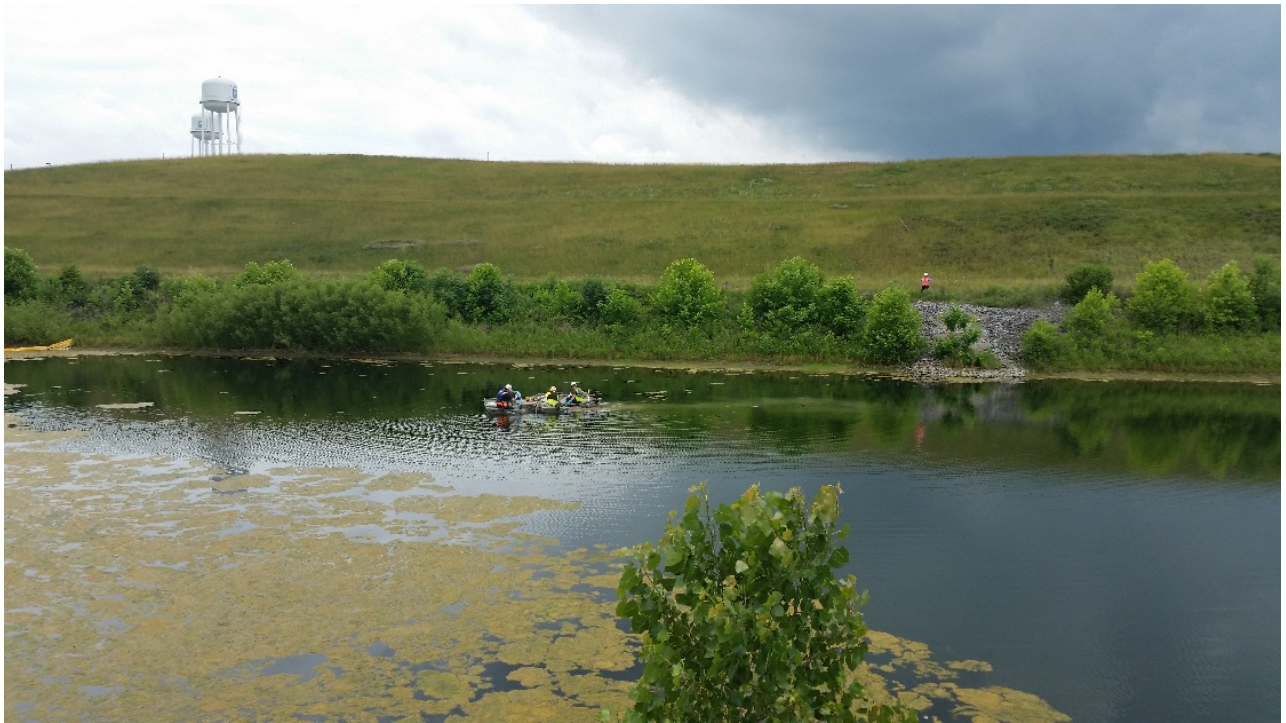
- The storm water pond required treatment with a chemical compound with the trade name “phoslock” in order to reduce the amount of algae buildup on the pond surface. The phoslock was applied by CRA crew in a boat, under the direction of the firm Jones Fish, in June 2015.

Photo 27: Phoslock Application in the stormwater pond facing southwest
