Re: RCRA Corrective Action Administrative Order on Consent (AOC)  
Progress Report 84, October 2022 through March 2023  
GM Casting Operations Bedford Facility, ID 006036099, Docket No. RCRA 05 2017 0011  
Bedford, Indiana

**Field Inspection Form and Photos**

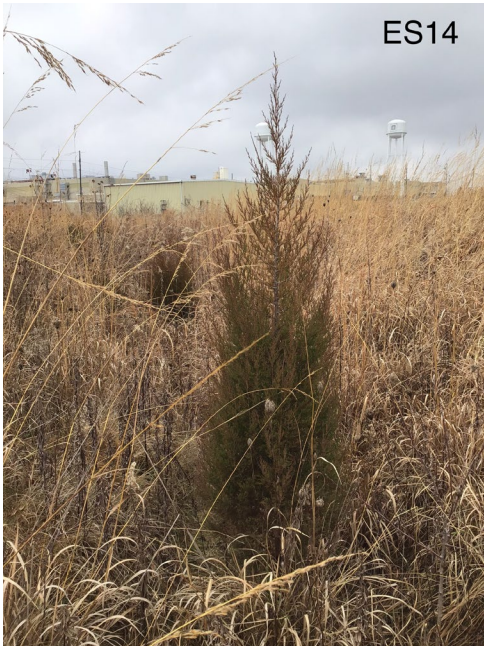
The cover system inspections have noted sapling growth, primarily in the ditches and at the edges of the cover system, are increasingly more difficult to pull by hand and with the use of a T-post remover. The subcontractor responsible for mowing the landfill has been contracted to pull these saplings using powered equipment. The work is scheduled to be conducted in the spring.

**Photo 1**    *Looking northwest, example of sapling to be removed*

11. Pull saplings within the cover system
12. Submit revised CMP and LTOMMP
13. Submit the EI CA750 Sampling Results Second Half 2022
14. Submit the sampling summary for the second half 2022 EI CA750 monitoring

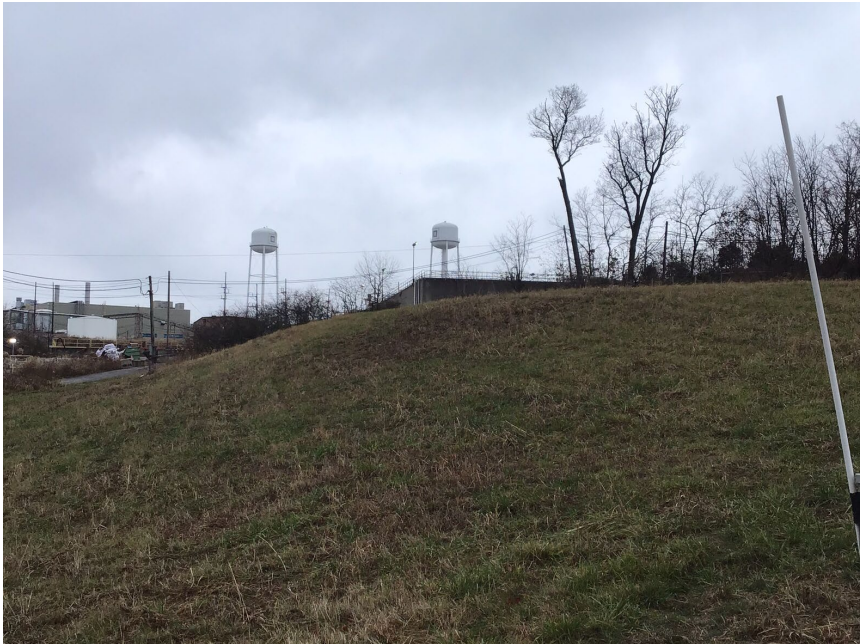
**Photo 2**    *Looking west, ground surface conditions conditions*

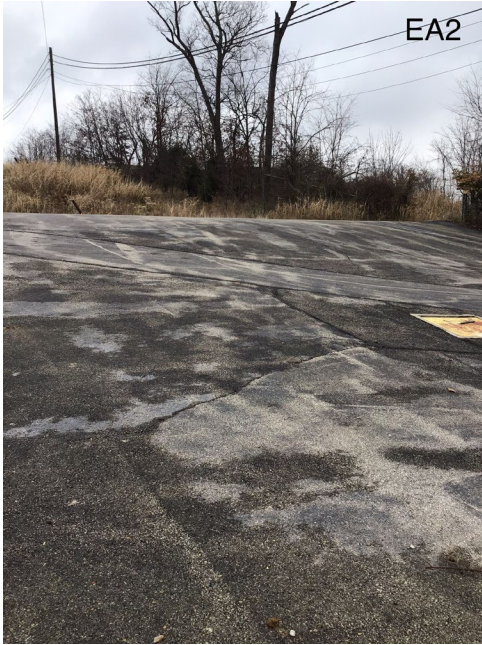
Cover system inspections also noted that the asphalt cover system cracks are widening. These cracks will need to be cleaned and sealed. Due to construction activities related to the Phase II Trench, we will look at scheduling the asphalt work in early Fall, coinciding with the completion of the trench.

**Photo 3** Looking north, example of asphalt cracks to be filled

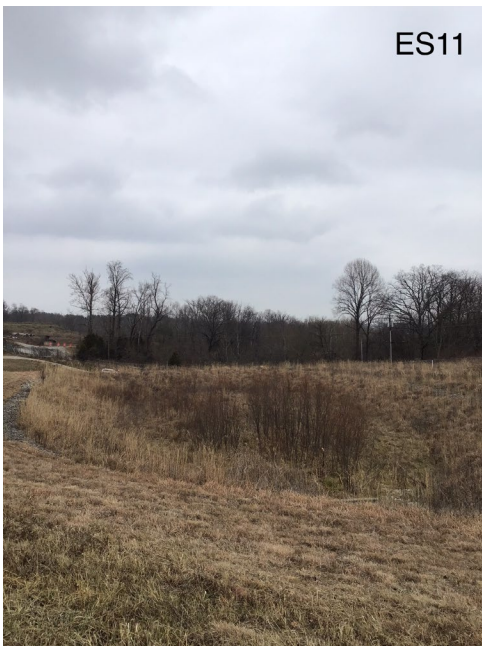
**Photo 4** Looking south, general site conditions

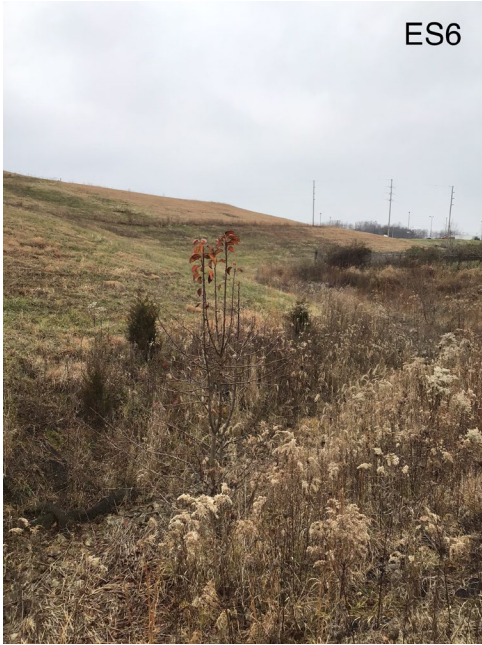
**Photo 5** *Looking west, general site conditions*

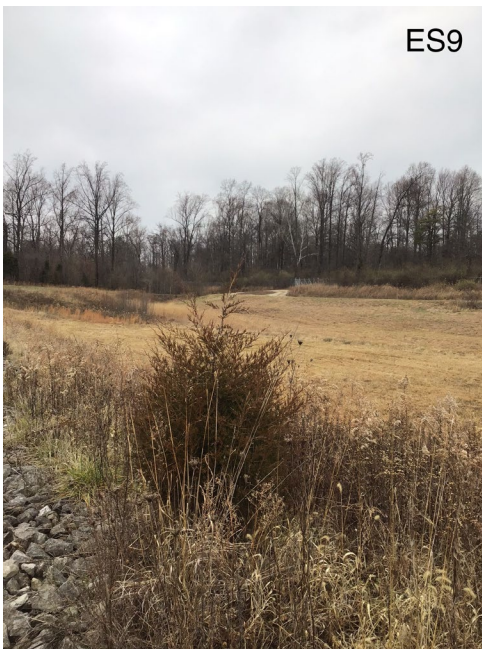
**Photo 6** *Looking northwest, general site conditions*
