Re: RCRA Corrective Action Administrative Order on Consent (AOC)
Progress Report 86, October 2023 through March 2024
GM Casting Operations Bedford Facility, ID 006036099, Docket No. RCRA 05 2017 0011
Bedford, Indiana

**COVER SYSTEMS INSPECTION LOG
CONSTRUCTION CERTIFICATION REPORT EAST PLANT COVER SYSTEM
GM CET BEDFORD FACILITY**

Date of Inspection: 11/20/2023
Inspector: Scott Sholar

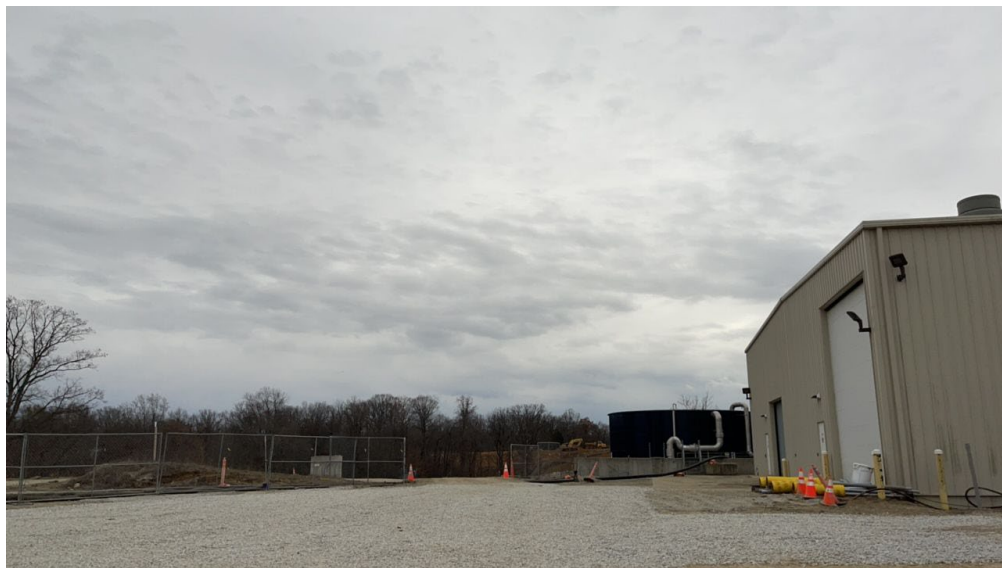
Photo 10 - Transect: Access Road - View Looking South

- EROSION	<input checked="" type="checkbox"/>	<input type="checkbox"/>				
	- OBSTRUCTIONS/DEBRIS	<input type="checkbox"/>	<input checked="" type="checkbox"/>		Covered with stone backfill with ongoing pilot trench construction.
