Re: RCRA Corrective Action Administrative Order on Consent (AOC)
Progress Report 75, Fourth Quarter 2019
GM GPS – Bedford Facility, ID 006036099, Docket No. RCRA 05 2017 0011
Bedford, Indiana

Cover System Inspection Fourth Quarter 2019

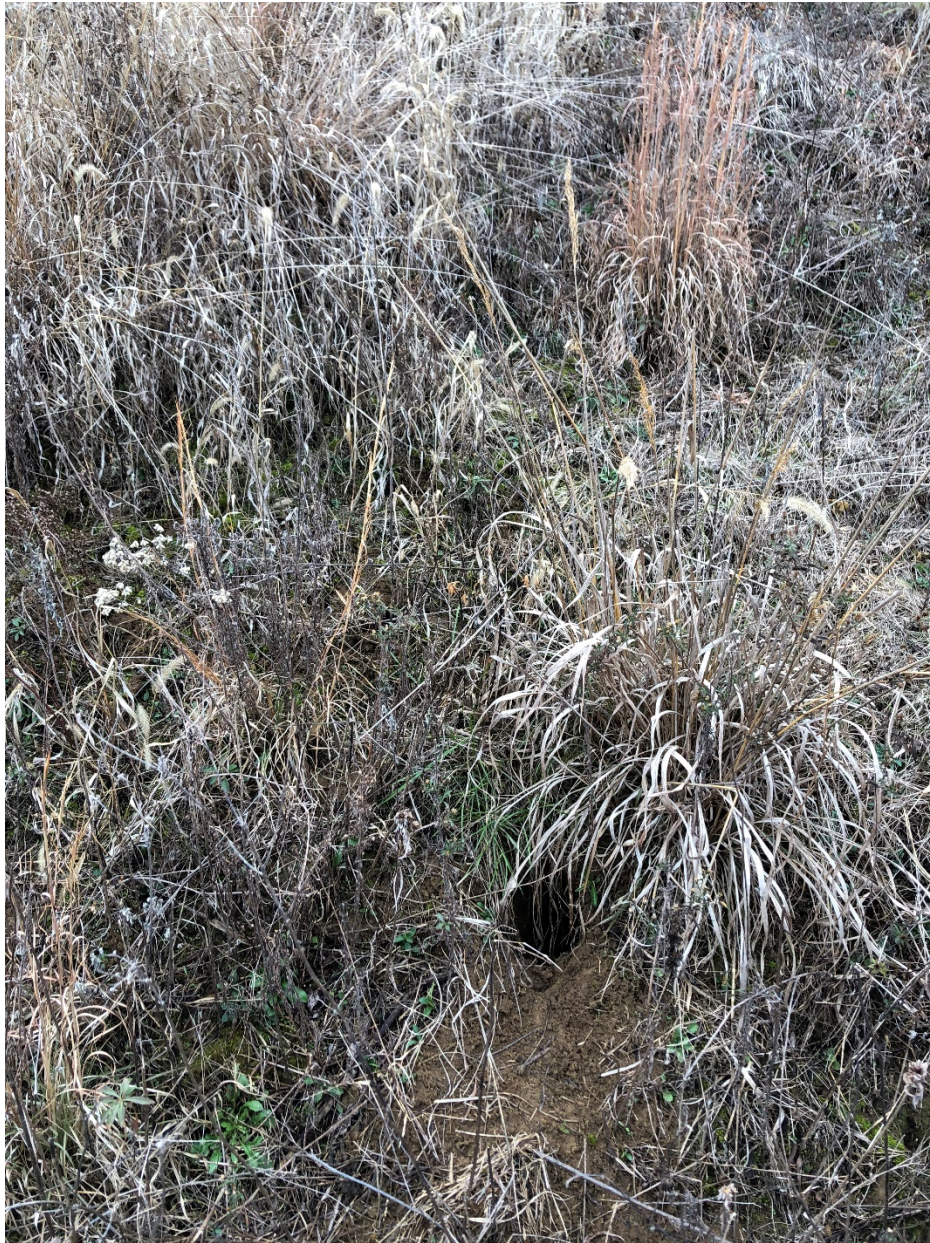
Photo 1: Observation of burrows at east side of ES14; facing north

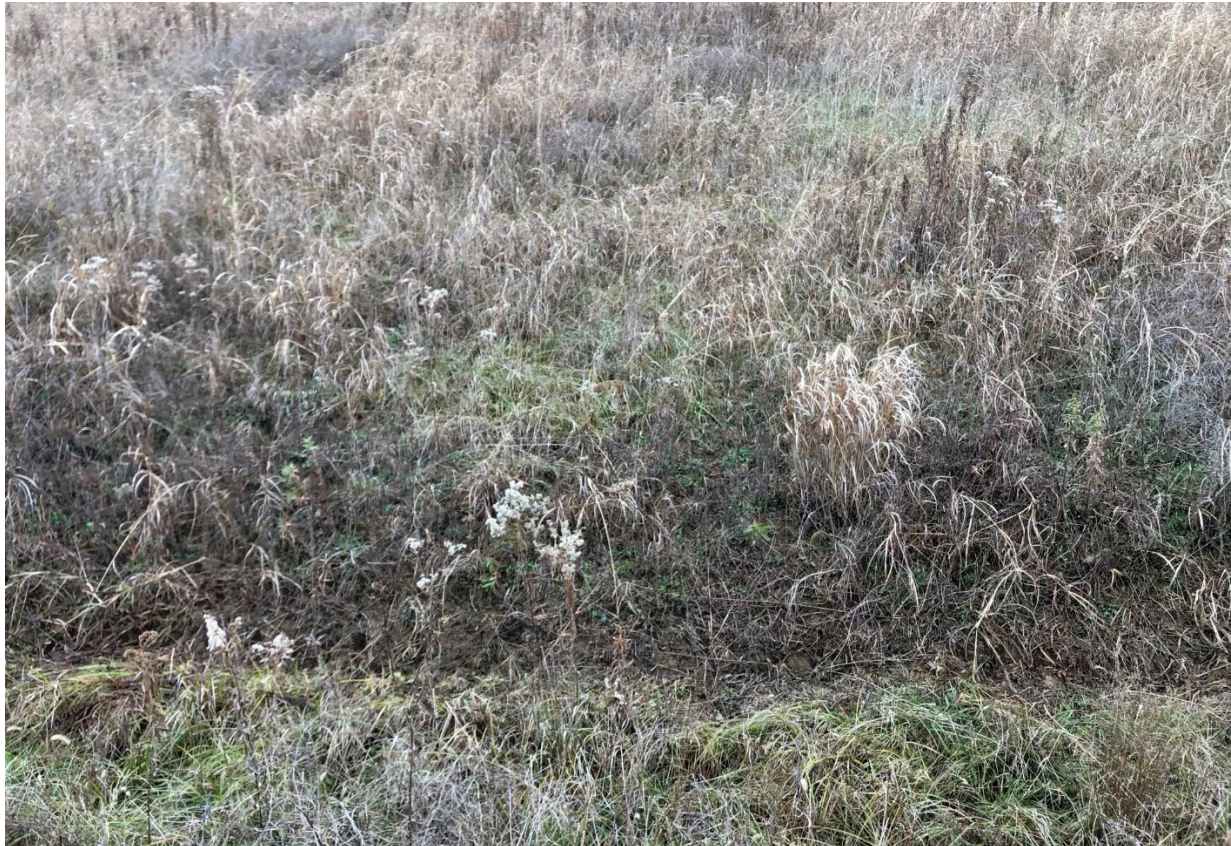
Photo 2: Evidence of erosion near WWTP; facing north

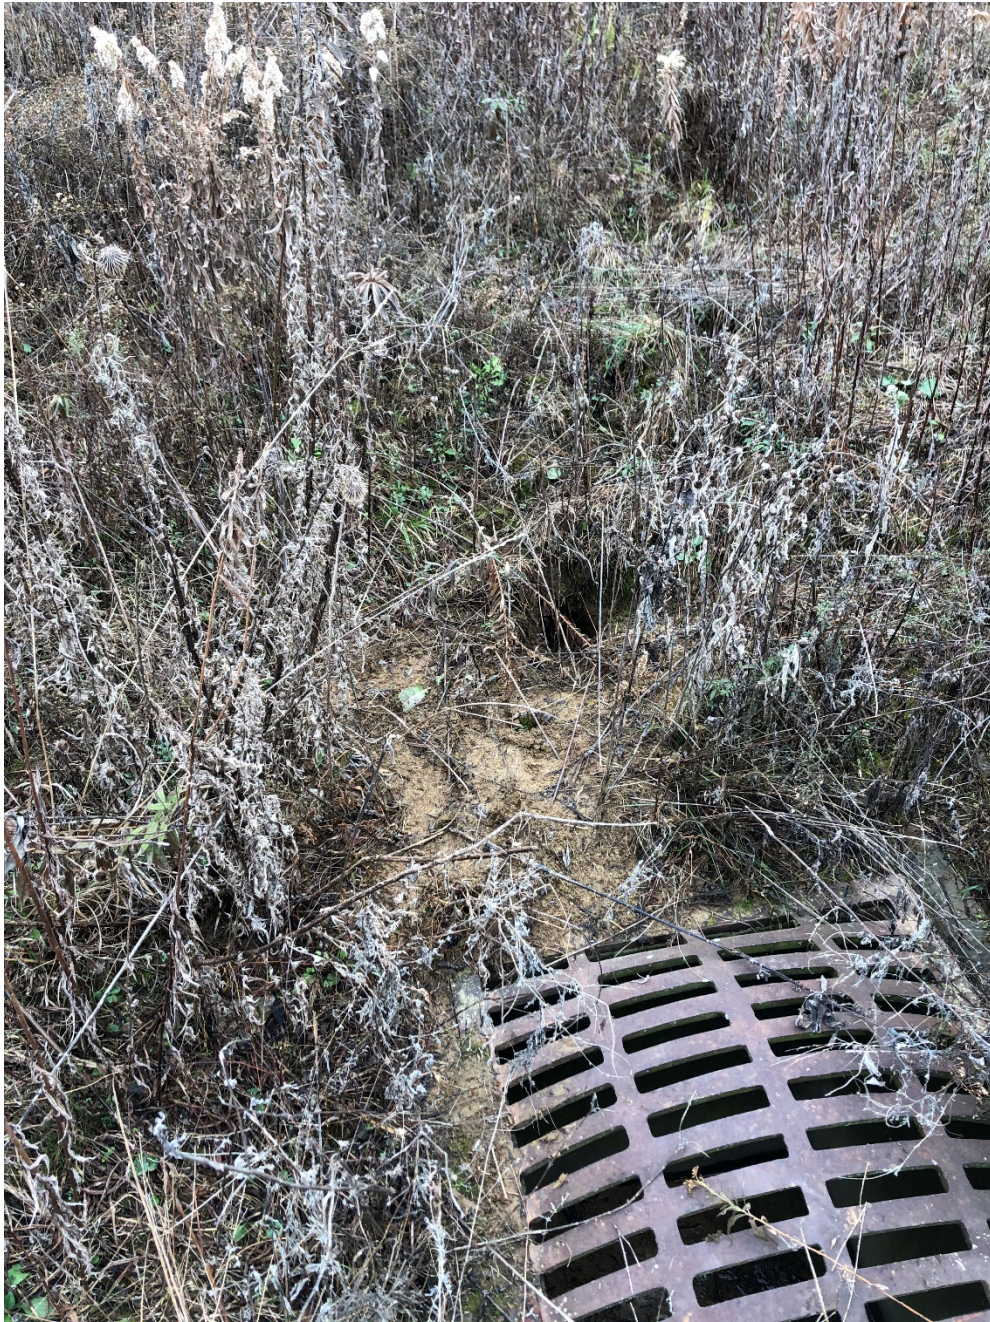
- SIGNS OF BURROWING BY ANIMALS	<input type="radio"/>	<input checked="" type="radio"/>		Picture saved on ipad27206	
	- ROOTING OF TREES	<input type="radio"/>	<input type="radio"/>			
Transect ES3	- QUALITY OF VEGETATIVE COVER - LENGTH OF GRASS - DEAD/DYING GRASS - GRASS COVERAGE - NOXIOUS WEEDS	<input type="radio"/>	<input type="radio"/>

Photo 3: Burrows near ES2 over Vault Cover System; facing southwest
