Re: RCRA Corrective Action Administrative Order on Consent (AOC)
Progress Report 65, Second Quarter 2017
GM GPS – Bedford Facility, IND 006036099, Docket No. RCRA 05-2014-0011
Bedford, Indiana

Second Quarter 2017 Progress Report 65 Revision 1

GM GPS – Bedford Facility
105 GM Drive
Bedford, Indiana
EPA ID# IND006036099
AOC Docket No. RCRA 05 2014 0011

Appendix A
Second Quarter 2017 Cover System Inspection:
Field Logs, Transect Figures,
and Photograph Log

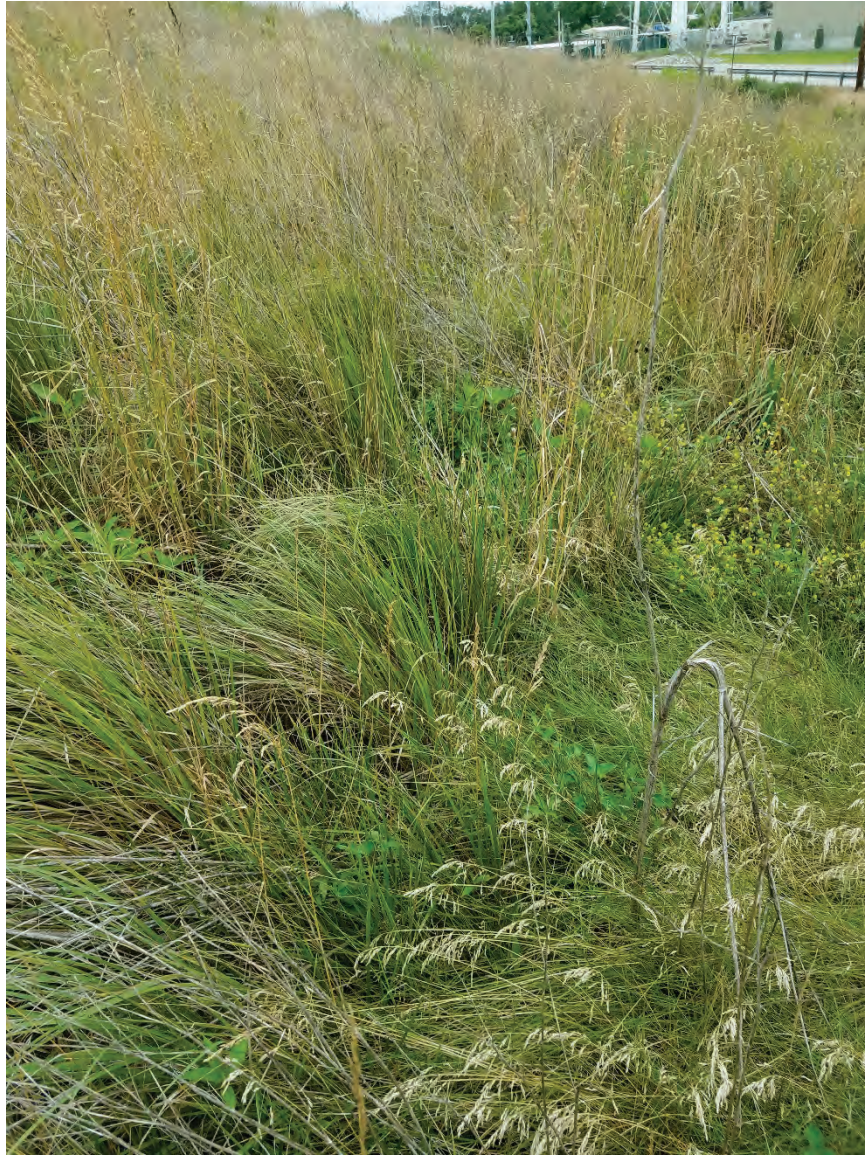
Photo 1: EV1 Vault Cover System west slope vegetation.

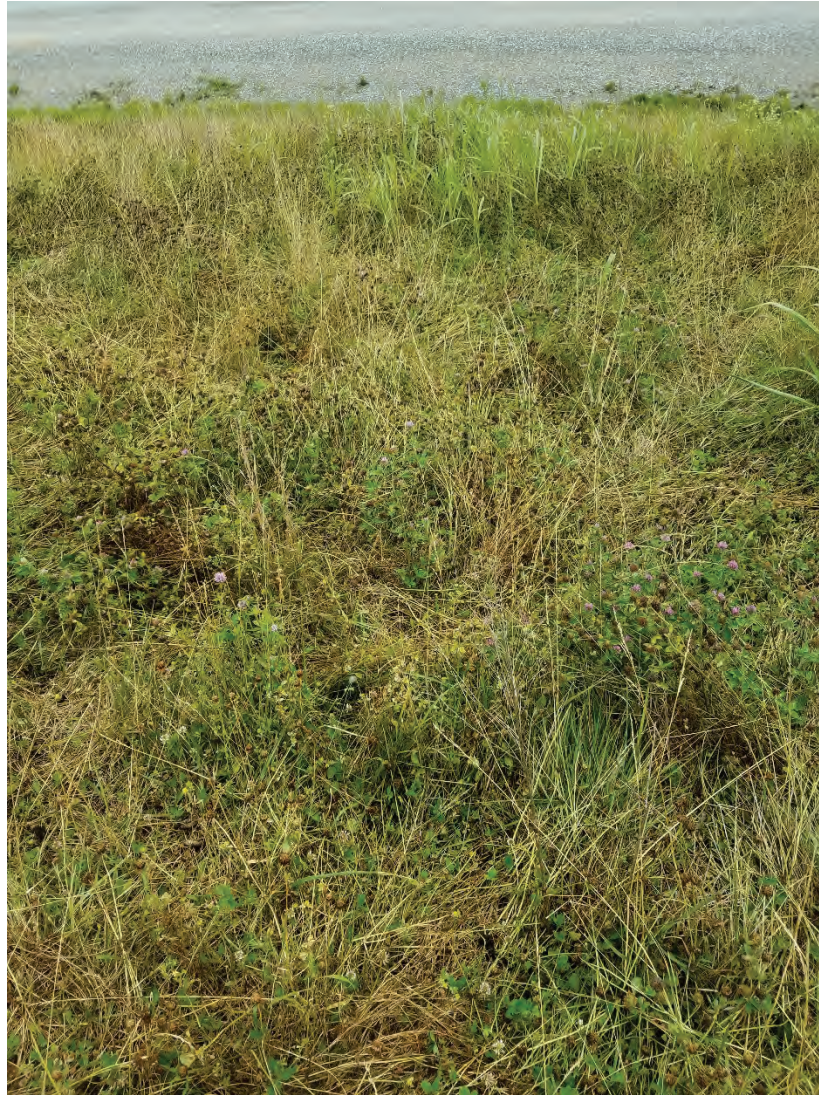
Photo 2: EV1 Vault Cover facing northeast toward pond

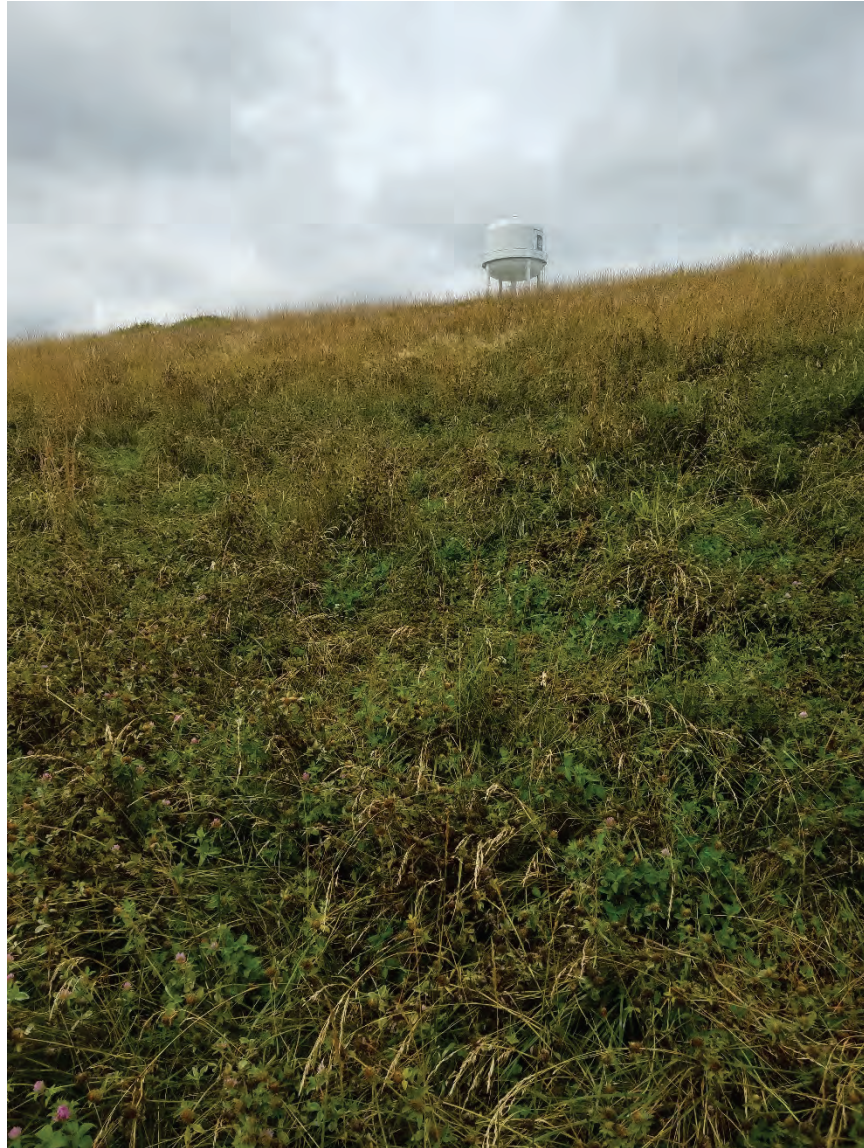
Photo 3: Vegetation at ES2 facing west.

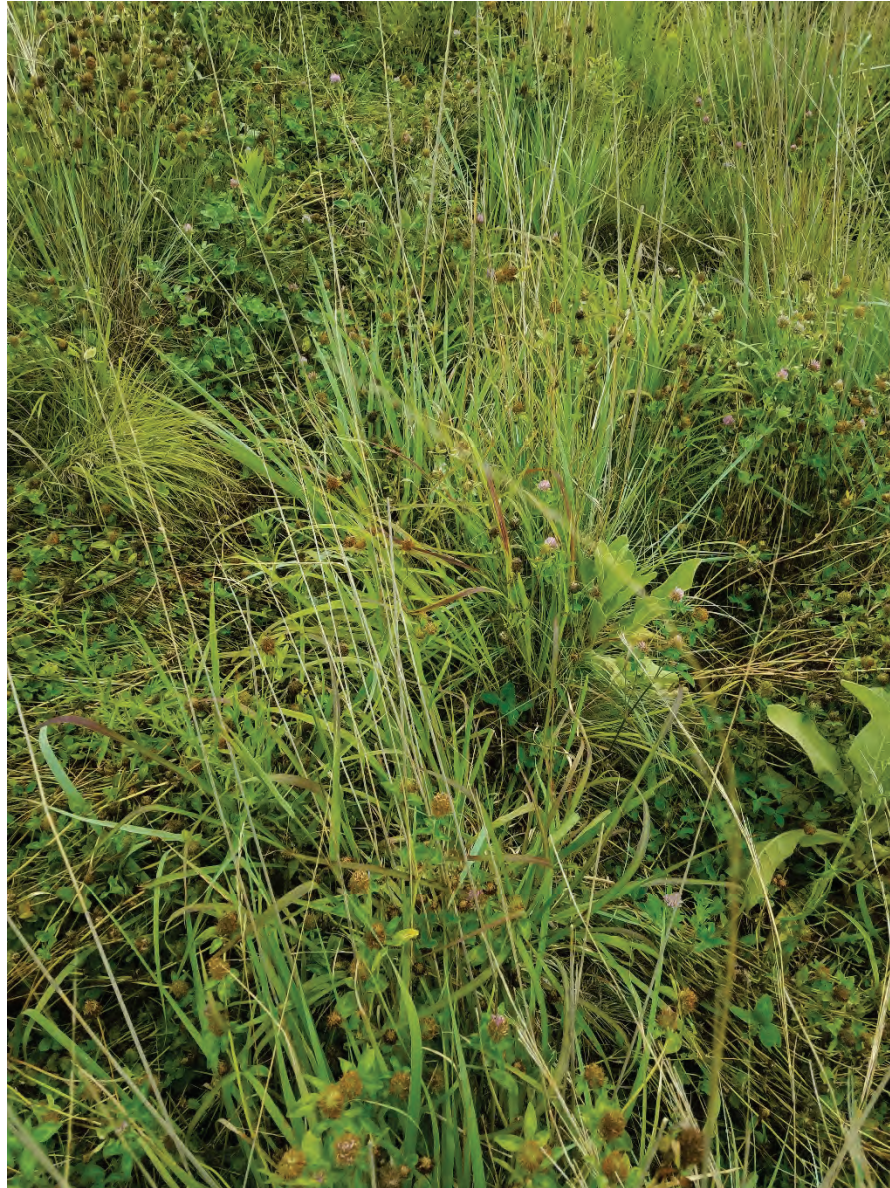
Photo 3: Vegetation growth at EV2

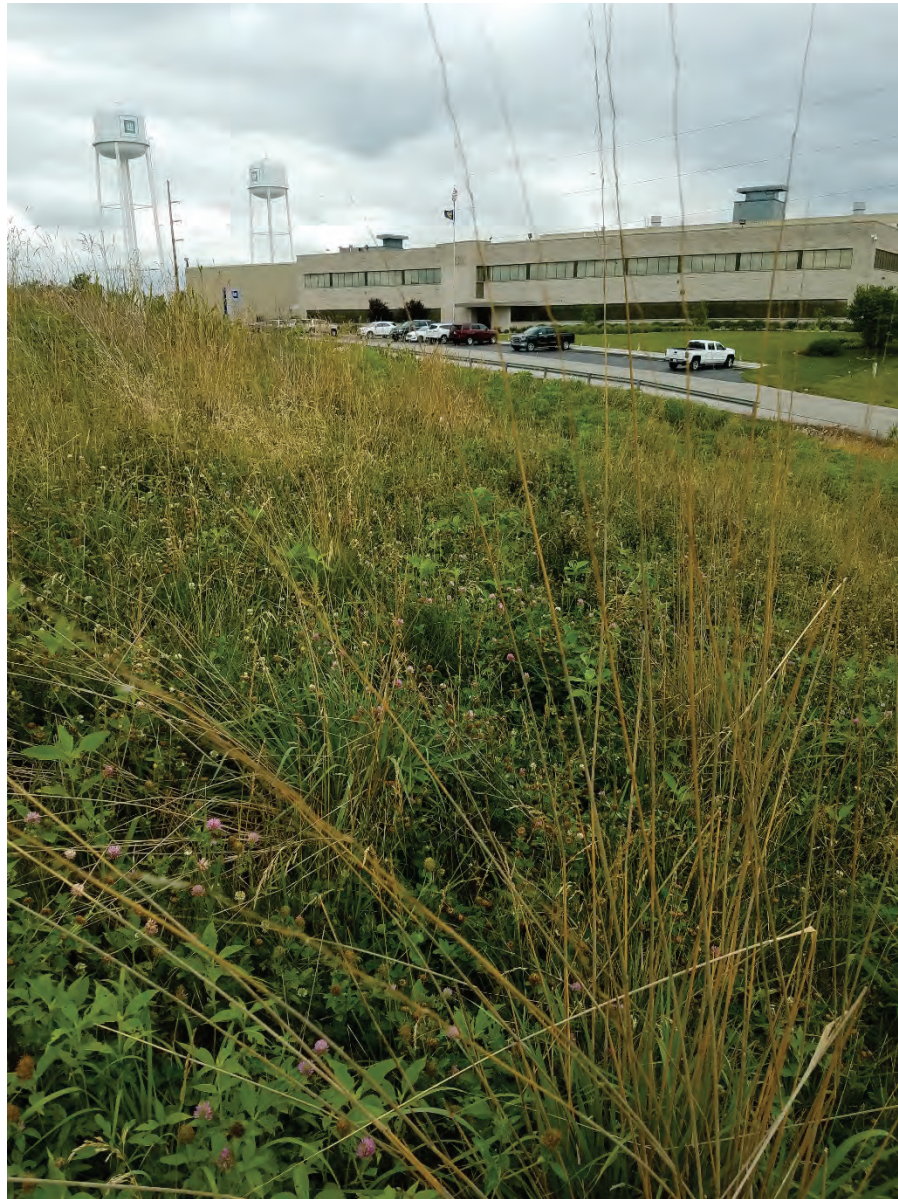
Photo 4: West of ES3 East Plant Area Cover, along GM Drive, facing south.

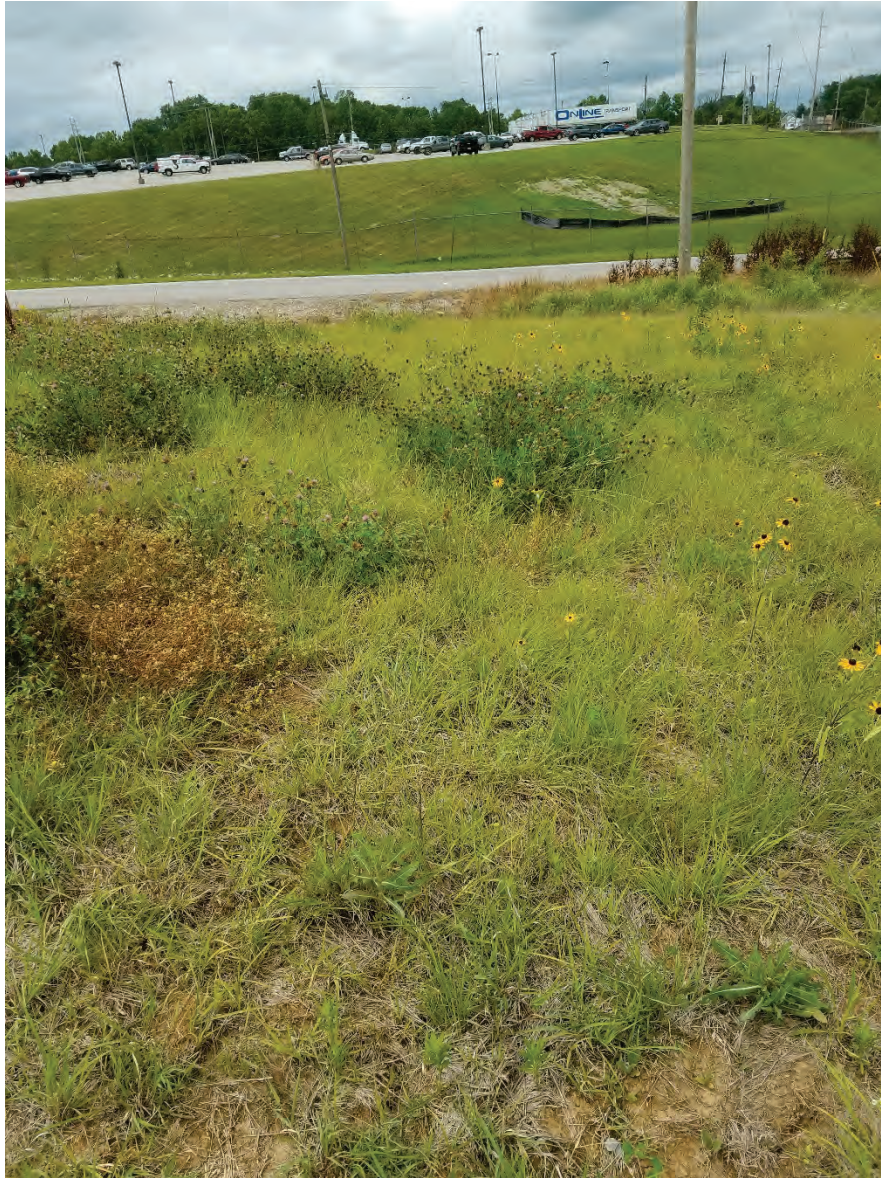
Photo 5: EV2 East Plant Area Cover facing west

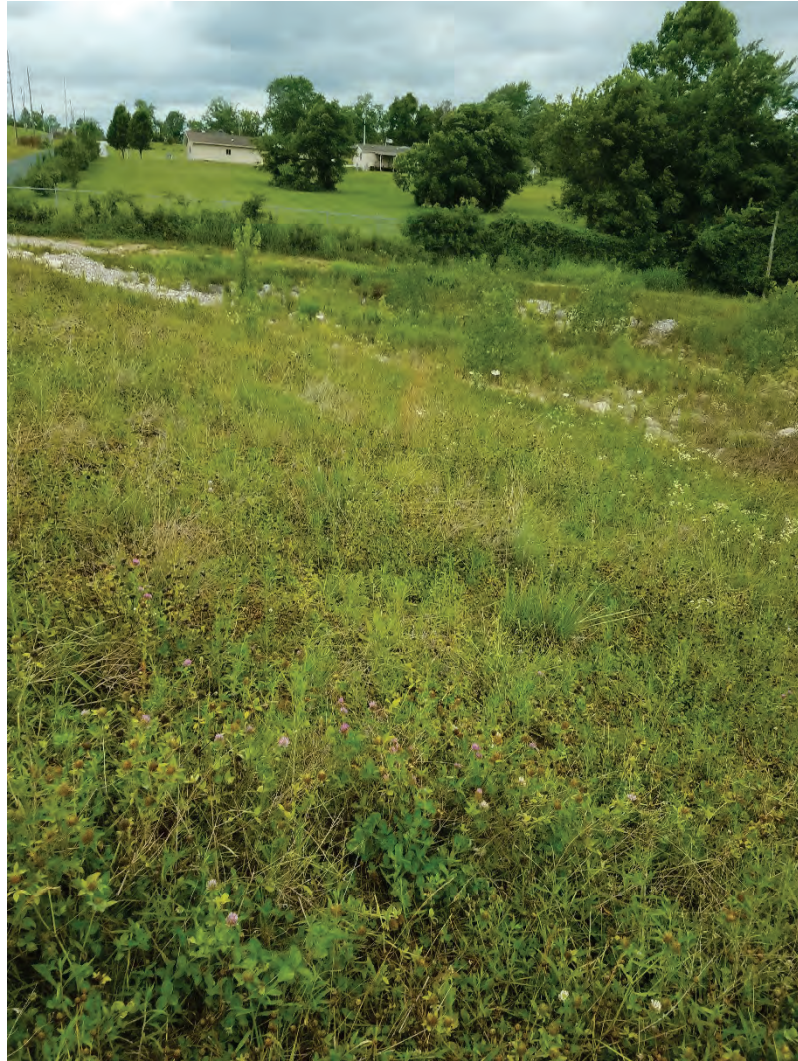
Photo 6: Drainage channel at ES6 East Plant Area Cover facing west.

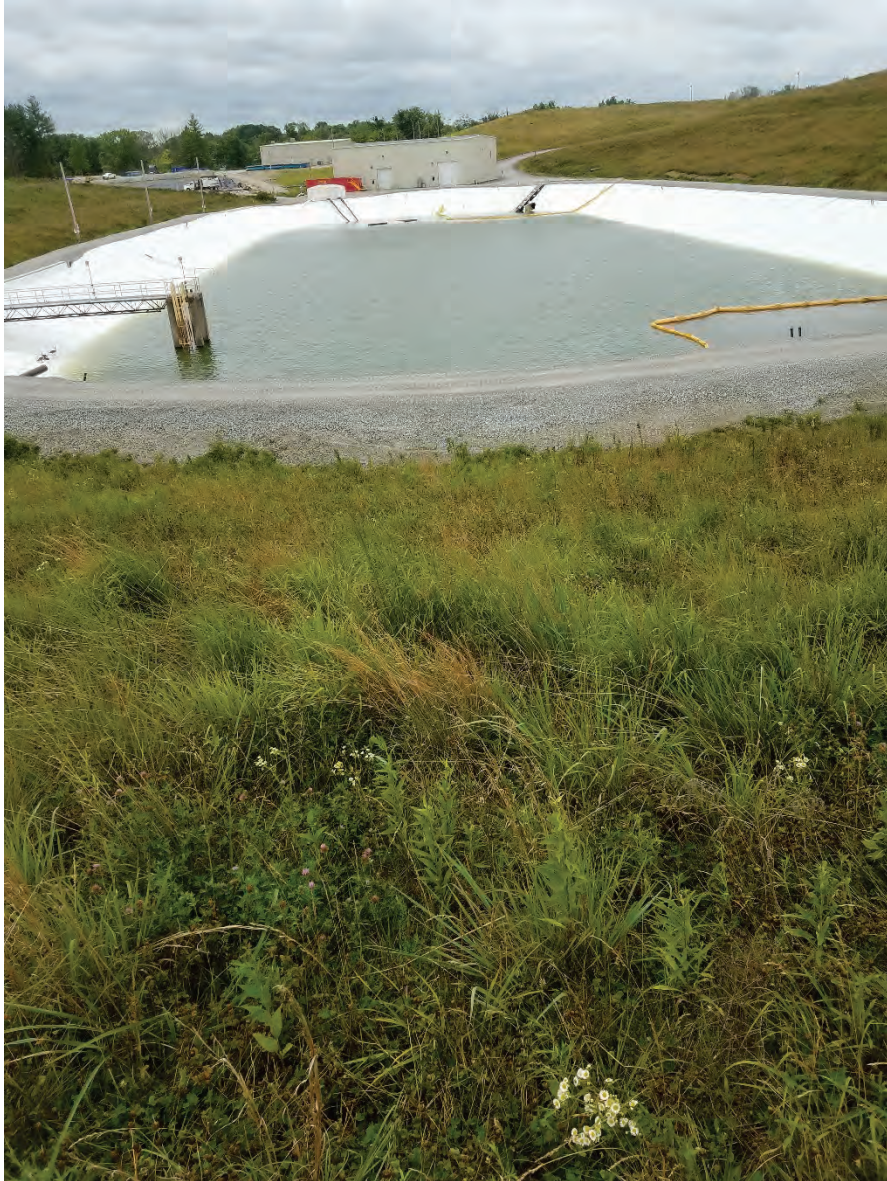
Photo 7: EV3 East Plant Area Cover facing south.

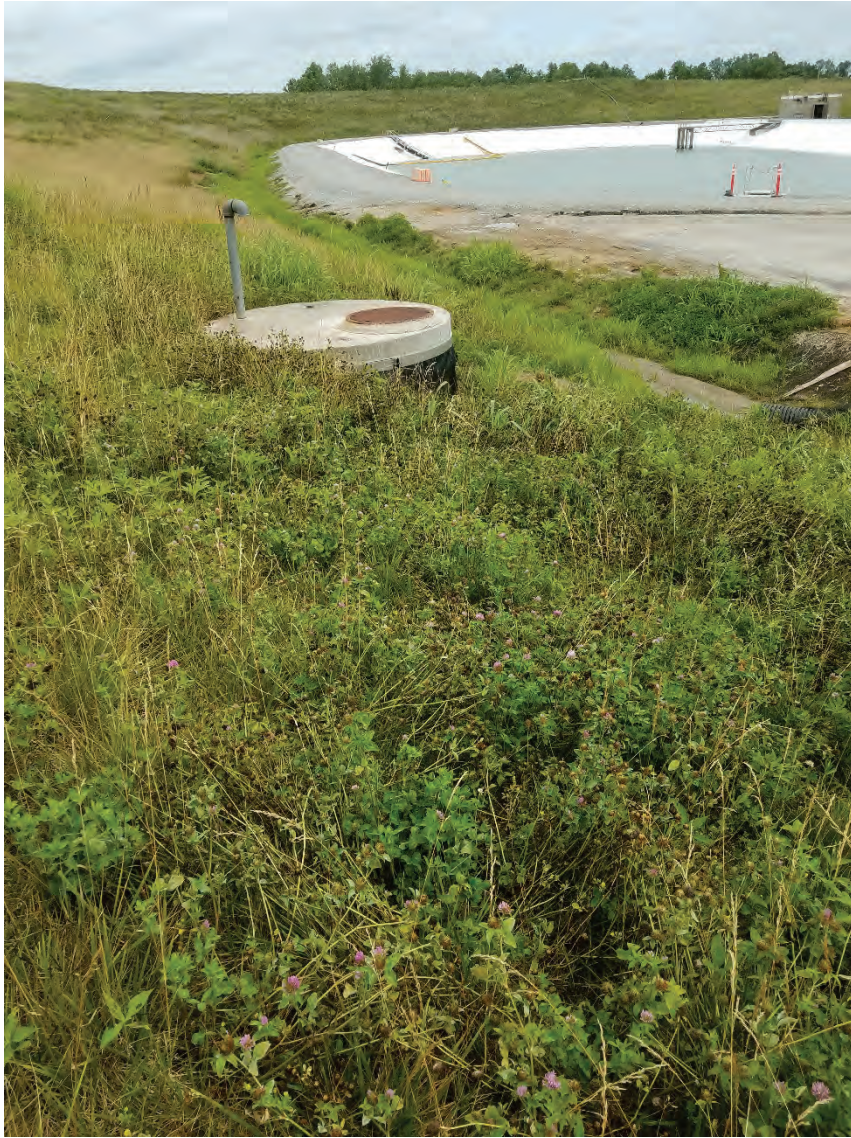
Photo 8: Vegetation growth on ES1 East Plant Area Cover at south end of Pond.

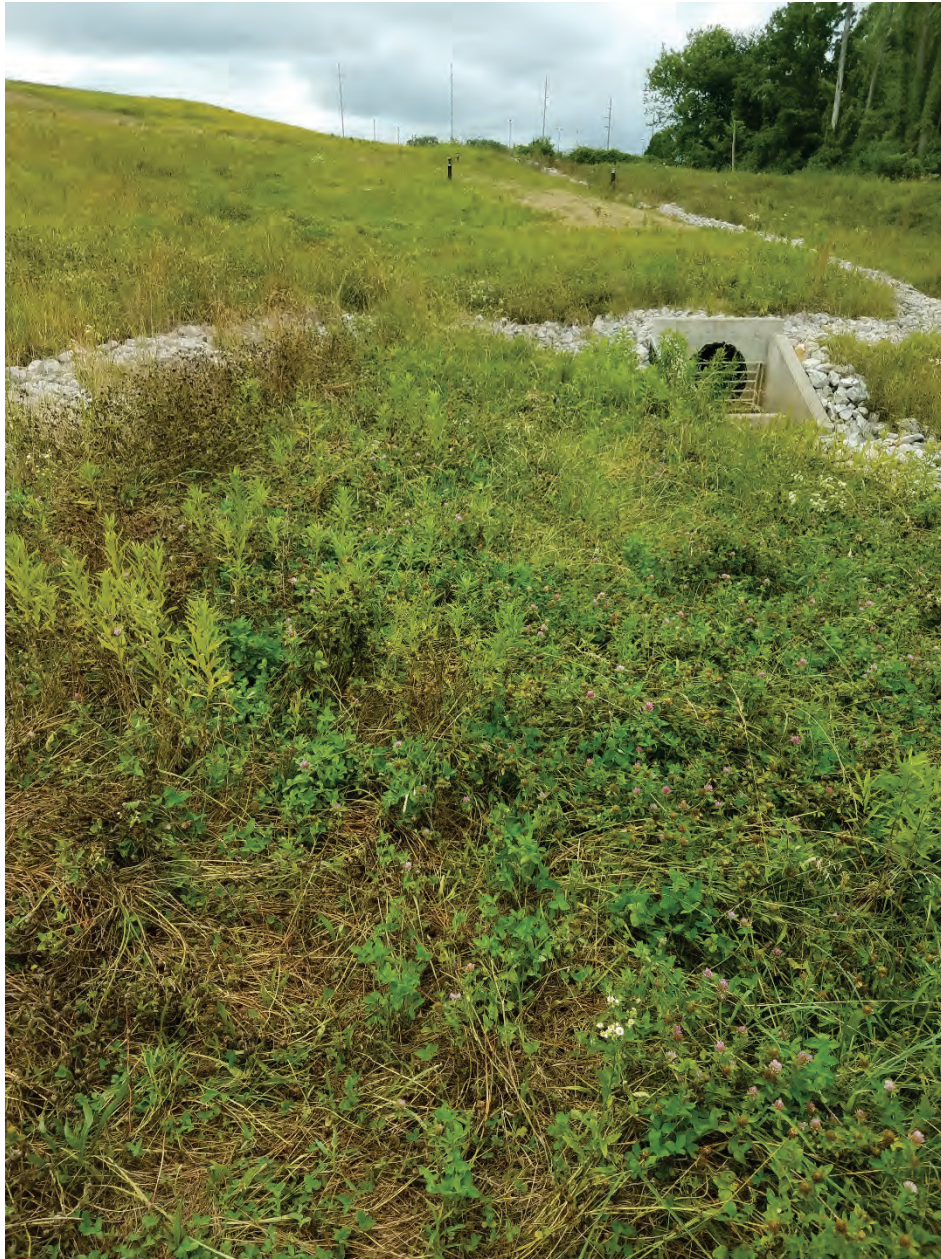
Photo 9: ES9 East Plant Area Cover detention basin 2 inlet

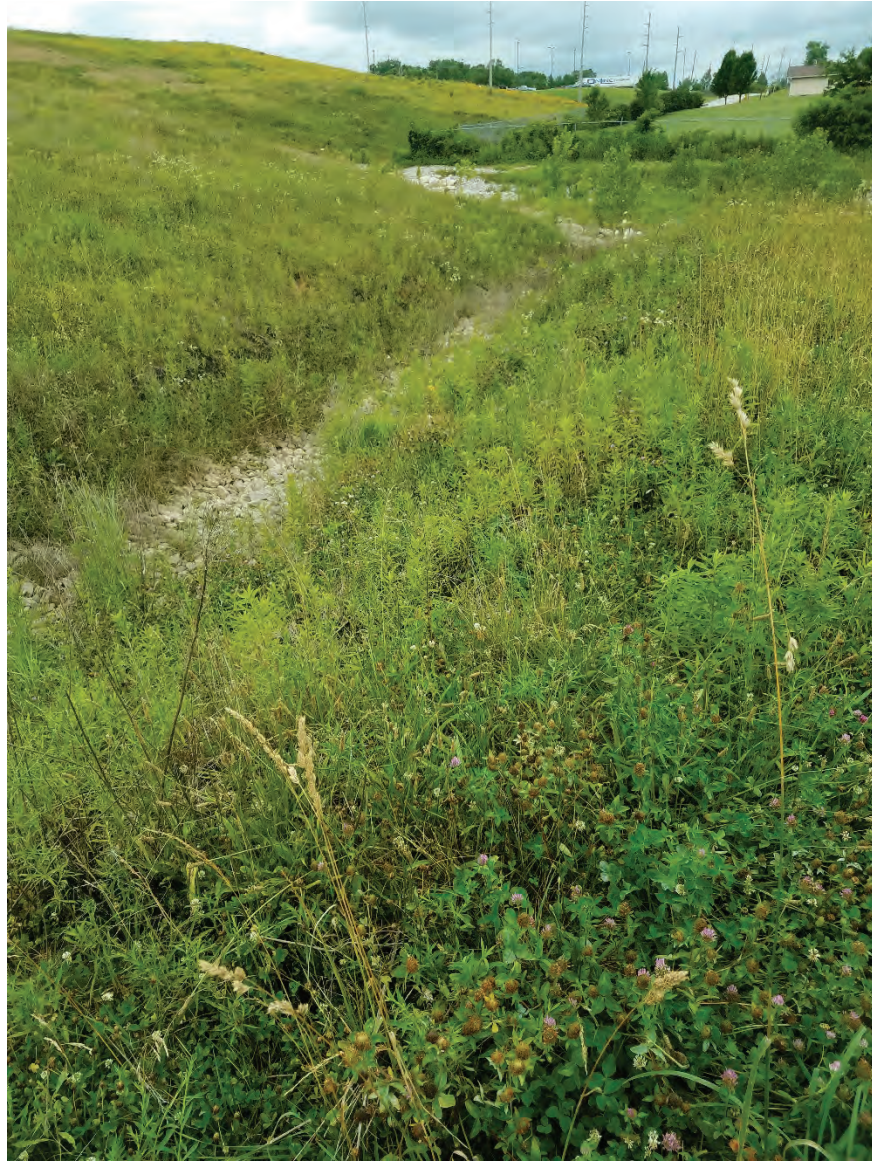
Photo 10: ES9 East Plant Cover System facing southwest

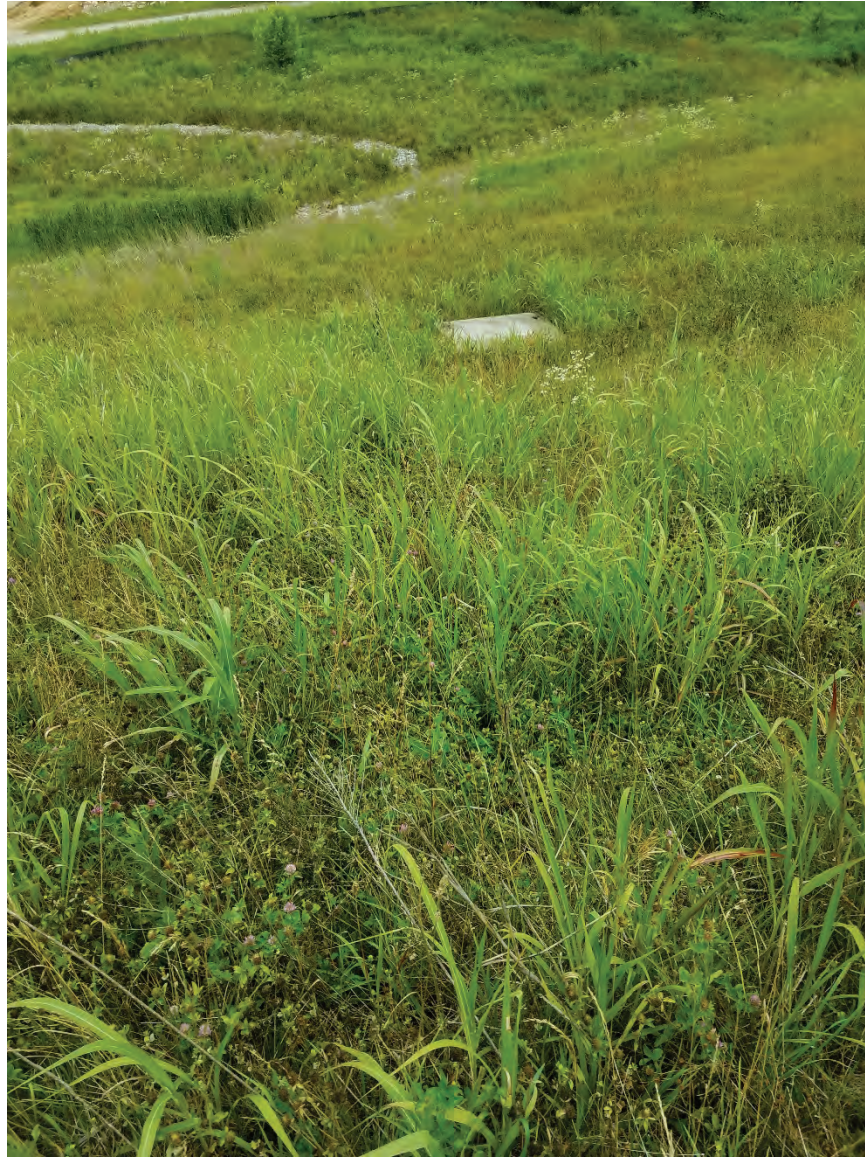
- EXPOSURE OF LINER					
	- EROSION					
	- LOCALIZED SETTLEMENT/SLUMPING					
	- PONDING OF WATER/DRAINAGE					
	- SIGNS OF BURROWING BY ANIMALS					
	- ROOTING OF TREES					
Transect EV4	- QUALITY OF VEGETATIVE COVER - LENGTH OF GRASS - DEAD/DYING GRASS - GRASS COVERAGE - NOXIOUS WEEDS	✓			Heavy weed growth some bare spots

- EXPOSURE OF LINER					
	- EROSION	✓			light erosion	
	- LOCALIZED SETTLEMENT/SLUMPING					
	- PONDING OF WATER/DRAINAGE					
	- SIGNS OF BURROWING BY ANIMALS

Photo 11: EV4 East Plant Area Cover looking northeast

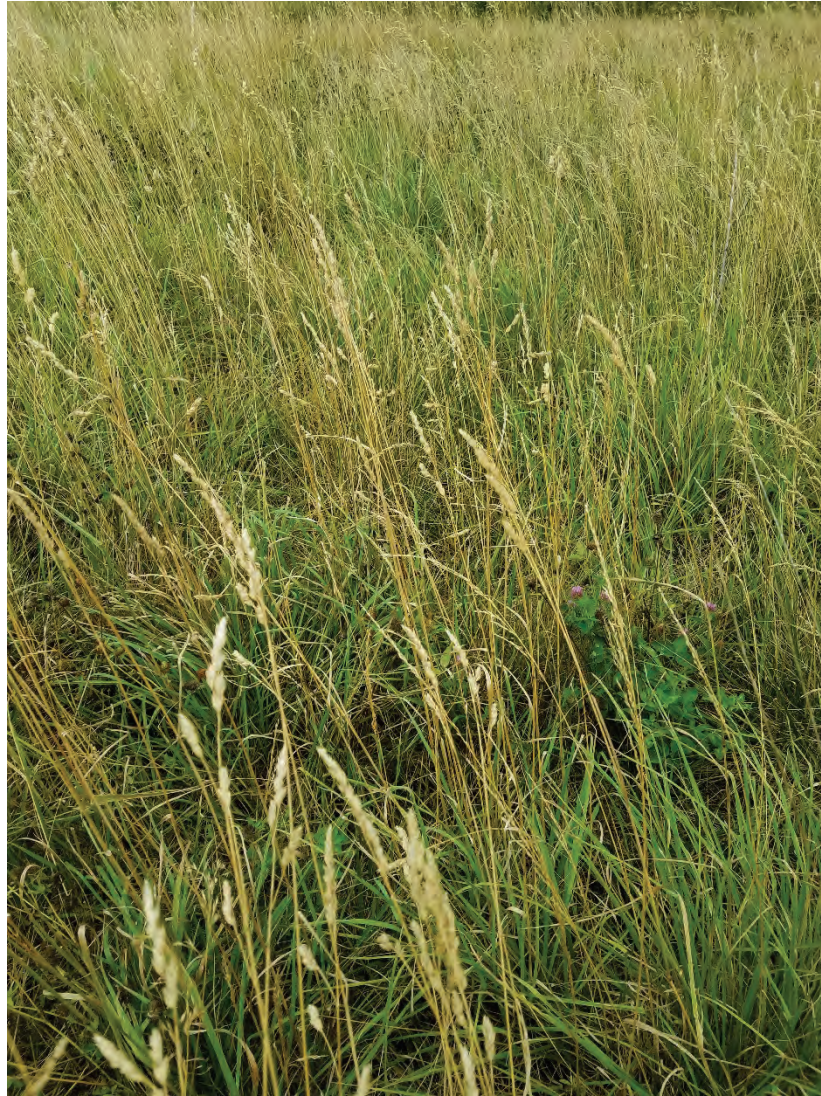
Photo 12: Vegetation growth southwest of ES2

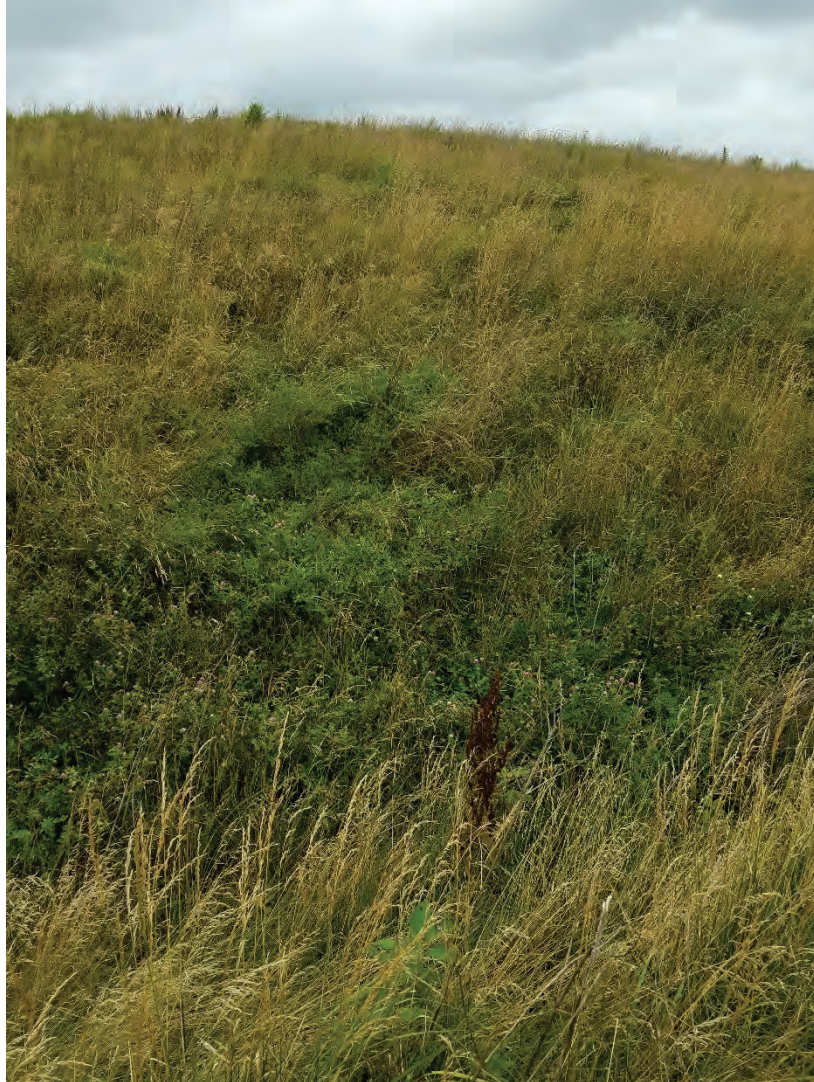
- ROOTING OF TREES					
Transect EV5	- QUALITY OF VEGETATIVE COVER - LENGTH OF GRASS - DEAD/DYING GRASS - GRASS COVERAGE - NOXIOUS WEEDS	✓			Heavy weed growth

- EXPOSURE OF LINER					
	- EROSION	✓			light erosion	
	- LOCALIZED SETTLEMENT/SLUMPING					
	- PONDING OF WATER/DRAINAGE					
	- SIGNS OF BURROWING BY ANIMALS

Photo 13: Vegetative growth along EV5 East Plant Area facing east, away from pond.

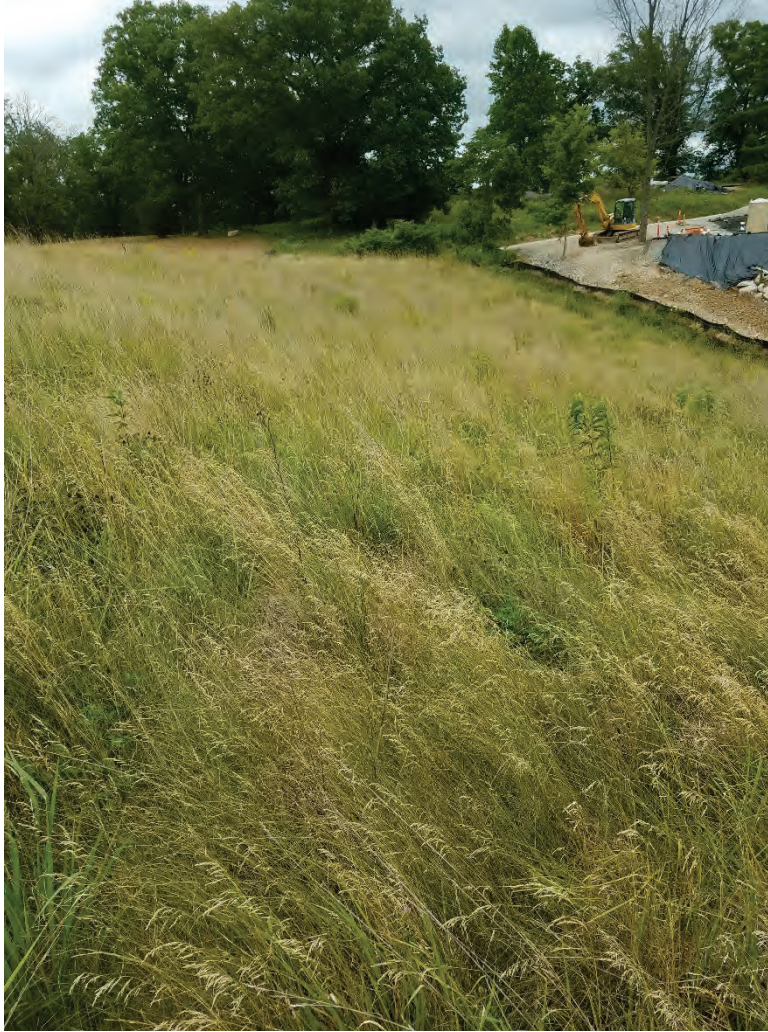
Photo 14: Vegetation growth at ES12 East Plant Area Cover facing Southeast.

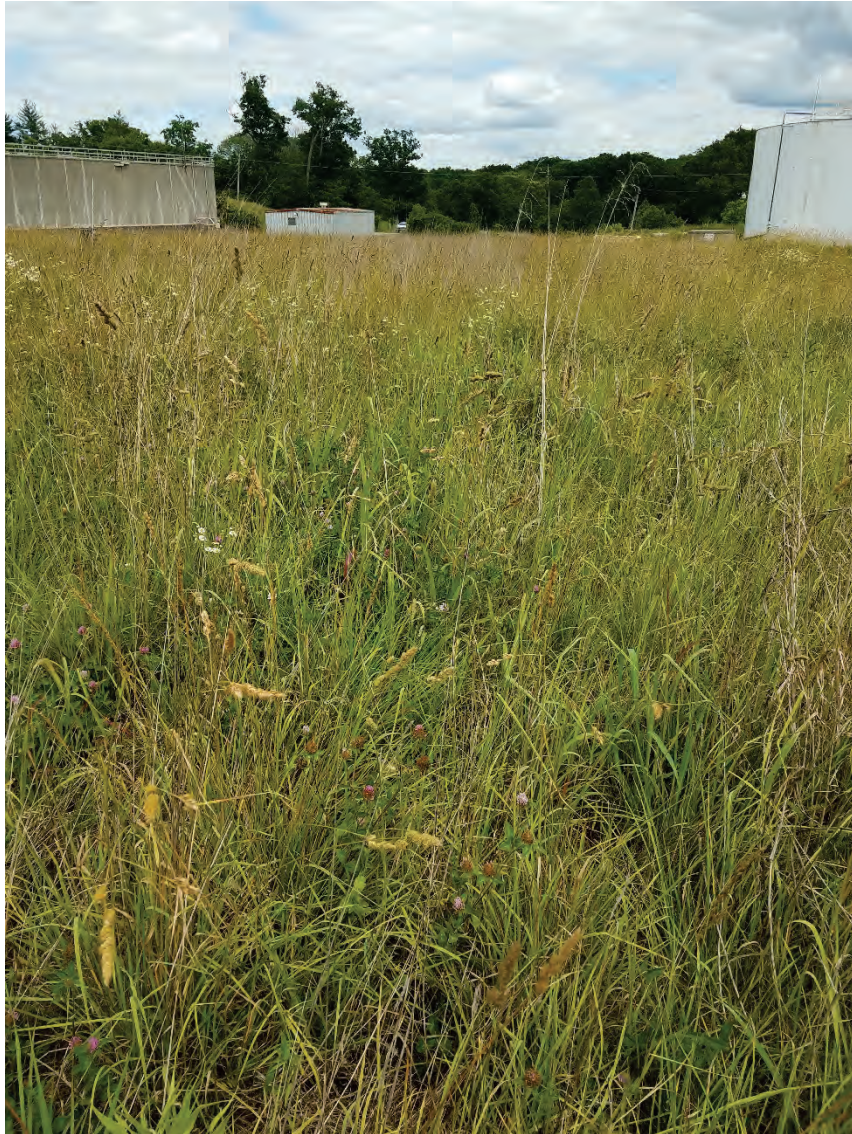
- LENGTH OF GRASS						
	- DEAD/DYING GRASS						
	- GRASS COVERAGE						
	- NOXIOUS WEEDS						
	- EXPOSURE OF LINER						
	- EROSION						
Transect EV7	- LOCALIZED SETTLEMENT/SLUMPING				Heavy weed growth some bare spots

Photo 15: Facing east along EV7 East Plant Cover.

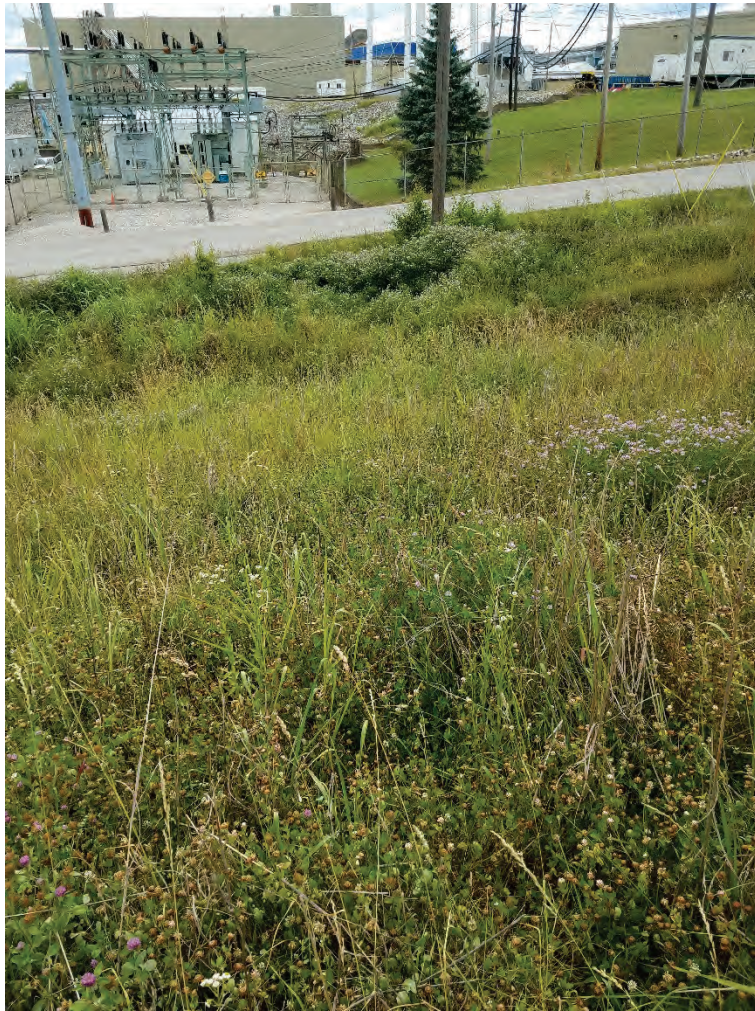
Photo 16: East Plant Area Cover System southeast of EV6, facing west.

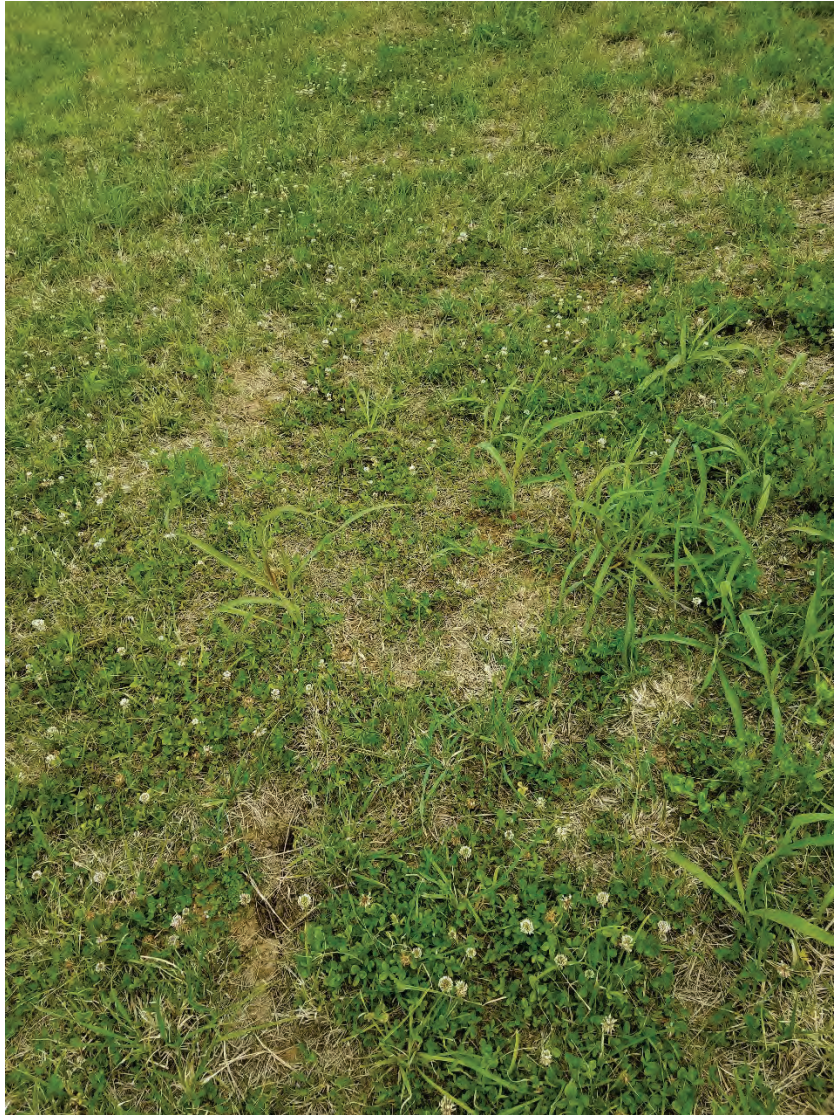
Photo 17: ES14 East Plant Area Cover patchy vegetation.

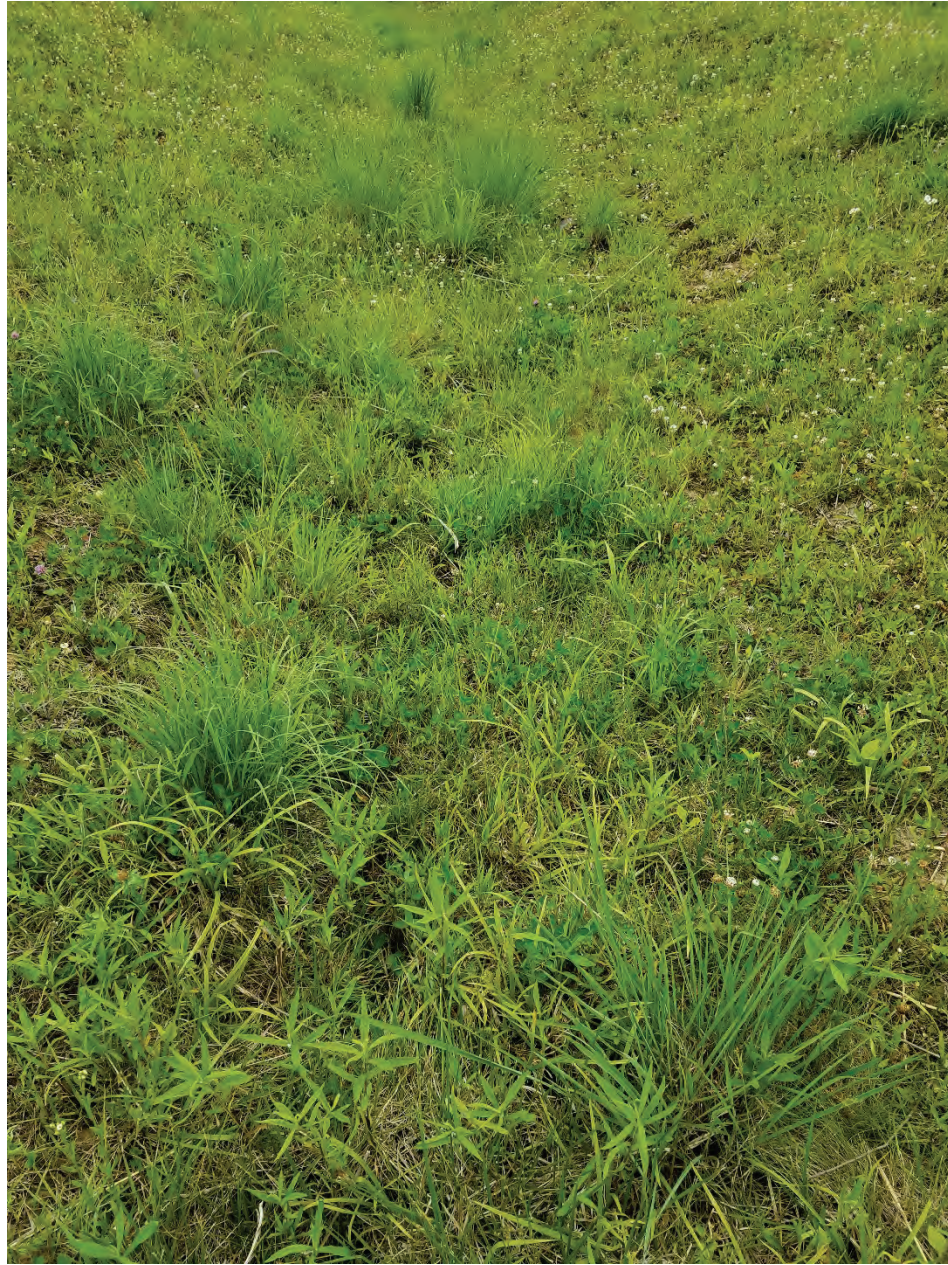
Photo 18: EV9 East Plant Area Cover vegetation growth.

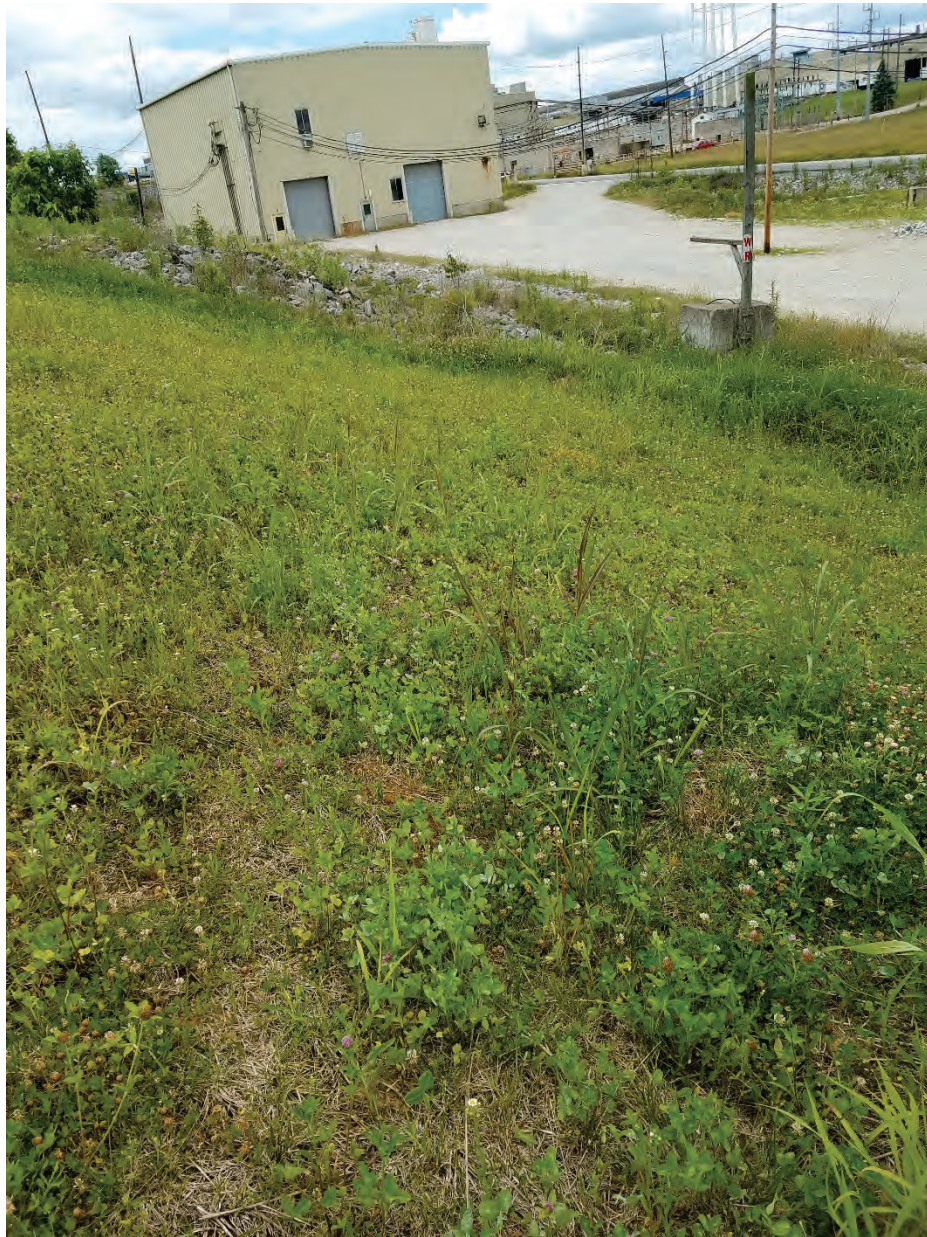
Photo 19: ES14 East Plant Area Cover vegetation facing west.
