Re: RCRA Corrective Action Administrative Order on Consent (AOC)
Progress Report 71, Fourth Quarter 2018
GM GPS – Bedford Facility, ID 006036099, Docket No. RCRA 05 2017 0011
Bedford, Indiana

Appendix A

Cover System Inspection Fourth Quarter 2018

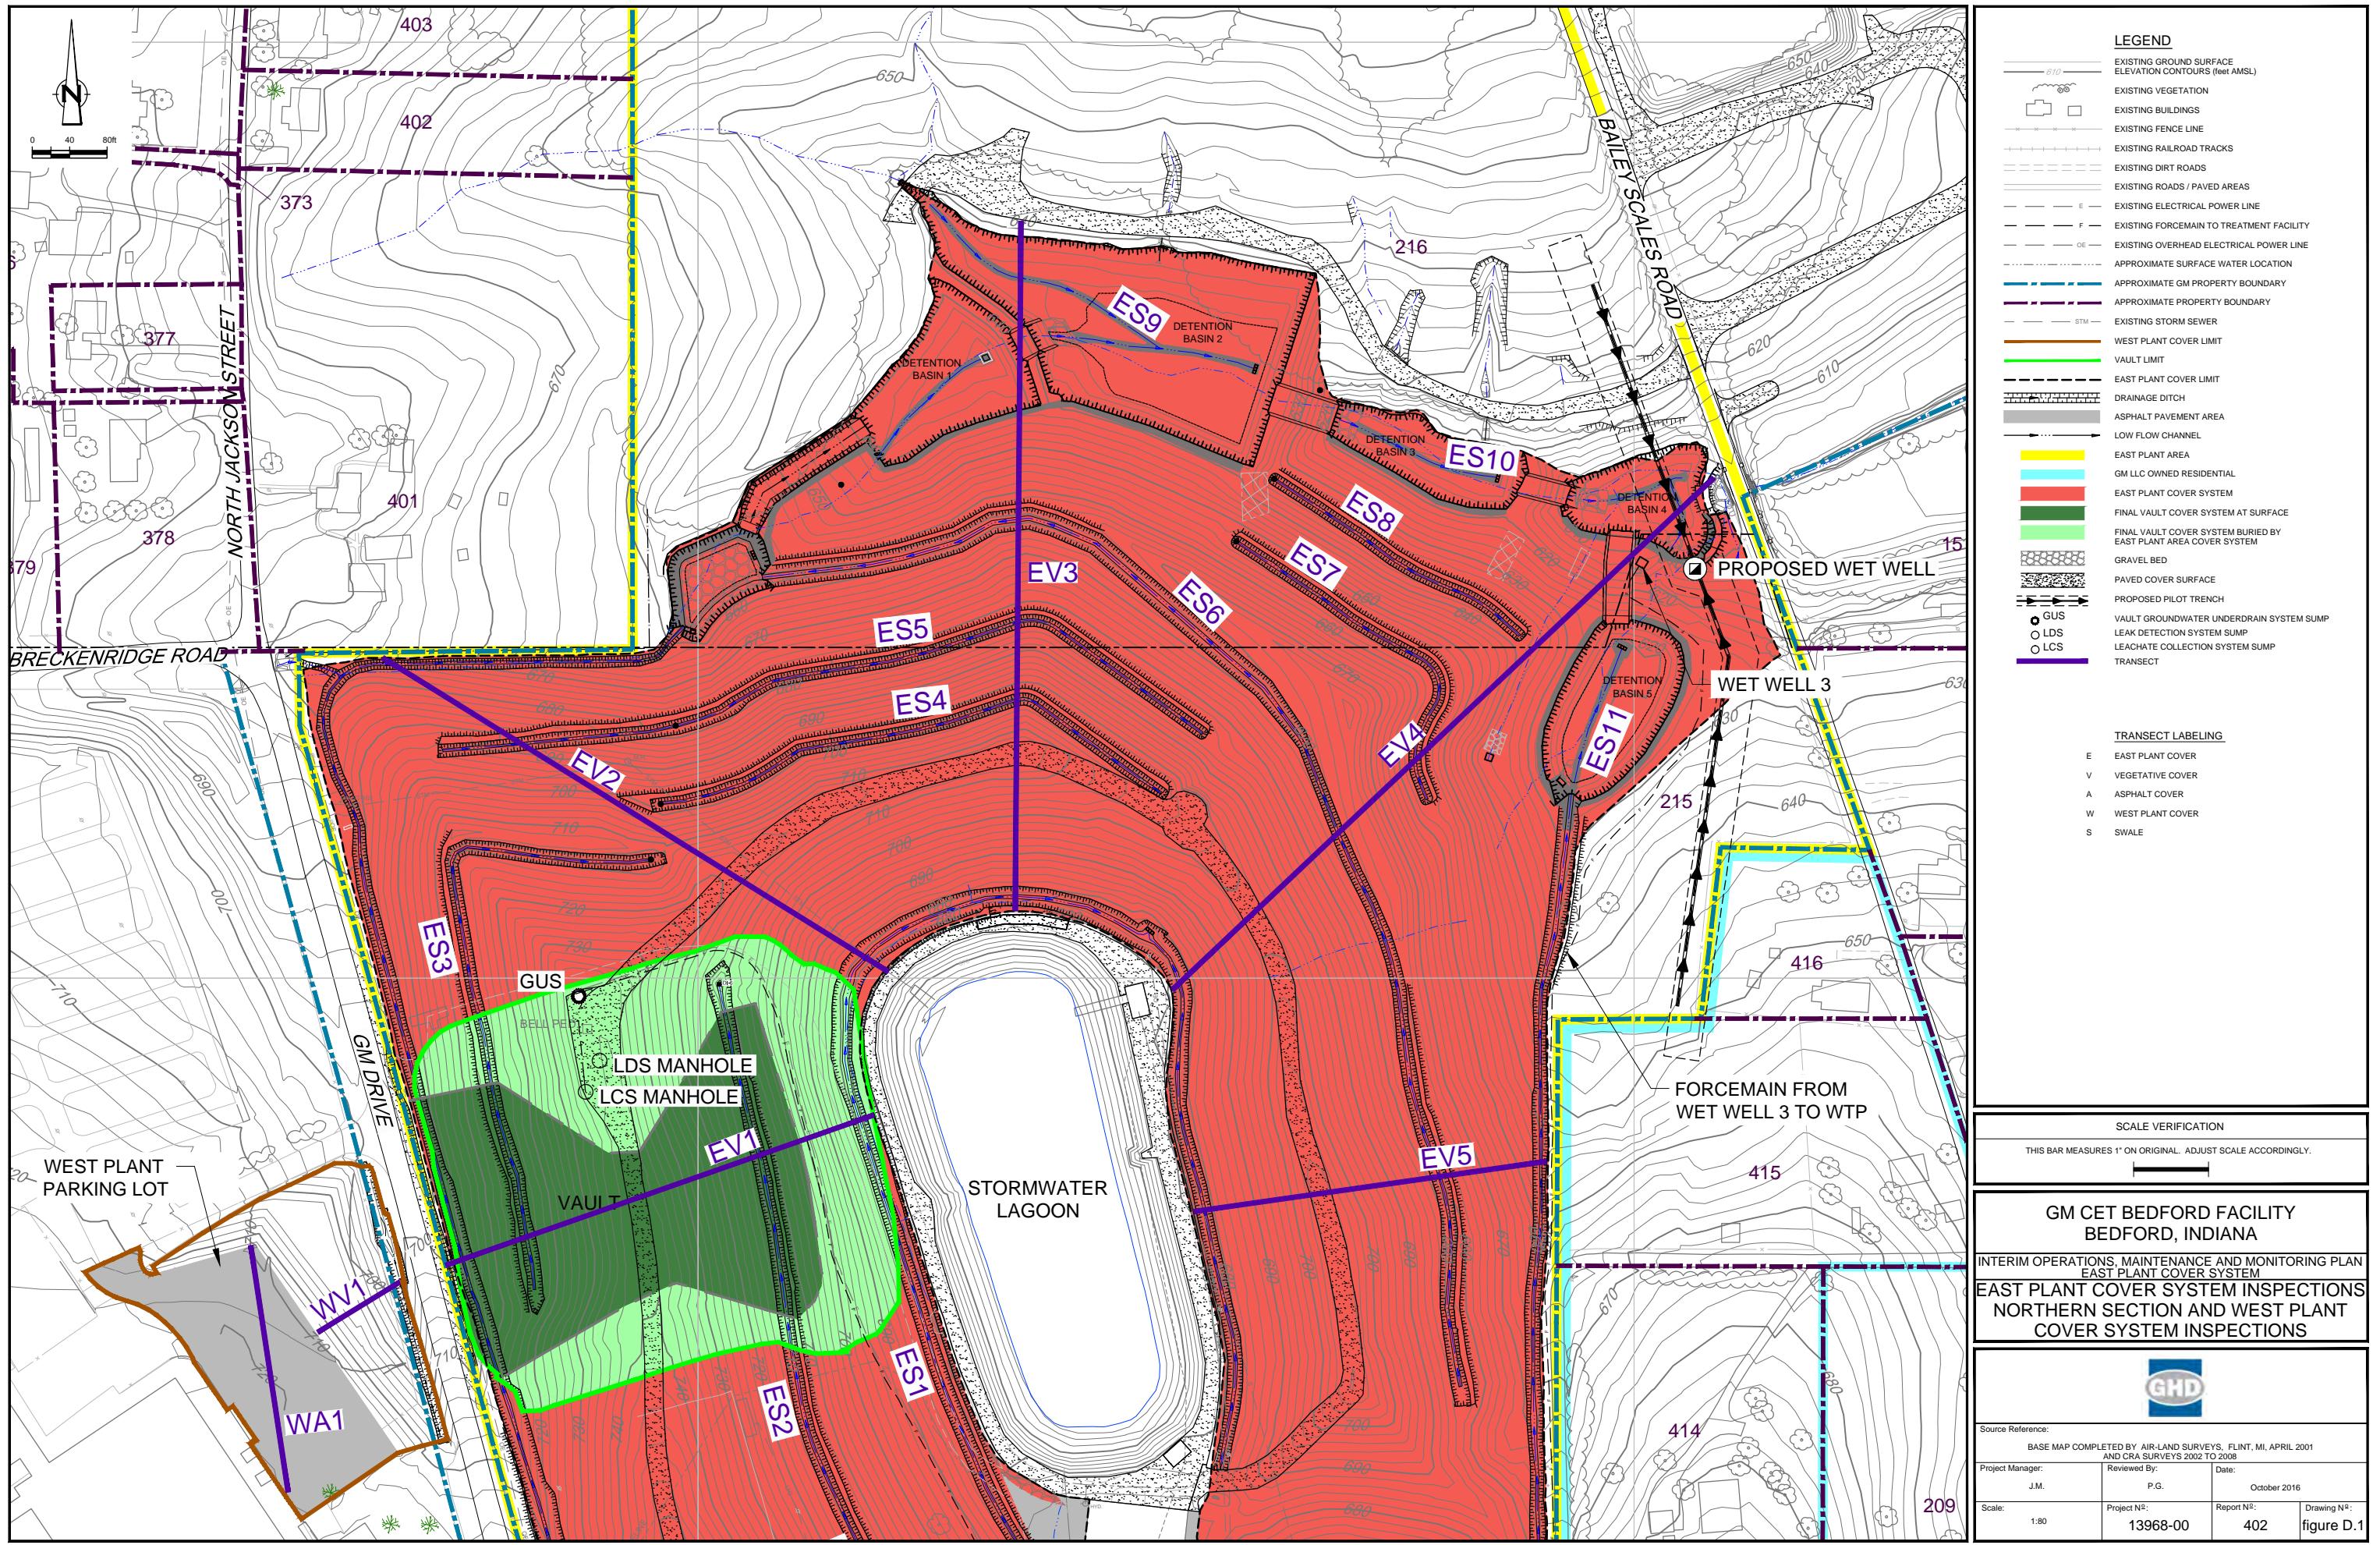
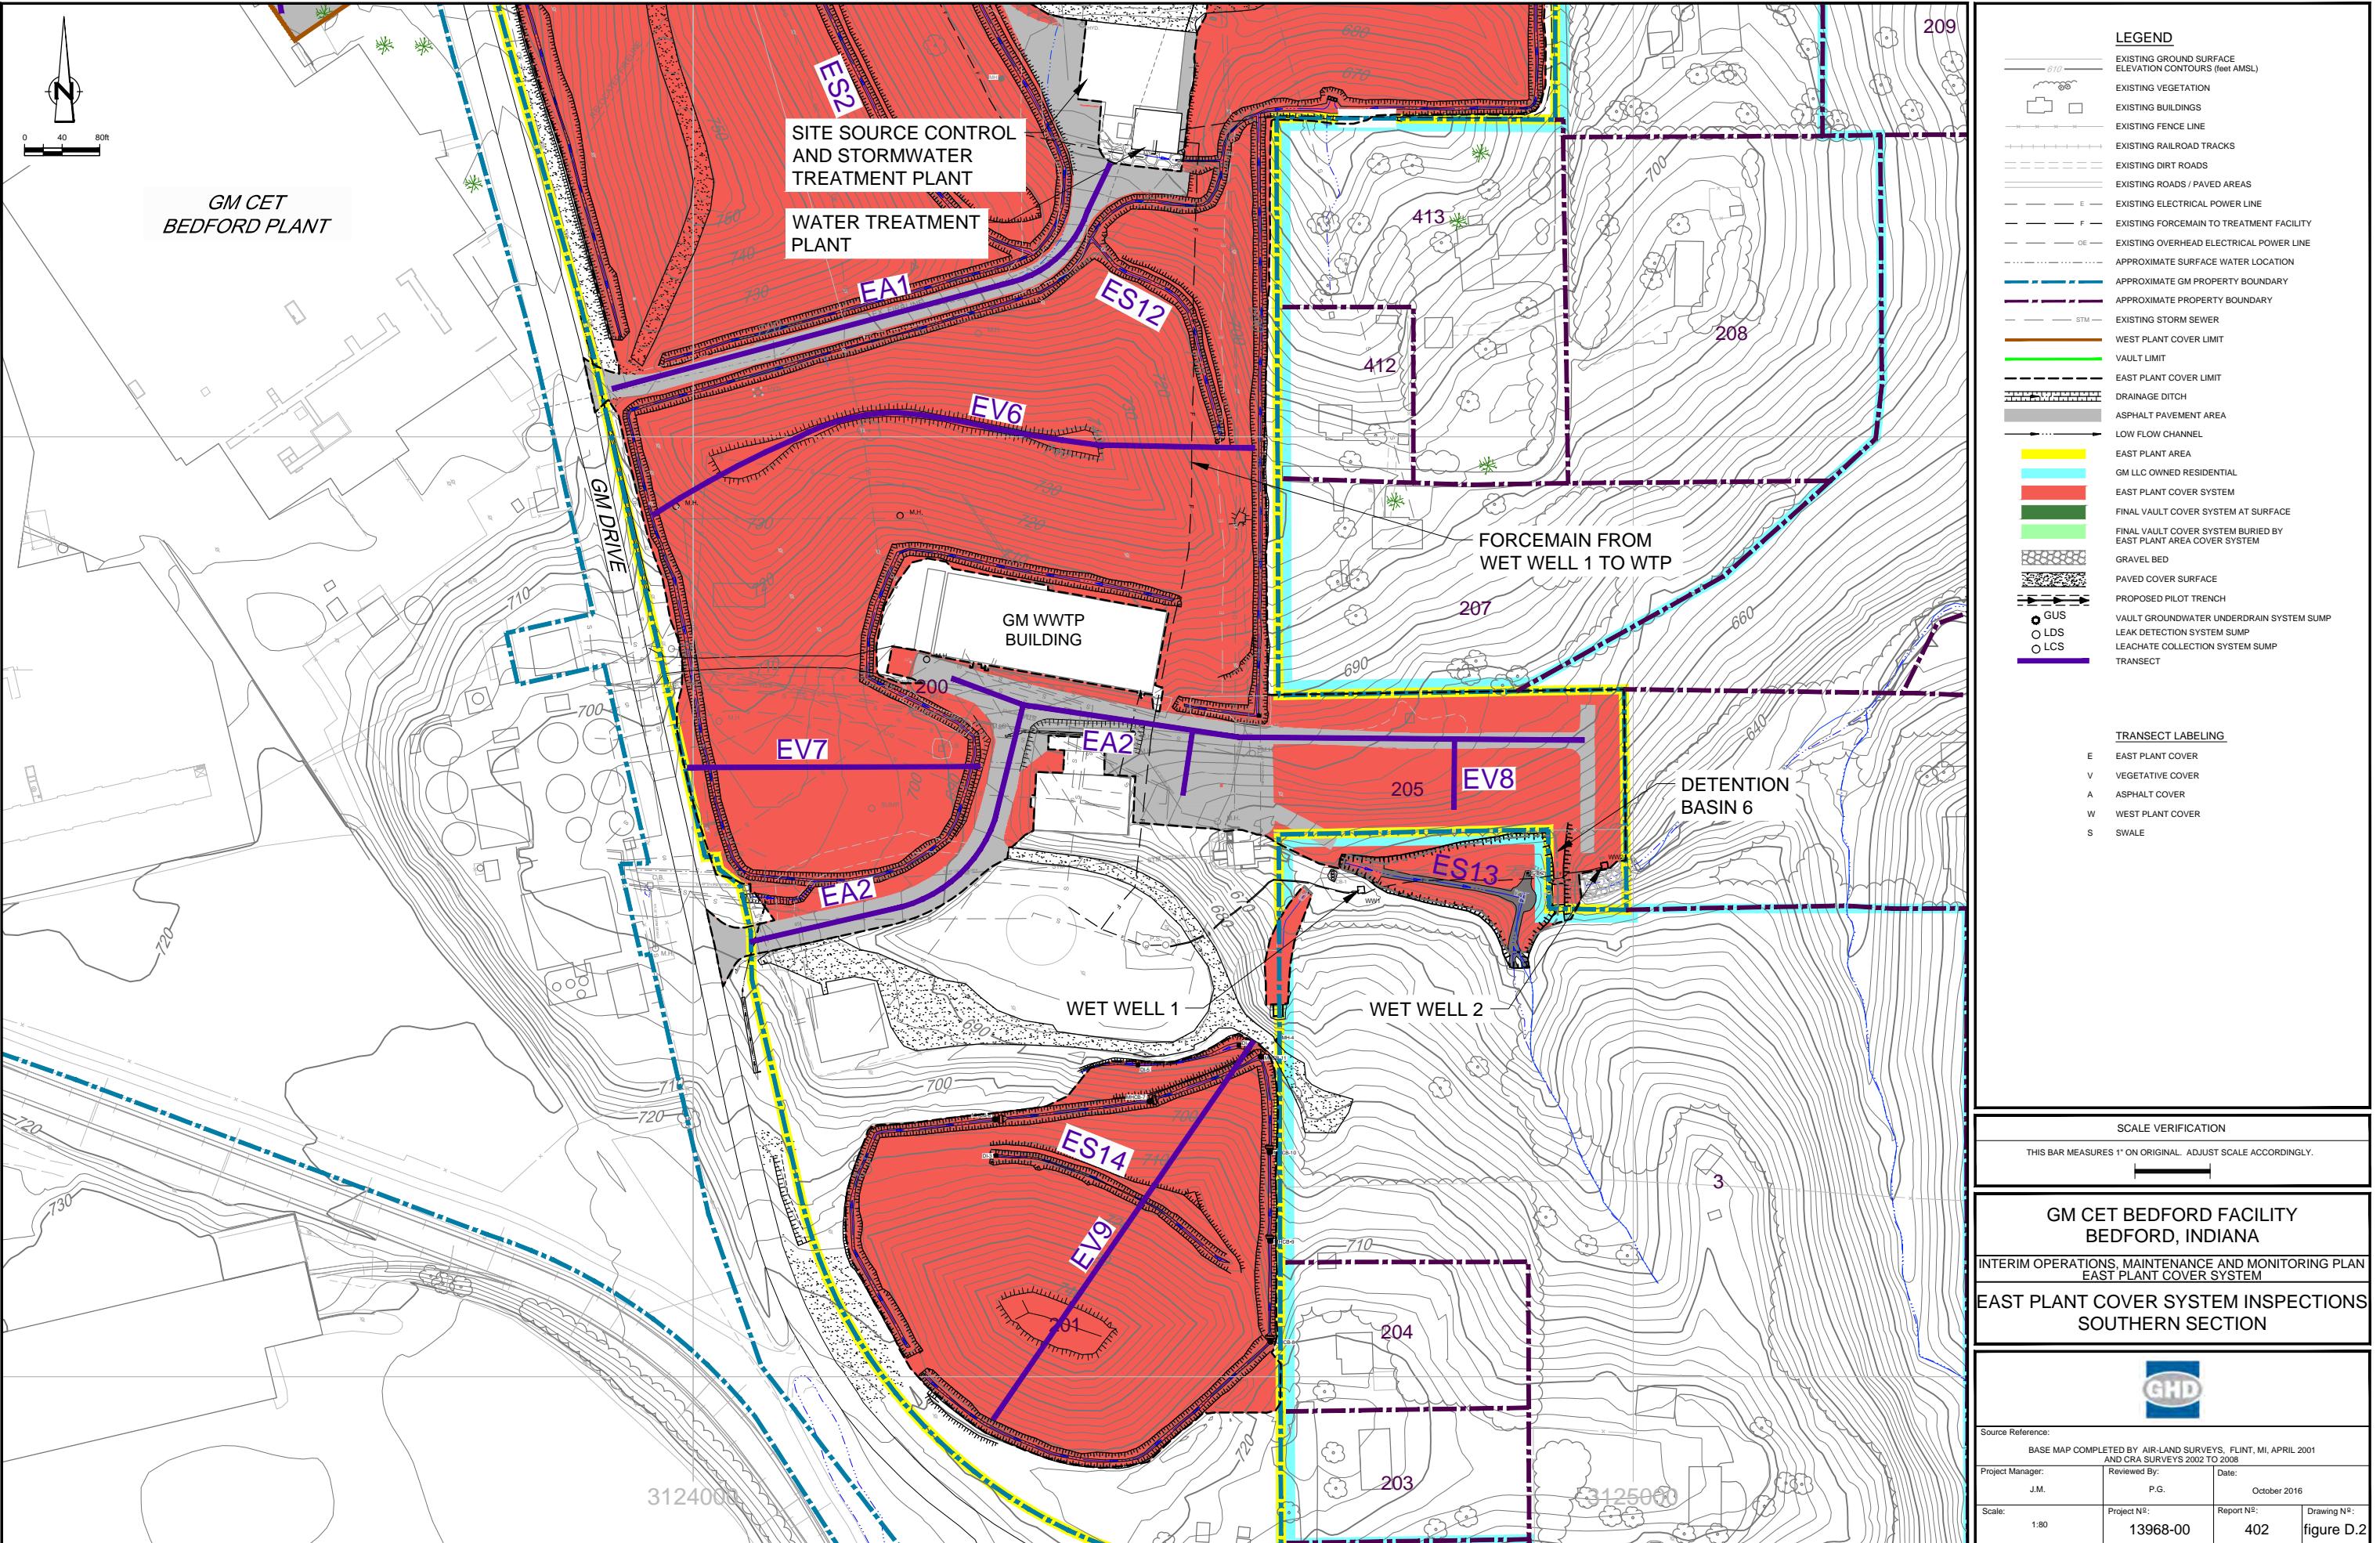
ITEM	TYPES OF PROBLEMS	CHECKED		DETAILED ACTIONS REQUIRED	DATE AND NATURE OF ACTIONS COMPLETED
		NO PROBLEMS	CORRECTIVE ACTION REQUIRED		
SWALE/DRAINAGE DITCHES (CONTINUED)					
Transect ES13	- QUALITY OF VEGETATIVE COVER - LENGTH OF GRASS - DEAD/DYING GRASS - GRASS COVERAGE - NOXIOUS WEEDS	X		heavy weed growth and some bare spots	
	- EROSION	X			
	- OBSTRUCTIONS	X			
	- CULVERT/CATCH BASIN - OBSTRUCTIONS - SEDIMENT ACCUMULATION	X			
	- SIGNS OF BURROWING BY ANIMALS	X			
	- ROOTING OF TREES	X			
Transect ES13	- QUALITY OF VEGETATIVE COVER - LENGTH OF GRASS - DEAD/DYING GRASS - GRASS COVERAGE - NOXIOUS WEEDS	X		heavy weed growth and some bare spots	
	- EROSION	X			
	- OBSTRUCTIONS	X			
	- CULVERT/CATCH BASIN - OBSTRUCTIONS - SEDIMENT ACCUMULATION	X			
	- SIGNS OF BURROWING BY ANIMALS	X			
	- ROOTING OF TREES	X
