Re: RCRA Corrective Action Administrative Order on Consent (AOC) Pilot Perimeter Groundwater Collection Trench Construction Certification Report GM GPS - Bedford Facility, IND 006036099, Docket No. RCRA 05-2014-0011 Bedford, Indiana

Construction Certification Report

Pilot Perimeter Groundwater Trench Collection System

General Motors LLC

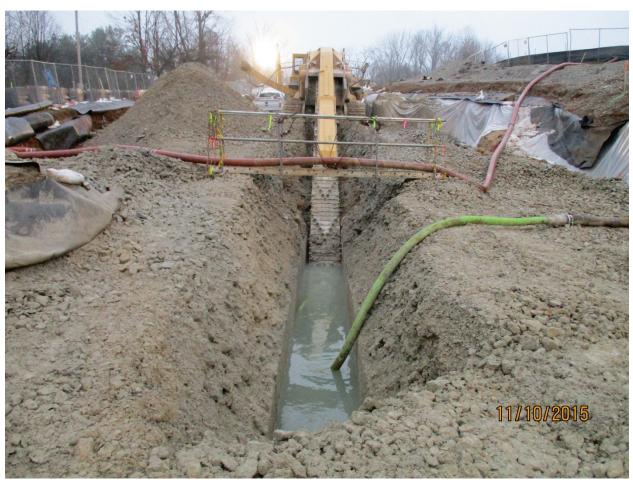
Photo 1: Trencher at WW, looking south. Nov. 2015

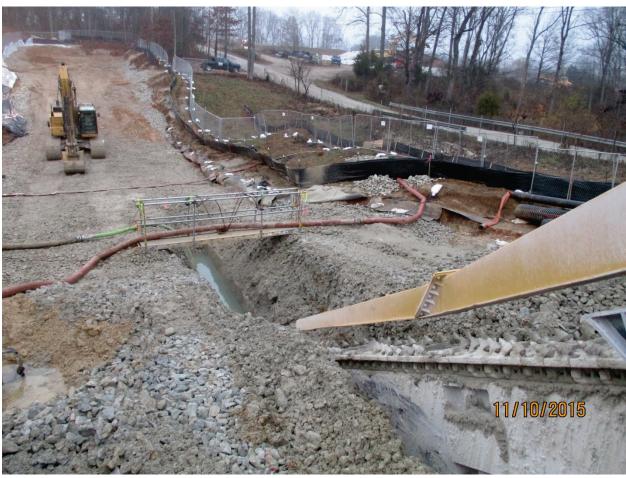
Photo 2: Trencher at WW, looking north. Nov. 2015

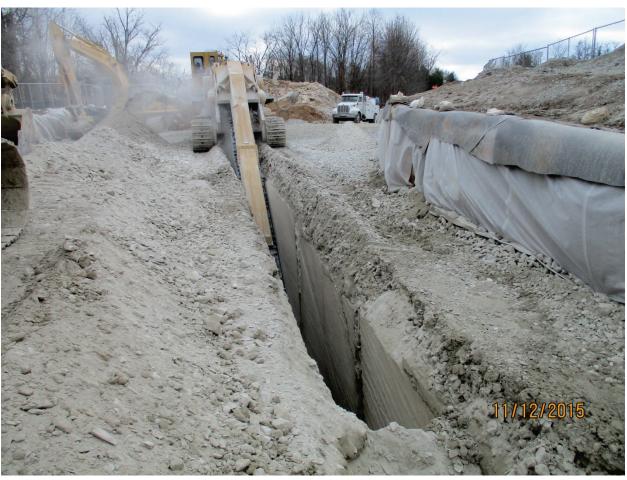
Photo 3: Trencher moving south from inflection point. Nov. 2015

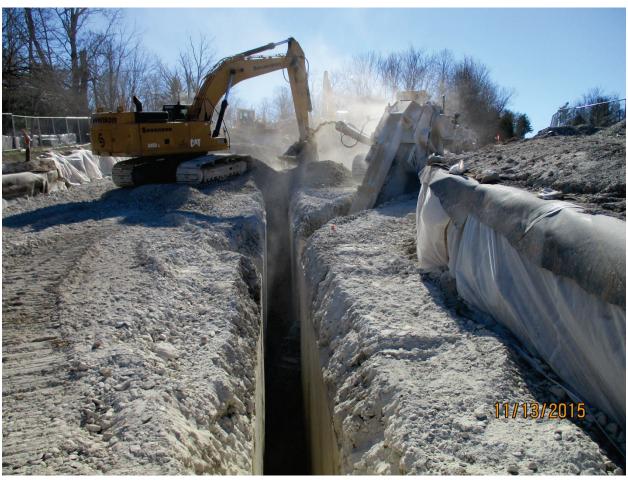
Photo 4: Trencher prior to inflection point. Nov. 2015

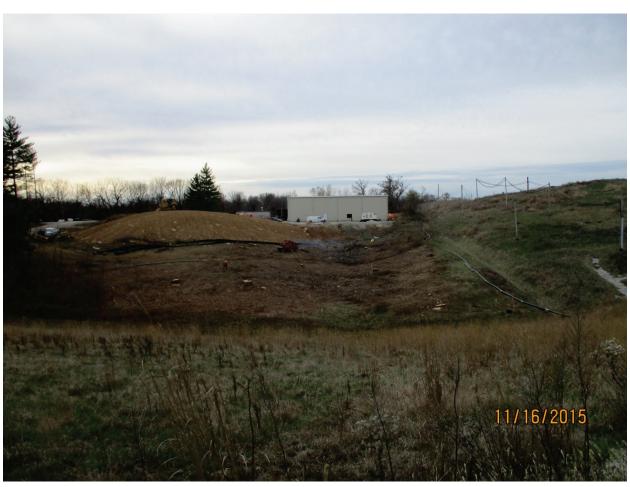
Photo 5: Tree clearing north of new GWTP. Nov. 2015

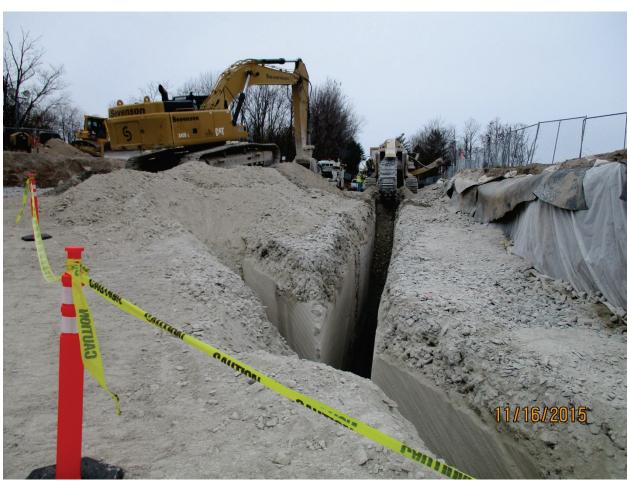
Photo 6: Trench north of bend. Nov. 2015

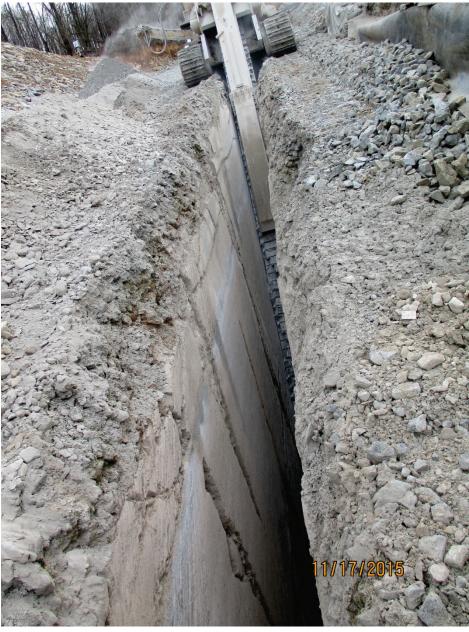
Photo 7:

East wall of trench at 5+00. Nov. 2015

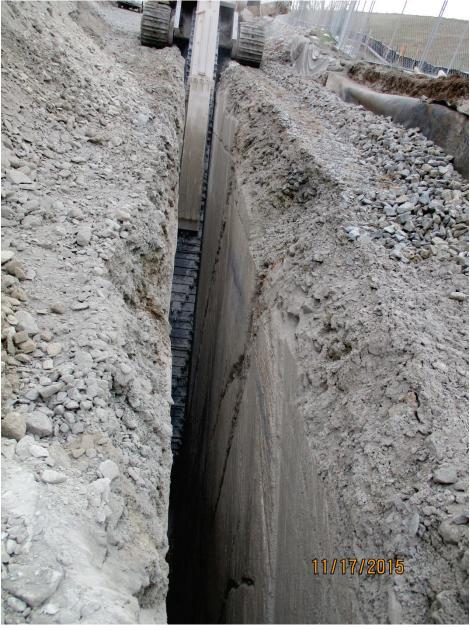
Photo 8: West wall of trench at 5+00. Nov. 2015

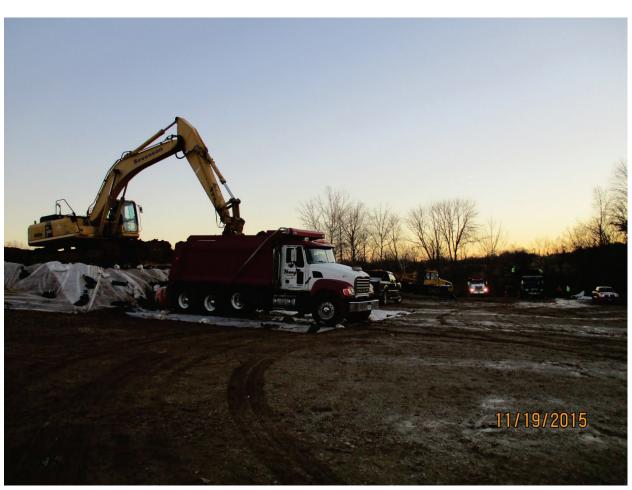
Photo 9: Loading contaminated soil. Nov. 2015

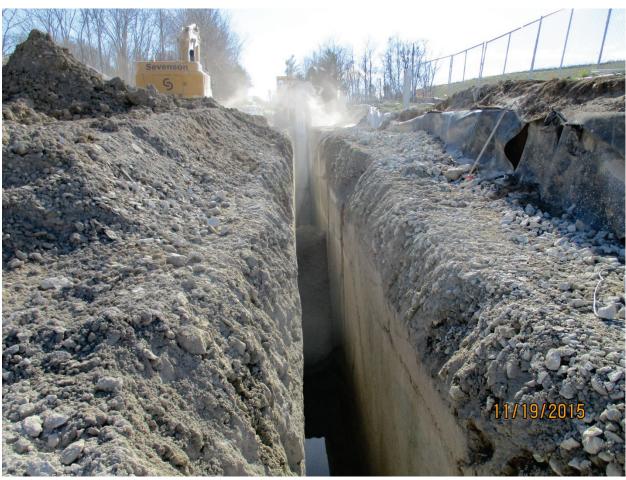
Photo 10: Trench from 5+75 to 6+25. Nov. 2015

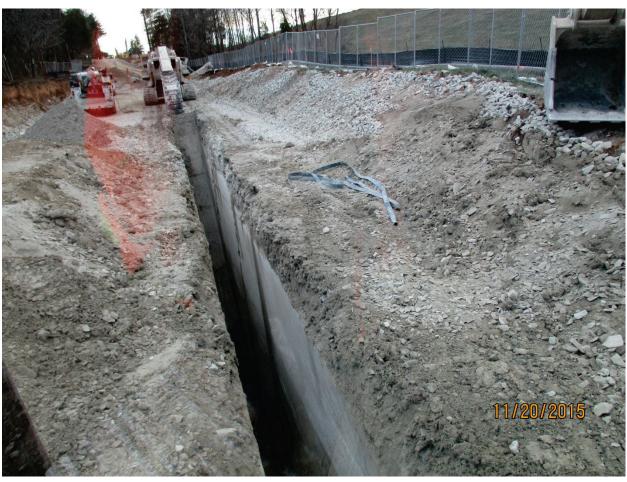
Photo 11: Trench at 6+50. Nov. 2015

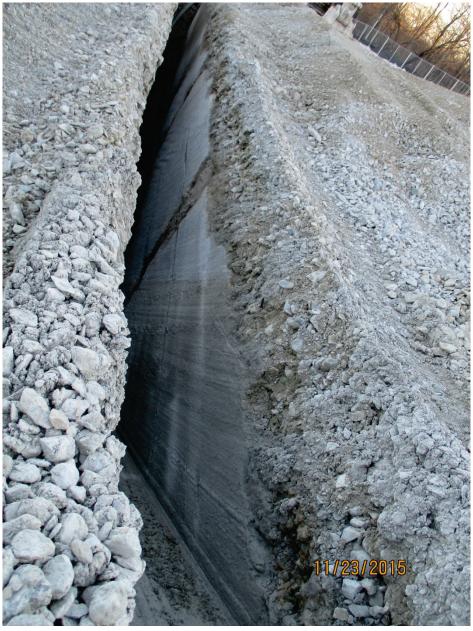
Photo 12: Trench at 6+50 stopped. Nov. 2015

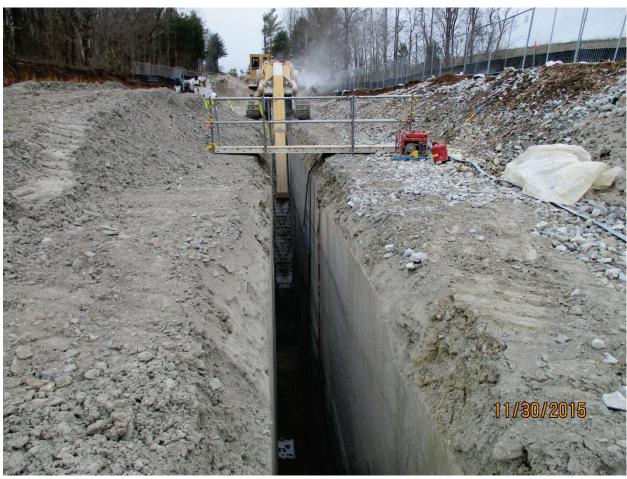
Photo 13: Surficial void at 6+70. Nov. 2015

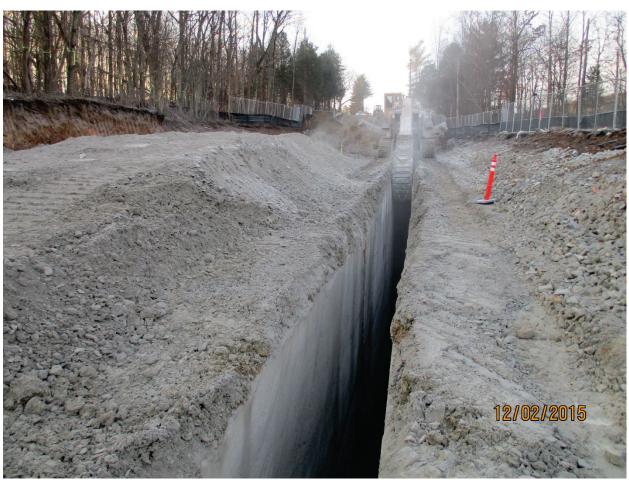
Photo 19: East trench wall near 7+50. Dec. 2015

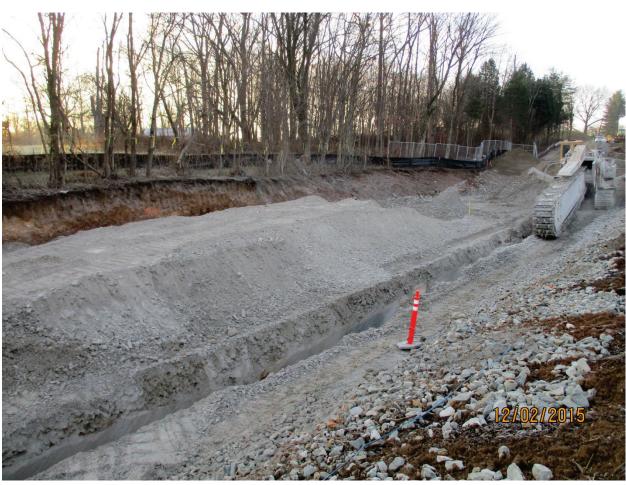
Photo 20: Orange marking at 7+50. Dec. 2015

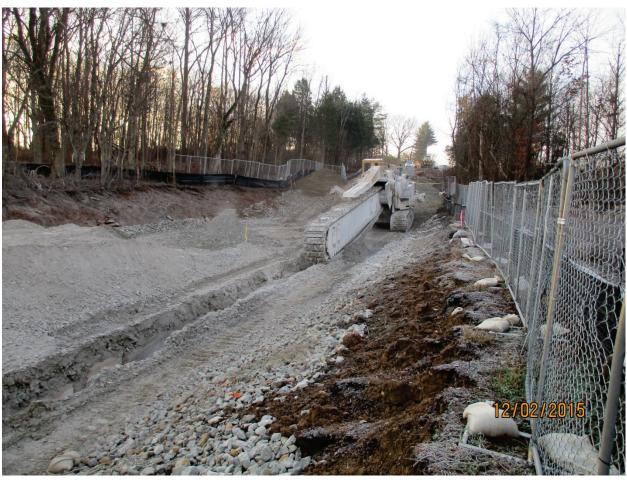
Photo 21: Pink line at end of trench. Dec. 2015

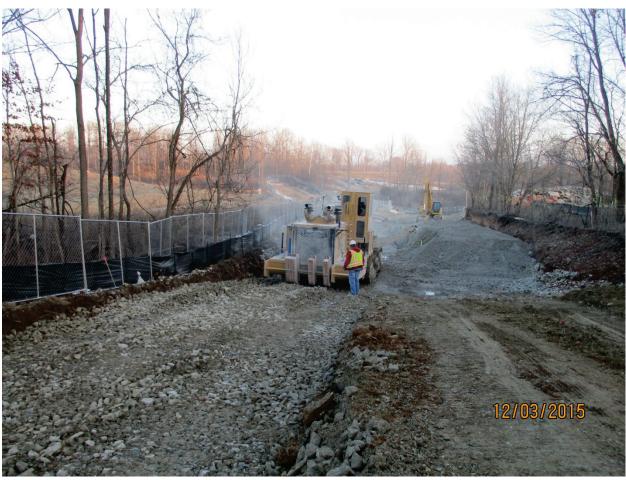
Photo 22: Extended working platform. Dec. 2015

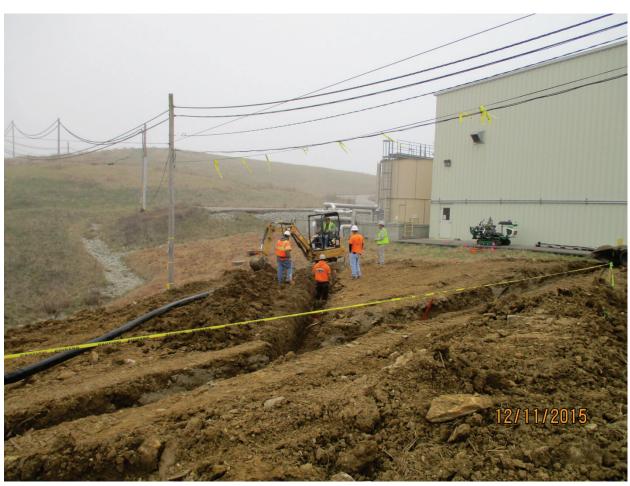
Photo 23: Pipe trenches to WTP. Dec. 2015

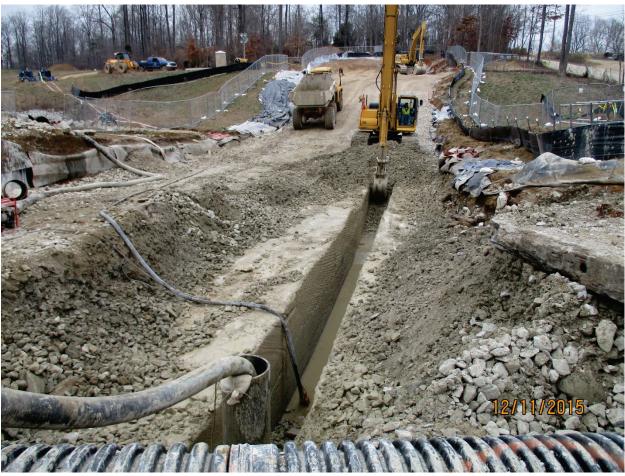
Photo 24: Exposed trench from 3+50 to 3+20. Dec. 2015

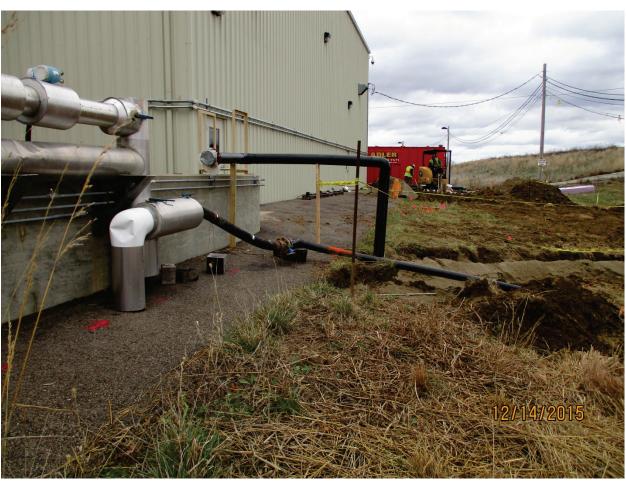
Photo 25: Connection at WTP containment area. Dec. 2015

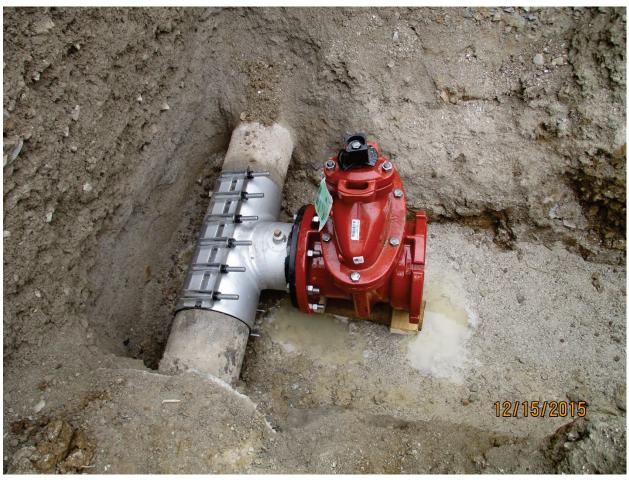
Photo 26: PIV for new firemain. Dec. 2015

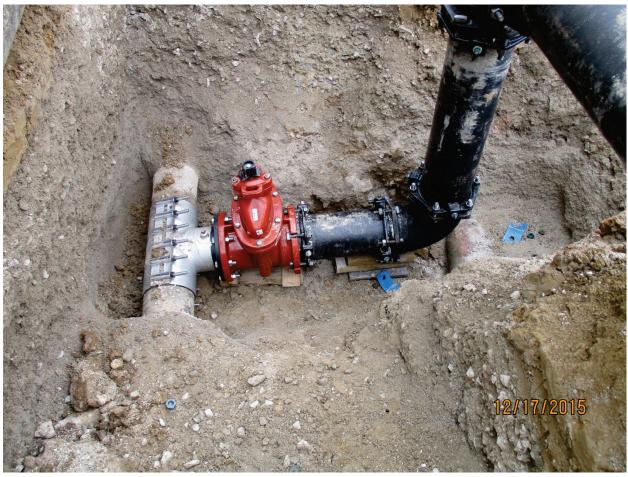
Photo 27: Joint restraints on firemain (deep). Dec. 2015

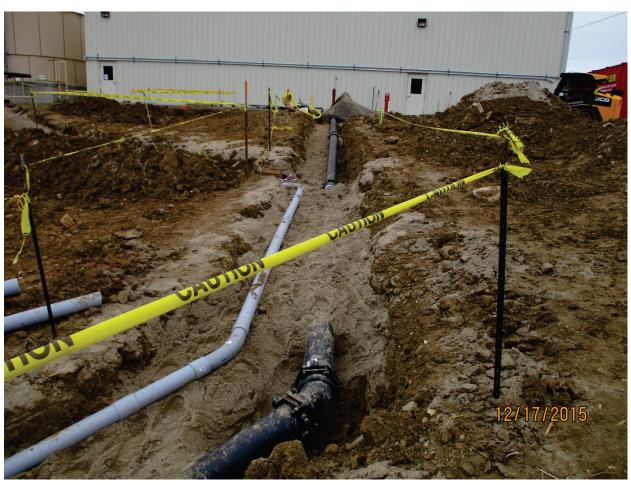
Photo 28: Joint restraints on firemain (shallow). Dec. 2015

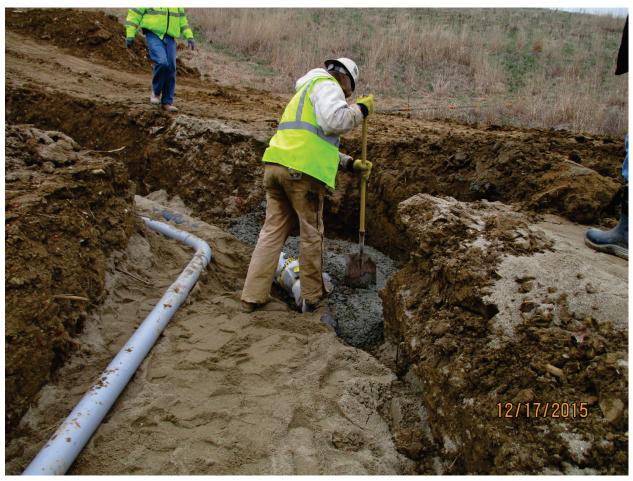
Photo 29: Thrust block for firemain. Dec. 2015

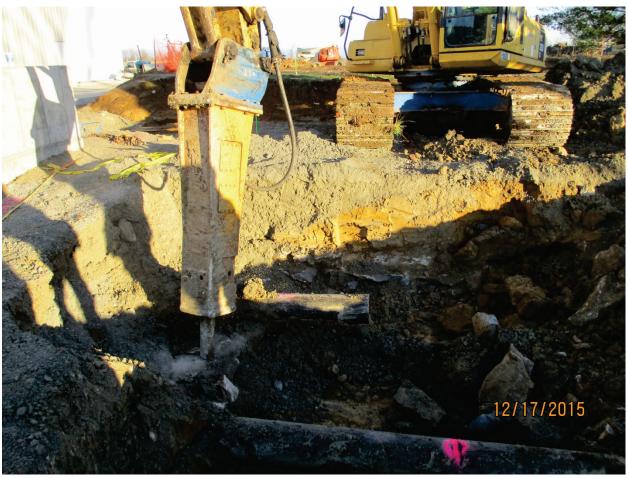
Photo 30: Concrete breaking at MH-10 and MH-14. Dec. 2015

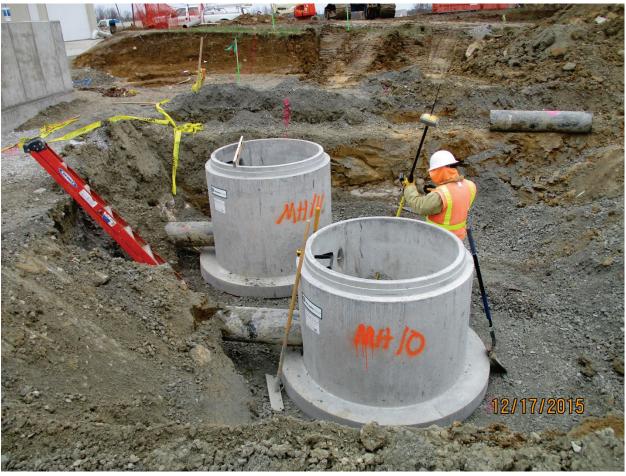
Photo 31: Manhole placement at MH-10 and MH-14. Dec. 2015

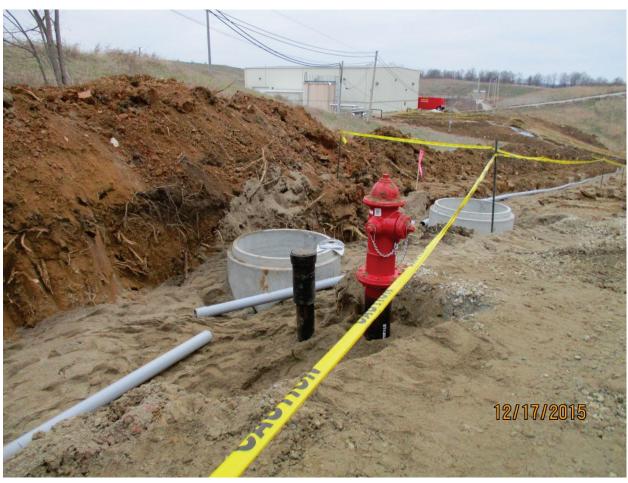
Photo 32: Fire hydrant at new WTP. Dec. 2015

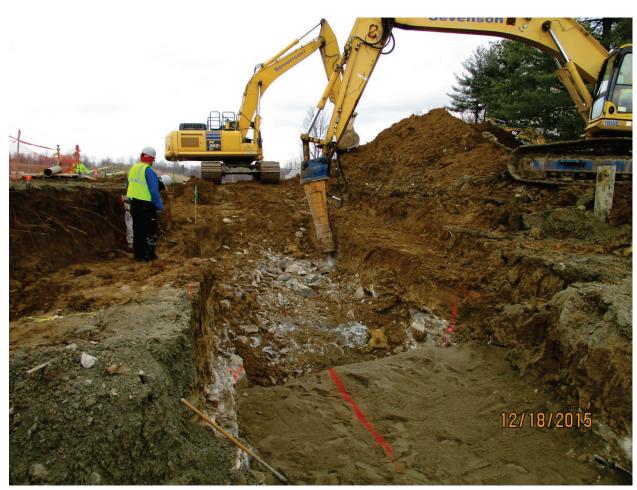
Photo 33: Rock breaking east of GWTP. Dec. 2015

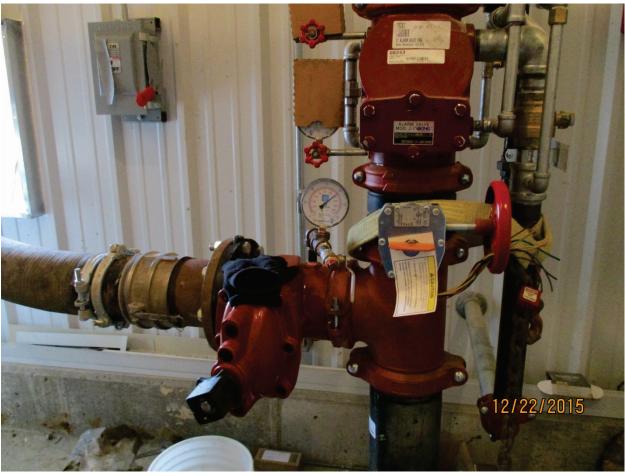
Photo 34: Pressure testing of firemain. Dec. 2015

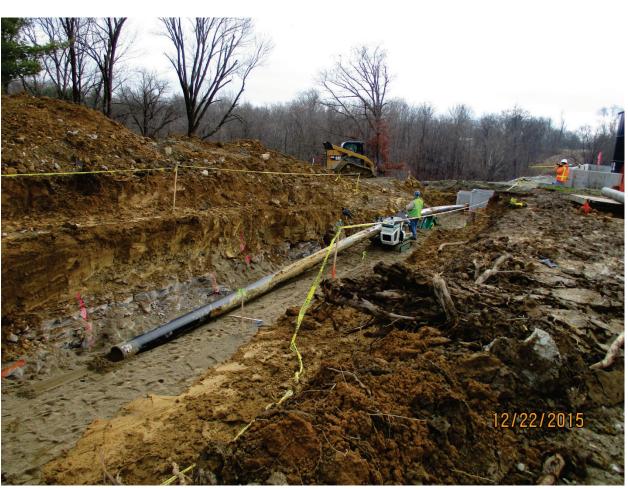
Photo 35: Laying pipe in trench. Dec. 2015

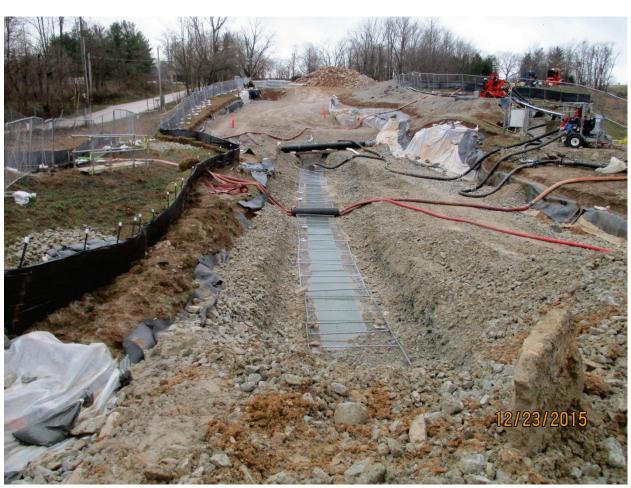
Photo 36: Fence panels over trench. Dec. 2015

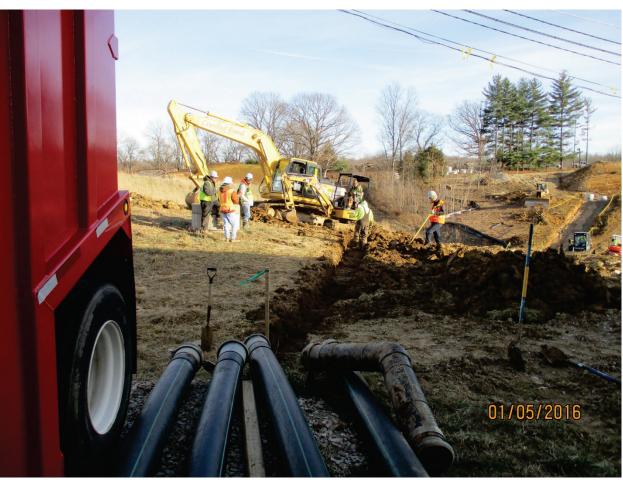
Photo 37: Pipe trench towards Adler tank. Jan. 2016

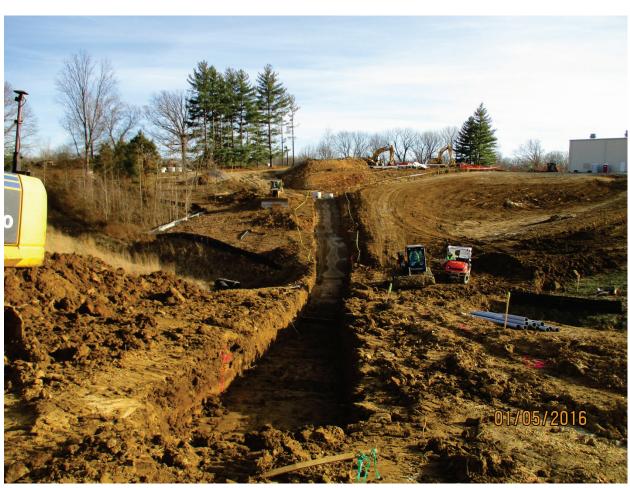
Photo 38: Pipe trench looking southeast. Jan. 2016

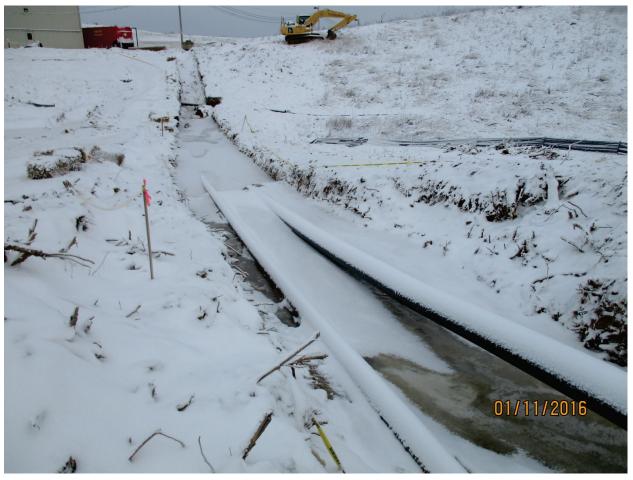
Photo 39: Water in pipe trench. Jan. 2016

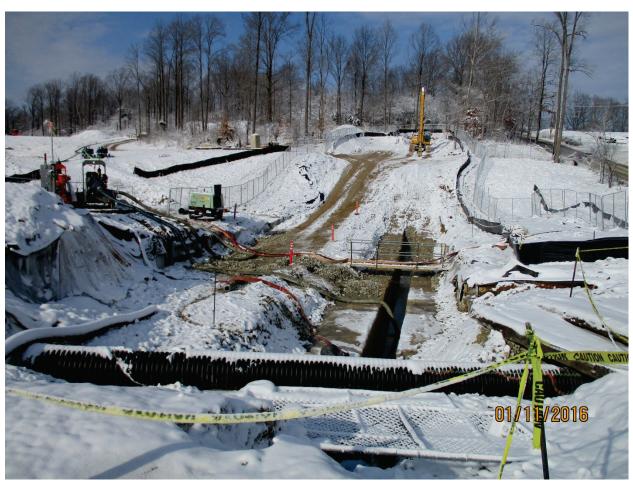
Photo 40: Trench cleared for sheet piling. Jan. 2016

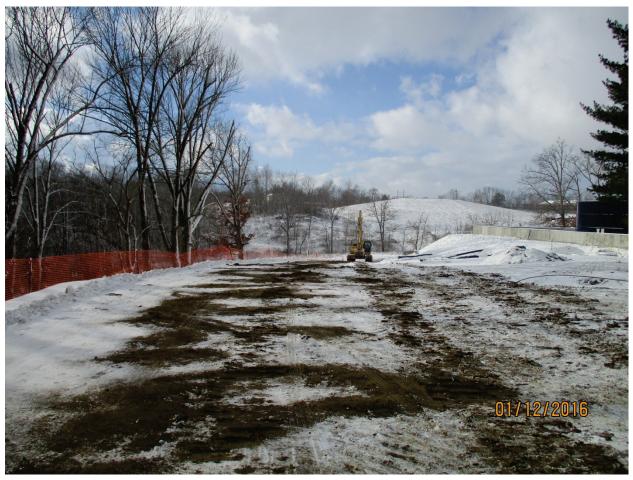
Photo 41: Sanding access road due to freezing. Jan. 2016

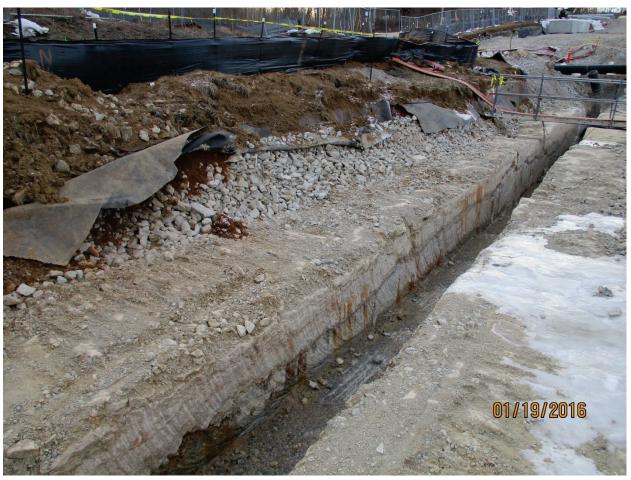
Photo 42: East side of pilot trench at 3+20, looking north. Jan. 2016

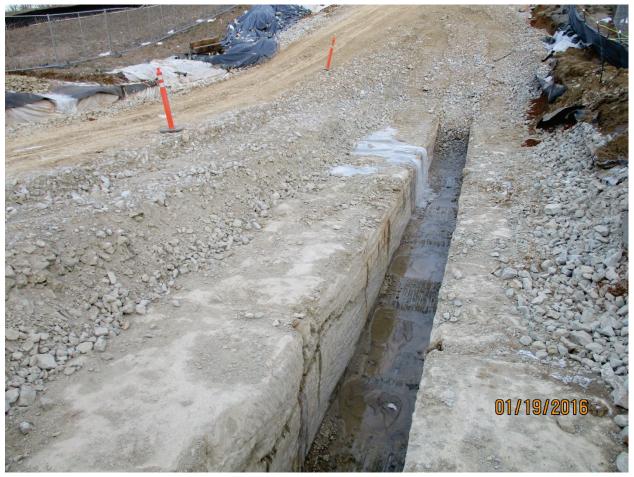
Photo 43: West side of pilot trench at 3+20, looking north. Jan. 2016

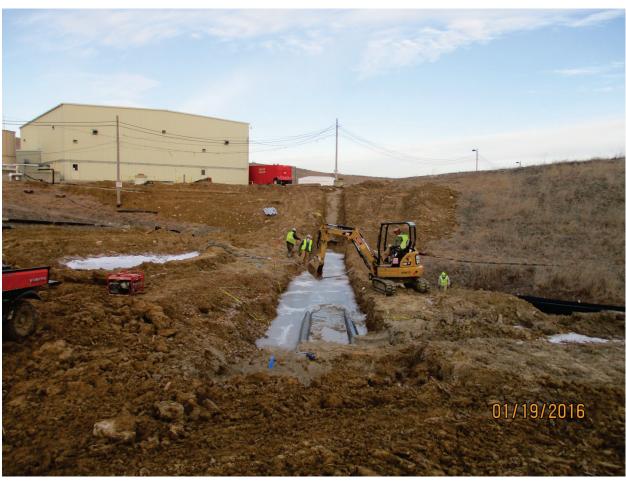
Photo 44: Ice in pipe trench. Jan. 2016

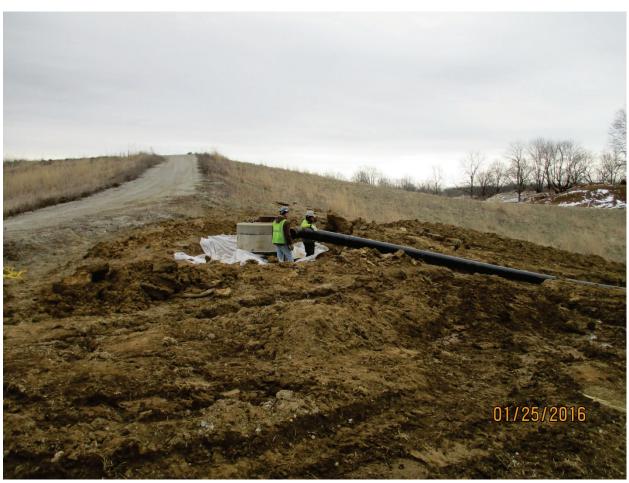
Photo 45: Setting pipe into MH-7. Jan. 2016

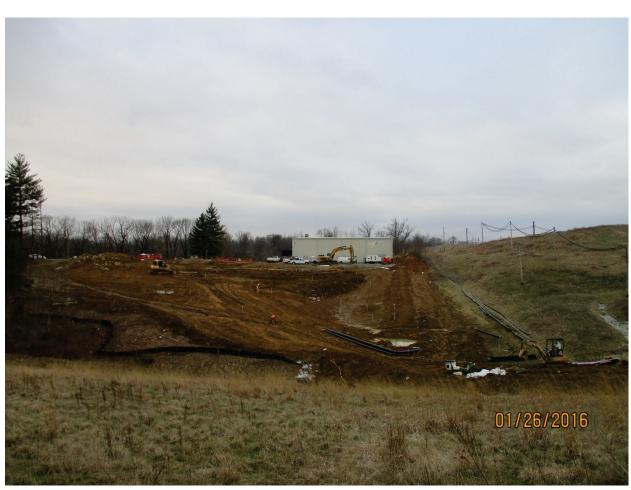
Photo 46: Grading north of GWTP. Jan. 2016

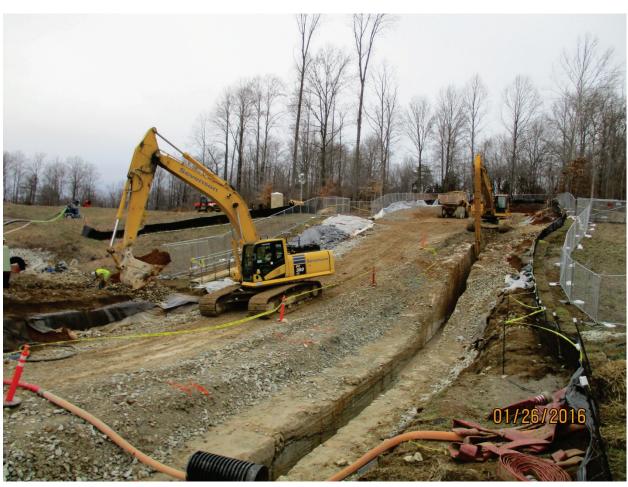
Photo 47: Trench cleanout for vinyl sheet installation. Jan. 2016

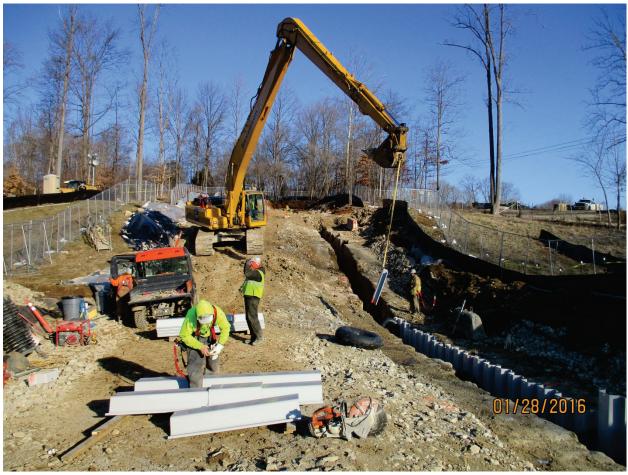
Photo 48: Vinyl sheeting installation. Jan. 2016

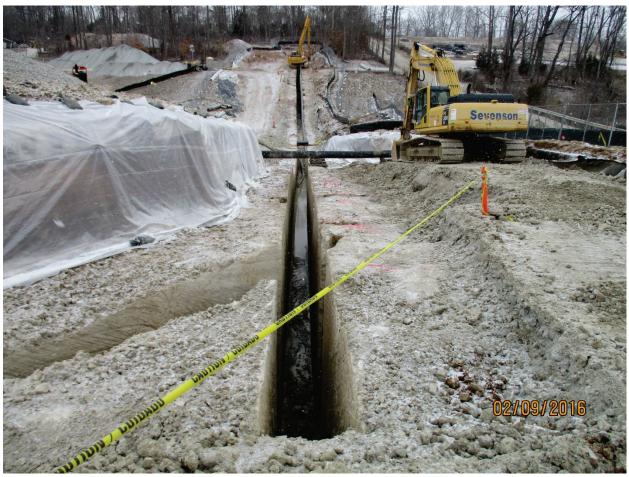
Photo 49: Trench cleaned out north of 4+70. Feb. 2016

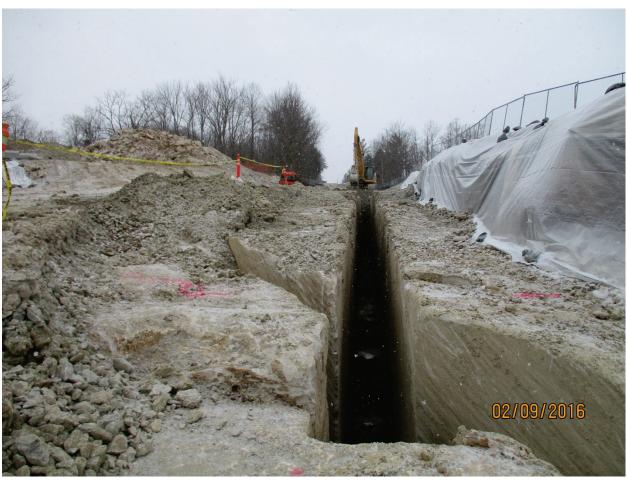
Photo 50: Cleaning out trench south of 4+70. Feb. 2016

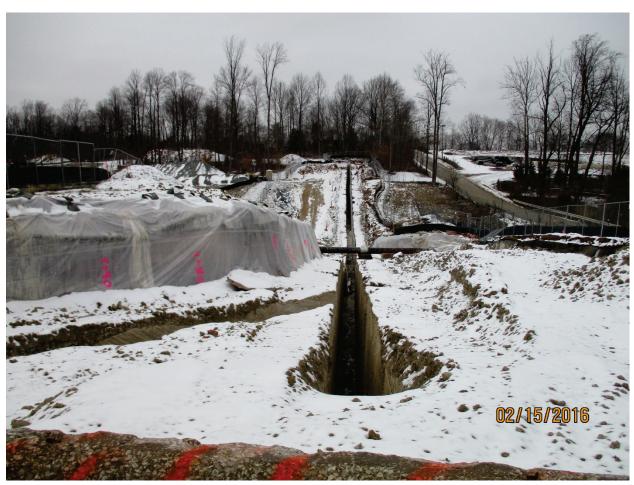
Photo 51: Buildup of fines at trench bottom. Feb. 2016

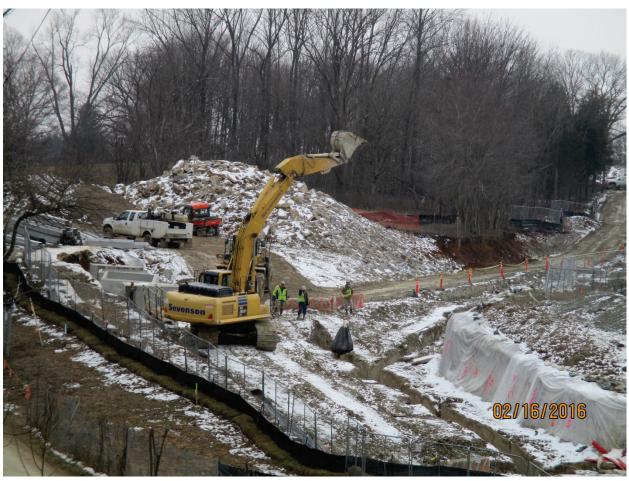
Photo 53: Lowering super sack for dam. Feb. 2016

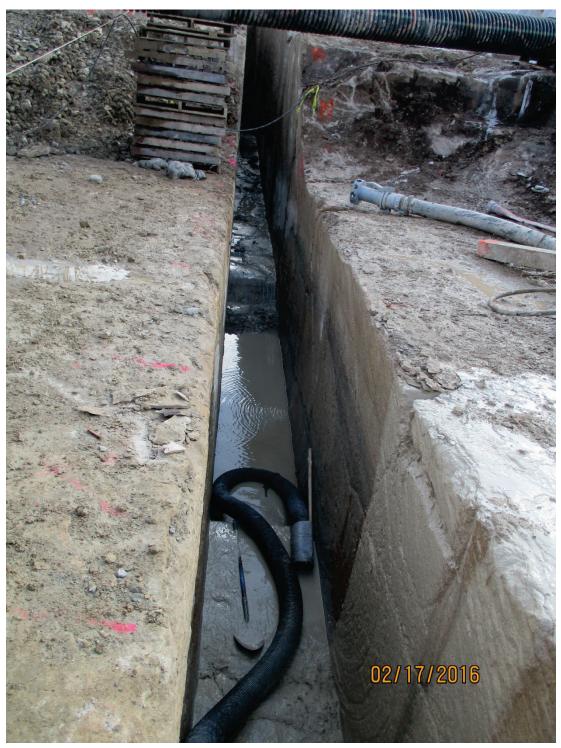
Photo 54:

Sump location cleaned out. Feb. 2016

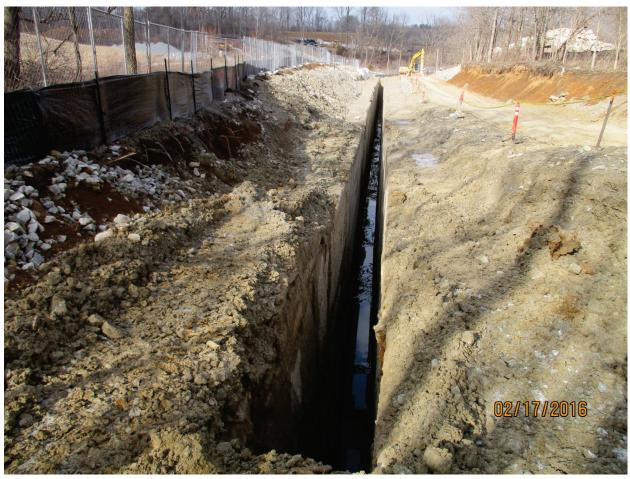
Photo 55: South trench with cuttings removed. Feb. 2016

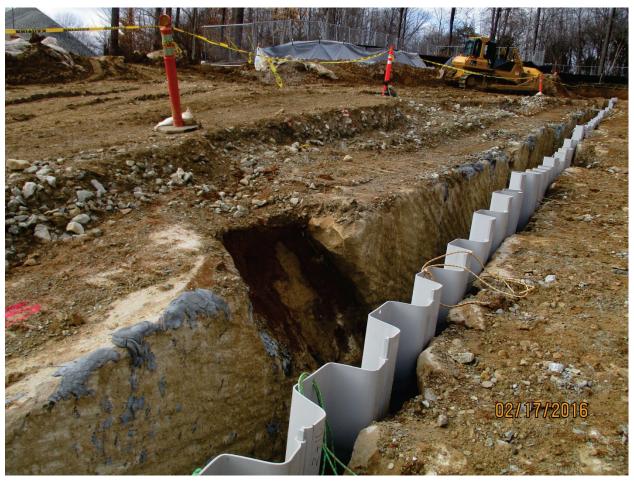
Photo 56: Trench cave-in. Feb. 2016

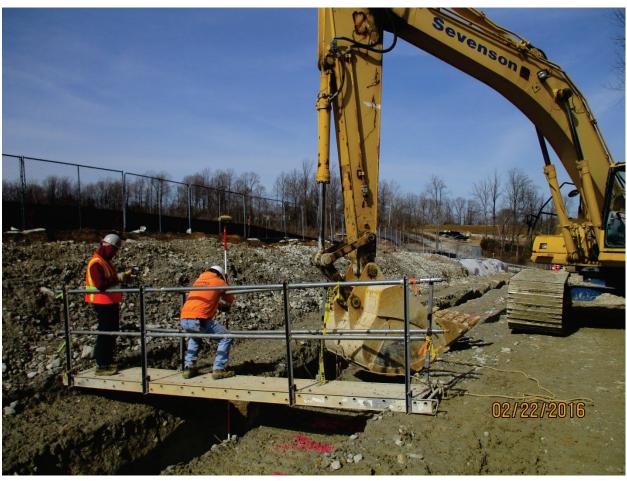
Photo 57: Trench video and survey verification. Feb. 2016

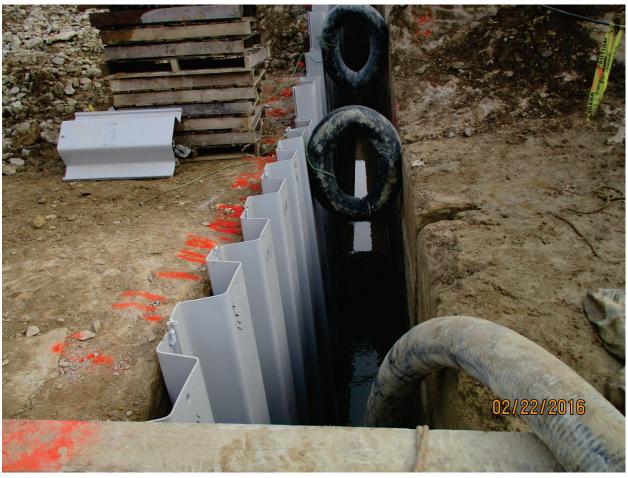
Photo 58: Sump cleanout. Feb. 2016

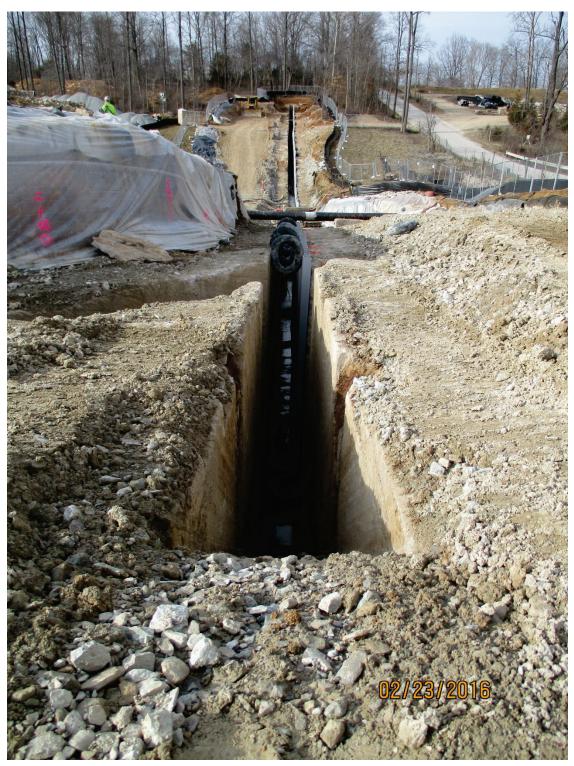
Photo 60: Sheet piling to inflection point. Feb. 2016

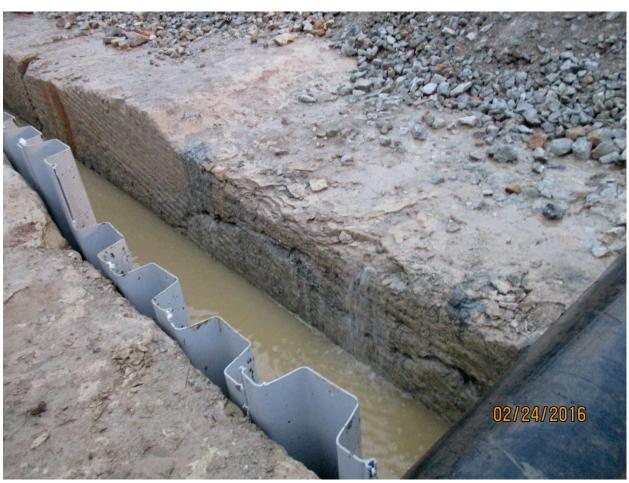
Photo 61: Runoff from working platform. Feb. 2016

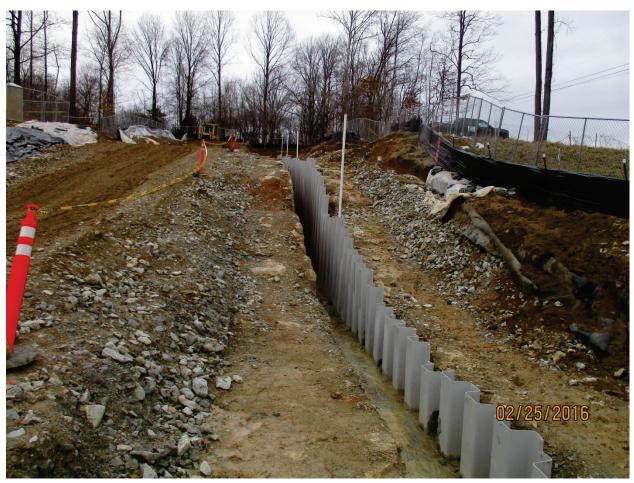
Photo 62: Piezometer in trench. Feb. 2016

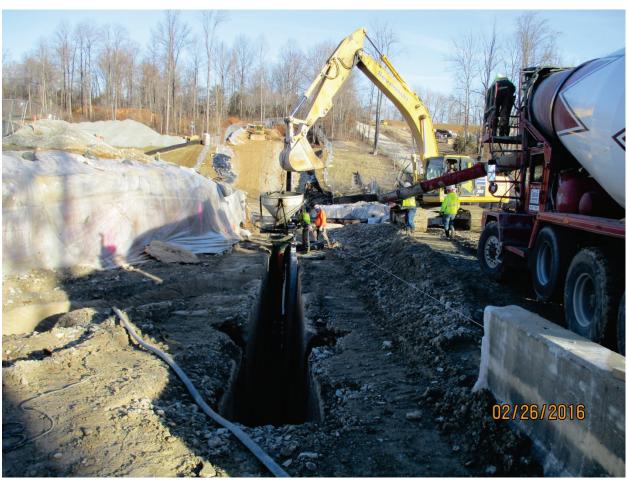
Photo 63: Pouring grout using concrete bucket. Feb. 2016

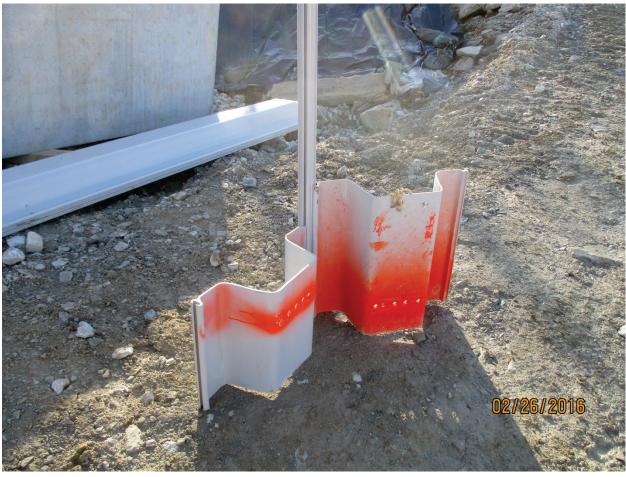
Photo 64: Angle connection for vinyl sheeting. Feb. 2016

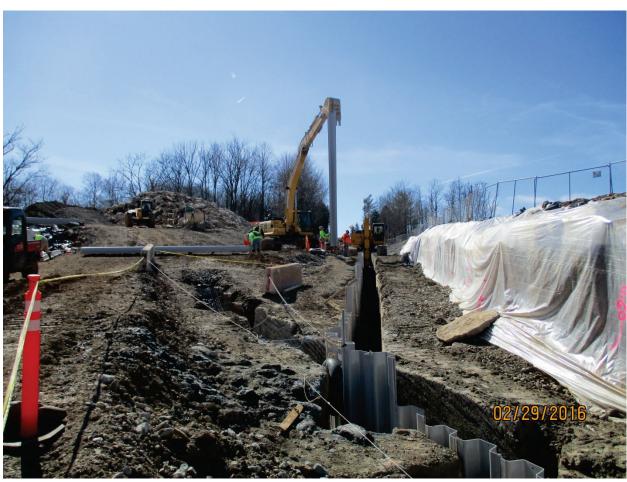
Photo 65: Vinyl sheet piling to the south. Feb. 2016

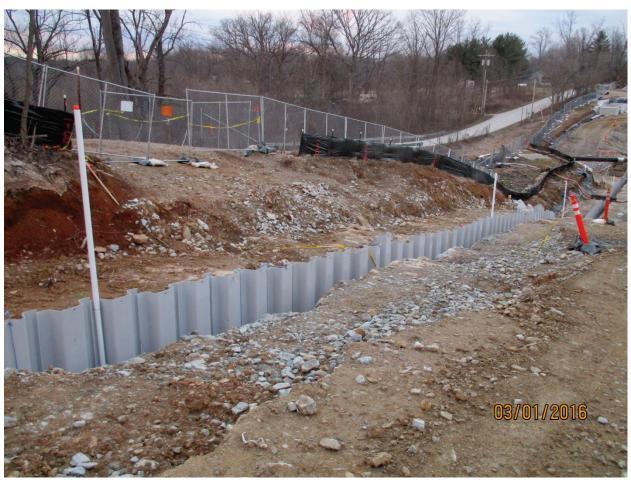
Photo 66: Monitoring wells inside the trench. Mar. 2016

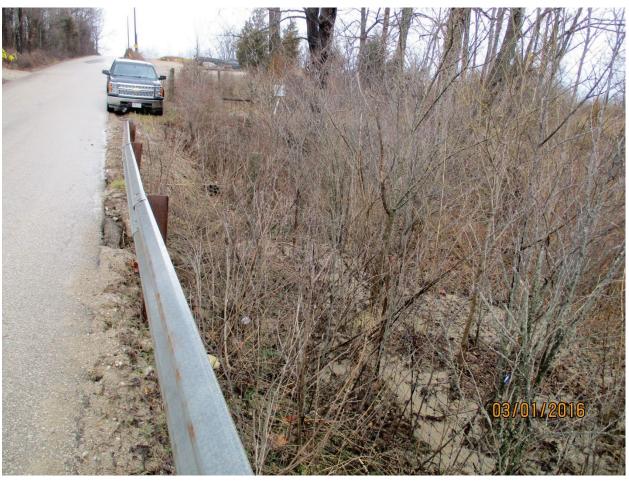
Photo 67: Road erosion at guard rail on east side of Bailey Scales Road. Mar. 2016

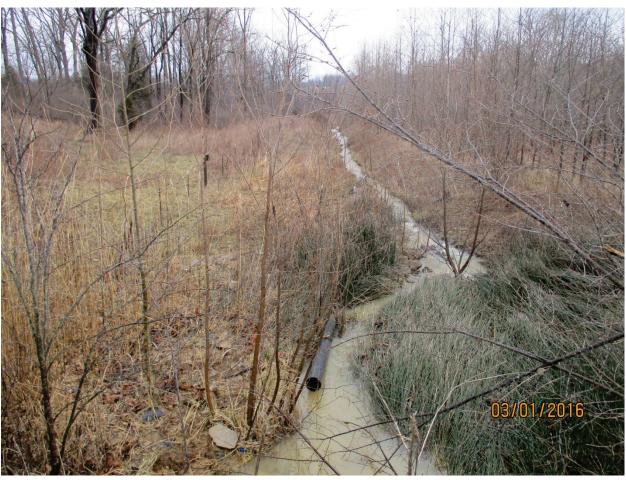
Photo 68: Flow in creek downstream of site. Mar. 2016

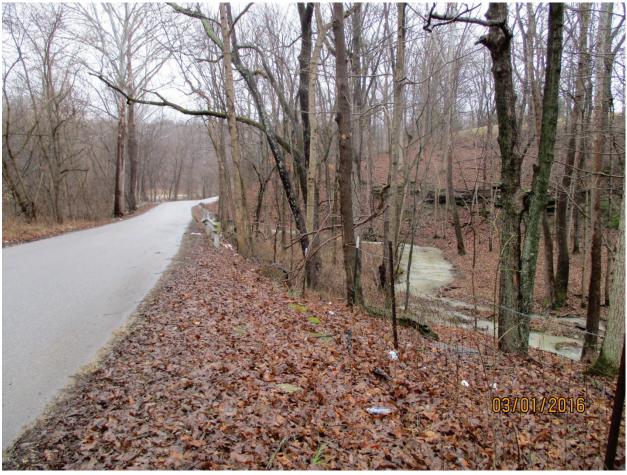
Photo 69: Flow just past North Jackson. Mar. 2016

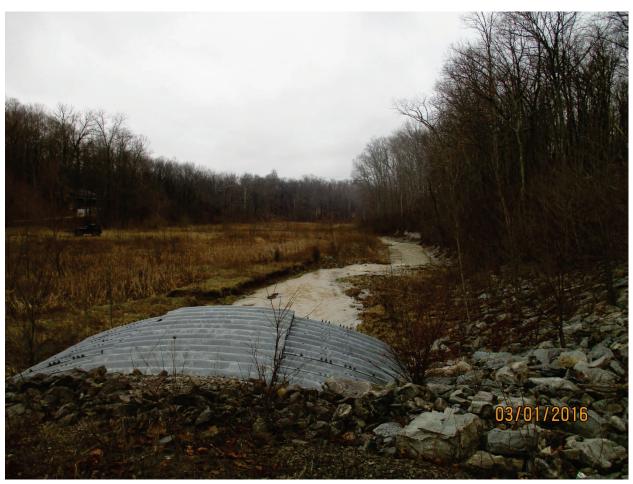
Photo 70: Flow at Broomsage Bridge. Mar. 2016

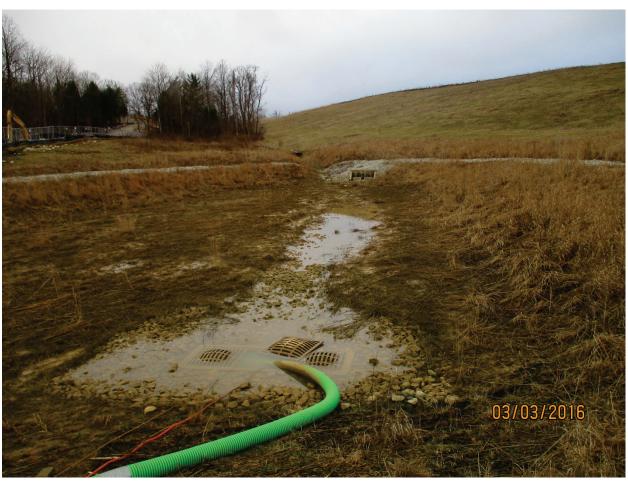
Photo 71: Water in DB-5 cleared up. Mar. 2016

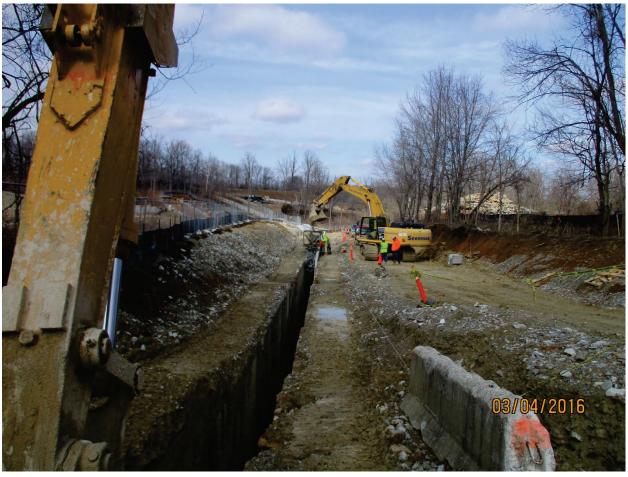
Photo 72: Grout placement using concrete bucket. Mar. 2016

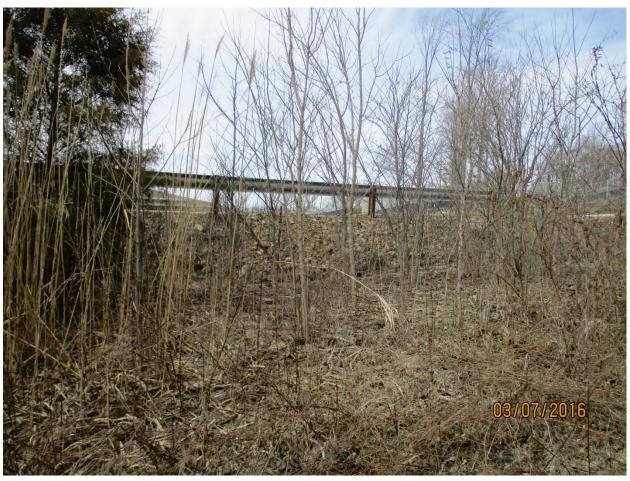
Photo 73: Erosion protection installed by SES on east side of the Bailey Scales Road. Mar. 2016

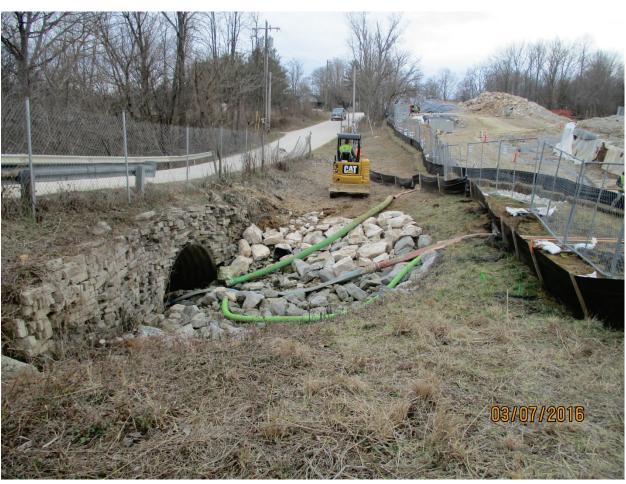
Photo 74: Riprap at discharge under Bailey Scales Road. Mar. 2016

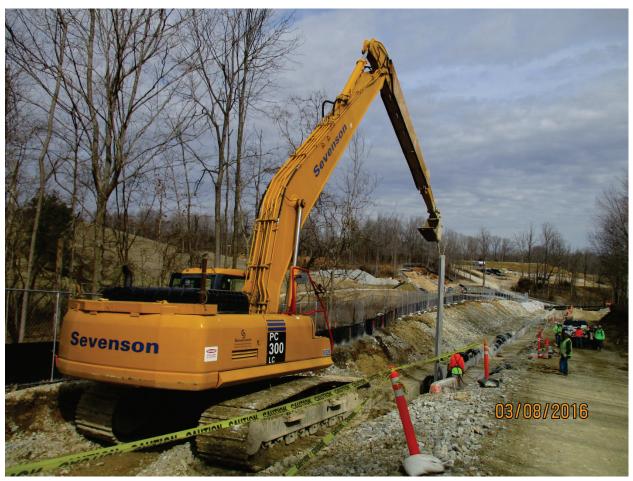
Photo 75: Completion of vinyl sheeting. Mar. 2016

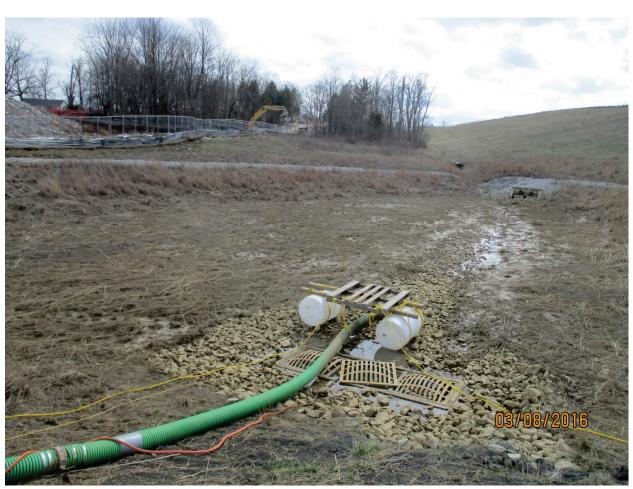
Photo 76: Floating barge in DB-5. Mar. 2016

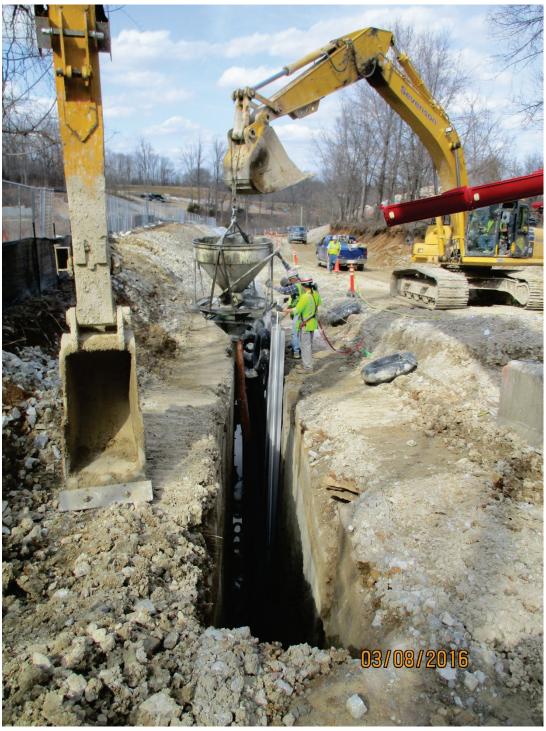
Photo 77: Completion of grout placement. Mar. 2016

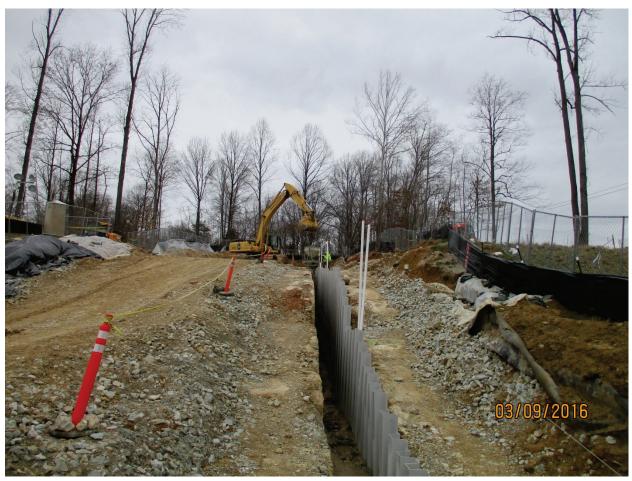
Photo 78: Stone placement in base of trench. Mar. 2016

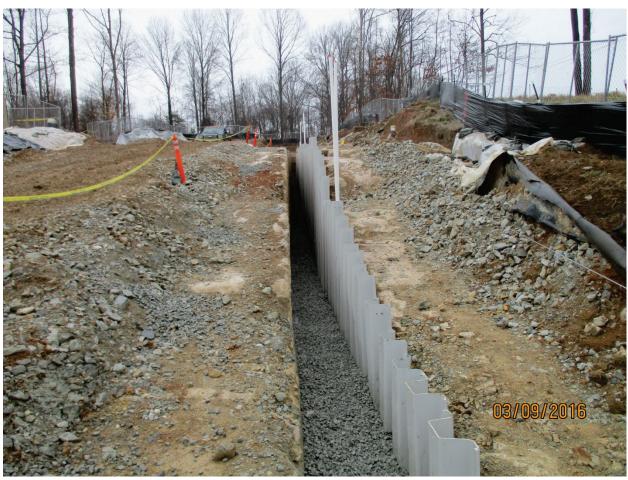
Photo 79: Gravel base placed in trench. Mar. 2016
