Re: RCRA Corrective Action Administrative Order on Consent (AOC) Pilot Perimeter Groundwater Collection Trench Construction Certification Report GM GPS - Bedford Facility, IND 006036099, Docket No. RCRA 05-2014-0011 Bedford, Indiana

Construction Certification Report

Pilot Perimeter Groundwater Trench Collection System

General Motors LLC

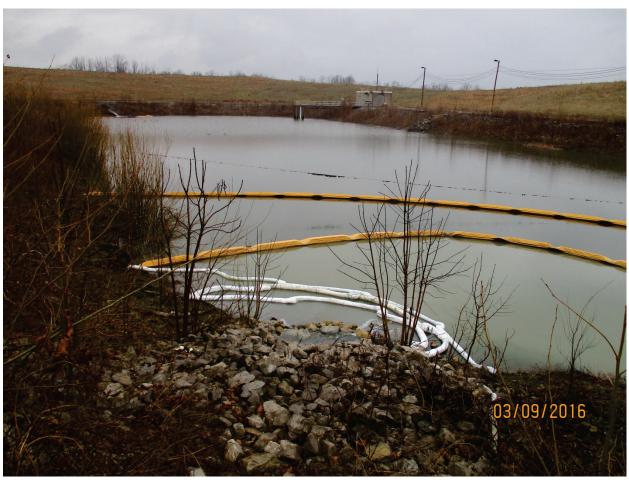
Photo 80: Absorbent boom at SW outfall to SW pond. Mar. 2016

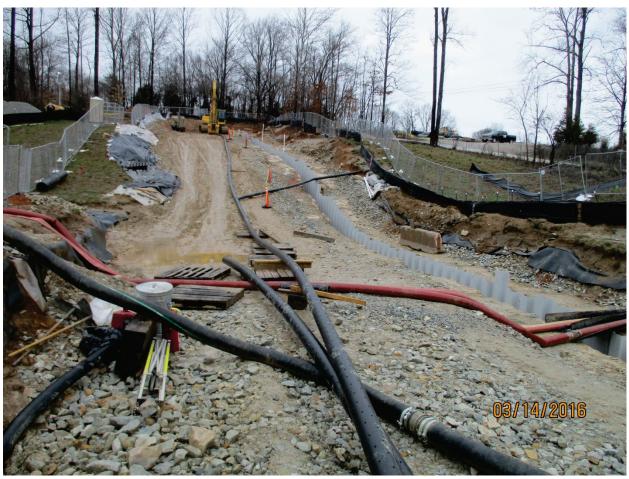
Photo 81: Welded perforated pipe. Mar. 2016

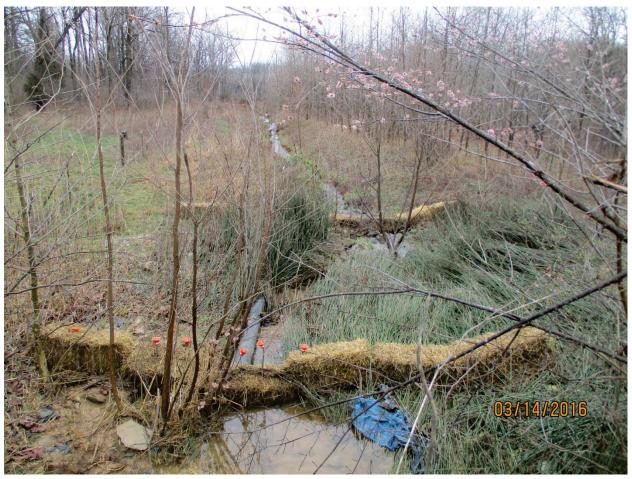
Photo 82: Water quality in creek downstream from site. Mar. 2016

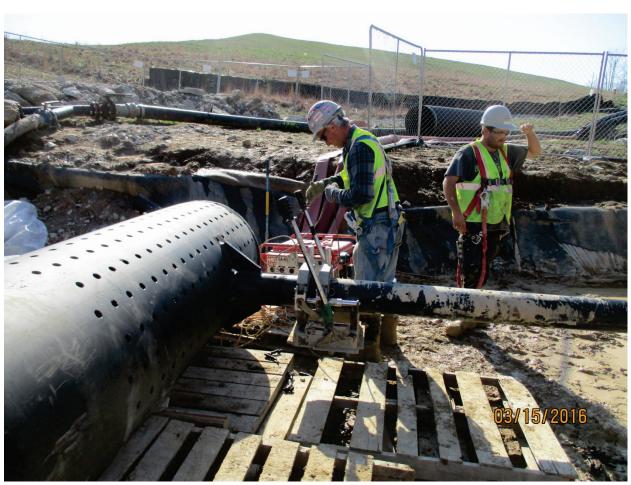
Photo 83: Welding perforated pipe to WW sump. Mar. 2016

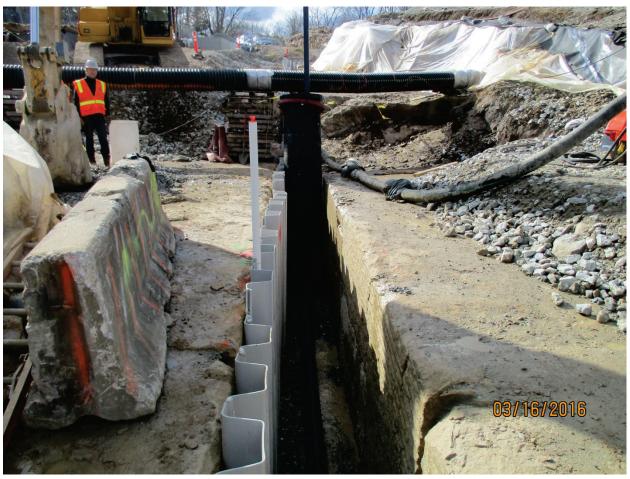
Photo 84: Sump and perforated pipe in north trench. Mar. 2016

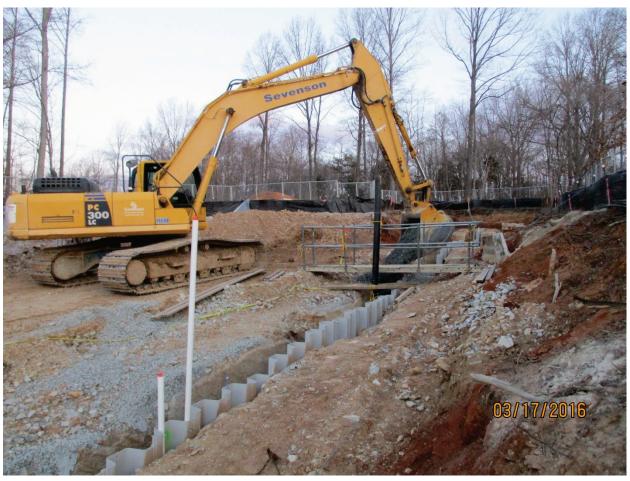
Photo 85: Stone placement at northern cleanout. Mar. 2016

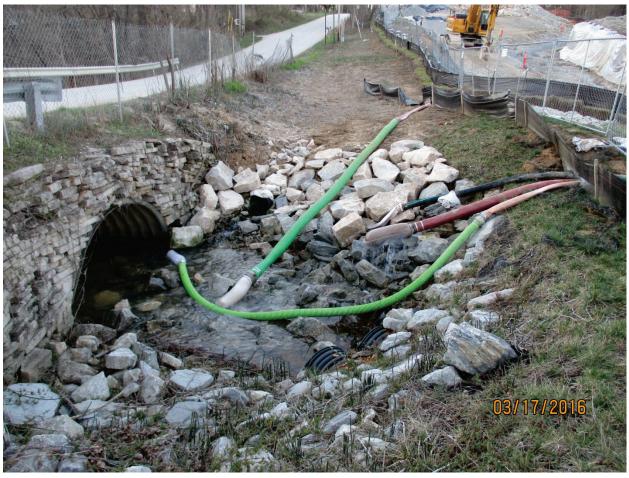
Photo 86: Stormwater discharge from DBs (filter socks on discharge). Mar. 2016

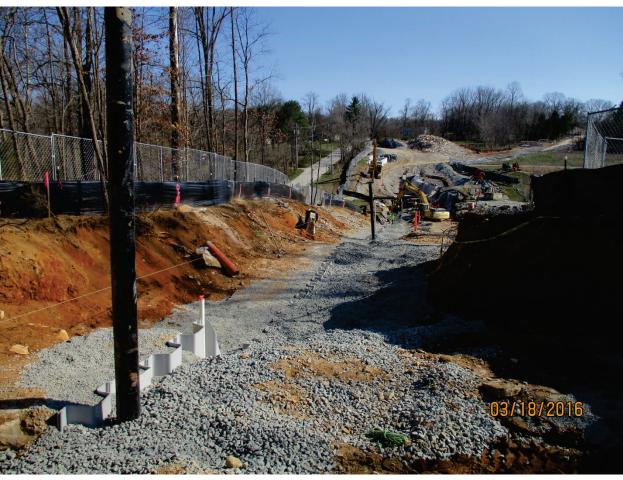
Photo 87: Stone backfill in north trench section. Mar. 2016

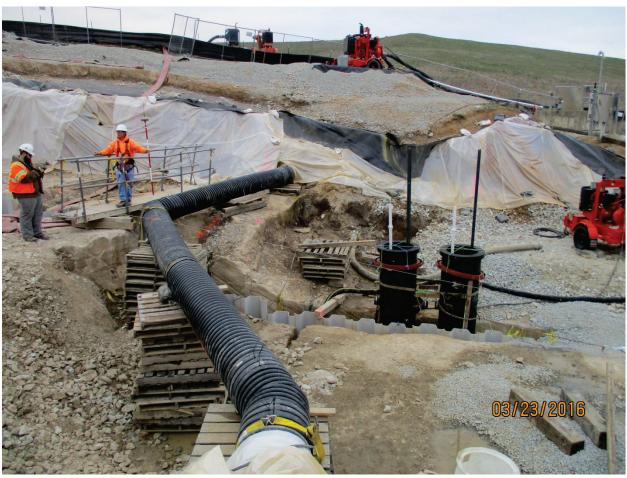
Photo 88: WTP discharge around WW4 chamber. Mar. 2016

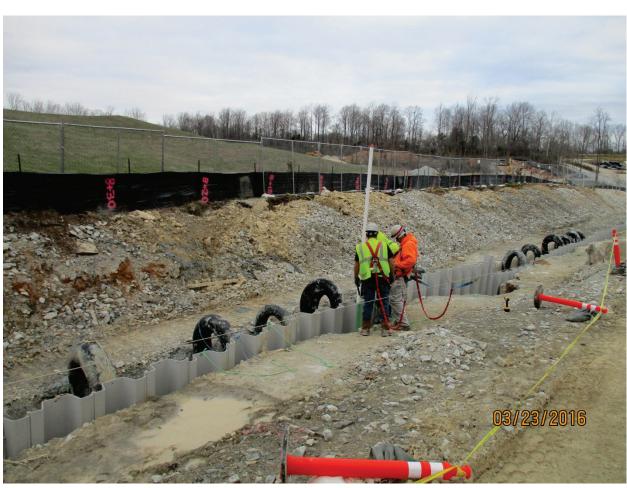
Photo 89: Piezometers in south trench. Mar. 2016

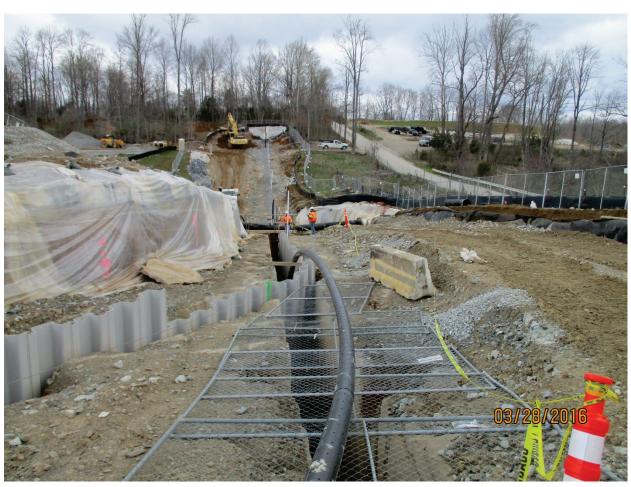
Photo 90: Perforated pipe in south trench. Mar. 2016

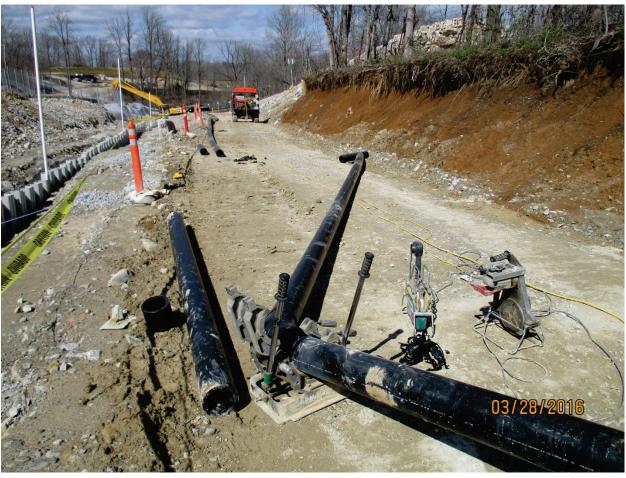
Photo 91: Welding south cleanout. Mar. 2016

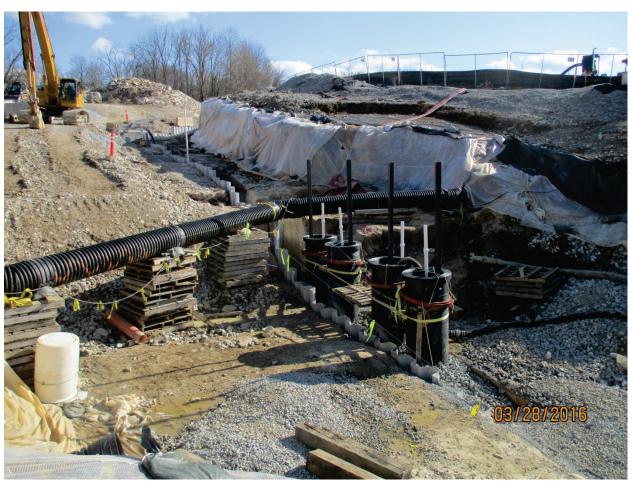
Photo 92: Sump pipes set into trench, surrounded by 2-inch stone. Mar. 2016

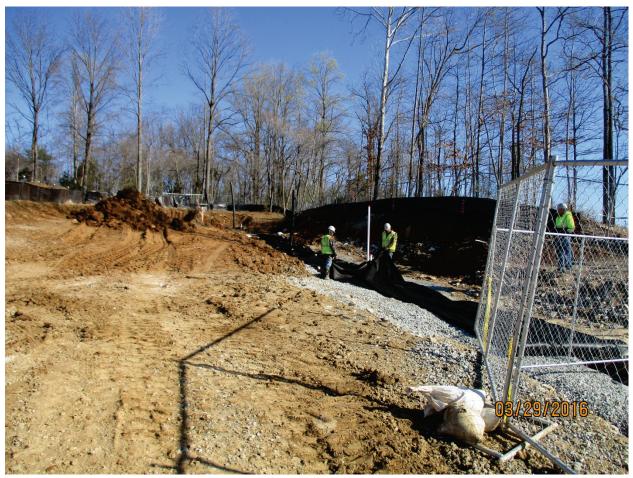
Photo 93: Filter fabric over north trench. Mar. 2016

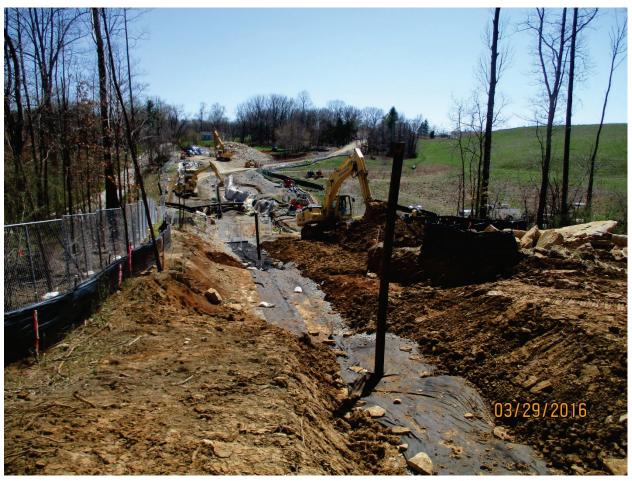
Photo 94: Clay backfill over north trench. Mar. 2016

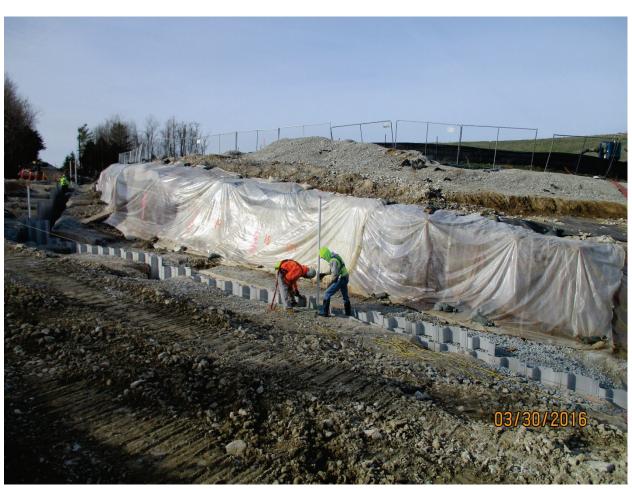
Photo 95: Cutting vinyl sheets to bedrock. Mar. 2016

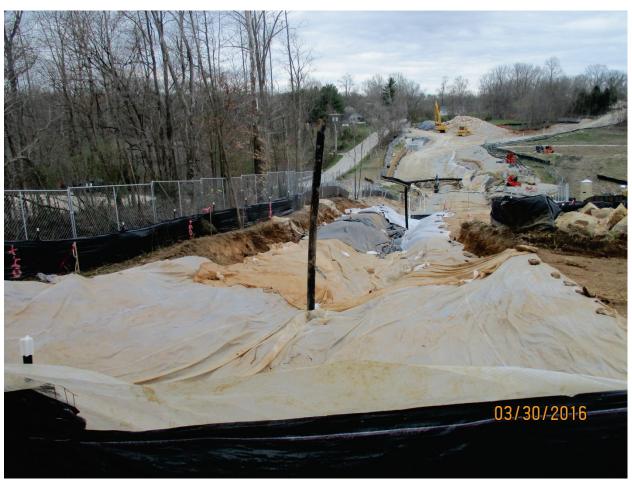
Photo 96: Cover clay before pending rain. Mar. 2016

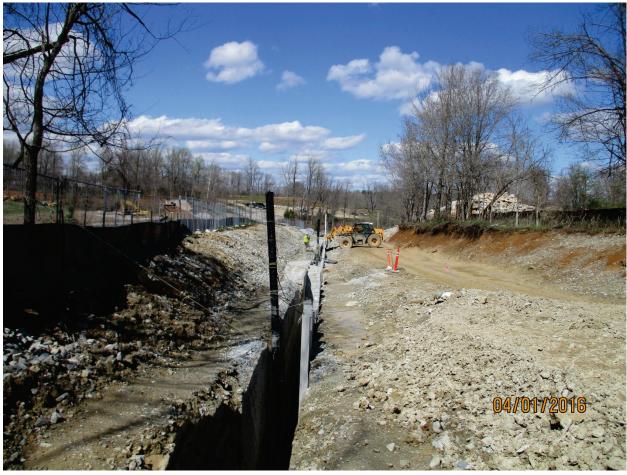
Photo 98: Stone backfill in south trench. Apr. 2016

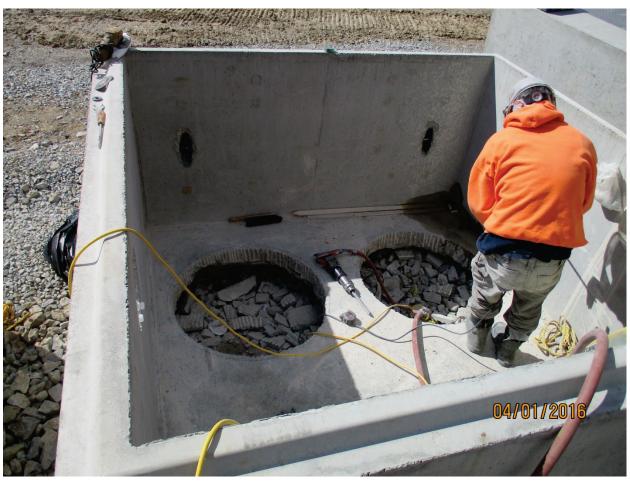
Photo 99: Cutting holes in WW chamber. Apr. 2016

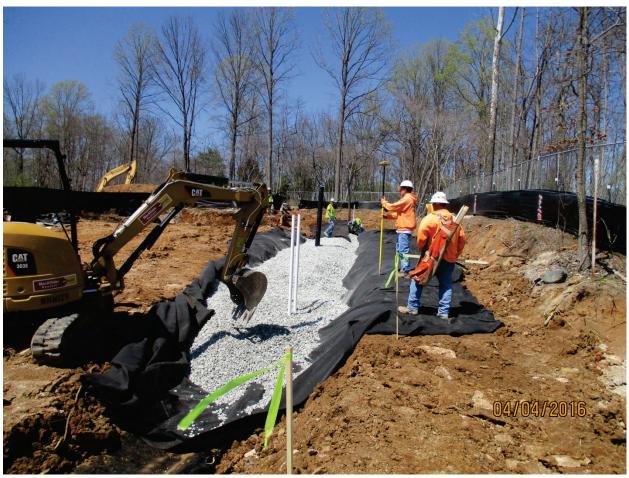
Photo 100: Filtration media over north trench. Apr. 2016

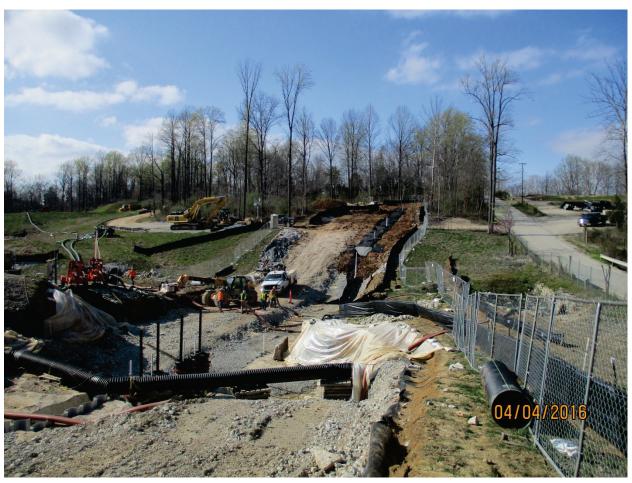
Photo 101: Covered filtration media over north trench. Apr. 2016

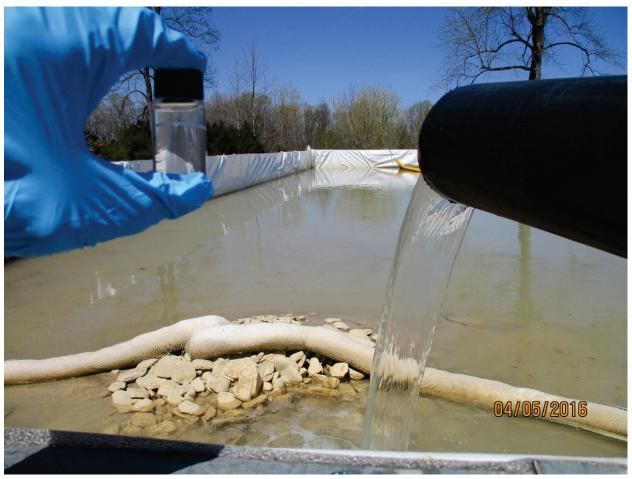
Photo 102: Discharge from pilot trench at modutanks. Apr. 2016

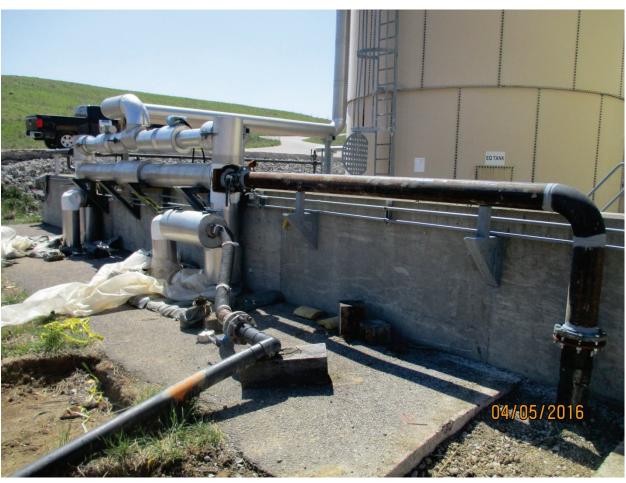
Photo 103: Pipe manifold connection at existing WTP. Apr. 2016

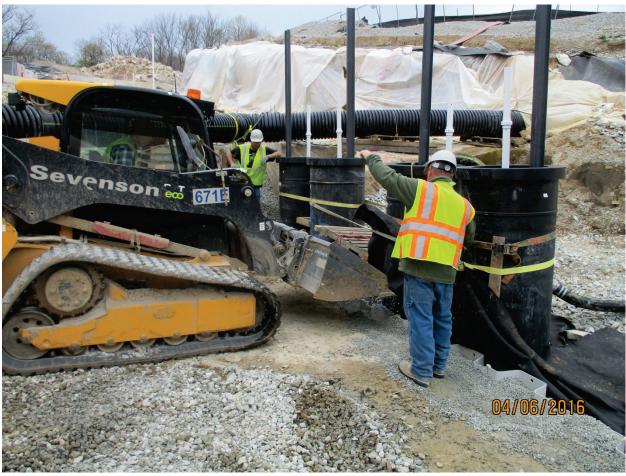
Photo 104: Backfill behind sheets at sump area. Apr. 2016

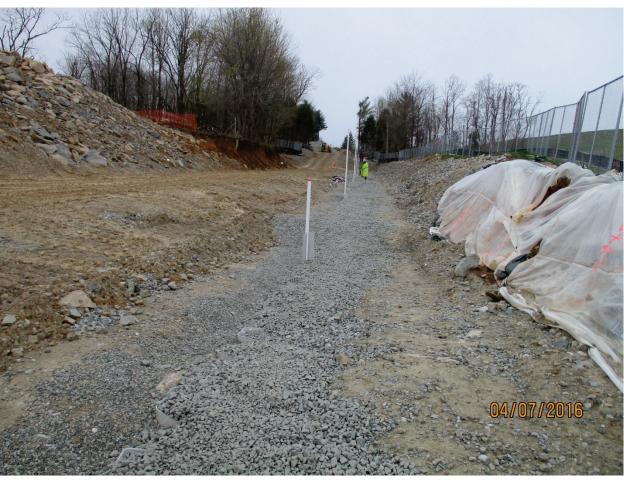
Photo 105: Stone placed in south trench. Apr. 2016

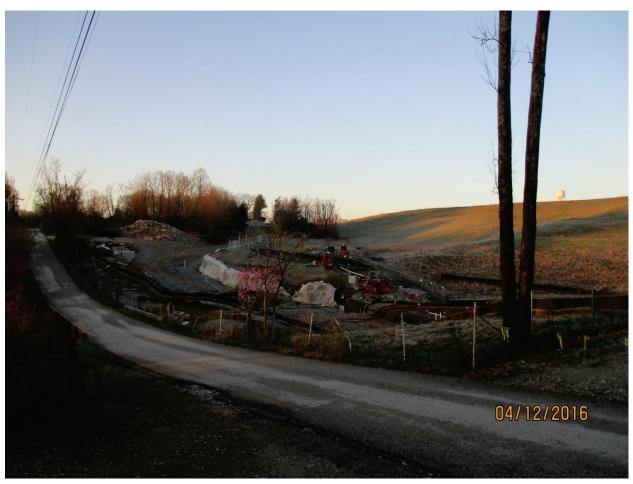
Photo 106: Secure site during rainfall event. Apr. 2016

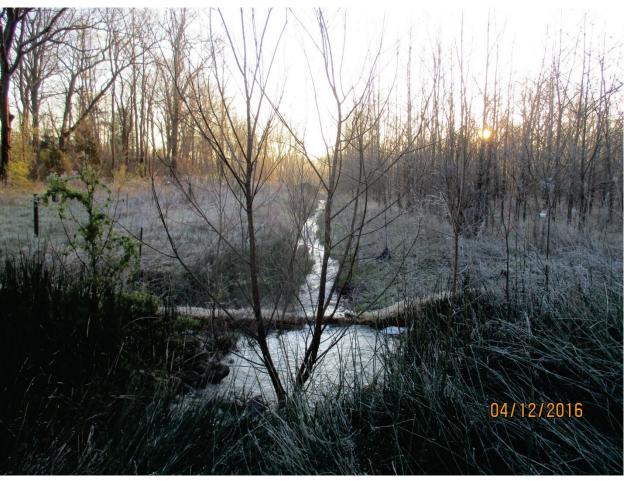
Photo 107: SW discharge after DBs settled. Apr. 2016

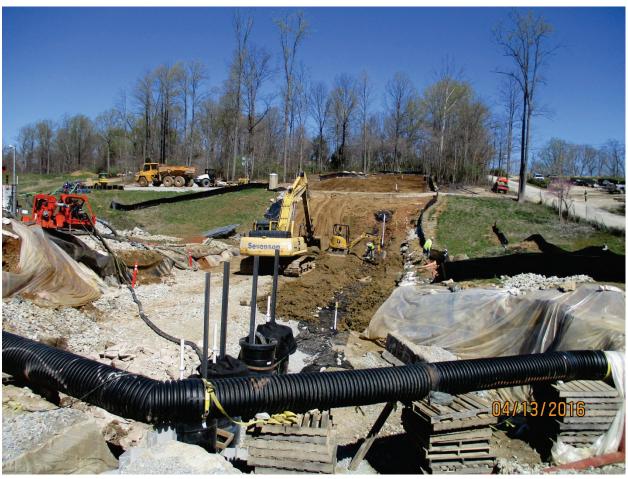
Photo 108: Backfilling working platform. Apr. 2016

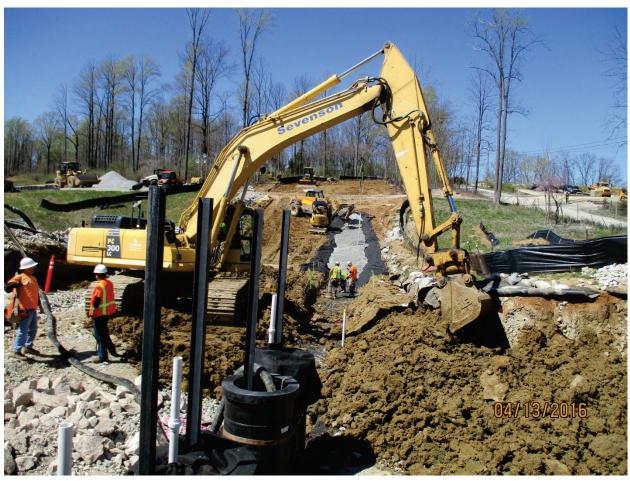
Photo 109: Placement of filtration media at working platform. Apr. 2016

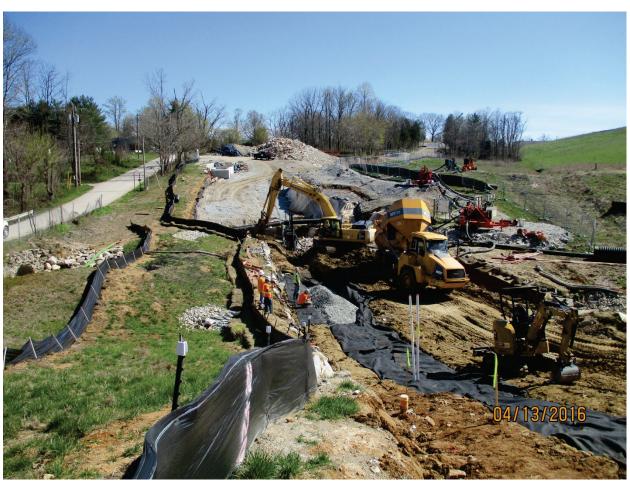
Photo 110: Covering of filtration media at working platform. Apr. 2016

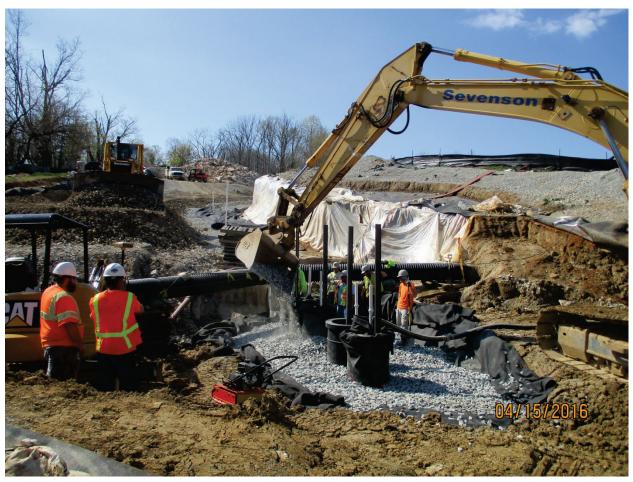
Photo 111: Backfilling around sumps with 2-inch stone. Apr. 2016

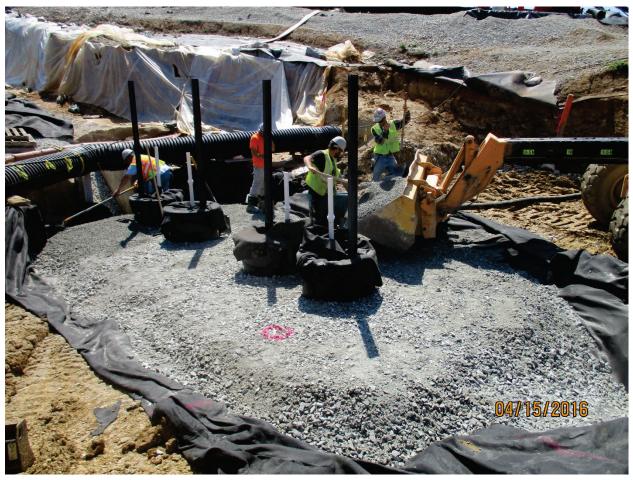
Photo 112: Levelling subgrade with #11 stone and filter fabric at WW sumps. Apr. 2016

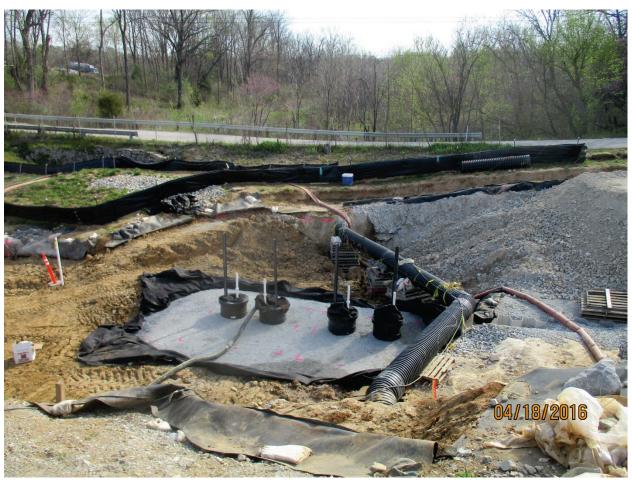
Photo 113: Compacting subgrade around WW4 sumps. Apr. 2016

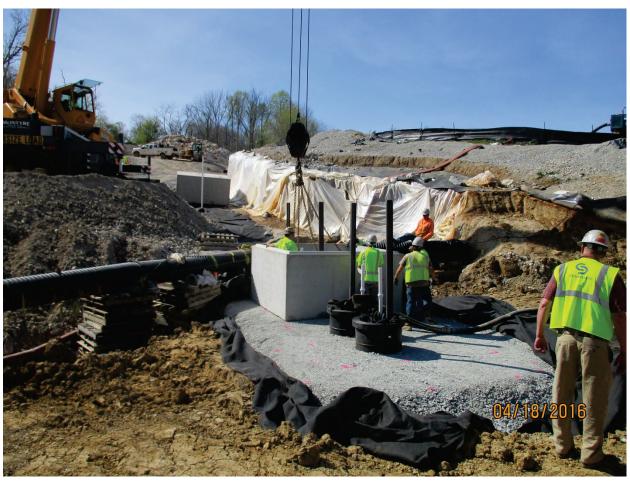
Photo 114: Setting south chamber base for WW sumps. Apr. 2016

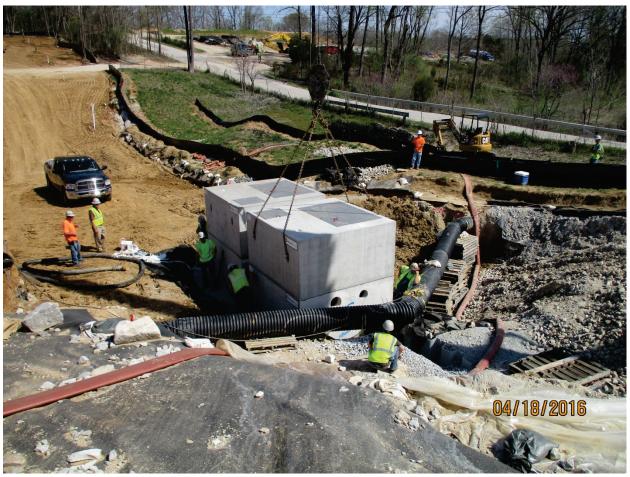
Photo 115: Setting top of south chamber for WW sumps. Apr. 2016

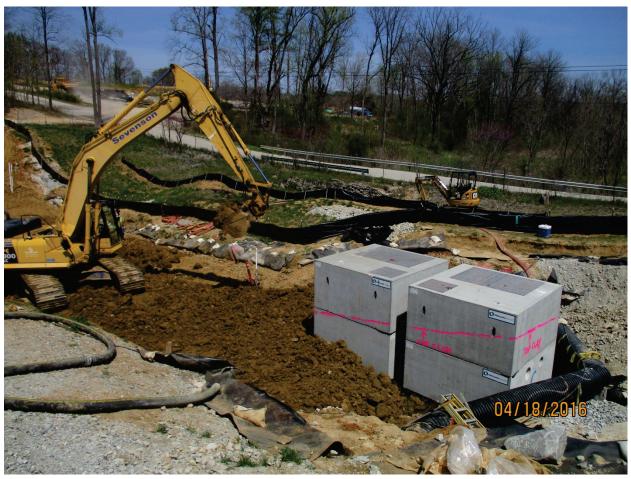
Photo 116: Backfilling around WW chambers. Apr. 2016

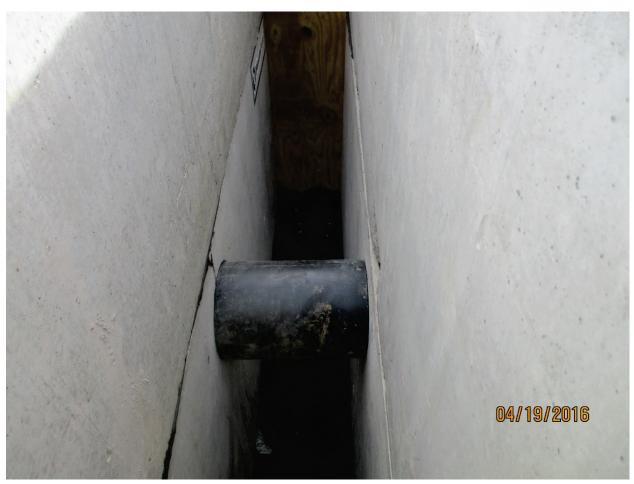
Photo 117: HDPE sleeve between WW chambers. Apr. 2016

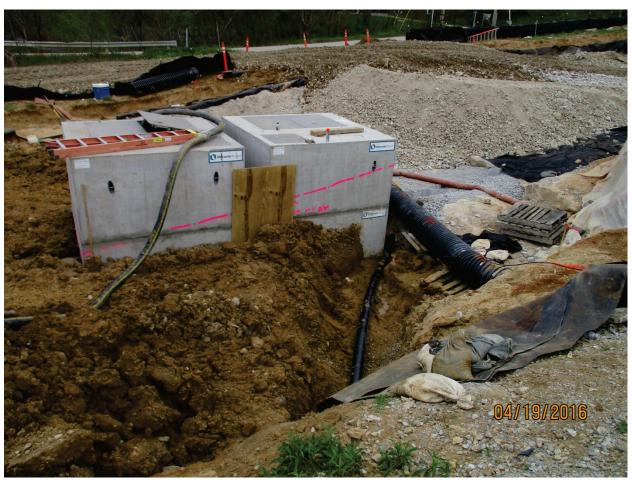
Photo 118: Overflow pipe from WW3. Apr. 2016

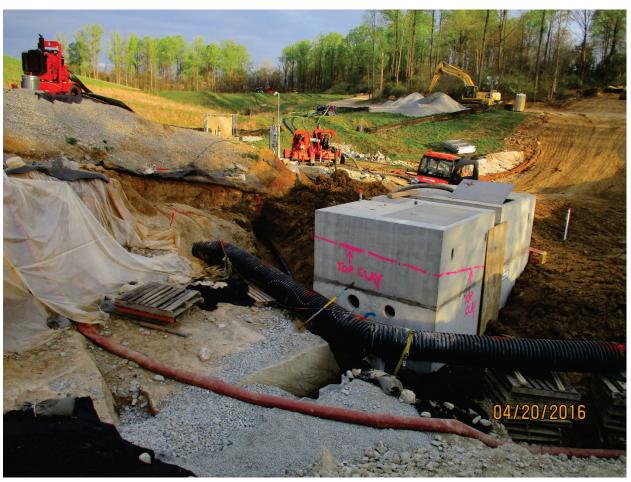
Photo 119: Clay level around WW chambers. Apr. 2016

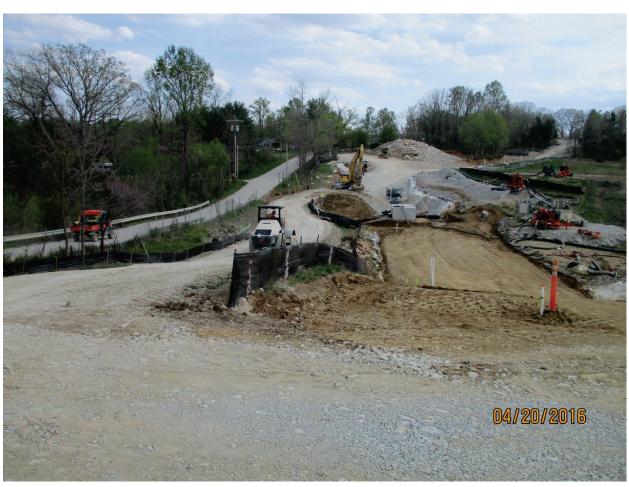
Photo 120: Bypass access road. Apr. 2016

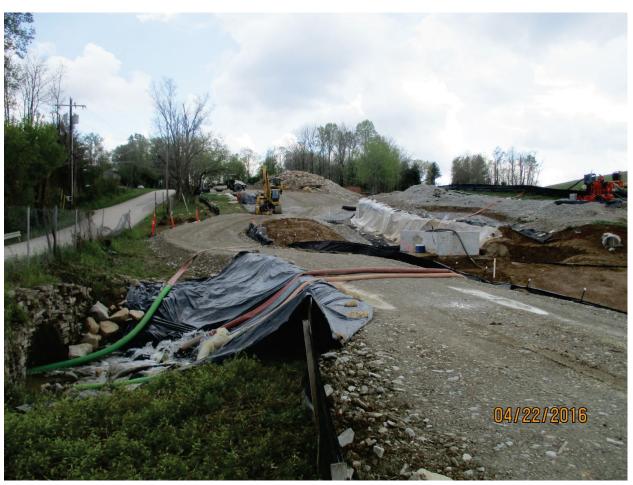
Photo 121: Pumping DB-2 water through bag filters. Apr. 2016

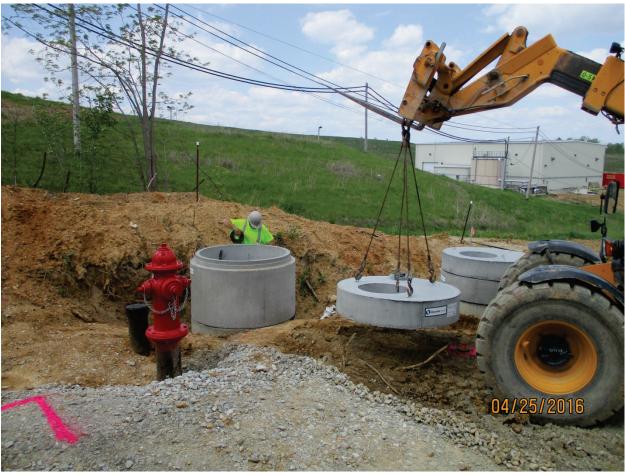
Photo 122: Risers installed on firemain and forcemain MHs. Apr. 2016

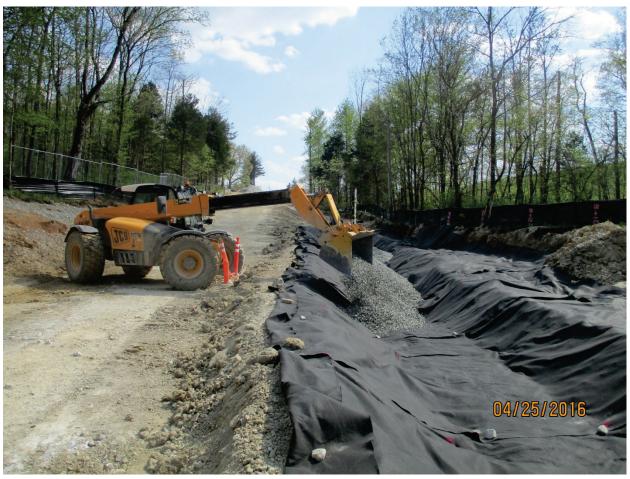
Photo 123: Filtration media over south trench. Apr. 2016

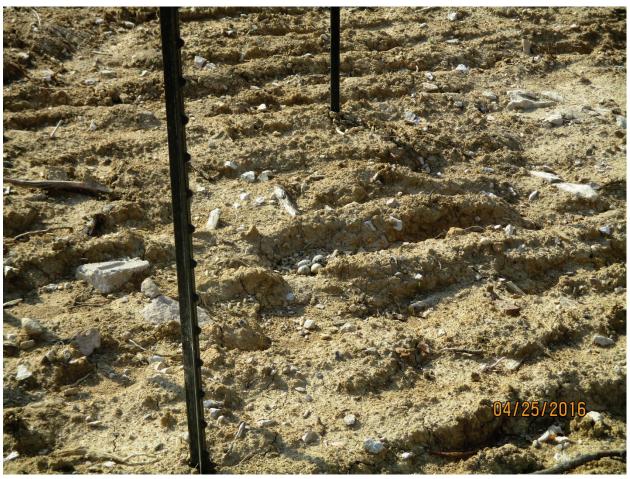
Photo 124: Killdeer eggs north of GWTP. Apr. 2016

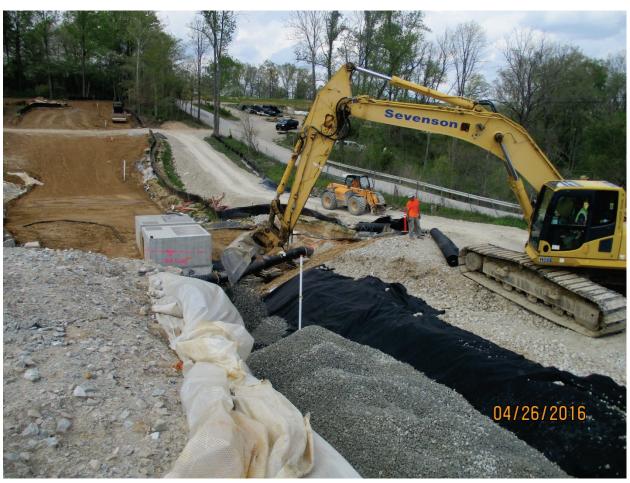
Photo 125: Filtration media south of WW4. Apr. 2016

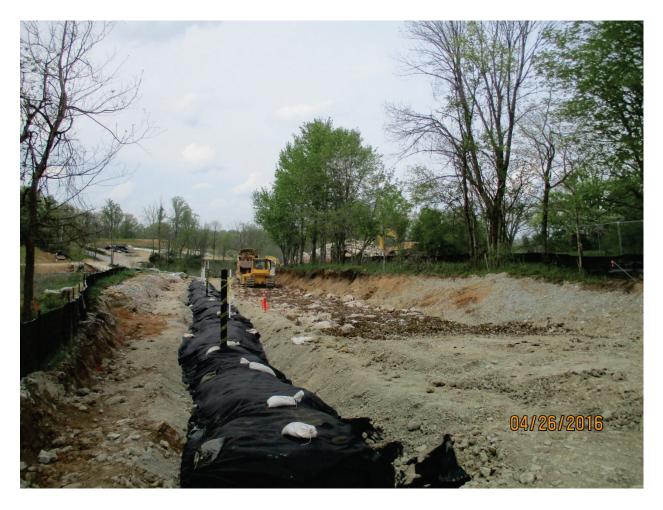
Photo 126: Backfilling south trench. Apr. 2016

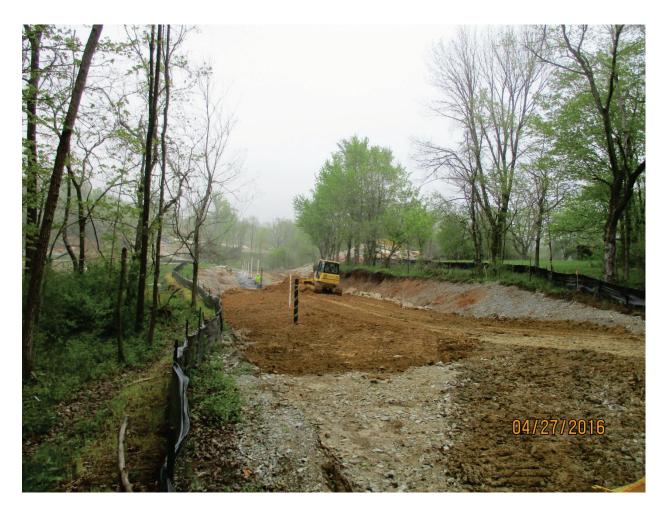
Photo 127: Clay from GWTP placed over south trench. Apr. 2016

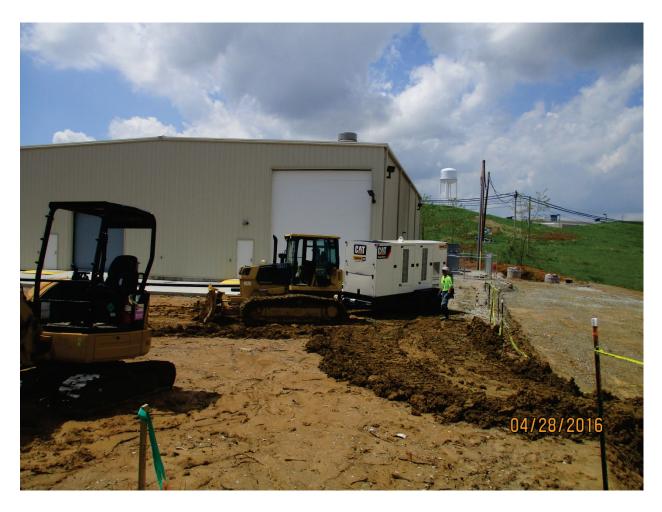
Photo 128: Removal of generator for GWTP. Apr. 2016

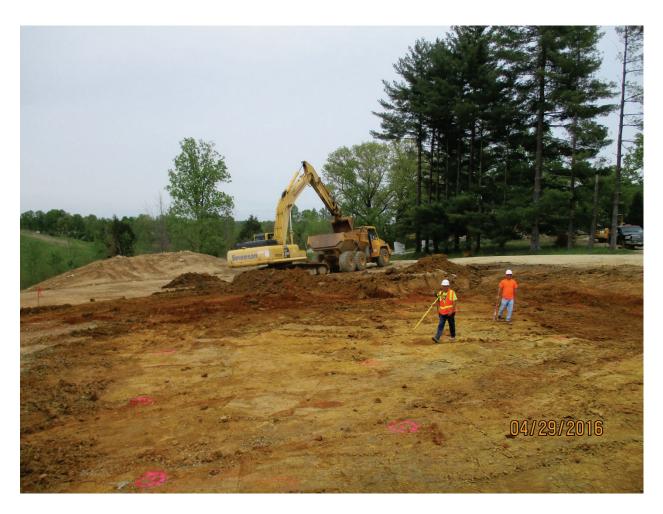
Photo 129: Excavating north of GWTP. Apr. 2016

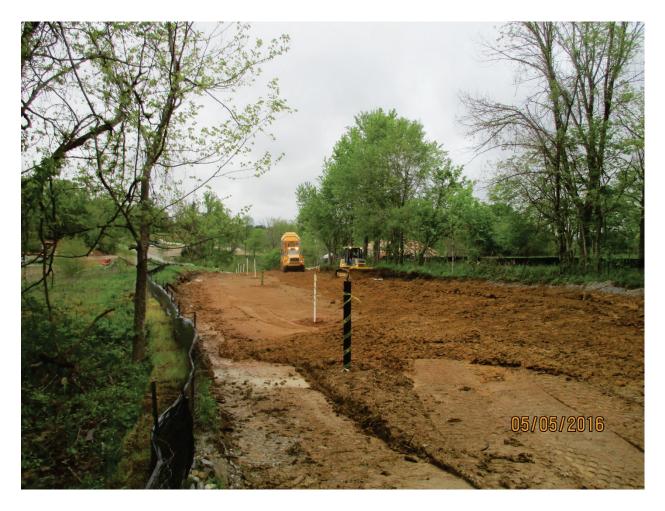
Photo 131: Backfilling south trench. May. 2016

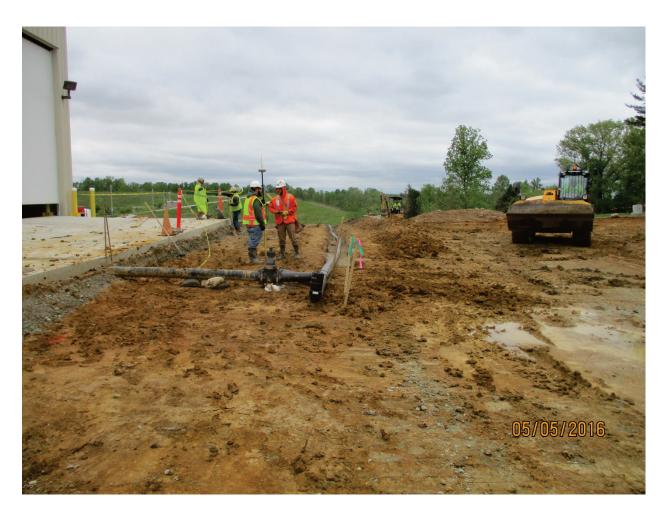
Photo 132: Storm drain along east side of GWTP. May. 2016

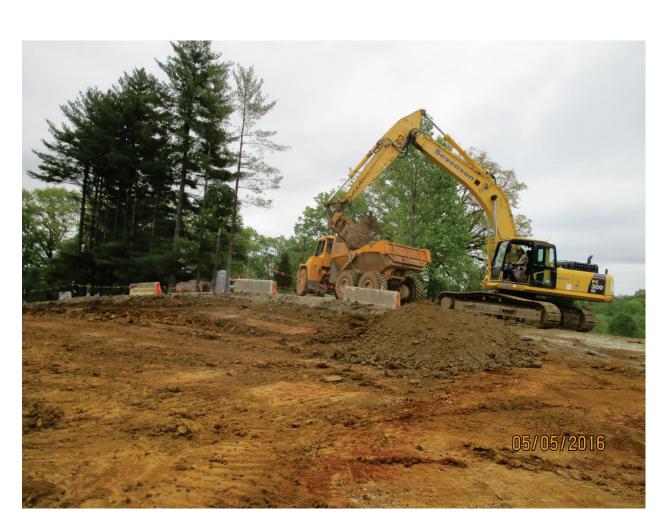
Photo 133: Excavating beside Old Barlow Lane. May. 2016

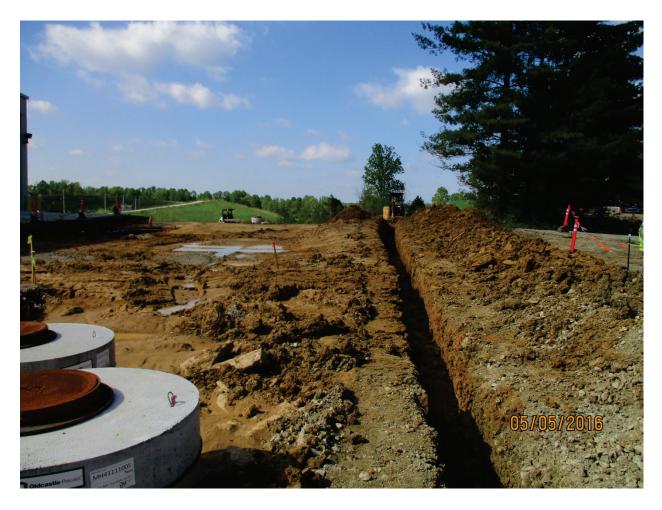
Photo 134: Excavation for 8-inch forcemain. May. 2016

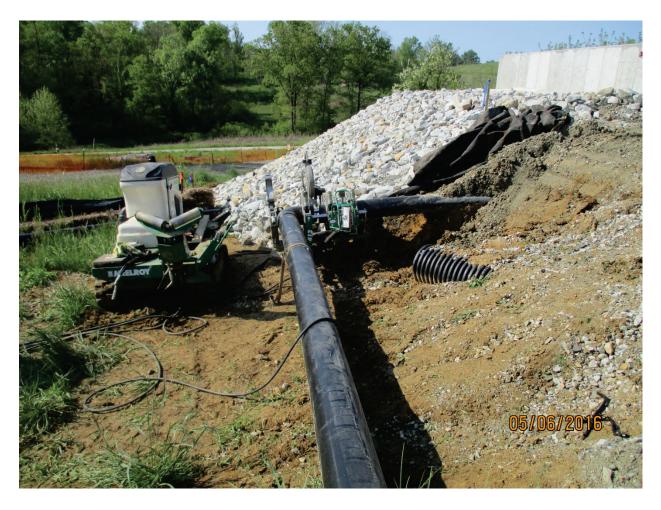
Photo 135: Forcemain to EQ tank. May. 2016

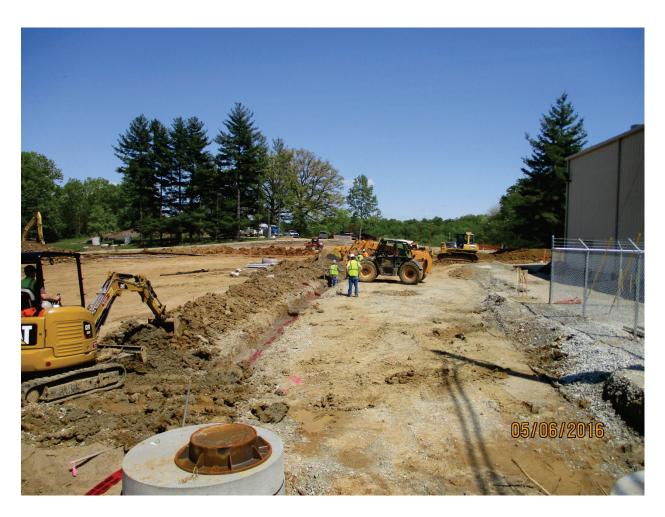
Photo 136: Backfilling conduit trench to pull box. May. 2016

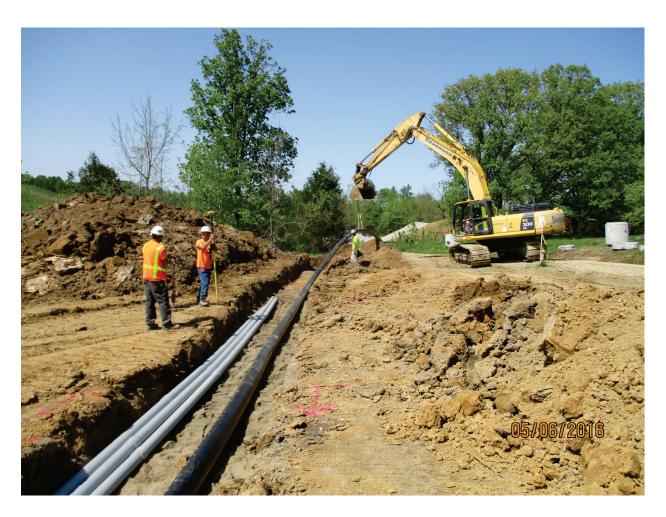
Photo 137: Forcemain in trench north of drive area. May. 2016

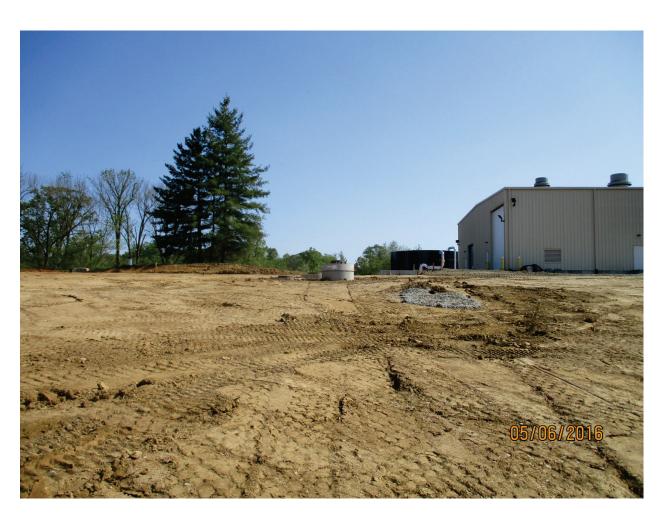
Photo 138: Storm drain from east side of GWTP to north area. May. 2016

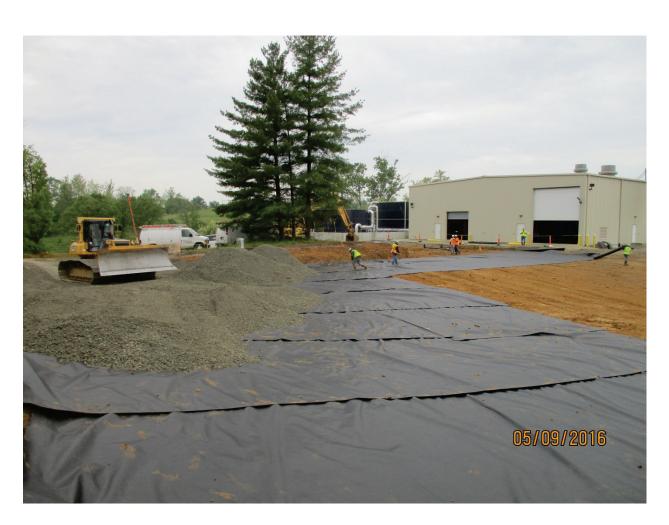
Photo 139: First lift of stone on drive area. May. 2016

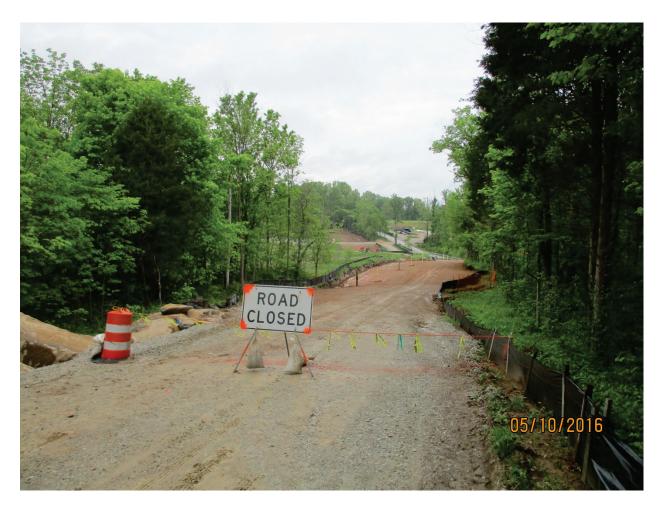
Photo 140: Blocked access road from Barlow Lane to trench. May. 2016

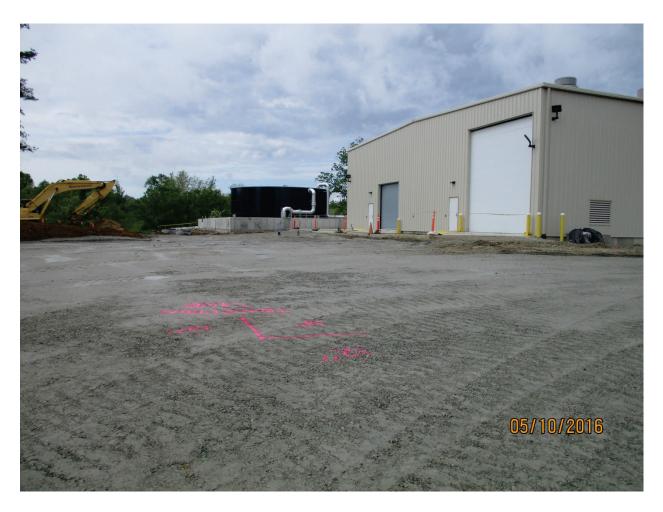
Photo 141: Transition from 12-inch to 18-inch stone at drive area. May. 2016

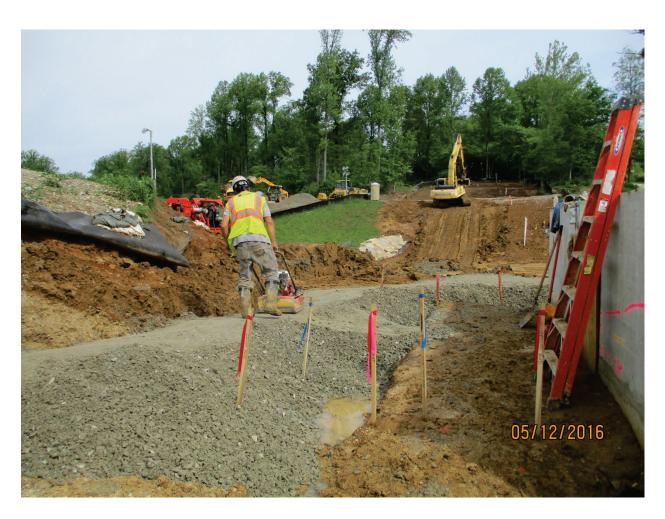
Photo 143: Compacting stone over outfall pipe. May. 2016

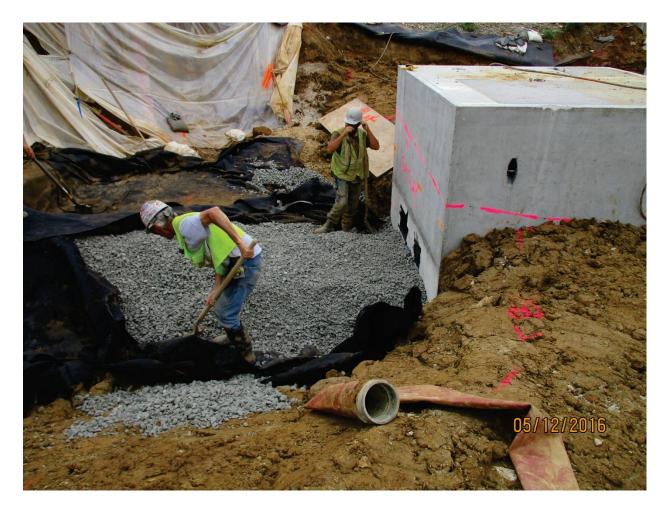
Photo 144: Infiltration media south of WW4 chamber. May. 2016

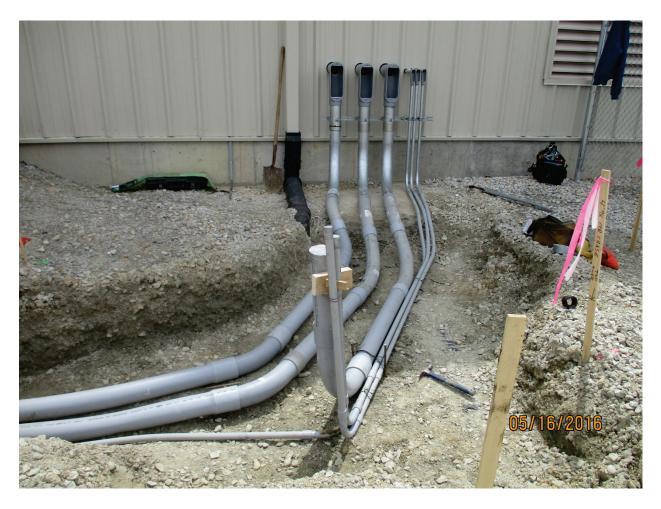
Photo 146: Conduits run for WW4 cables and generator. May. 2016

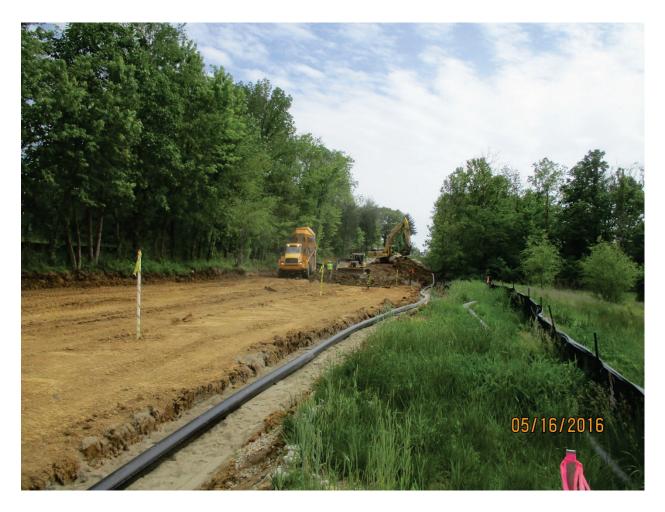
Photo 148: Clay over fill along south trench forcemain. May. 2016

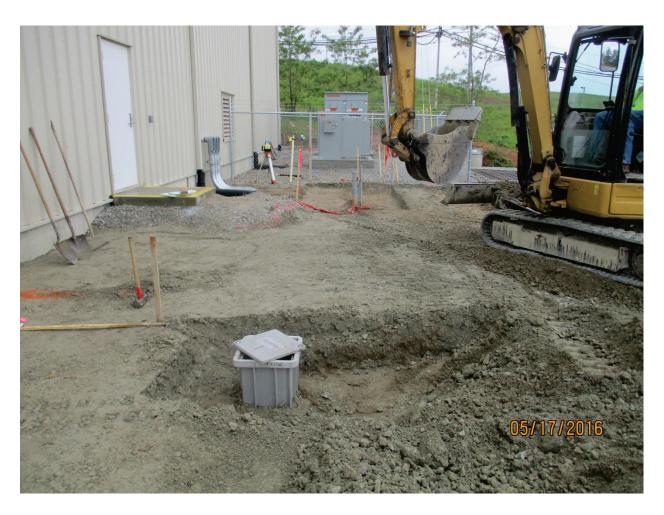
Photo 149: Grounding inspection well by generator. May. 2016

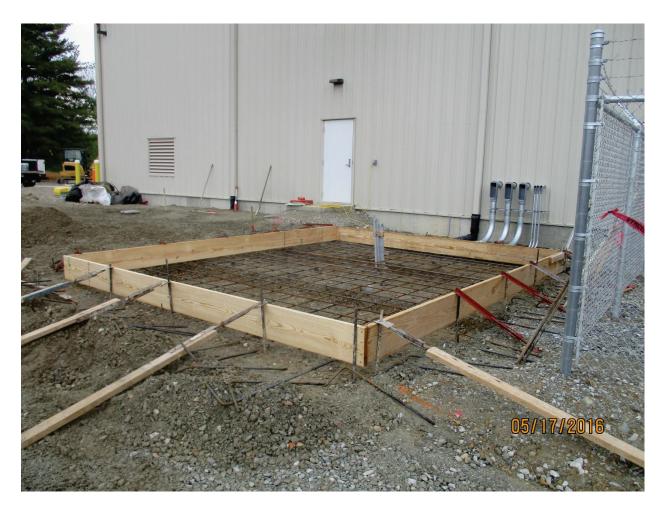
Photo 150: Forming rebar mat for generator pad. May. 2016

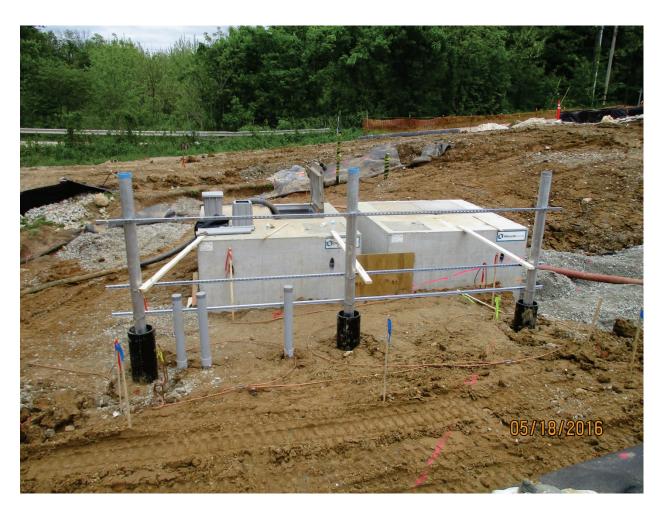
Photo 152: Posts for electrical panel at WW4. May. 2016

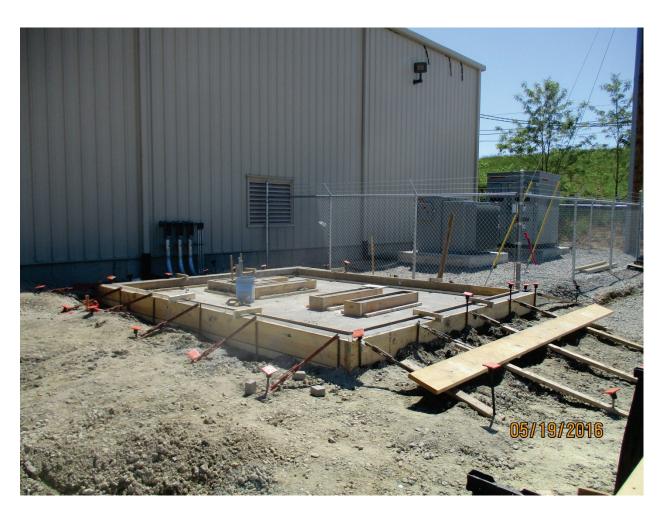
Photo 153: Concrete pour for containment around generator pad at GWTP. May. 2016

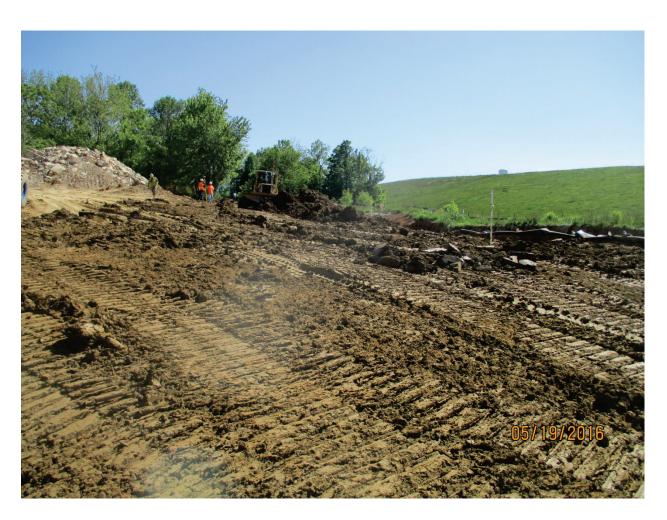
Photo 154: Grading clay over south trench area. May. 2016
