Re: RCRA Corrective Action Administrative Order on Consent (AOC) Pilot Perimeter Groundwater Collection Trench Construction Certification Report GM GPS - Bedford Facility, IND 006036099, Docket No. RCRA 05-2014-0011 Bedford, Indiana

Construction Certification Report

Pilot Perimeter Groundwater Trench Collection System

General Motors LLC

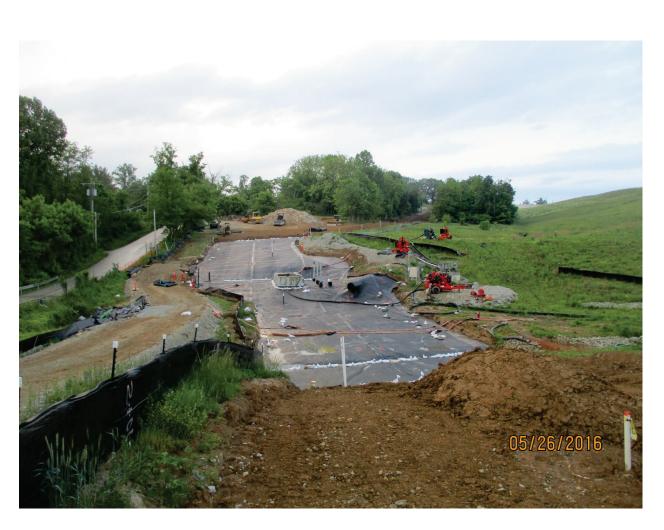
Photo 155: Liner placement over trench area. May. 2016

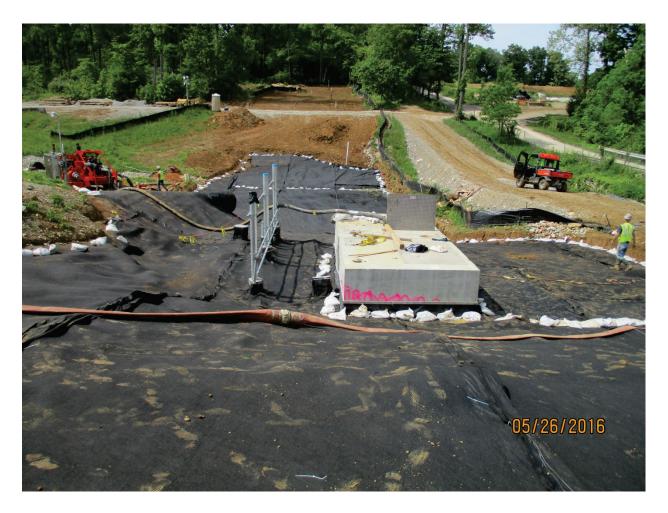
Photo 157: Geocomposite and filter fabric over liner. May. 2016

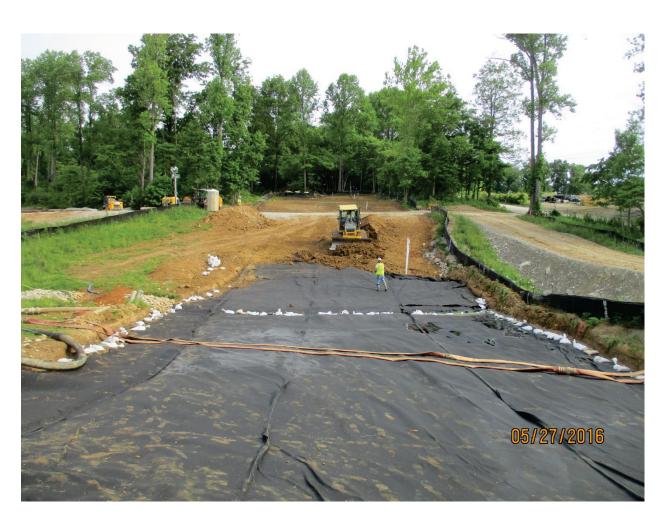
Photo 159: Backfilling anchor trench at north end. May. 2016

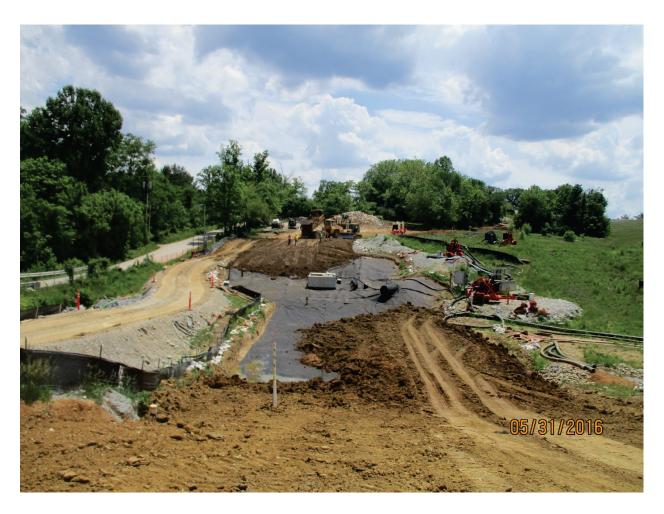
Photo 160: Placing common fill over liner. May. 2016

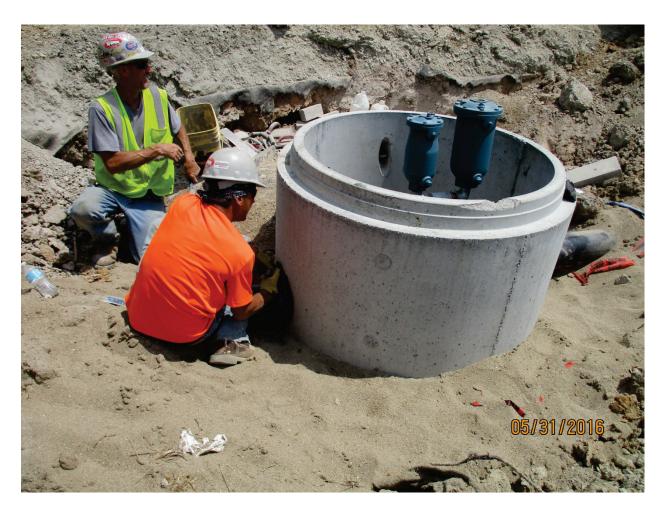
Photo 161: Grout sealing of MH-16. May. 2016

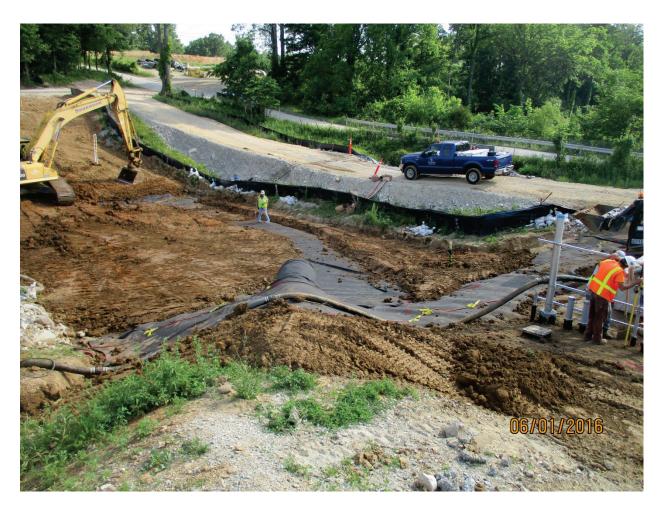
Photo 163: Re-establishing low flow channels in DB-4. Jun. 2016

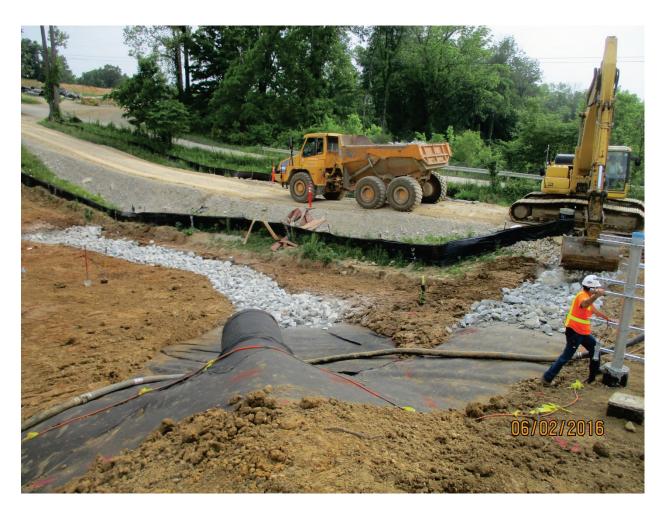
Photo 164: Placing stone in DB-4 low flow channels. Jun. 2016

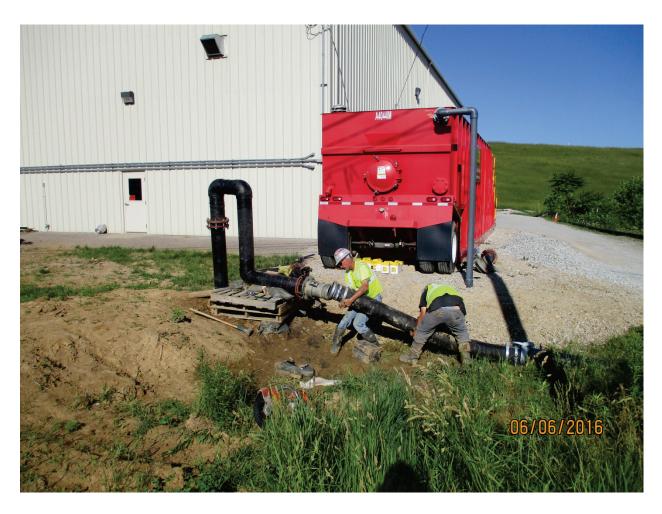
Photo 165: Backwash pipe connected for SW pond discharge. Jun. 2016

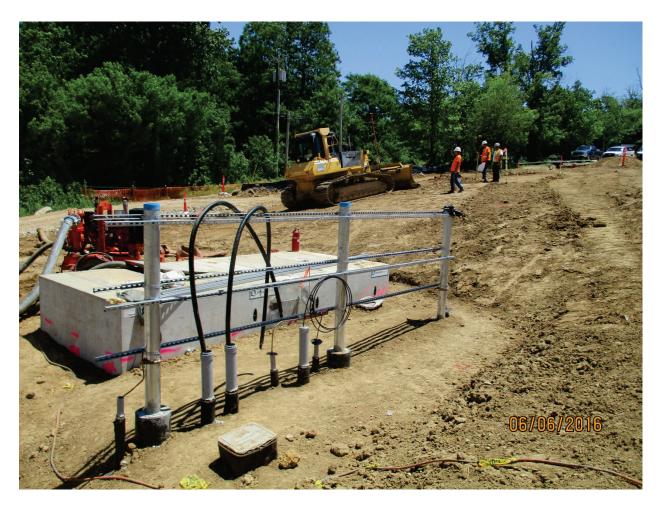
Photo 166: Power cables and fiber optic pulled to WW4 control panel. Jun. 2016

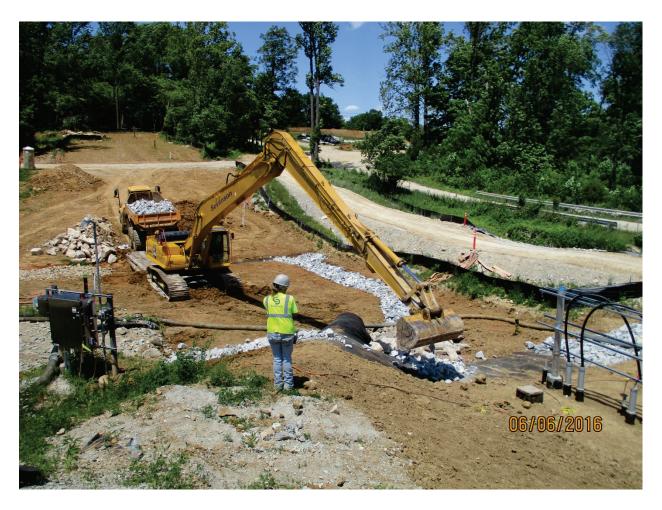
Photo 167: Riprap around DB-5 outfall pipe. Jun. 2016

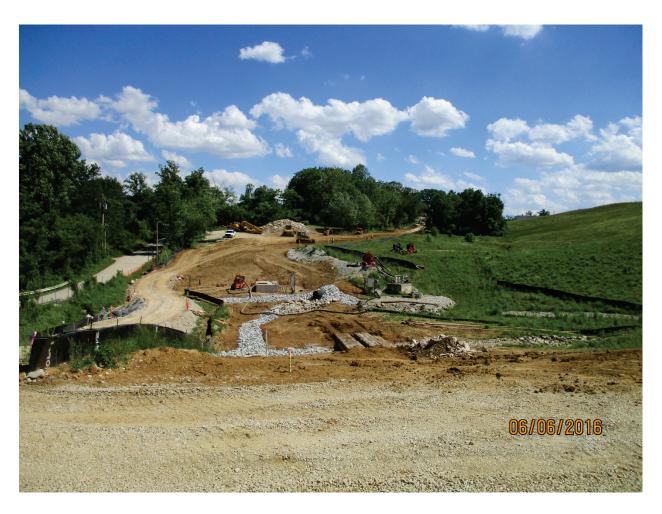
Photo 168: Riprap in low flow channel for DB-4. Jun. 2016

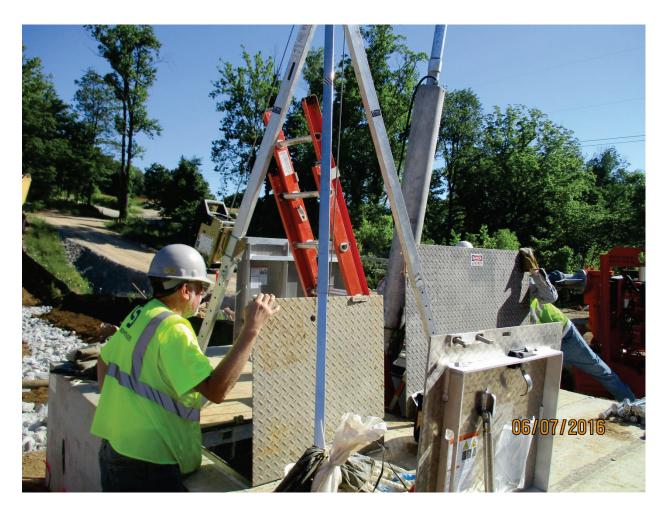
Photo 169: Lowering pump into WW4. Jun. 2016

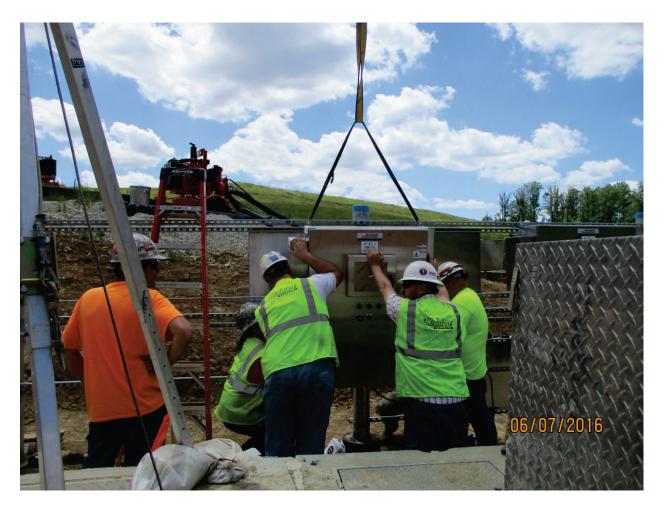
Photo 170: Installation of electrical panels at WW4. Jun. 2016

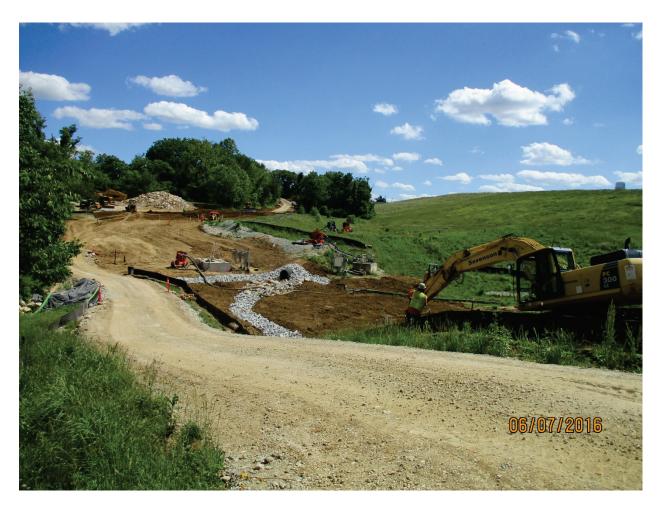
Photo 171: Grading topsoil over trench area. Jun. 2016

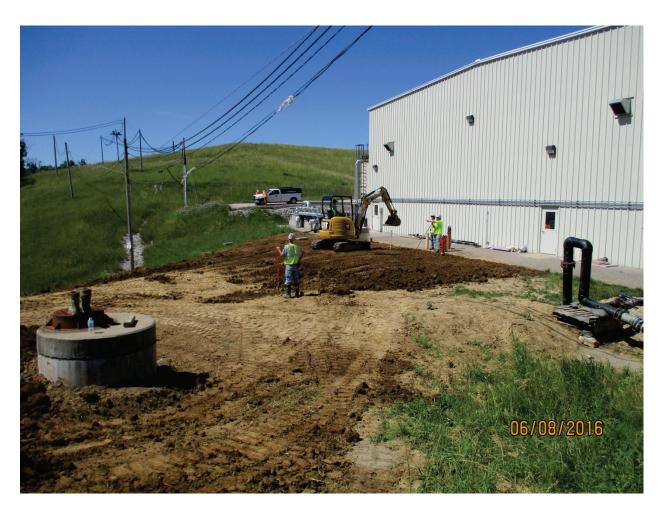
Photo 172: Grading topsoil over PIV and MHs. Jun. 2016

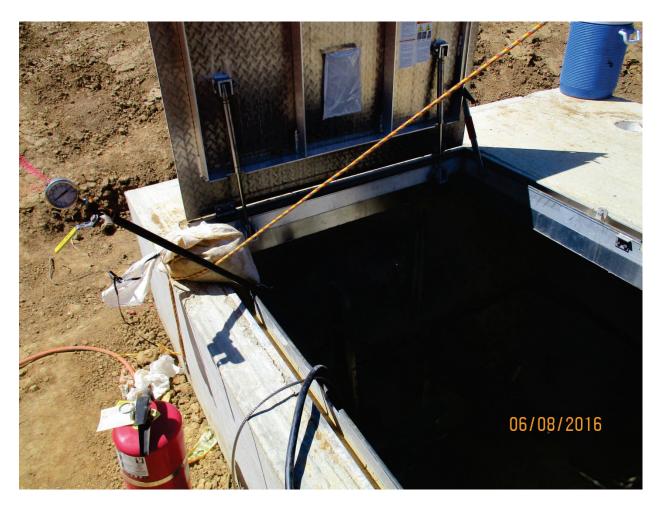
Photo 173: Pressure valve outside of WW4. Jun. 2016

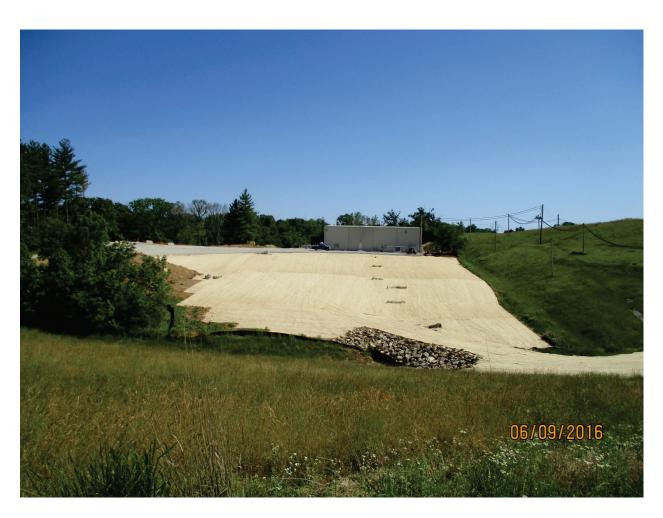
Photo 175: Seeding north of new GWTP. Jun. 2016

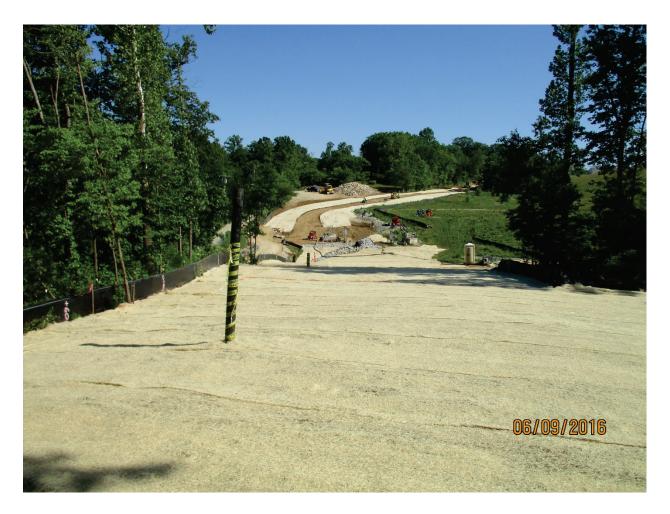
Photo 176: Seeding and erosion control mat over trench. Jun. 2016

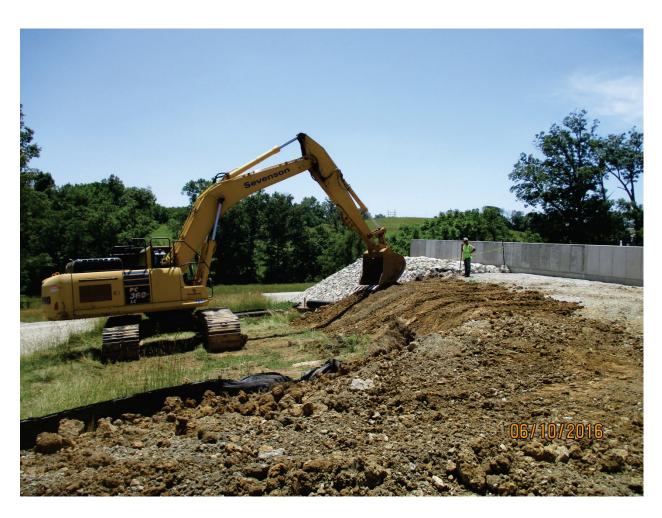
Photo 178: Backfilling over 8-inch forcemain. Jun. 2016

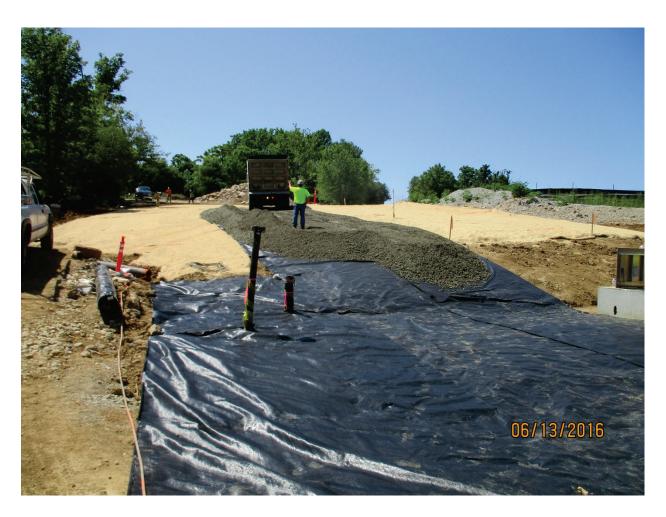
Photo 179: Placing #53 stone for WW4 access road. Jun. 2016

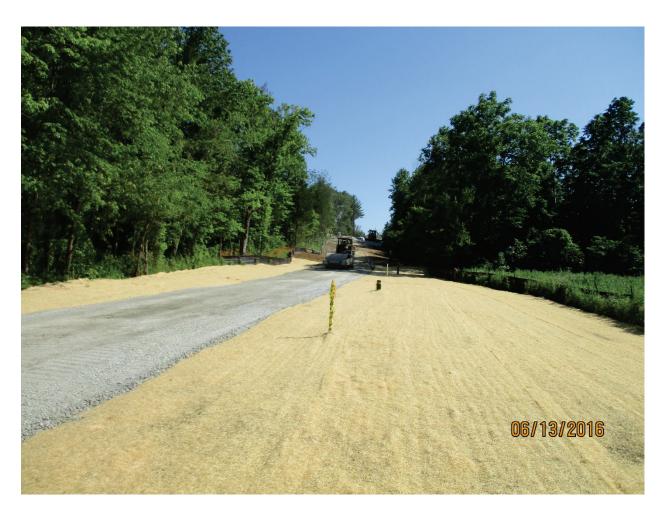
Photo 180: Compaction of #53 stone for WW4 access road. Jun. 2016

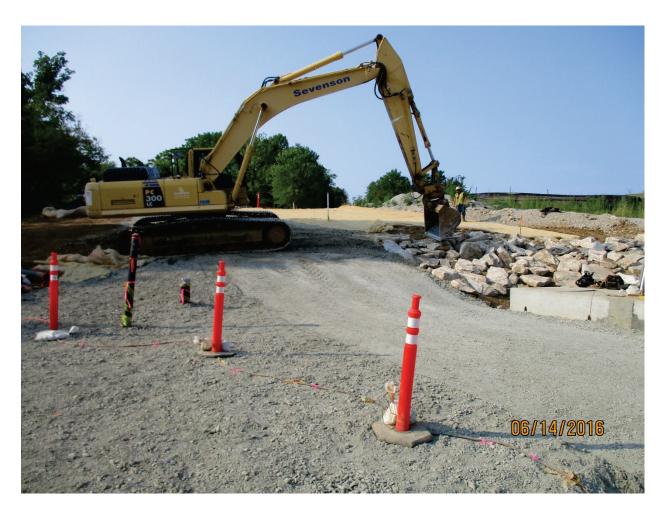
Photo 181: Placement of rock southeast of WW4. Jun. 2016

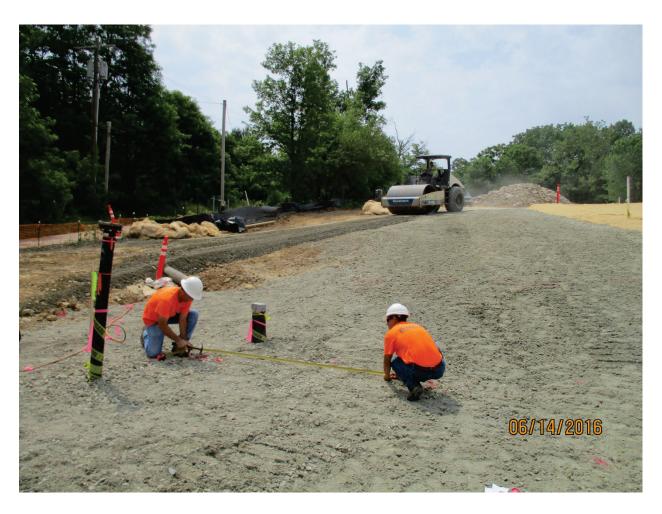
Photo 182: Laying out diesel pump pad. Jun. 2016

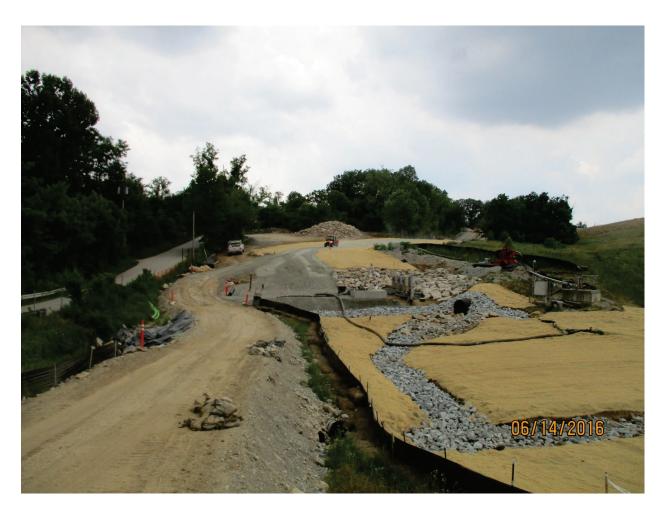
Photo 183: Access road to WW4 and around DB-4. Jun. 2016

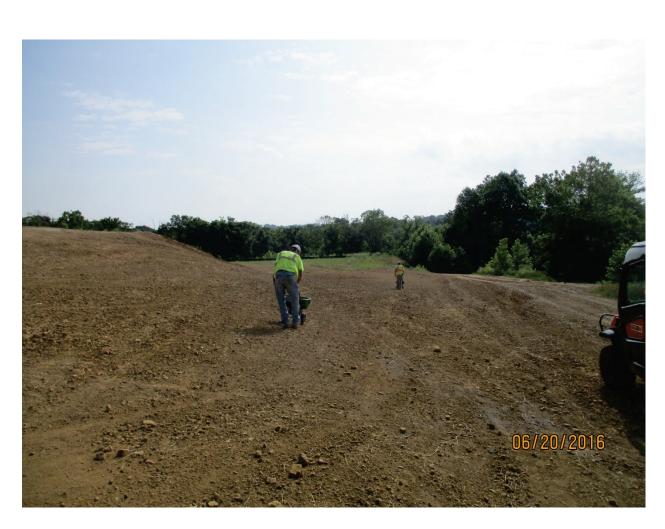
Photo 184: Seeding former modutanks area. Jun. 2016

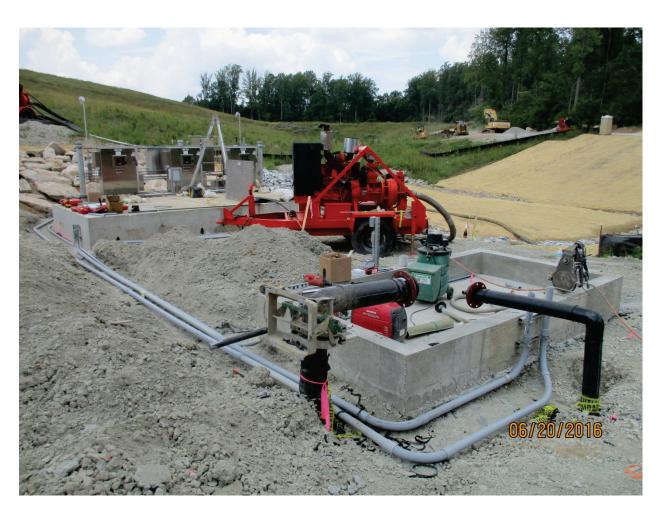
Photo 185: Conduits between WW4 and diesel pump pad. Jun. 2016

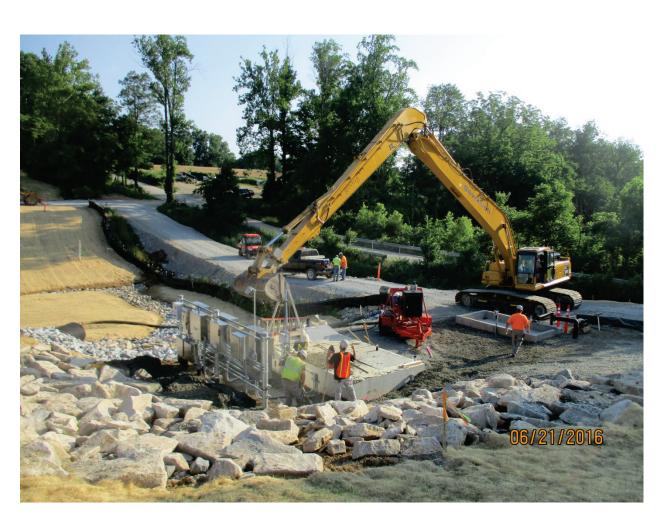
Photo 186: Placing stone for pad around WW4. Jun. 2016

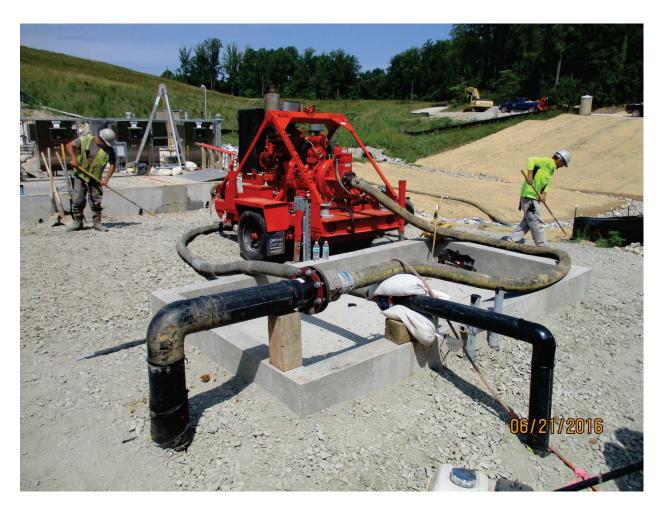
Photo 187: Hooking up backup pump near WW4. Jun. 2016

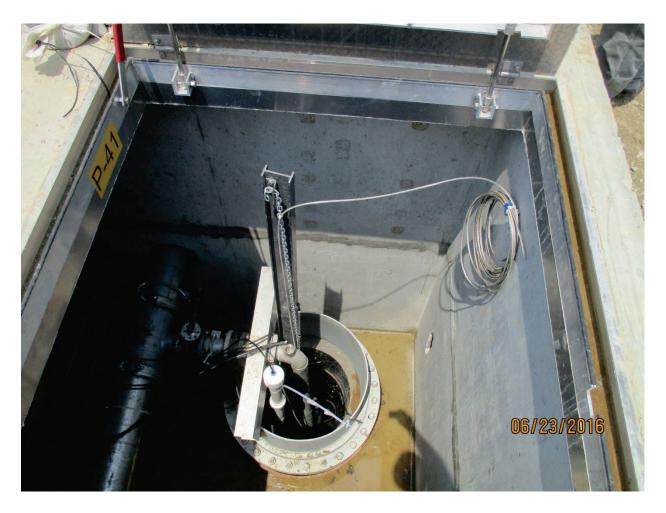
Photo 188: Floats and transducers in WW4. Jun. 2016

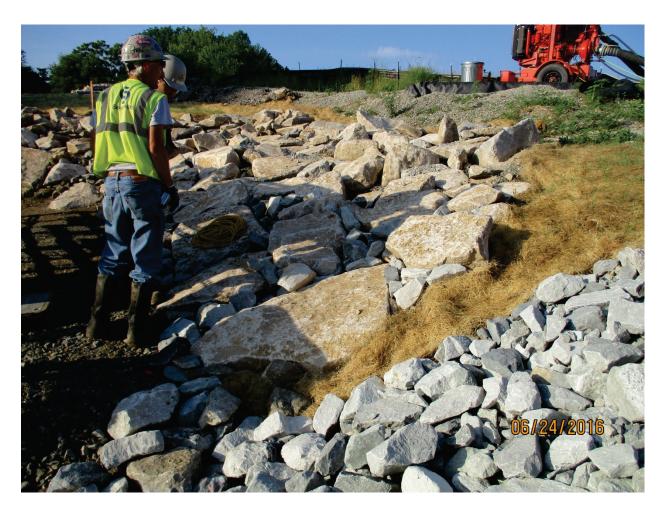
Photo 189: Re-enforcing rock barrier with riprap. Jun. 2016.

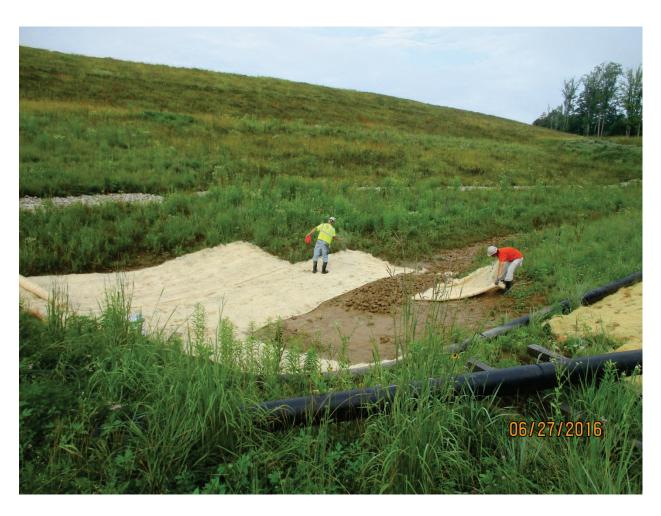
Photo 190: Seeding and placing erosion control mat in DB-3. Jun. 2016

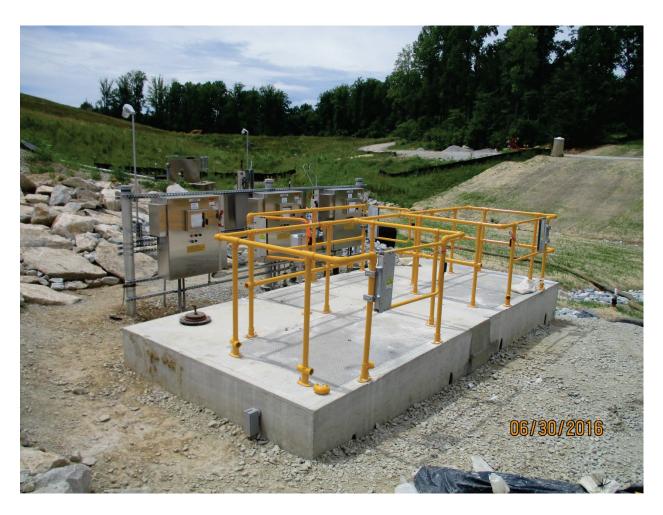
Photo 192: WW4 guard rails installed. Jun. 2016

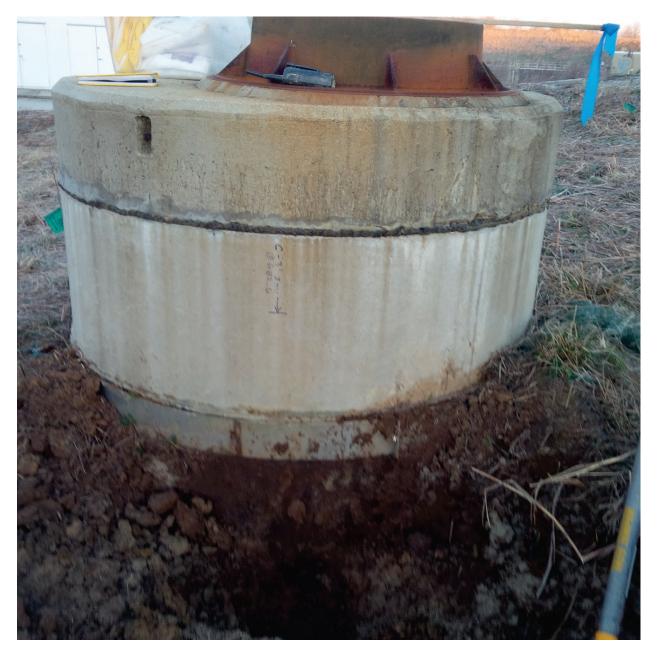
Photo 193: Raising pipe into MH-7. Jul. 2016
